Completion Report  
Pueblo Pintado Ruin  
Chaco Canyon National Monument  
1969

Ruins Stabilization Unit  
Southwest Archeological Center  
Globe, Arizona  
November 1971

Description: Comprehensive stabilization of Pueblo Pintado Ruin, Chaco Canyon National Monument, second season.

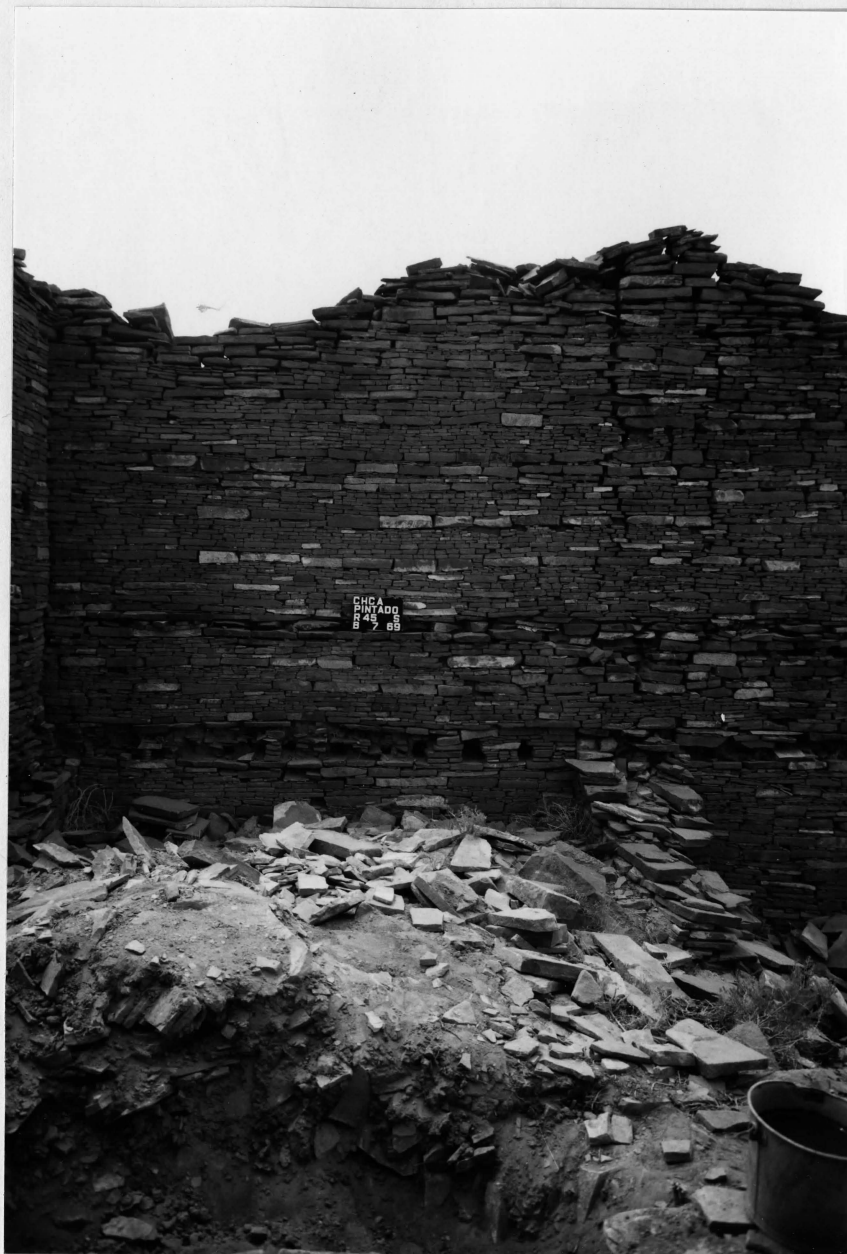
Pueblo Pintado Ruin  
Chaco Canyon National Monument

Room 45, South wall, before stabilization. This wall is an excellent example of the wall masonry conditions throughout the ruin. The top courses are loose and "ready to fall". The face has missing veneer, eroding beam sockets and cracks which weaken the entire wall.

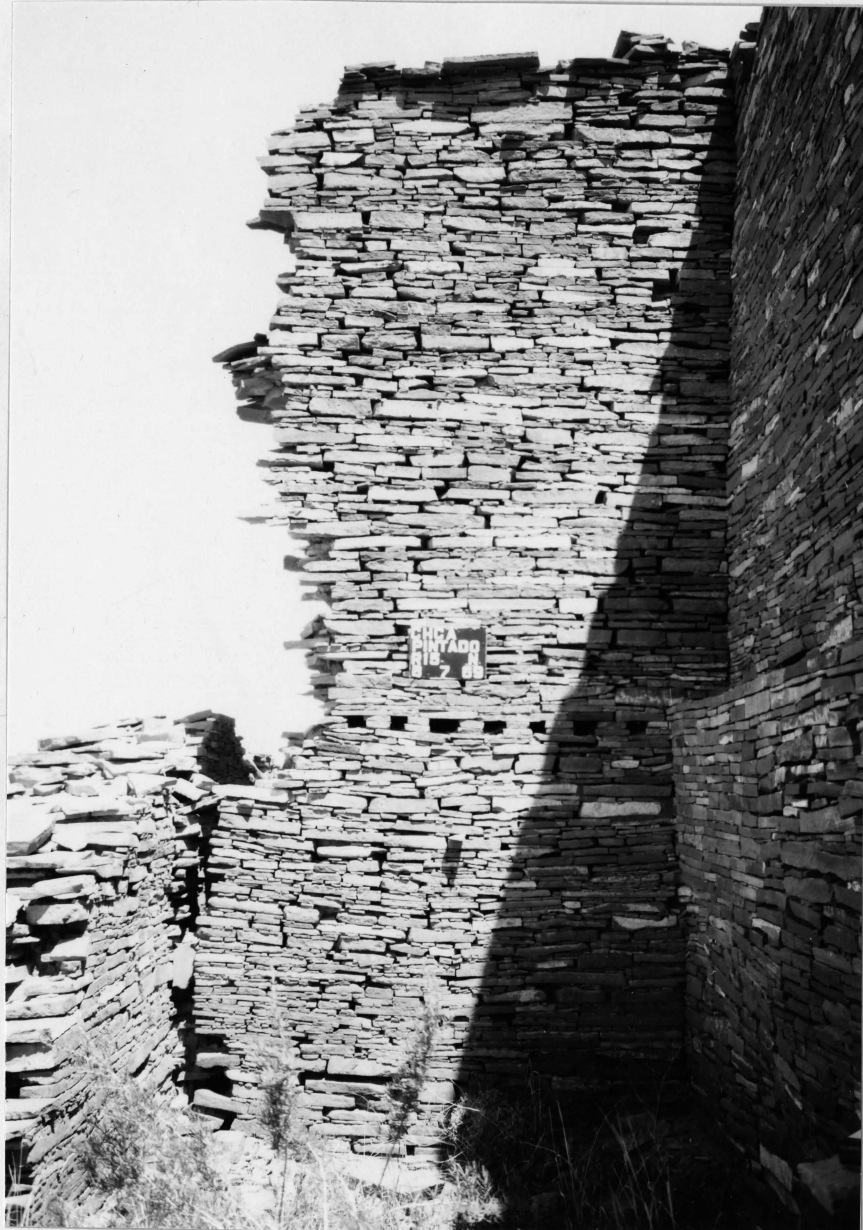
Pueblo Pintado Ruin  
Chaco Canyon National Monument

Room 15, north wall, before stabilization. This view, in the west wing of the ruin, illustrates the extremely loose, separated and overhanging condition of the wall stubs. Advanced erosion threatens the collapse of superb wall sections.
