# Burnside Bridge

## Historic Structure Report

Antietam National Battlefield  
Burnside Bridge  
**Historic Structure Report**

February 2017

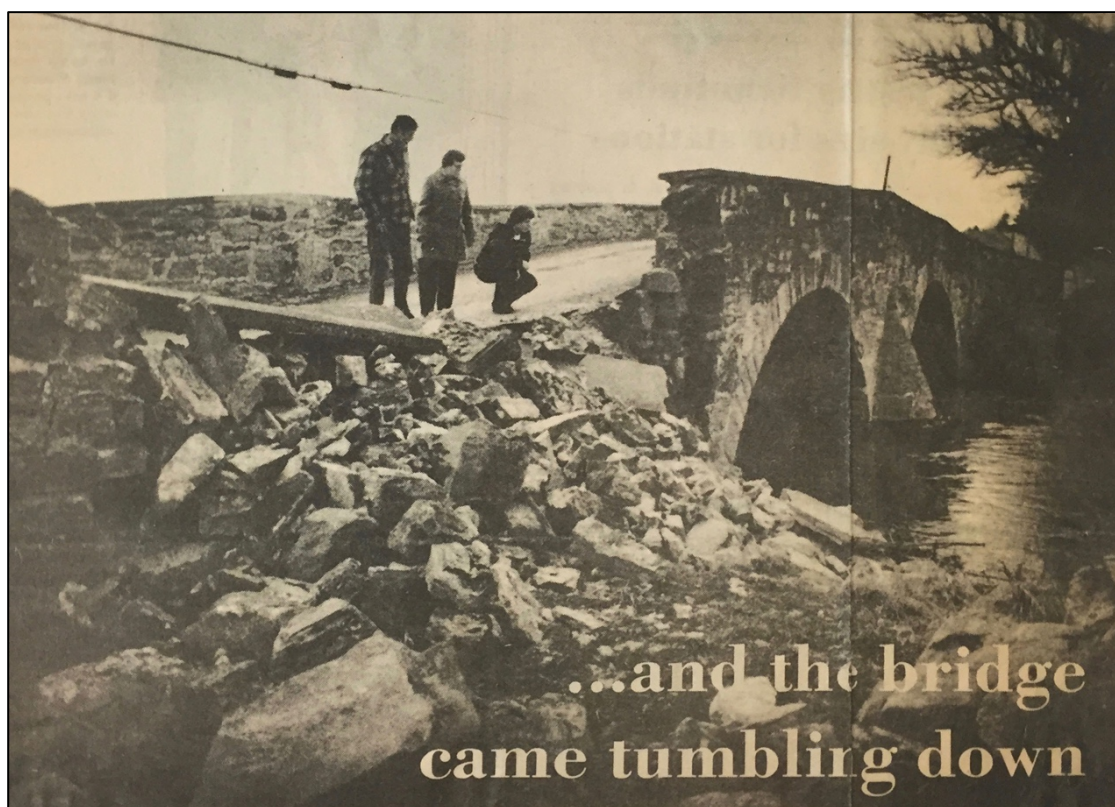
**Figure 10.** A wall collapses at Leitersburg bridge (also referred to as Strite's Mill Bridge in 1982. Source: Washington County Free Library, Washington County Bridges vertical file.

These bridges are referred to as “stone masonry spandrel filled spans” by engineers. The fill material has soaked up all the rain water over the past one-hundred-plus years, causing the walls to bulge outward and pull away from the pavement (particularly at Rose's Mill Bridge on Garis Shop Road). Also, the forces by vehicles, trucks over the five-ton limit, and speeding cars were causing too much damage and strain to the bridges.<sup>35</sup> A stone bridge spanning over the Conococheague was demolished in the late 1970s due to damage done by Hurricane Agnes in 1972. At that time, it was considered cheaper to replace a bridge than to repair it. Wider bridges were built which allowed for two-way traffic.<sup>36</sup> Due to damage by storms and the strain from vehicular traffic, the bridges began to decay and crumble. For example, the Wilson Bridge began to crumble into the Conococheague Creek (fig. 11). Many efforts were made to save the bridge, the largest span in the county. It was

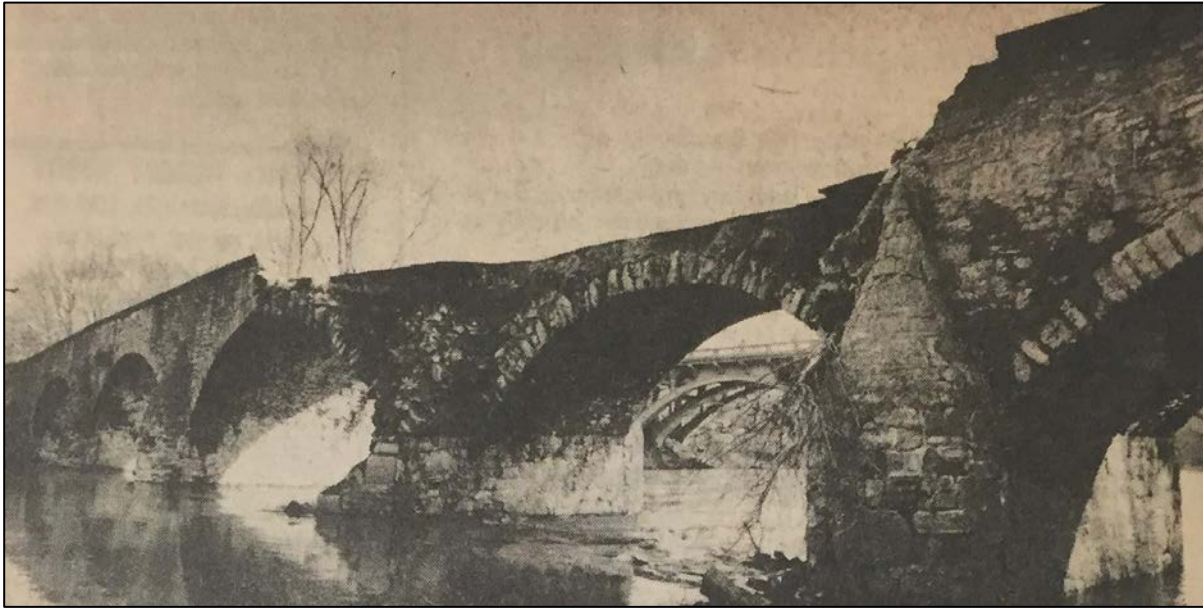
**Figure 11.** Wilson Bridge in a state a decay, crumbling into the water. Source: Washington County Free Library, Wilson Bridge vertical file.

believed that Hurricane Agnes had a lot to do with its state. The portions which had crumbled into the water were rebuilt and the bridge is now used for pedestrians and fishermen.

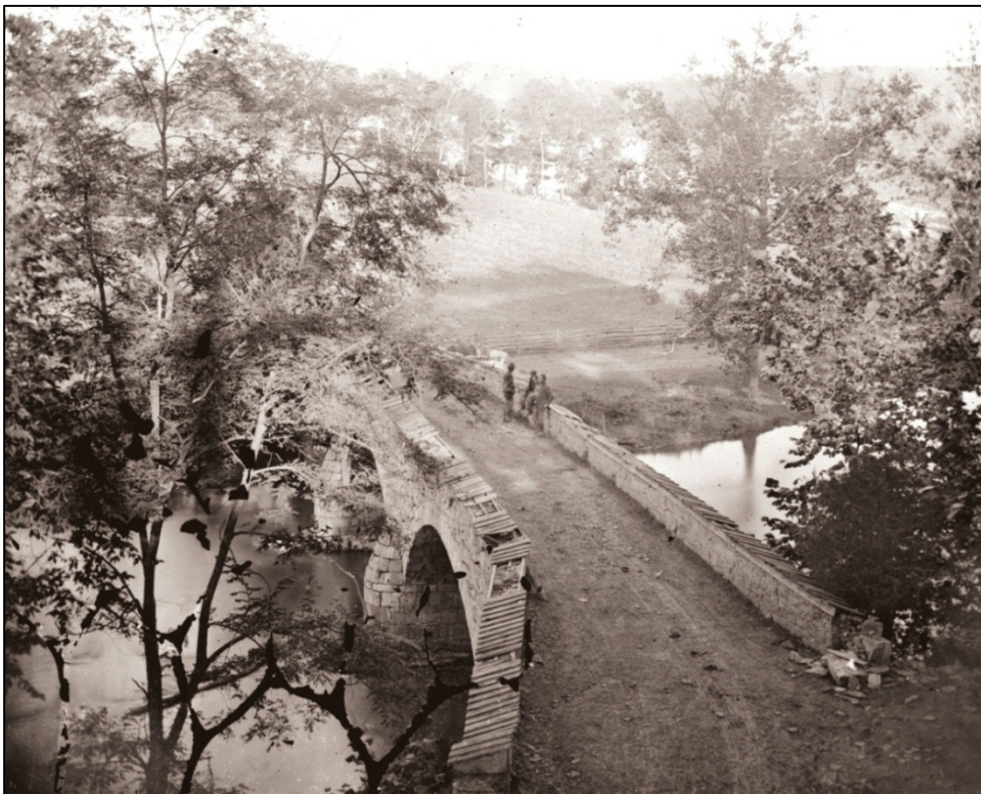
**Figure 15.** Alexander Gardner's photograph of Burnside Bridge after the Battle of Antietam. As can be seen, the coping of the bridge was heavily damaged, as was the southwest corner. Photo: Library of Congress, <https://www.loc.gov/item/cwp2003006118/PP/>.

Two days after the battle, Civil War photographer Alexander Gardner took photographs of the battlefield at Antietam, including Burnside Bridge. These are the earliest known photographs of the bridge. A view from the high ground shows the wood coping heavily damaged and some debris on the roadway (fig. 15). The stone of the bridge looks relatively intact from this perspective, except the southwest corner appears to be damaged. In another photograph, a soldier is standing near the stone wall on the east bank of the creek (fig. 16). Several markers can be seen in the foreground. It is believed that pieces of the wood coping were used as temporary grave markers for soldiers. Many of these pictures depict conditions of the bridge at that time (fig. 17). Vegetation can be seen growing in some of the abutments.

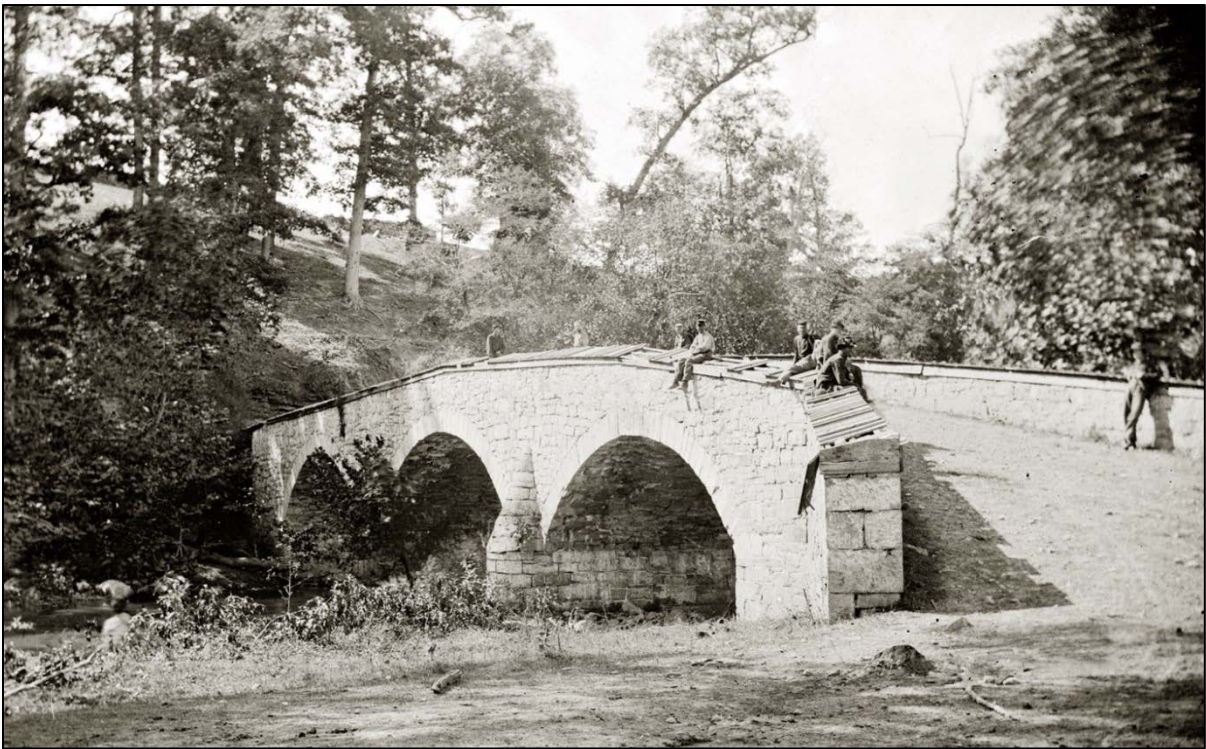
**Figure 17.** Alexander Gardner's photograph of soldiers sitting on the damaged wood coping of the bridge. This photograph is looking west across the bridge to the Confederate's position on the hill. Photo: Library of Congress, <https://www.nps.gov/anti/learn/photosmultimedia/gardnerphotos.htm>.

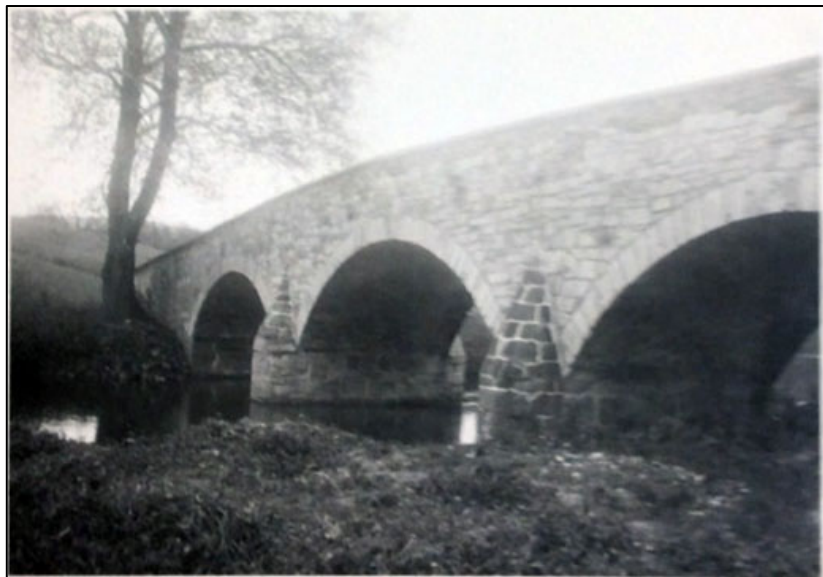
**Figure 26.** Photograph from 1947 of the repointing completed by Boonsboro contractor B.L. Smith. Photo: Antietam National Battlefield archives images.

Beginning in the late 1940s, the bridge was repointed every few years for continued maintenance and to upkeep a clean appearance. Portland-cement mortar was used until the 1960s. The repointing and repairing work performed in 1947 was completed by Boonsboro contractor B.L. Smith. The scope of work included “pointing and repairing of the stone work in the arches and piers” of the bridge (fig. 26).<sup>27</sup>

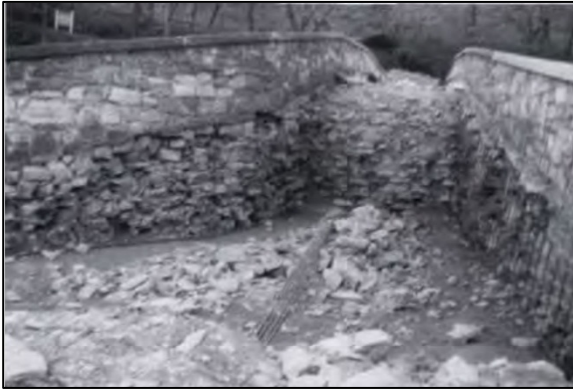
**Figure 28.** The 1955-56 work, seen above, included removing the fill above the arches, placing reinforcing bars against the spandrel walls. Note the condition of the back of the spandrel wall. Photo: Peck Peck & Associates and McMullan & Associates Pre-Design Bridge Composition & Analysis report, 2014.

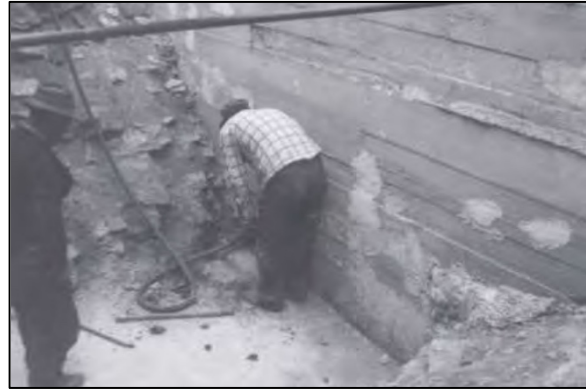
**Figure 29.** The 1955-56 work, seen above, included drilling holes through the arches for new weep holes. Note the condition of the back of the arch barrels. Photo: Peck Peck & Associates and McMullan & Associates Pre-Design Bridge Composition & Analysis report, 2014.

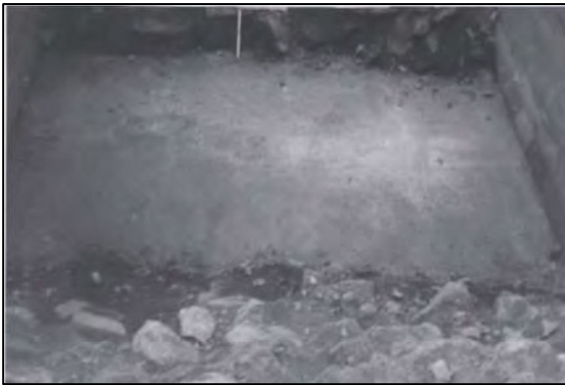
**Figure 30.** The 1955-56 work, seen above, included placing a concrete slab over the piers and the abutments a few feet above the springline and sloped to weep holes. Photo: Peck Peck & Associates and McMullan & Associates Pre-Design Bridge Composition & Analysis report, 2014.

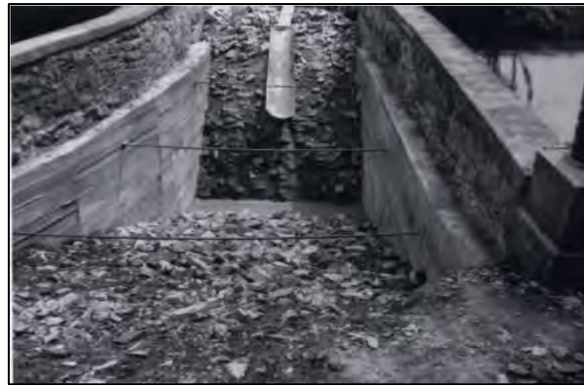
**Figure 31.** The 1955-56 work, seen above, included placing concrete walls against the spandrel walls with tie bars between. Note the concrete chute placed against the backside of the arch barrel stones. The walls are located over the piers and abutments do not extend to the centerline of the span. Photo: Peck Peck & Associates and McMullan & Associates Pre-Design Bridge Composition & Analysis report, 2014.

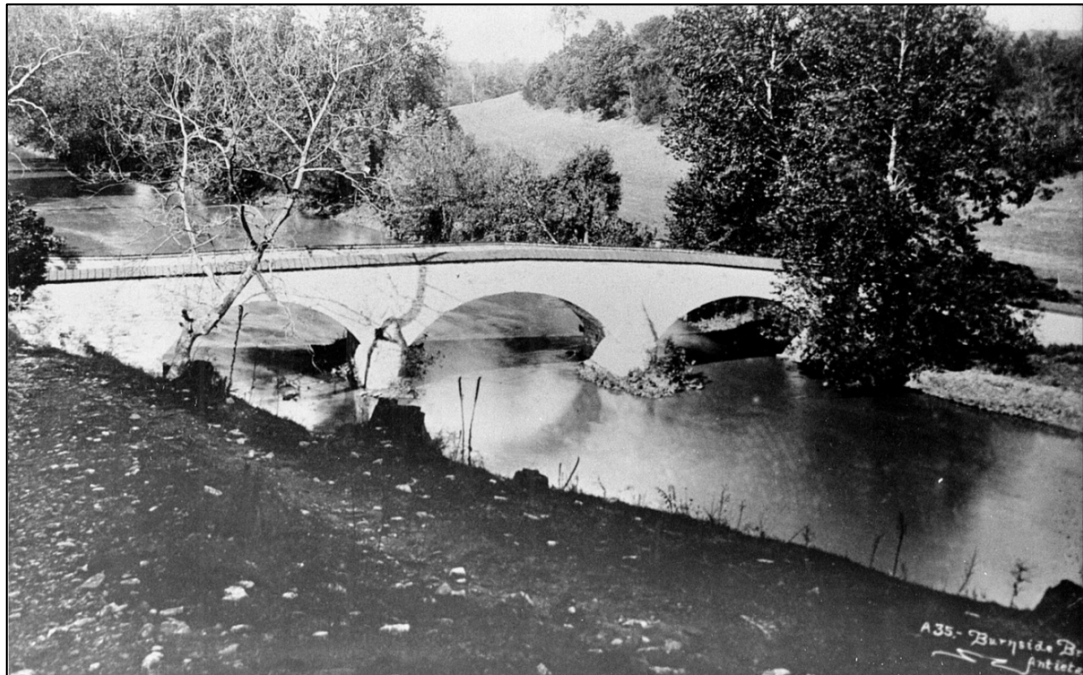
**Figure 36.** Photograph of Burnside Bridge taken from west bank looking north towards the bridge. Photo: NPS DSC eTIC No. ANTI 302 D15.

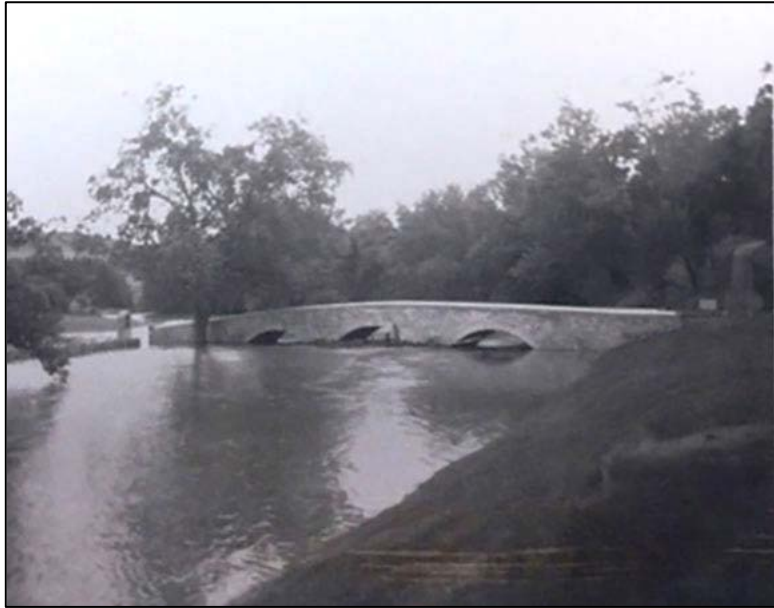
**Figure 38.** The creek rose during Hurricane Agnes. The bridge is partially submerged in water, as seen in this June 20, 1972 photograph. Photo: Antietam National Battlefield archives images.

In 1972, Hurricane Agnes struck Washington County and caused area-wide flooding. A photograph shows the water line of Antietam Creek nearly to the top of the bridge's arches (fig. 38).

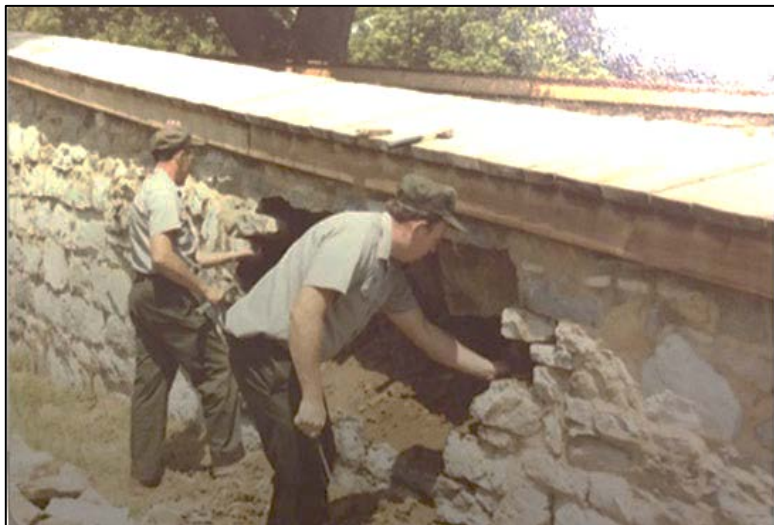
**Figure 39.** Maintenance workers repair the outer face of the spandrel wall in 1980. Photo: Antietam National Battlefield archives images.

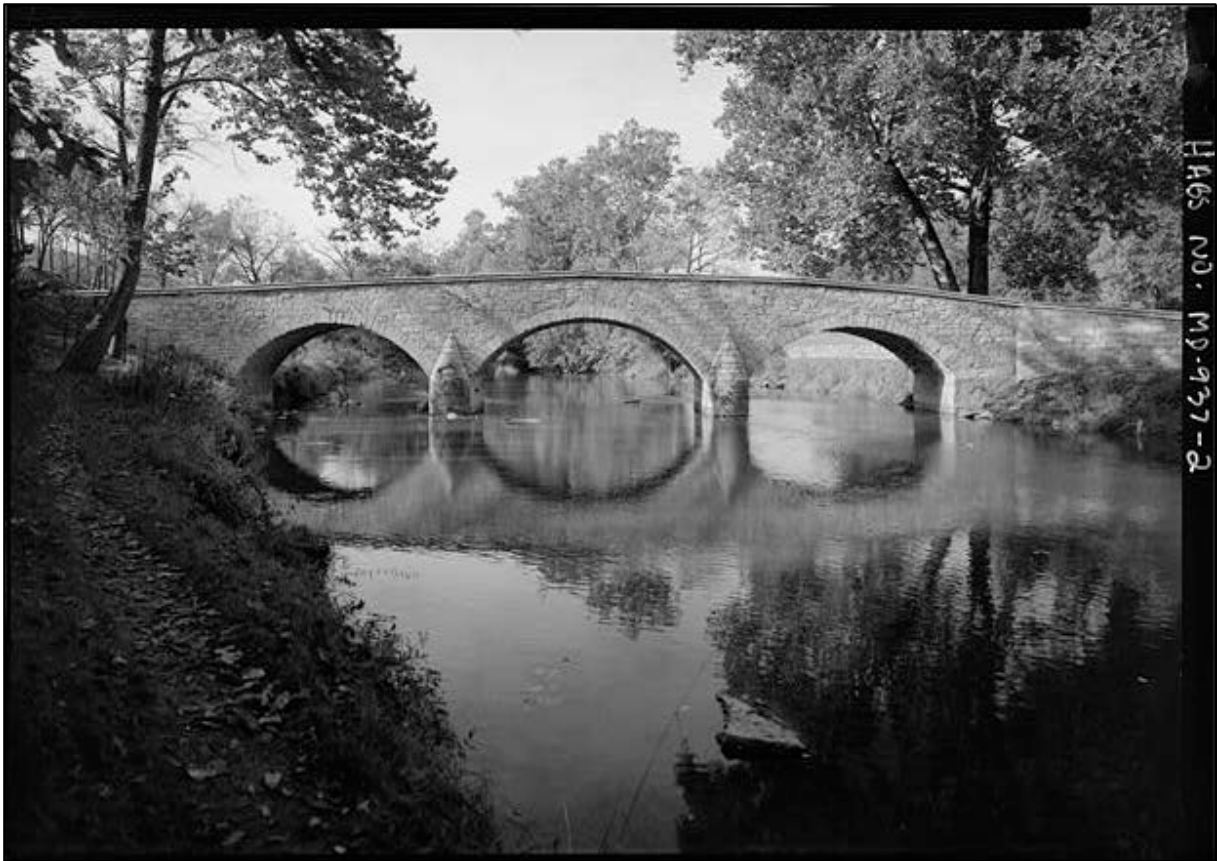
**Figure 40.** 1980s Historic American Building Survey (HABS) photograph of Burnside Bridge taken by Jack Boucher. The view is from the south looking upstream. Photo: Library of Congress, <https://www.loc.gov/item/md1081/>. Refer to Appendix B for larger printout of this photograph.

Also during the 1980s, Historic American Building Survey (HABS) photographer Jack Boucher photographed the bridge, which shows the condition of the bridge at this time (fig. 40). Concurrently HABS documented the bridge in a three-sheet drawing set (figs. 41-42).

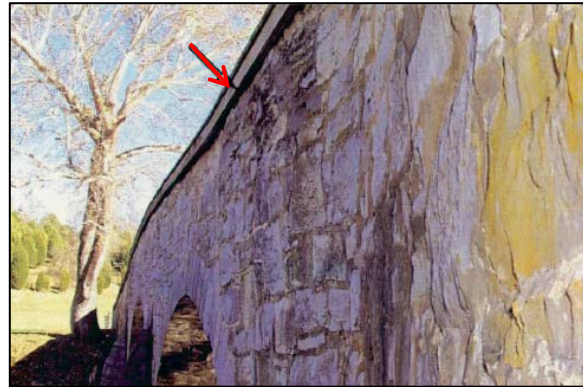
**Figure 43.** Bulge (arrow) in upstream side of spandrel wall noted in 2001 FHWA inspection report. Photo: NPS DSC eTIC No. ANTI 302 D37H.

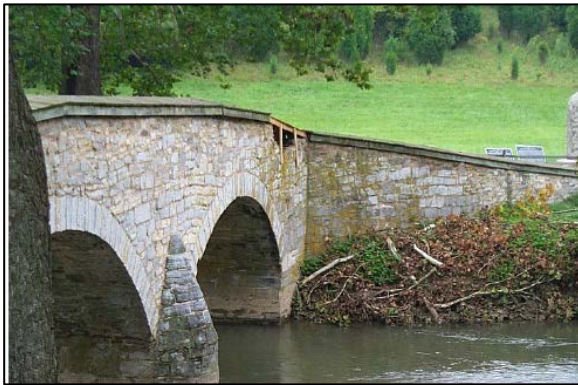
**Figure 45.** Damage to south spandrel wall (downstream) near east abutment. Photo: NPS DSC eTIC No. ANTI 302 D371.

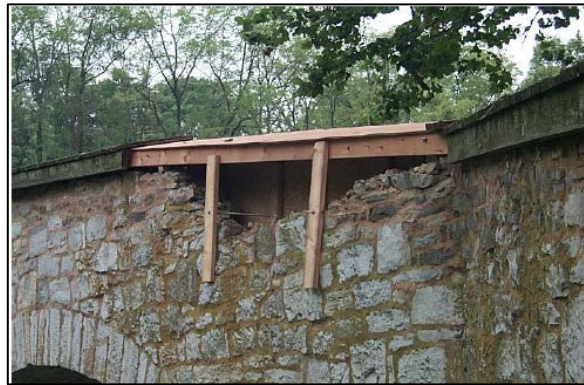
**Figure 46.** The park installed a temporary wood barrier at the damaged section. Photo: NPS DSC eTIC No. ANTI 302 D371.

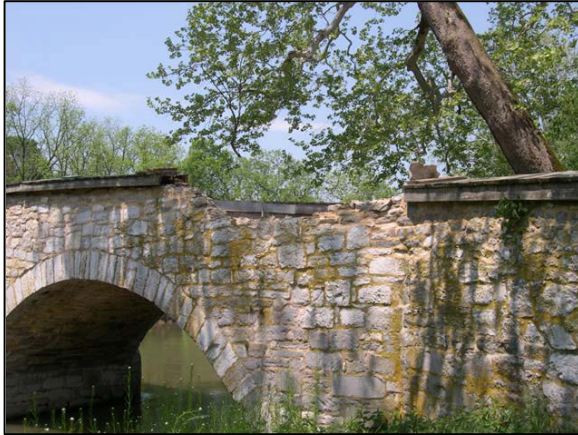
**Figure 47.** A witness tree limb fell and incurred damage to the bridge during 2003's Hurricane Isabel. Photo: NPS DSC eTIC No. ANTI 302 C10.

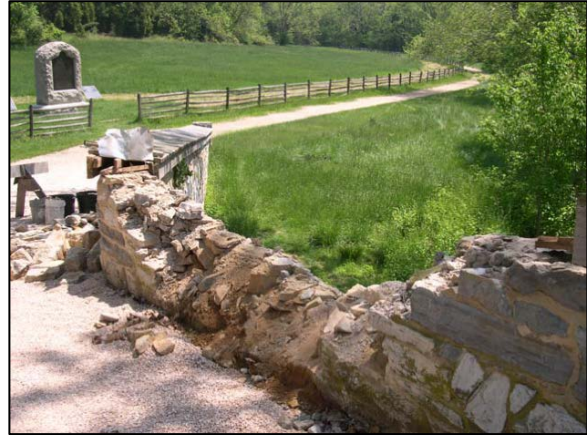
**Figure 48.** Severe damage on interior face looking southeast. Photo: NPS DSC eTIC No. ANTI 302 C10.

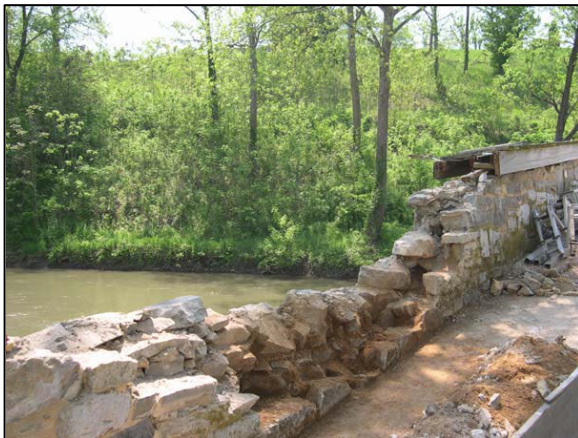
**Figure 49.** Looking southwest, the damaged masonry was removed down to sound material. Photo: NPS DSC eTIC No. ANTI 302 C10.

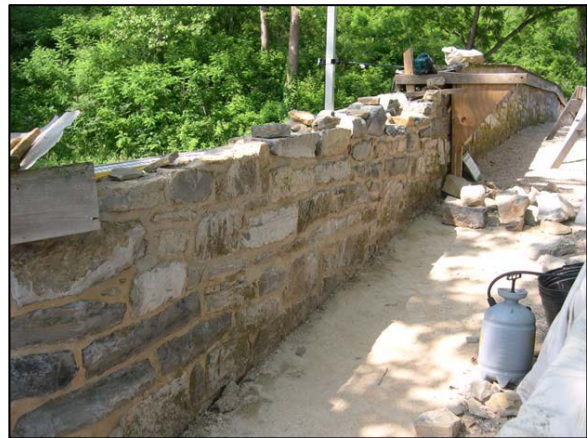
**Figure 50.** The stone was relaid with historic coursing and historic construction techniques. Photo: NPS DSC eTIC No. ANTI 302 C10.

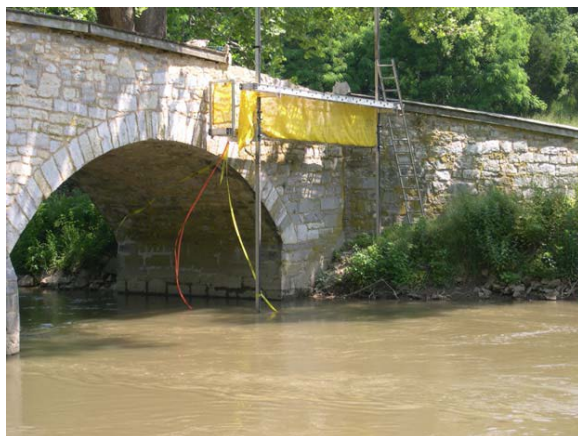
**Figure 51.** Scaffolding was installed on the south side of the bridge. Photo: NPS DSC eTIC No. ANTI 302 C10.

The storm-damaged portions were repaired by the NPS Historic Preservation Training Center (HPTC) in 2004 (figs. 47-52). Tasks included “reestablish[ing] damaged/missing masonry associated with the parapet wall, damage to the wood coping, and failing mortar joints throughout the bridge.”<sup>61</sup>

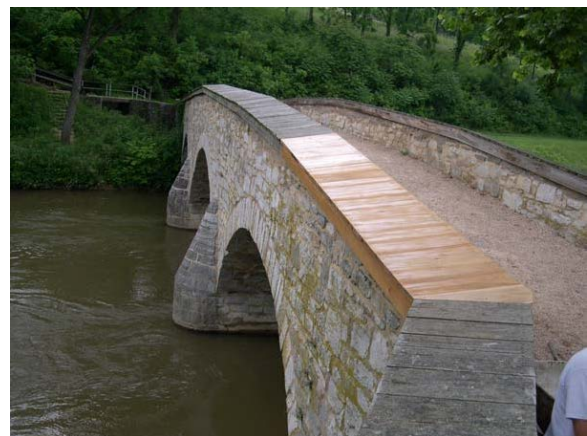
**Figure 52.** The completed repairs. Photo: NPS DSC eTIC No. ANTI 302 C10.

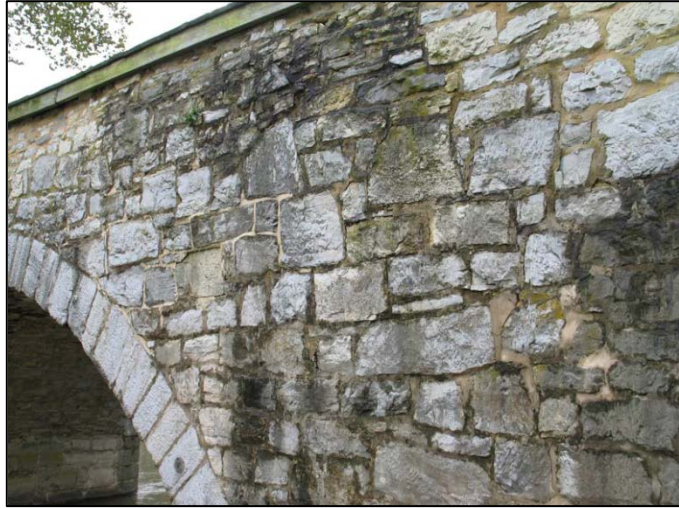
**Figure 53.** Condition of bulging northwest spandrel wall in 2005. Note the discoloration of the stone which is much darker near the bulge. Photo: 2005 Bridge Inspection Report, NPS DSC eTIC.

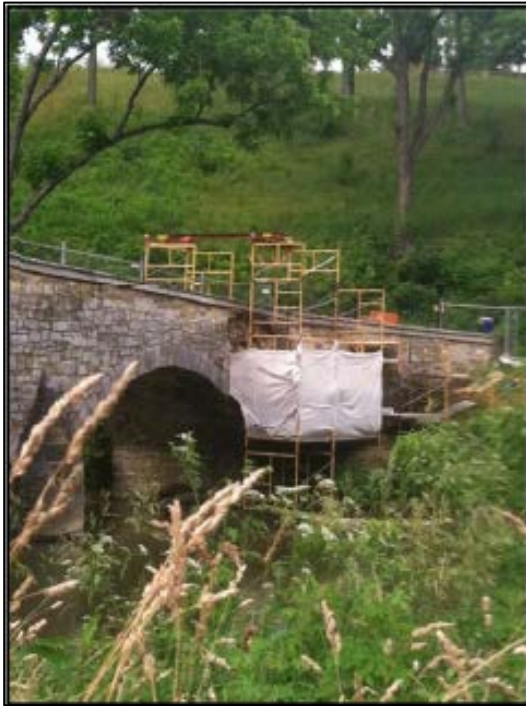
**Photo 54.** Scaffolding was set in creek to service as a working platform. Photo: NPS DSC eTIC No. ANTI 302 127626.

In June 2014, several months after the collapse, a NPS HPTC crew conducted an emergency stabilization and restored the bridge using a Maryland Heritage Areas Authorities grant. The scope of work included: installation of scaffolding in the creek (fig. 54); temporarily removing 16’-0” of wood coping (fig. 55); relaying recovered stone (80% of total) and new stone (20% of total) and pointing of spandrel and parapet walls in 1:2½ mix of Type 5 Natural Hydraulic Lime to C-144 sand from Silver Hill Aggregates, the same mix used by HPTC in 2004 (figs. 56-57); installation of stainless steel reinforcement in line with concrete support wall extant on the bridge interior; installation of three PVC weep holes beginning at bottom course of interior parapet wall and

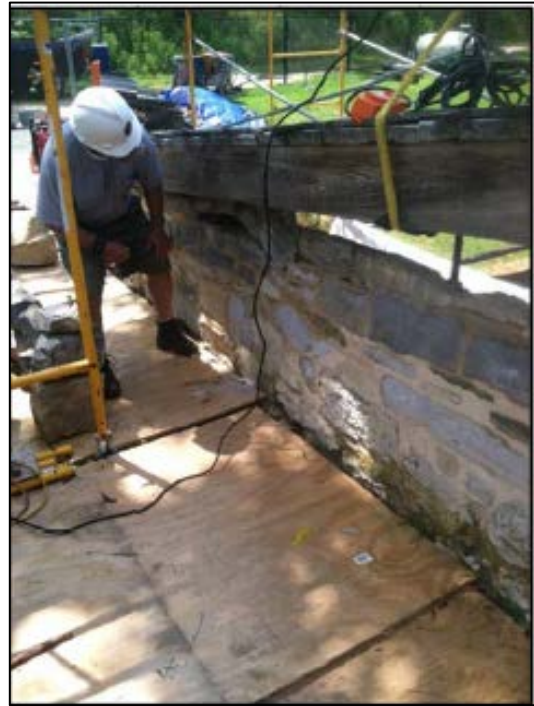
**Figure 55.** Removing the wood coping. Photo: NPS DSC eTIC No. ANTI 302 127626.

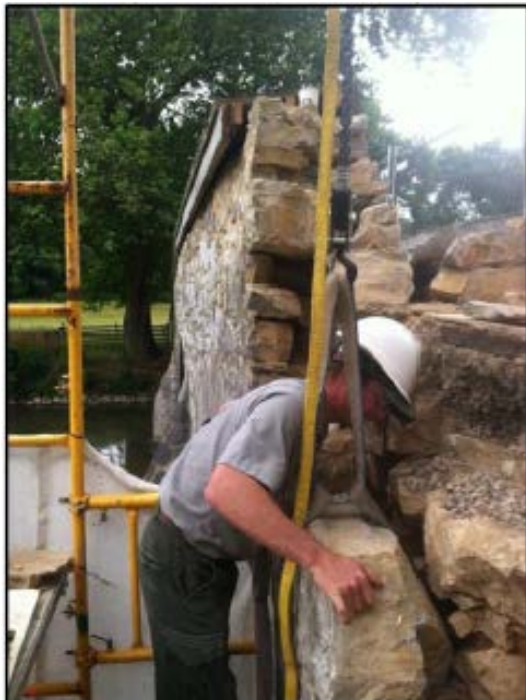
**Figure 56, left.** Setting a recovered stone in place. Photo: NPS DSC eTIC No. ANTI 302 127626.

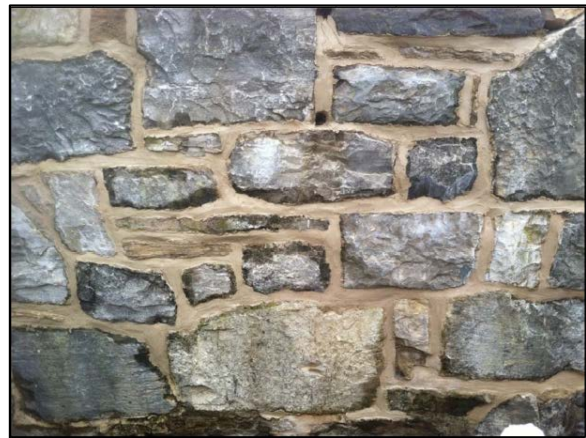
**Figure 57, above.** After pointing is completed. Photo: NPS DSC eTIC No. ANTI 302 127626.

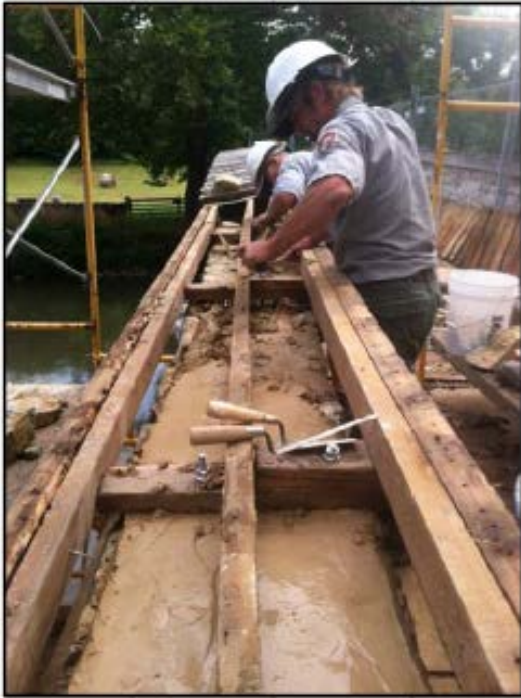
**Figure 58.** Installation of mortar wash atop stone parapet wall. Photo: NPS DSC eTIC No. ANTI 302 127626.

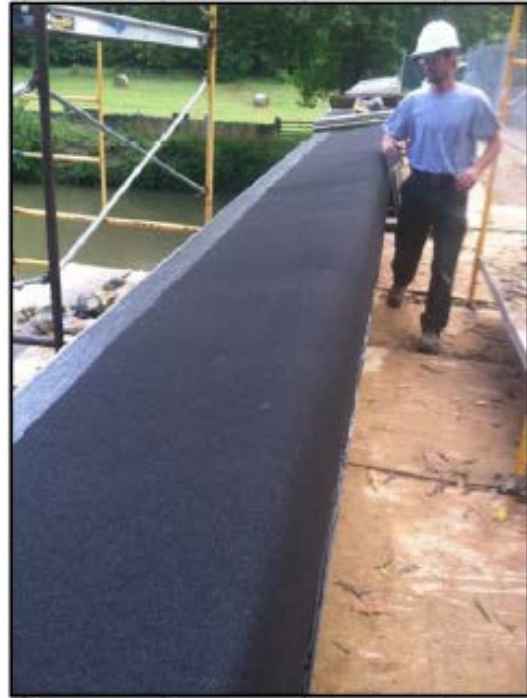
**Figure 59.** Installation of flashing above wood frame and below wood coping. Photo: NPS DSC eTIC No. ANTI 302 127626.

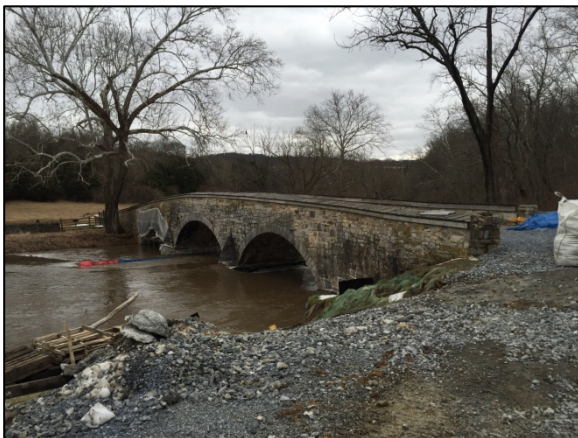
**Figure 64.** North elevation, from west bank, during Phase I of rehabilitation. Photo: HPTC, 02/25/16.

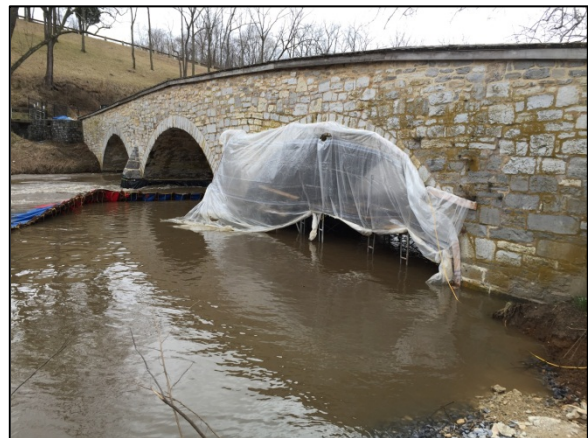
**Figure 65.** South elevation, from east bank, during Phase I of rehabilitation. Photo: HPTC, 02/25/16.

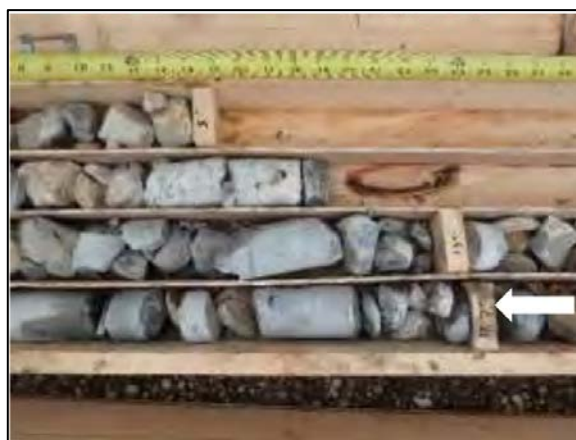
**Figure 66.** Material extracted from the interior of the piers. Note the material from the pier below the arch bearing indicated by the arrow. Photo: 2014 Pre-Design report.

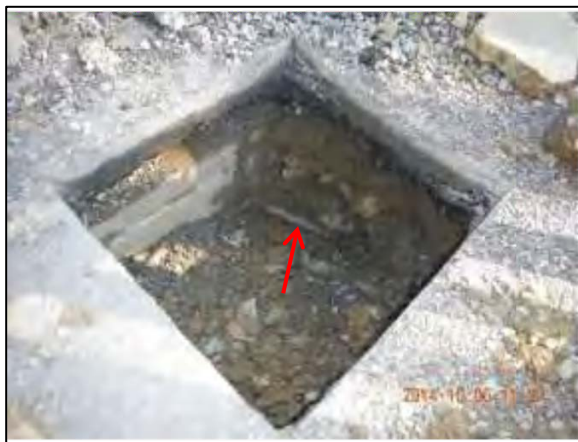
**Figure 67.** Test pit behind the west abutment. Arrow indicates tie bar. Note exposed surface of concrete wall on the left side of the pit. Also, note the brown color of the fill material. Photo: 2014 Pre-Design report.

Test pits were executed at each end of the bridge behind the abutment by the McMullan & Associates assessment team in Fall 2014 (fig. 67). The pits revealed fill composed of 0’-5”- to 0’-6”- thick, irregular-shaped stone mixed with wet, cohesive soil (fig. 68). “The edges of these stones are in contact with each other with the interstitial spaces filled with soil. The soil retained its shape when rolled into a ball or a cylinder with one’s hand. This fill was placed in the 1953 rehabilitation when the original fill was removed for installation of the concrete walls.”<sup>14</sup>

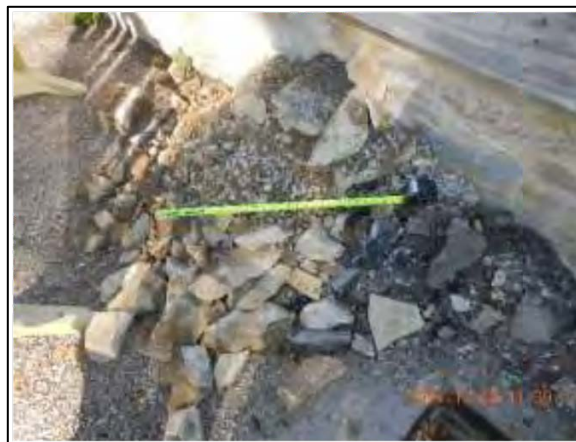
**Figure 68.** Fill material from the test pit behind the west abutment. Note the size of the stones. Photo: 2014 Pre-Design report.

| <b>Figure 68.</b> Fill material from test pit (PP&A, 2014) ..... | 64 |

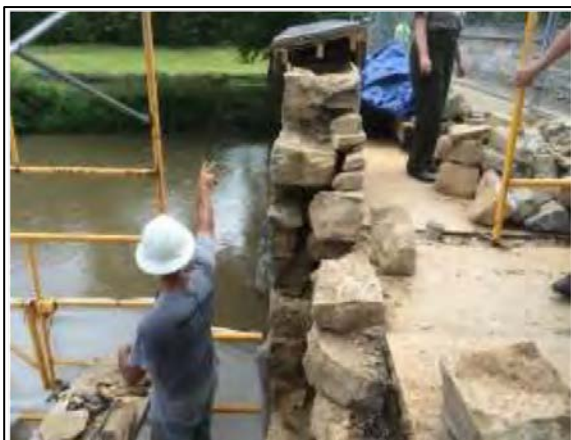
**Figure 69.** Sectional view of the parapet and the spandrel wall which shows the double-wythe wall construction. Note the limited overlap of the stones of each wythe. Photo: 2014 Pre-Design report.

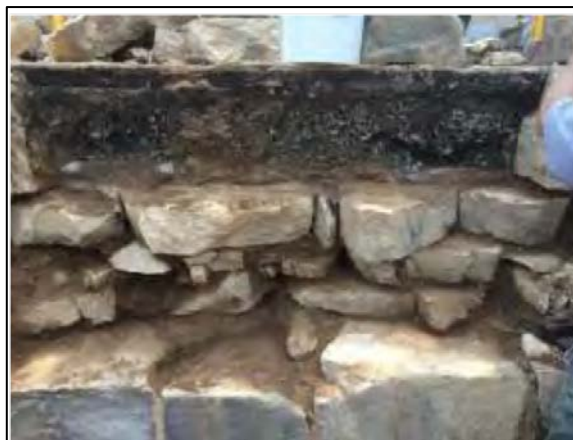
**Figure 70.** The stones below the asphalt and gravel are part of the spandrel wall. Note the smaller stone used to pin the larger stone overlaps between the wythes. Note also the lack of mortar. Photo: 2014 Pre-Design report.

| <b>Figure 70.</b> Sectional view of the roadbed and spandrel wall below (PP&A, 2014) ..... | 65 |

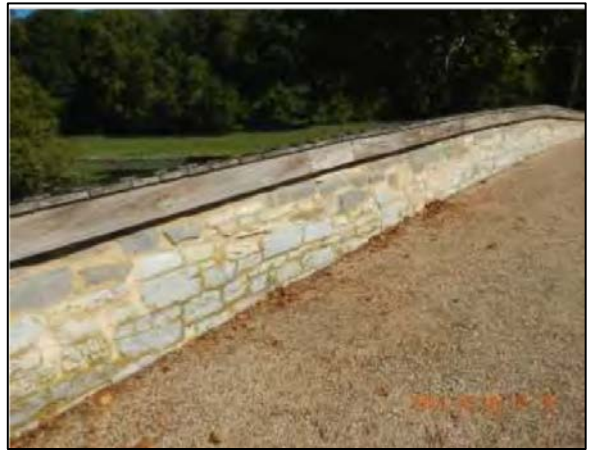
**Figure 71.** The deck abuts the parapet on each side of the bridge. The surface of the deck is fairly level between parapets. Water was observed to run against the northwest parapet wall during coring and during rain. Photo: 2014 Pre-Design report.

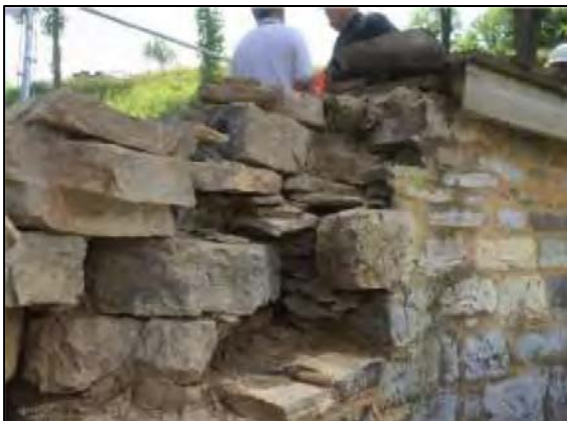
**Figure 72.** Construction of the parapet. Note the smaller flat stone units on the interior and the lack of mortar between the stones. There is little overlap between the two wythes of stones. Photo: 2014 Pre-Design report.

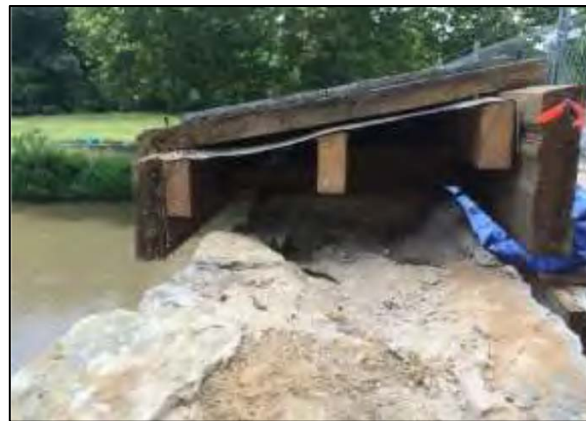
**Figure 73.** Construction of the wood coping over the parapet. Note the rough surface of the top of the parapet could allow water to sit and infiltrate the wall. Photo: 2014 Pre-Design report.

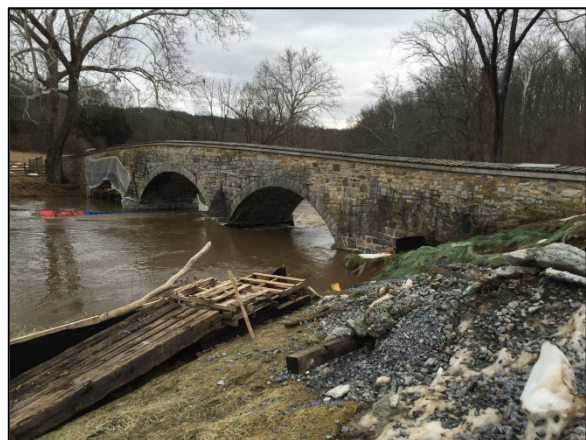
**Figure 74.** The north elevation of the three-span Burnside Bridge from the west bank with Antietam Creek flowing underneath and through it. Photo: HPTC, 02/25/16.

- Three-span stone masonry bridge with spandrel walls and fill in between (figs. 74-75).
- Arched spans and are supported by abutments (fig. 76) and two interstitial rounded stone masonry piers anchored in the stream bed and slightly extend out past the spandrel and arch faces (fig. 77).
- Stone masonry parapets are an extension of the spandrel walls (no break or watertable) (fig. 78).
- Stone masonry wing walls at each end of the bridge. On the west bank the north wing wall is angled to accommodate vehicles entering from the road; likewise occurs to the south wing wall of the east bank (fig. 79).

- Three arched spans (arcs of a circle) allow Antietam Creek to flow under and through the bridge (see fig. 74).
- The central span is 25'-6" between the two stone masonry piers. Each side span measures 30'-0" between a stone pier and adjacent abutment walls.

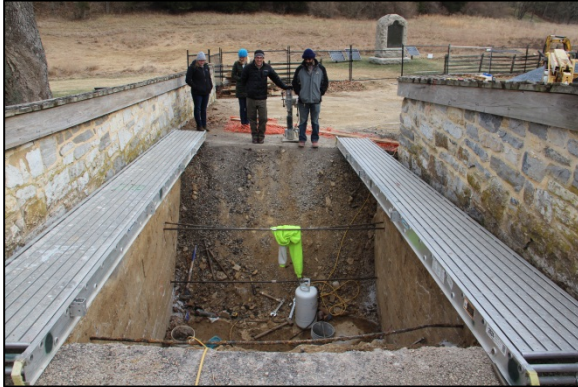
**Figure 75.** Fill was removed from between the spandrel walls during the currently ongoing rehabilitation project. Photo: HPTC, 01/20/16.

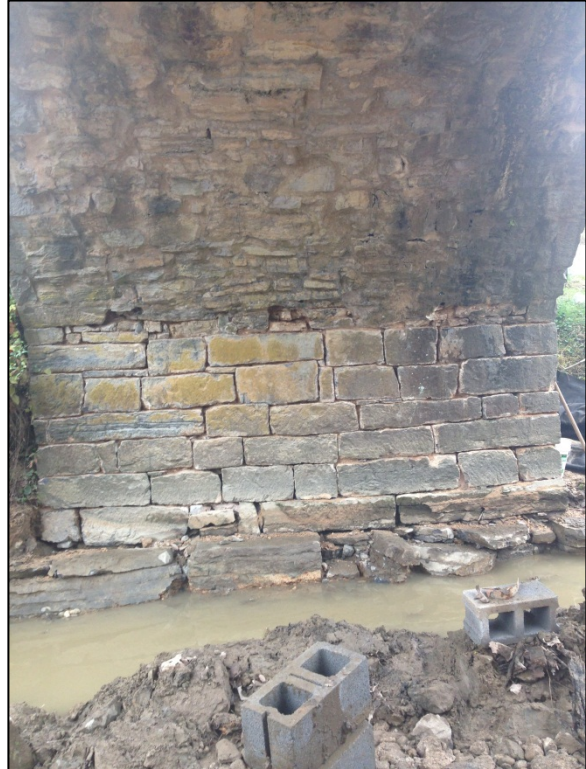
**Figure 76, right.** The west abutment wall from underneath the arch. Photo: HPTC, 10/27/15.

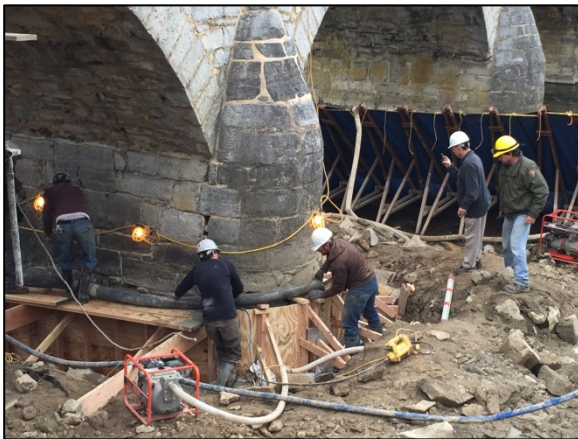
**Figure 77.** The two piers project from the face of the bridge spandrel walls and are rounded to ease water flow under the bridge. A footing is being poured around each pier during the current rehabilitation project. Photo: HPTC, 11/18/2015.

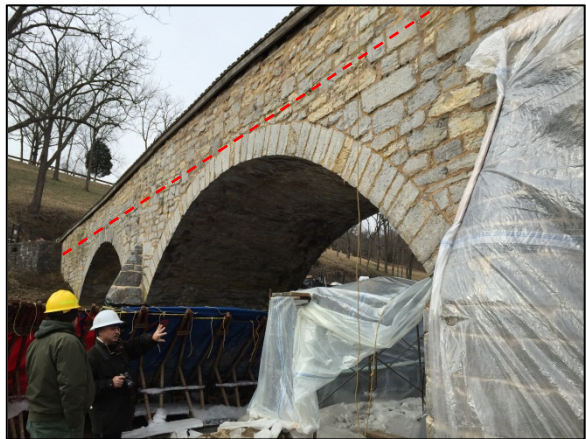
**Figure 78.** The parapet walls (above dotted line) are a continuation of the spandrel walls with no breaks or water tables. Photo: HPTC, 01/20/16.

- Faced rubble stone masonry laid in some historically correct lime-based mortar (Portland cement-based mortar is not character defining) (see figs. 78-82).
- Wood coping of small boards perpendicular to the length of the wall and sloped toward the creek (see fig. 81).

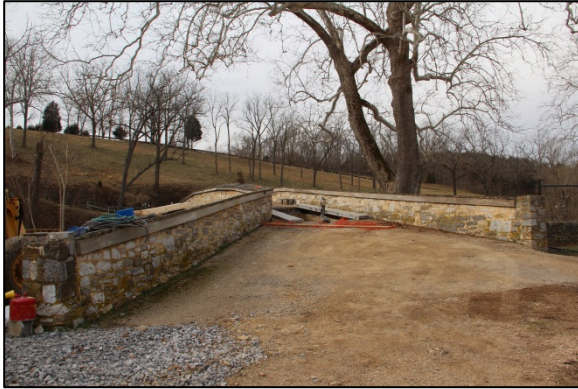
**Figure 79.** The south wing wall on the east bank (shown here) and the north wing wall on the west bank are splayed to accommodate turning vehicles onto the bridge. Photo: HPTC, 01/20/16.

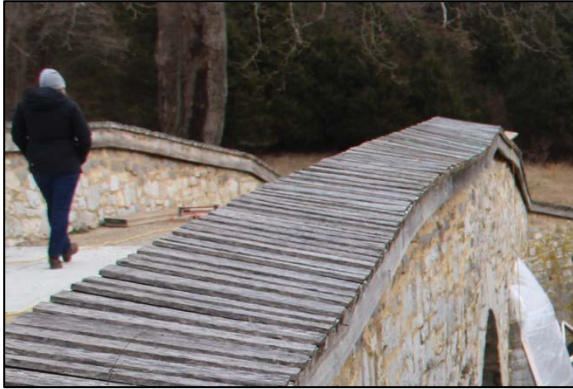
**Figure 81.** Wood coping boards run along the top of the parapets sloping toward the creek. Photo: HPTC, 01/20/16.

- Wood coping of small boards perpendicular to the length of the wall and sloped toward the creek (fig. 81).
- *Voissoirs* (arch ring stones) are pronounced; no keystones are present (fig. 82).

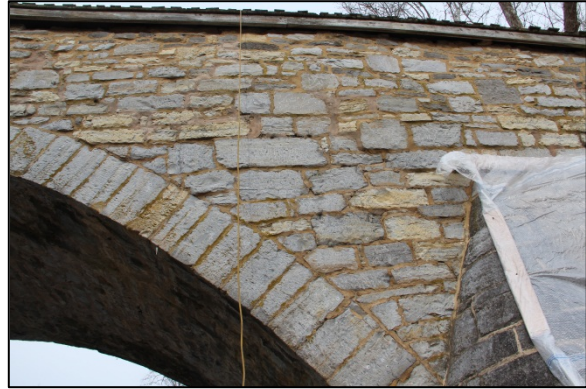
**Figure 82.** *Voussoirs* ring the arch. Photo: HPTC, 01/20/16.

- Faced rubble stone masonry laid in some historically correct lime-based mortar (Portland cement-based mortar is not character defining) (see figs. 78-82).
- *Voissoirs* (arch ring stones) are pronounced; no keystones are present (see fig. 82).

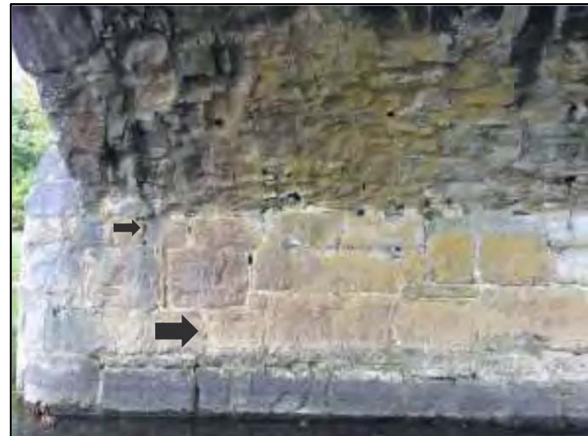
**Figure 84.** West Pier. Arrows indicate cracked stone. Photo: 2014 Pre-Design report.

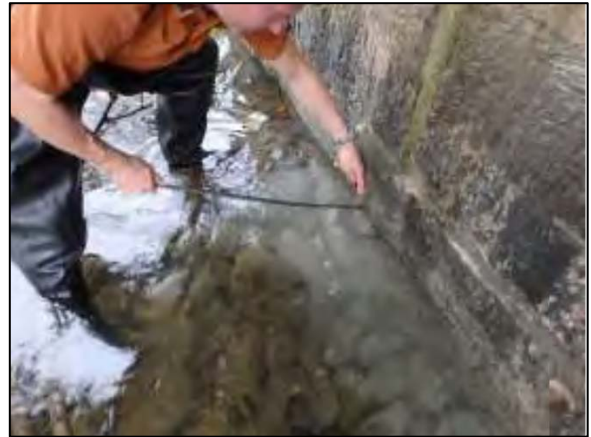
**Figure 85.** Probing under the East Pier with rebar that extended 2'-6" at one location. Photo: 2014 Pre-Design report.

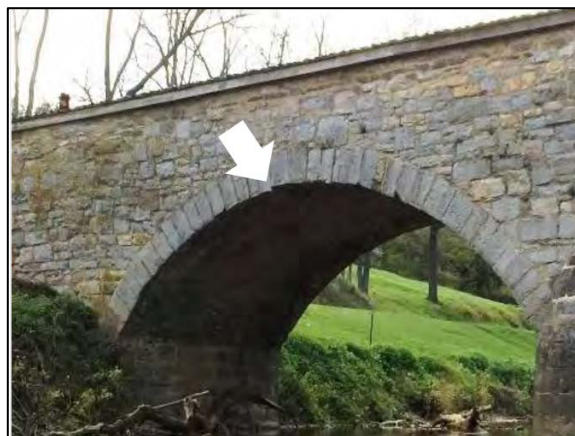
**Figure 86.** Arrow indicates location of slippage of ringstones on the south elevation of the west arch. No slippage has occurred in the arch’s barrel. This condition may have occurred during the original construction. Photo: 2014 Pre-Design report.

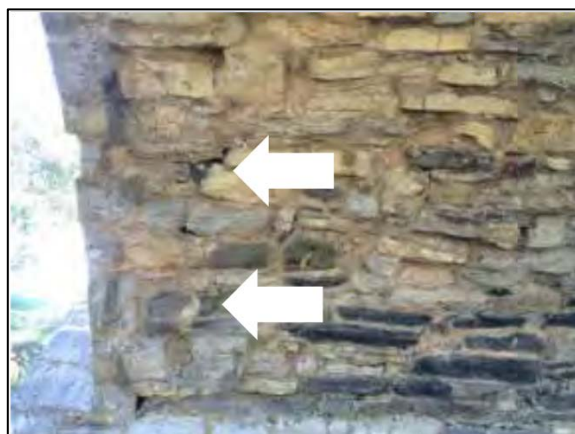
**Figure 87.** Barrel arch construction. The arrows indicate a crack underneath the spandrel wall. Photo: 2014 Pre-Design report.

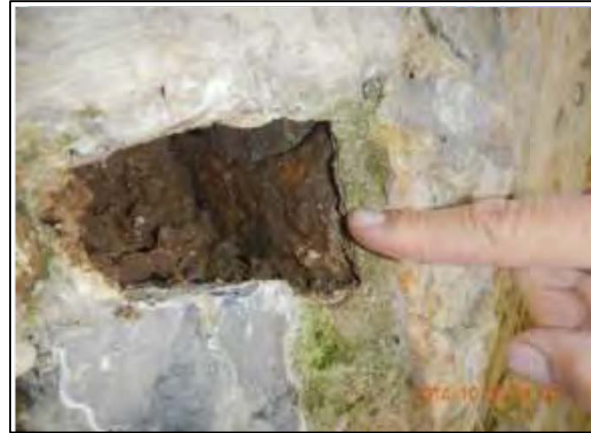
**Figure 88.** Missing mortar in arch barrel. Note the thin layer of pointing mortar in front of the brown sand at the back of the recess. Photo: 2014 Pre-Design report.

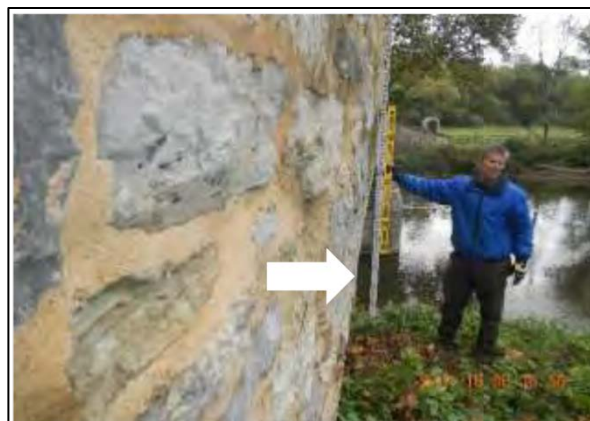
**Figure 90.** Checking to see if the wing wall on the south side of the West Abutment is plumb. Note the gap between the wall and the vertical survey rod at the arrow. Photo: 2014 Pre-Design report.
