## Wadeable Streams Monitoring at Natural Bridges National Monument, 2010–2018

Monitoring at Natural Bridges National Monument from 2010 to 2018 provided insight on the frequency and duration of large flow events in Armstrong Canyon. It also revealed how these events caused changes in the channel,

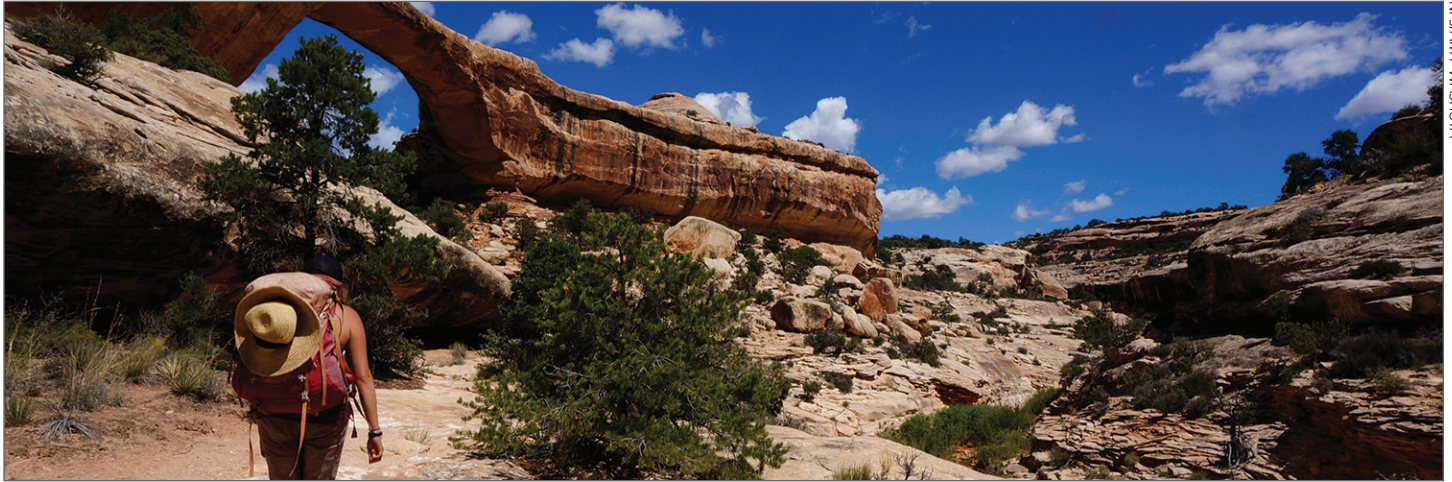
NPS/AMY WASHUTA

*Long-term monitoring shows there are many armored and scoured surfaces in Armstrong Canyon that are resistant to changes from flash floods. Vegetation appears well-adapted to these events.*

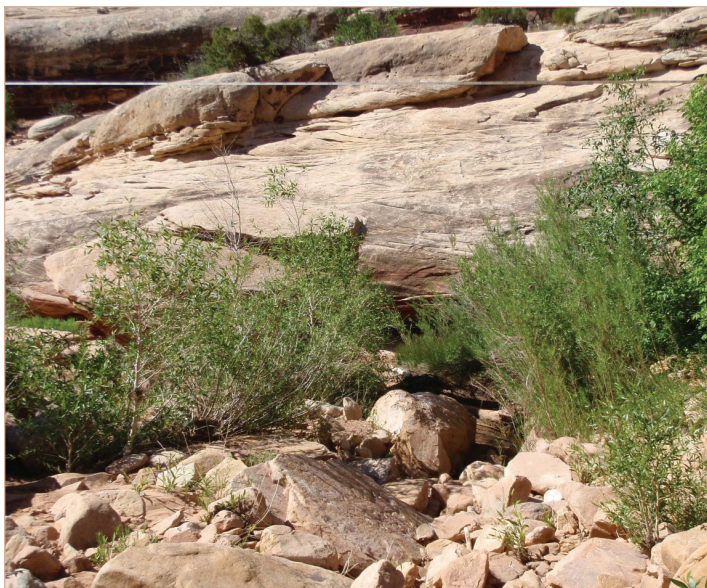
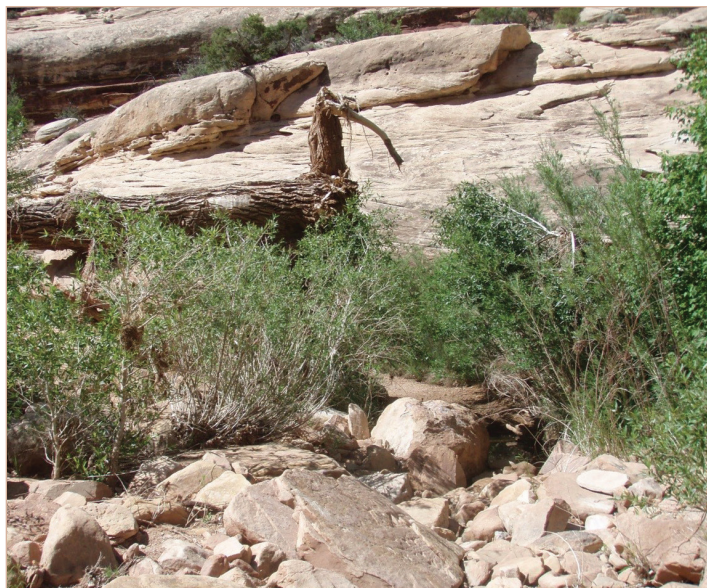
Reach 5, Transect 4 in June 2011 (left) and June 2014 (right). The channel surface and shrubs changed little after high-flow events in September 2013, but a large cottonwood trunk was washed into the reach. NPS photos.

Overall, changes in vegetation after the flash floods of September 2013 were minor, considering they were powerful enough to wash large trees down the canyon and perch them over three meters above the channel (see photos above). Plants in this sys-
