PROCEEDINGS OF THE

# **MID-CENTURY MODERN**

**Materials and Preservation**  
NATIONAL PARK SERVICE CENTENNIAL SYMPOSIUM SERIES

Proceedings of the  
Mid-Century Modern Structures: Materials and Preservation Symposium  
St. Louis, Missouri, April 13-16, 2015

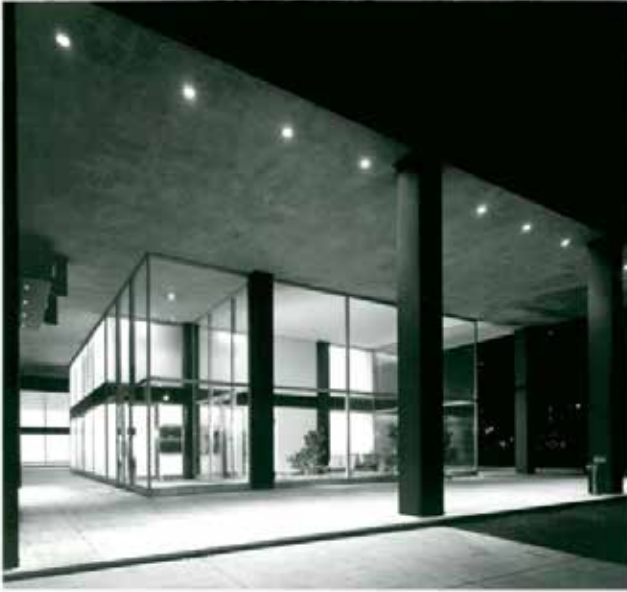
**Figure 11: 860-880 Lake Shore Drive, 1951**

Completed in 1951, 860-880 Lake Shore Drive is another of Mies' iconic works. Again, Krueck and Sexton were the architects of record, while I was restoration architect. Wiss, Janney, Elstner Associates provided the structural engineering and conservation and forensic services. In this case, the building did not need reglazing; in fact, its original aluminum window system is in surprisingly good shape. However, the steel required painting, and the concrete of the below-grade parking garage was failing. After a number of tests, it was determined that the building could in fact be painted at another time without having to fully strip all of the existing paint. [Figure 11]

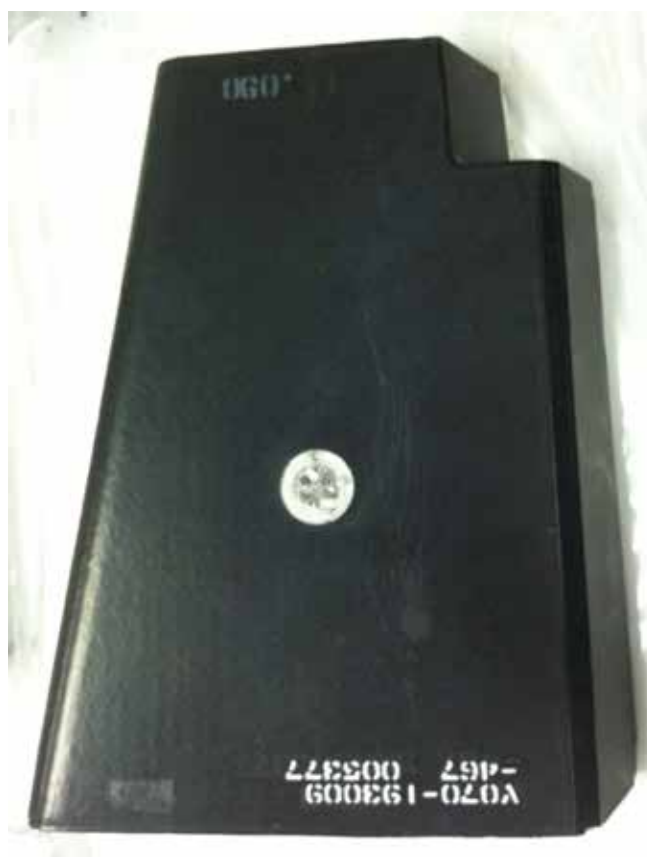
**Figure 10: Space shuttle HRSI tile. (Credit: Joseph Sembrat, Conservation Solutions, Inc., 2004)**

(on lower faces) to resist extreme heat during reentry. Each custom fitted tile was provided with an injection port so that it could be redensified with TEOS as part of reconditioning between missions. This represents one of the most compelling examples of cross-industry pollination, whereby the same compounds that have proven so useful in the preservation of historic masonry were concurrently used to great effect to further space exploration. [Figure 10]

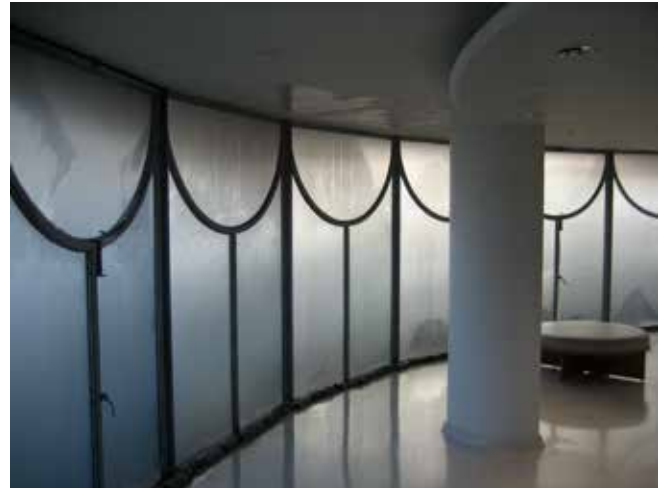
**Figure 4: Extreme condensation on the window-walls of the Guggenheim's Thannhauser Pavilion obscured the connection of the building to Central Park. (Photo by Angel Ayón.)**

At the Guggenheim, the window-walls were in an excellent state of preservation, and the skylights were in relatively good condition. However, unlike Fallingwater, in the case of the Guggenheim, the building is kept at 70° F and 50-55% relative-humidity level, producing severe condensation along the window-walls (Figure 4), making two floors of the Pavilion unusable during the colder months, and to a lesser degree, in the summer. During extreme cold weather, icicles formed at the interior steel mullions. The condensation on the window-walls at its worst obscured the view of Central Park entirely, thereby negating the building's connection to nature, one of the tenants of Frank Lloyd Wright's organic architecture. In addition, although the main skylight of the rotunda had been replicated in 1992 with a thermally-broken double-glazed unit, the original perimeter skylights were still in place and were problematic in terms of condensation within the cavity of the skylights. For a world-class art museum that exhibits priceless artwork, this was an unacceptable situation.<sup>12</sup>

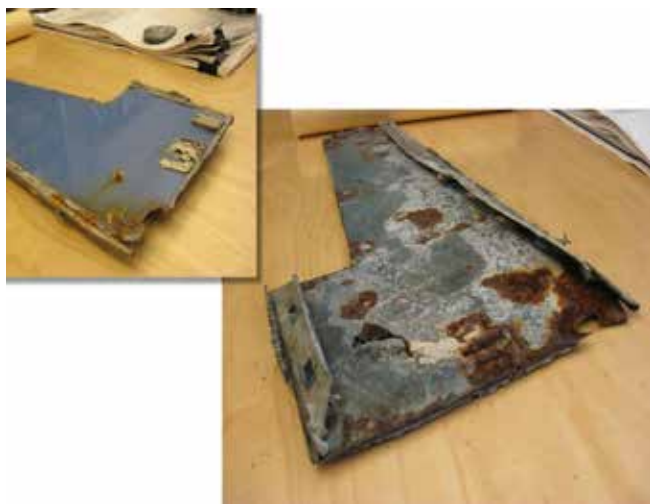
**Figure 5: rusted metal panel**

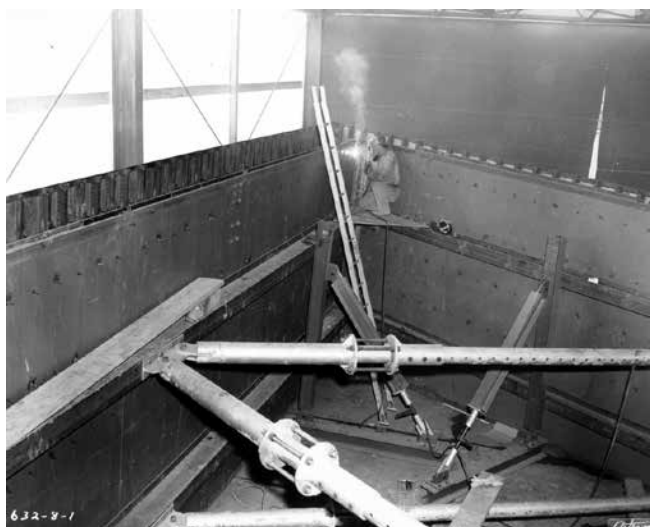
**Figure 3: Shop assembly of the Arch stations, showing internal temporary framing for placement and installation, JEFF Archives, image V106-35946**

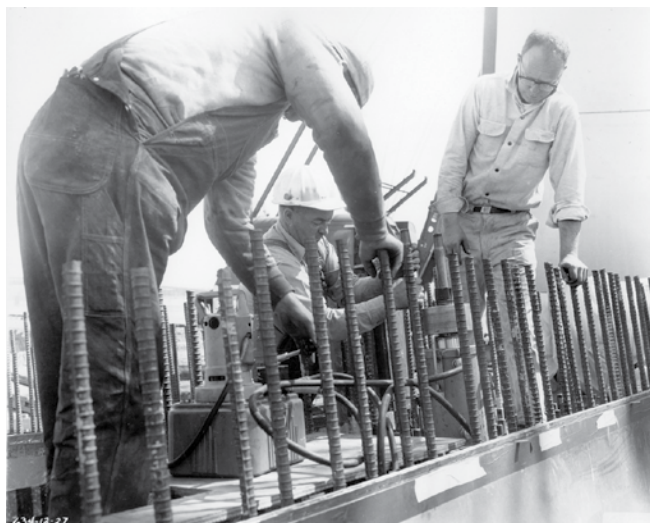
**Figure 7: Applying tensile stress to the post-tensioning bars, 1963, JEFF archives, image V106-3974**

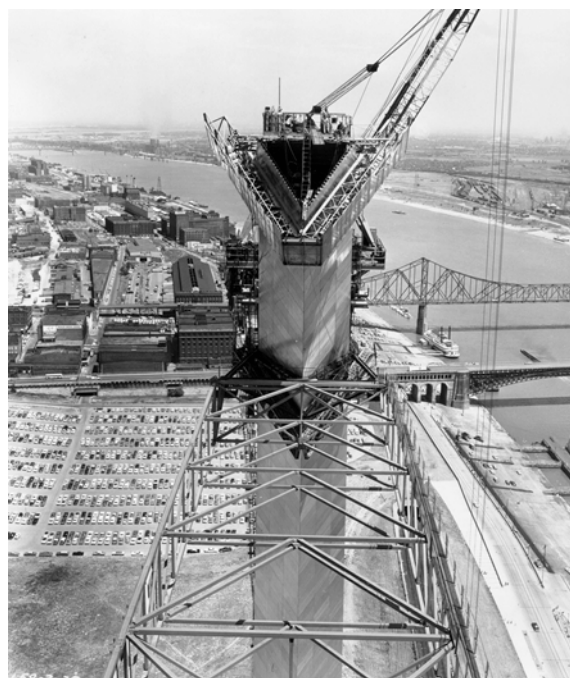
**Figure 11: View of the stabilizing strut installed during construction to resist overturning and deflection of the cantilevered Arch legs, JEFF archives, image V106-4119**

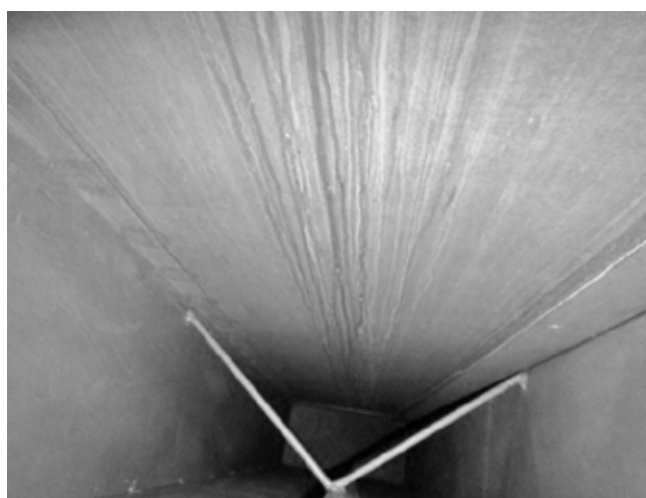
**Figure 16: Image looking upward into the interstitial spaces. The water streak orientation reveals that they were formed after the segment was set in place, but there are no signs of active water leaking.**

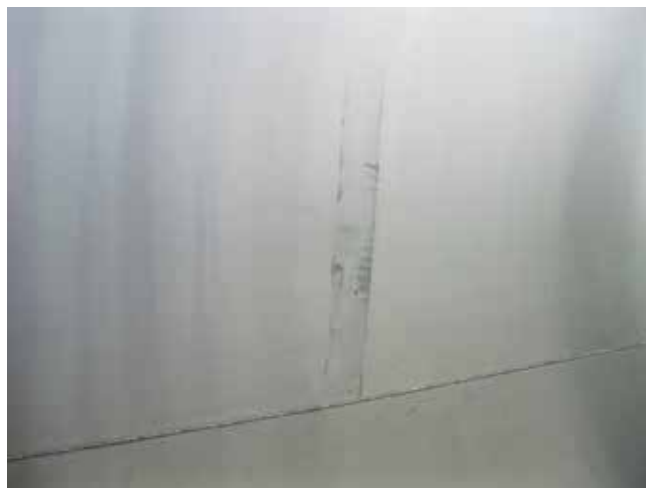
**Figure 3. Vertical blemish within panel section (west face) shown within the dashed line**

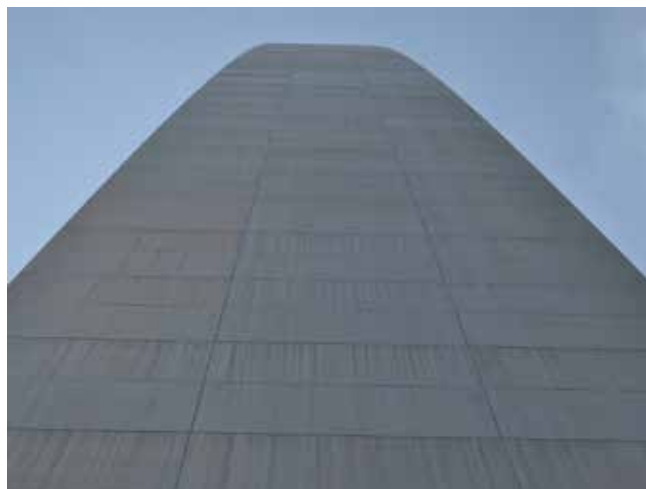
**Figure 4. Deposits from run off from horizontal welds**

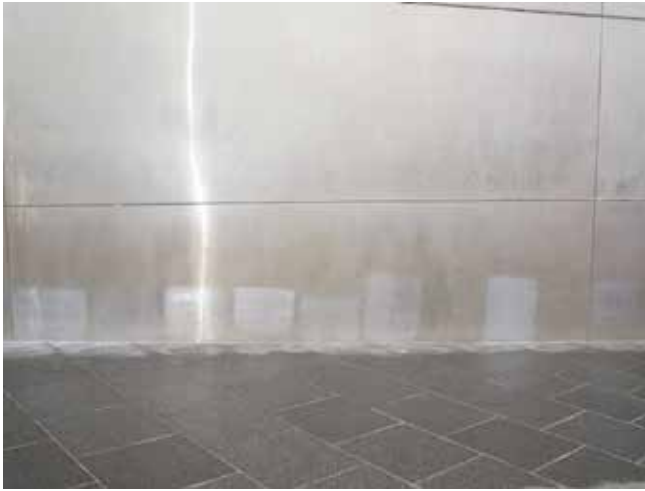
**Figure 5: Cleaning study test areas**

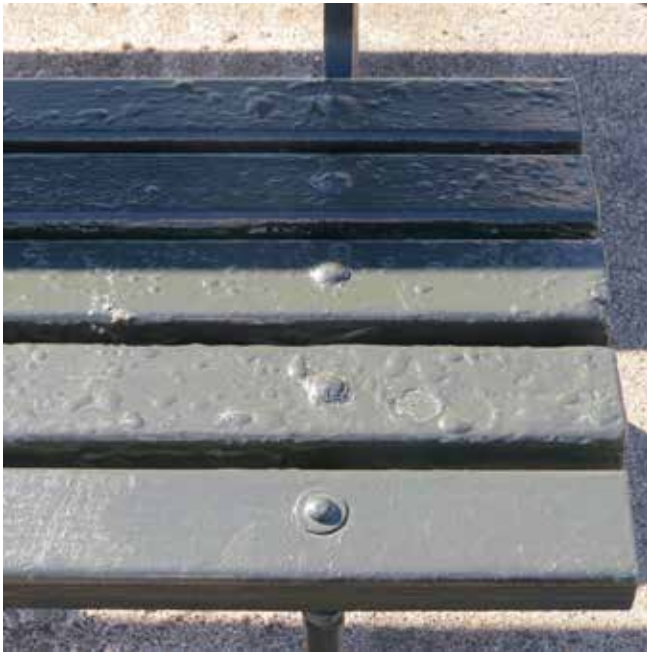
**Figure 3: Replaced slat with washer under bolt due to enlarged bolt hole. Photograph by author**

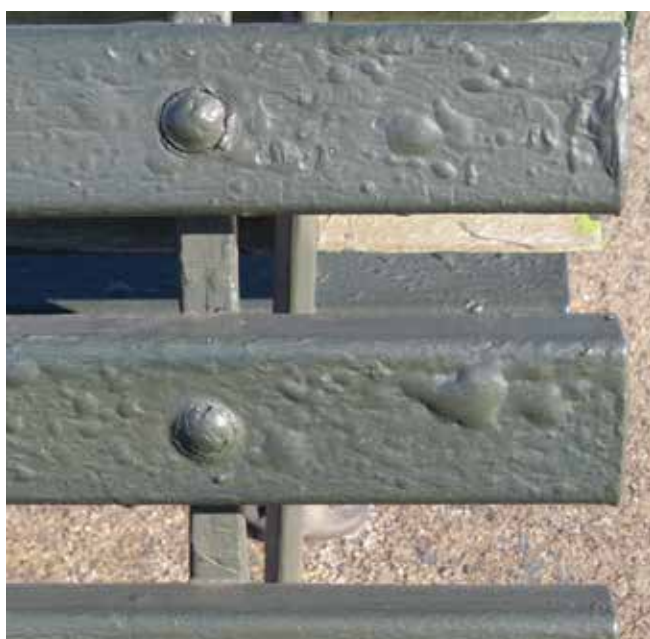
**Figure 4: Bubbling and blistering paint on bench slats.**  
Photograph by author

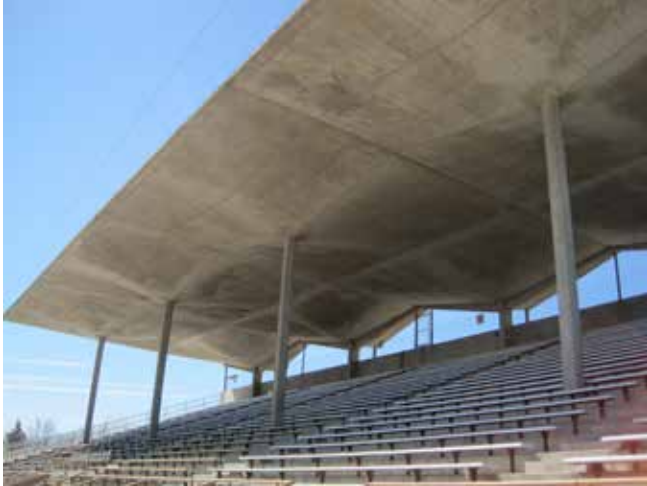
**Figure 7: Grant County Fairground Grandstand, Underside of Shell. Photo by the author, 2014**
