# Status of Climate and Water Resources at Tumacácori National Historical Park

*Water Year 2018*

Natural Resource Report NPS/SODN/NRR—2019/1972

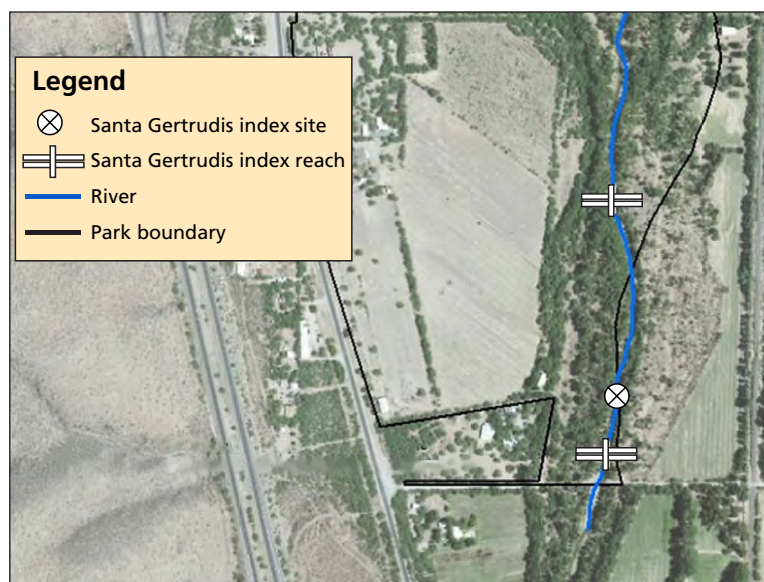
Figure 4-1. Map of Santa Cruz River, Tumacácori National Historical Park, with SODN water-quality sampling locations.
