# Wadeable Stream Suitability Assessment for Long-Term Monitoring

## *Horseshoe Bend National Military Park*

Natural Resource Data Series NPS/SECN/NRDS—2019/1234

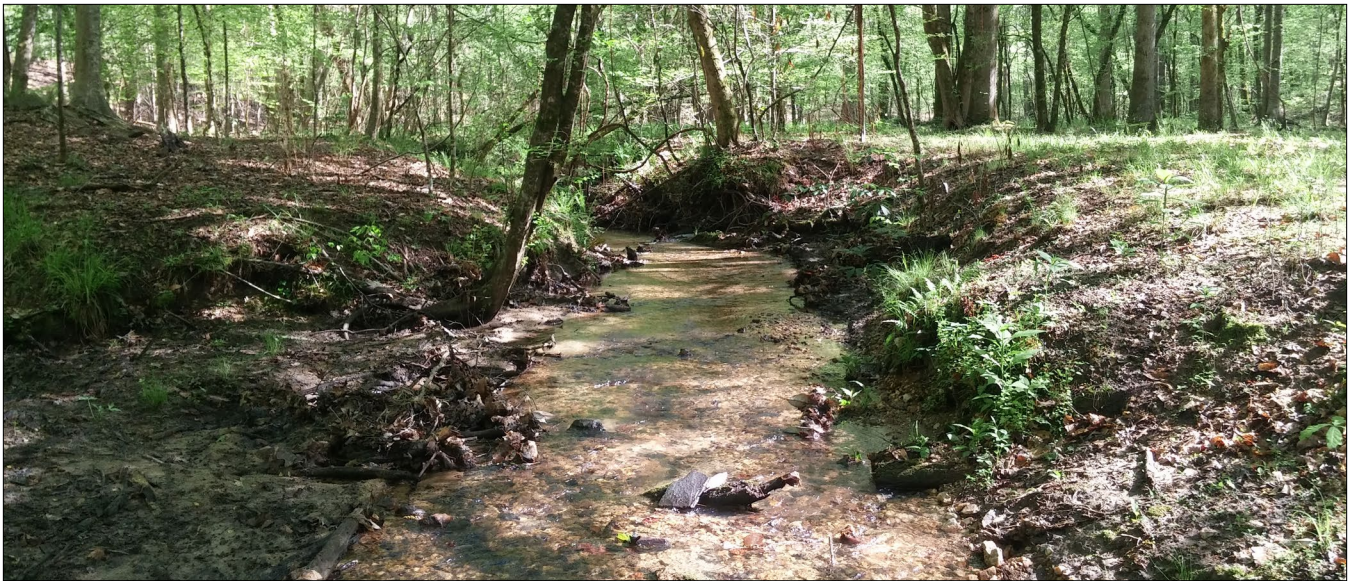
**Park Unit:** HOBE  
**Proposed Site Number:** pH01  
**Stream Name:** 'Salamander Creek'  
**Date:** 4.10.2019  
**Time:** 9:30 a.m.  
**Assessed by:** JMM (Jacob McDonald)  
**Accessible:** Yes  
**Gate Key Required:** Yes  
**Wadeable:** Yes  
**Recommend for Monitoring:** Yes

**Site Summary**—'Salamander Creek' (unnamed first order) is a small sandy gravel bedded stream. Wetted width was approximately 2.5 meters (8.2 feet) and bankfull width was around 3.25 meters (10.7 feet). Water depth was approximately 0.15 meter (0.5 feet). Bank heights were approximately 0.4 meter (1.3 feet). Initial assessment of the creek classified the entrenchment of the segment as low. Floodplains have developed within the slightly entrenched channel. These floodplains appear to have developed due to rotational slumping of the bank (low area on river left in example photo). The banks were sparsely vegetated (approximately 30–60%) with grasses and ferns covering the banks where present. Large woody debris (LWD) is present and is serving a variety of purposes. A variety of geomorphic channel units were observed within the reach. Crayfish and a salamander were also observed within the assessed reach. This stream alternates between being on park and Alabama Power lands. Just downstream from this reach, the channel is much more entrenched. In this higher entrenchment area, slumping as well as lateral migration are working to develop areas of floodplain.

**Monitoring Recommendation**—This site is recommended for monitoring because, though it has a slightly smaller watershed than pH05, it would be a good pair for the stream previously chosen for monitoring (pH05). One potential negative for this reach is that it was dry in 2008, during the drought, when Brian Gregory (SECN) and Jeffery Riley (USGS) conducted the initial suitability assessment.

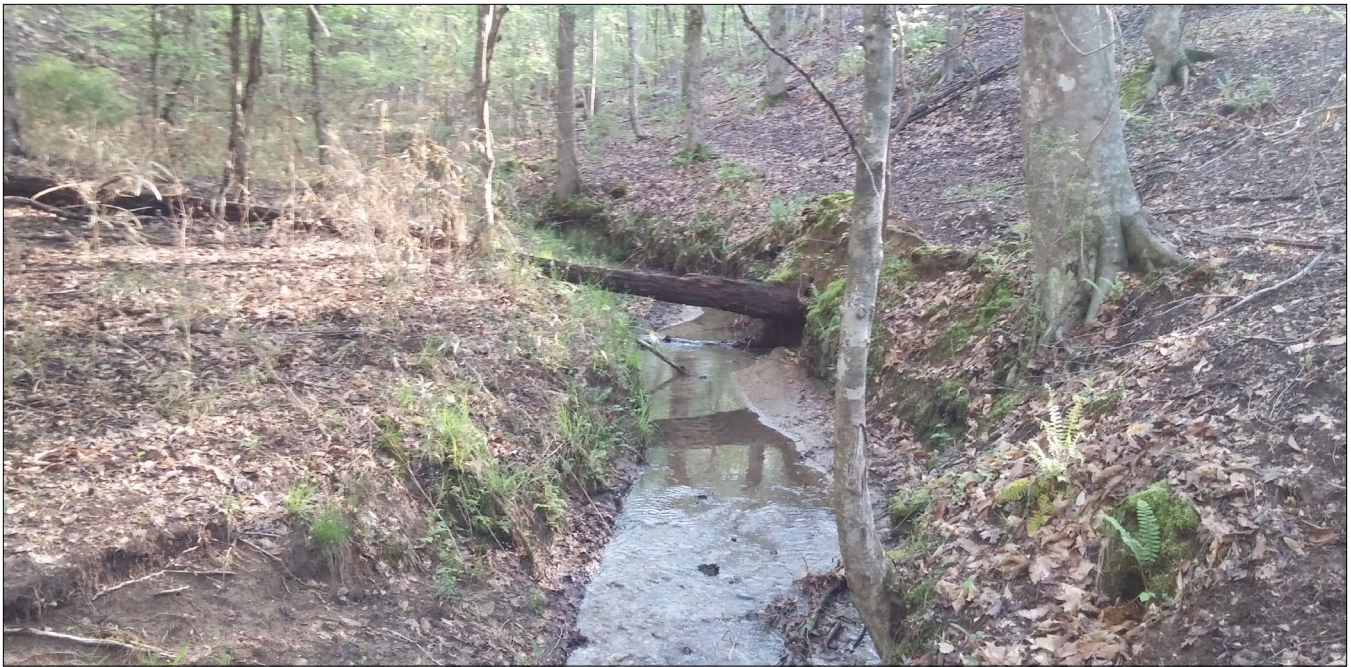
**Site Summary**—'Backwater Creek' (unnamed first order) is a small sand bedded stream that is frequently affected by the backwater effects of the Tallapoosa. Wetted width was approximately 1.5 meters (4.9 feet) and bankfull width was around 2.25 meters (7.4 feet). Water depth was approximately 0.15 meter (0.5 feet). Bank heights were approximately 0.75 meter (2.5 feet). Initial assessment of the creek classified the entrenchment of the segment as medium to high. Floodplains have not developed within the assessed reach though some semi-stable point bars were observed. Many of the side bars within the reach were organic bars. Bank slumping and undercutting were observed. The banks were sparsely vegetated (approximately 20–40%) with grasses and ferns covering the banks where present. Some river cane was observed growing along a portion of the reach. Large woody debris is present and many pieces were seen bridging the channel. In the upstream portions of the reach, the rocky hillslope encroaches on the stream.

**Monitoring Recommendation**—This site not recommended for monitoring because backwater effects of the Tallapoosa River affect the area that is not being encroached on by the hillslope. Additionally, this stream is very small and it is likely not perennial and was only flowing because of the wet winter and spring of 2019.

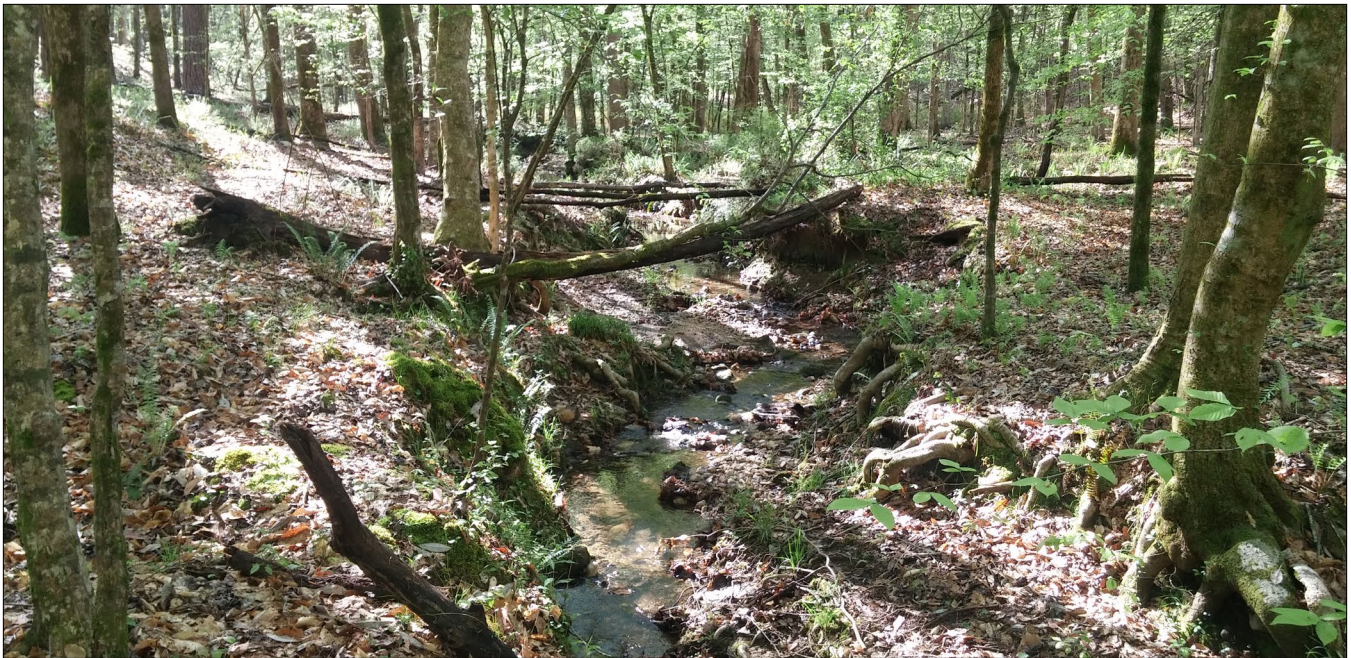
**Site Summary**—“Two Gully Creek” (unnamed first order) is a small sandy gravel bedded (likely ephemeral) stream. The reach that was assessed is just downstream from the confluence of two gullies. Wetted width was approximately 1.0 meter (3.3 feet) and bankfull width was around 2.5 meters (8.2 feet). Water depth was approximately 0.05 meter (0.2 feet). Bank heights were approximately 1 to 1.5 meters (3.3 to 4.9 feet). Initial assessment of the creek classified the entrenchment of the segment as medium to high. Floodplains have developed within the assessed reach (an example can be seen on river left in example picture [picture looks downstream]). Bank slumping and undercutting were observed. The banks were sparsely vegetated (approximately 20–40%) with grasses and ferns covering the banks where present. Large woody debris is present and many pieces were bridging the channel. A large plunge pool (greater than 2 meters [6.6 feet] high) was observed in the river right upstream gully.

**Monitoring Recommendation**—This site is not recommended for monitoring because it is likely ephemeral and was only flowing because of the wet winter and spring of 2019. Though this stream is not suitable for long-term monitoring following the methods outlined by McDonald et al. (2018), the gully systems that feed into this channel are very well developed and may be of interest for studies into the long-term development of these systems.

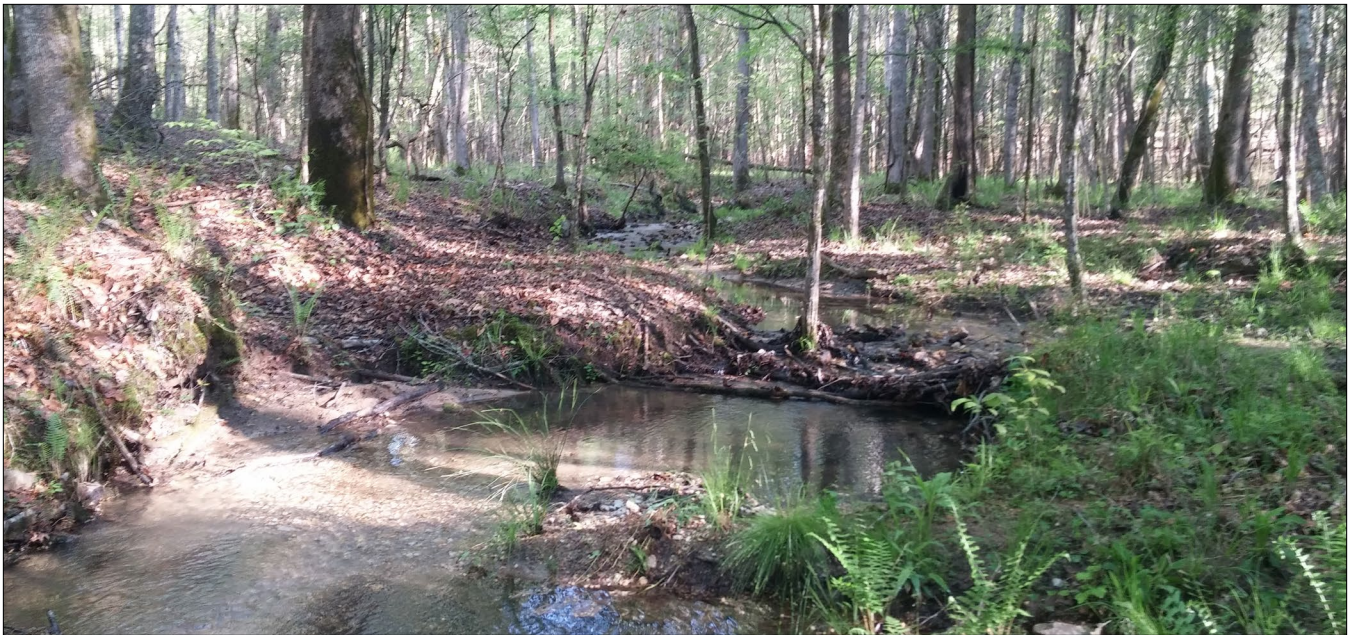
**Park Unit:** HOBE  
**Proposed Site Number:** pH04  
**Stream Name:** 'Bowser Creek'  
**Date:** 4.10.2019  
**Time:** 8:45 a.m.  
**Assessed by:** JMM  
**Accessible:** Yes  
**Gate Key Required:** Yes  
**Wadeable:** Yes  
**Recommend for Monitoring:** Maybe

**Site Summary**—'Bowser Creek' is a medium sized sandy gravel bedded stream that is heavily influenced by large woody debris. A newly cutoff meander was observed just upstream from the reach that was assessed (on river left in example picture [picture looks upstream]). Wetted width was approximately 2.5 meters (8.2 feet) and bankfull width was around 3.5 meters (11.5 feet). Water depth was approximately 0.12 meter (0.4 feet). Bank heights were approximately 0.5 meter (1.6 feet). Initial assessment of the creek classified the entrenchment of the segment as low. Floodplains have developed throughout the reach. Further downstream (below the small bridge), the creek is undercutting the banks on both sides of the creek for a series of meanders. The banks were sparsely to moderately vegetated (approximately 20–70%) with grasses and ferns covering the banks where present. Large woody debris is present and has caused a large number of LWD steps throughout the assessed reach. A good variety of geomorphic channel units were observed.

**Monitoring Recommendation**— This site is recommended for monitoring because it is representative of the streams in the northern portion of the park. This stream was classified as 'Maybe' recommended because it may be ephemeral. If there are enough resources to add an additional monitoring site, this stream should be visited in the late summer after an extended dry period to determine if it is perennial.

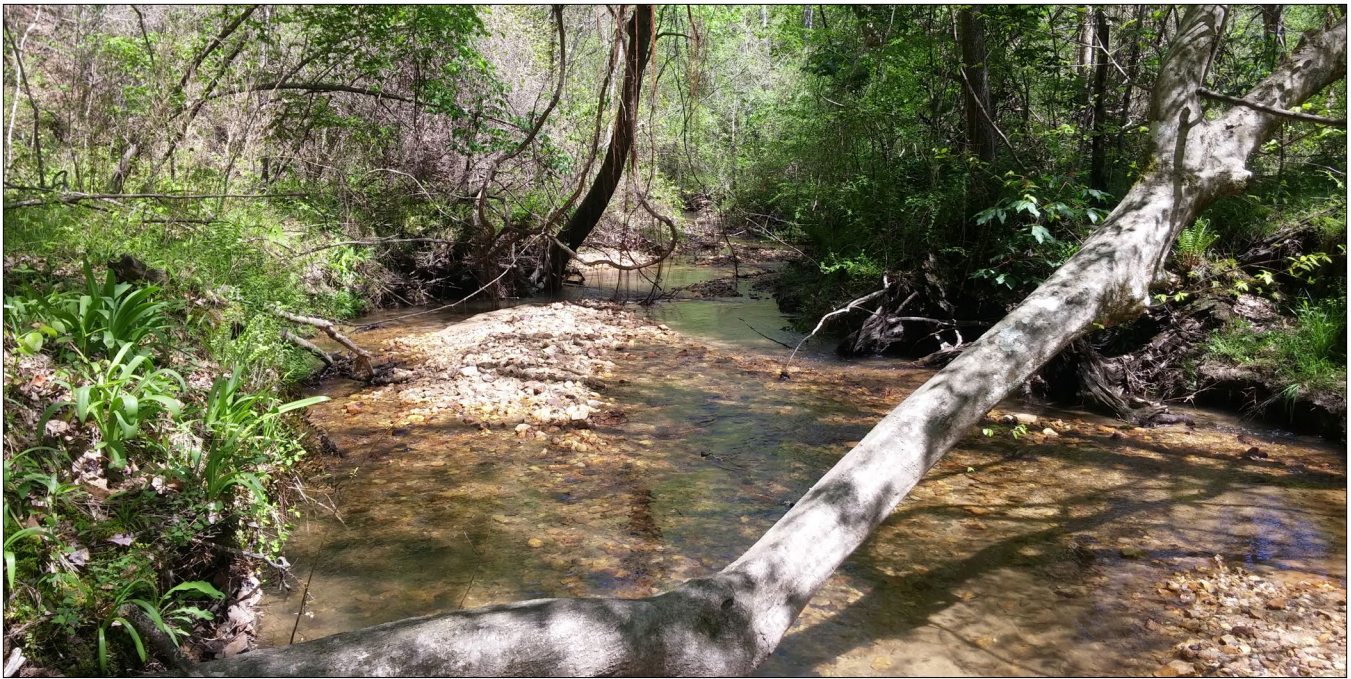
**Park Unit:** HOBE  
**Proposed Site Number:** pH05  
**Stream Name:** 'Claybed Creek'  
**Date:** 4.10.2019  
**Time:** 11:23 a.m.  
**Assessed by:** JMM  
**Accessible:** Yes  
**Gate Key Required:** Yes  
**Wadeable:** Yes  
**Recommend for Monitoring:** Yes

**Site Summary**—'Claybed Creek' is a medium sized sandy gravel bedded stream that has a slightly sandier bed than the rest of the streams in this portion of the park. Cobble and gravel bars were observed throughout the assessed reach. Additionally, in some areas, the stream has incised down to clay. Wetted width was estimated to be approximately 2 meters (6.6 feet) and bankfull width around 6 meters (19.7 feet). Water depth was approximately 0.12 meter (0.4 feet). Bank heights were approximately 0.5 meter (1.6 feet) where floodplain has developed and 1.1 meters (3.6 feet) where they have not. Initial assessment of the creek classified the entrenchment of the stream as medium to high. Some floodplains have developed within the reach. Some undercutting was observed. The banks were moderately vegetated (approximately 50–70%) with grasses and ferns covering the banks where present. Large woody debris is present but not prevalent. A variety of geomorphic channel units were observed within the reach.

**Monitoring Recommendation**—This site recommended for monitoring because it is the only stream within the park that was classified as perennial by the high definition National Hydrography Dataset (NHDhd). Additionally, this reach is a good example of a Piedmont stream that is slowly developing/equilibrating to modern conditions (of discharge and sediment yield).

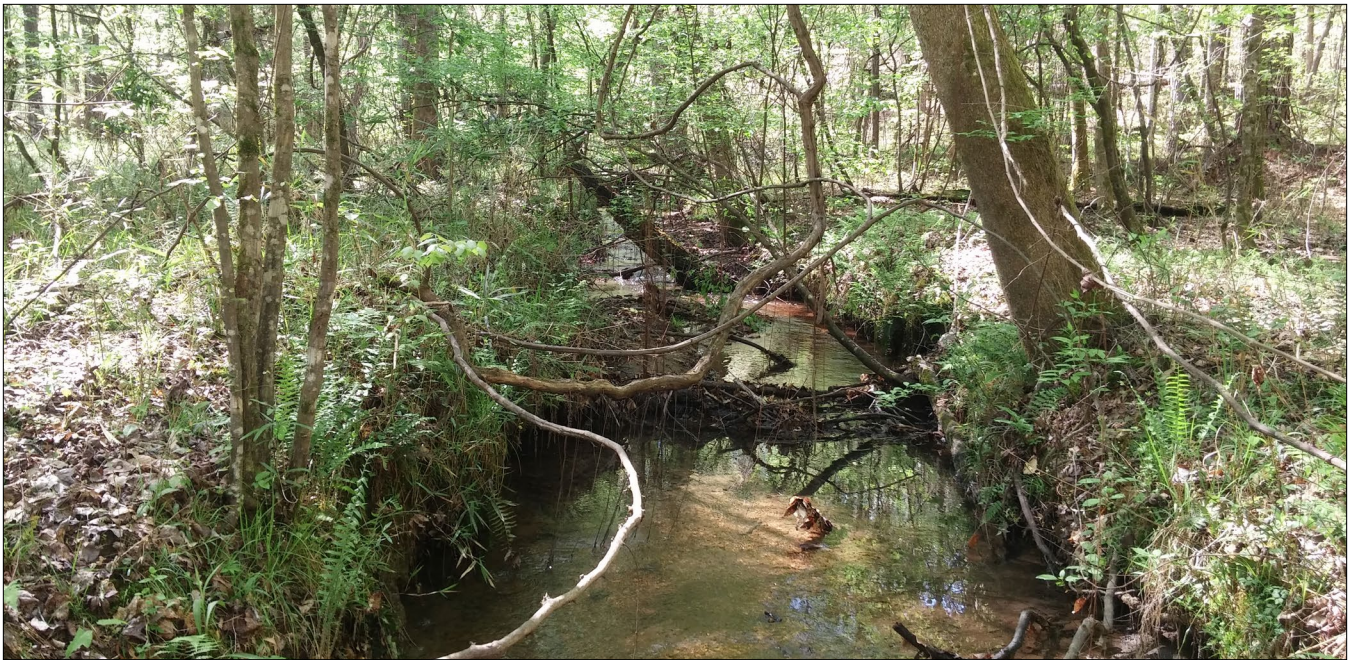
**Park Unit:** HOBE  
**Proposed Site Number:** pH06  
**Stream Name:** 'Small Step Creek'  
**Date:** 4.10.2019  
**Time:** 10:00 a.m.  
**Assessed by:** JMM  
**Accessible:** Yes  
**Gate Key Required:** Yes  
**Wadeable:** Yes  
**Recommend for Monitoring:** No

**Management Issues Noted:** Fine sediment draping bed.

**Site Summary**—'Small Step Creek' is a small sized sandy gravel bedded stream that has a relatively high concentration of fines draping the bed of the stream. Wetted width was approximately 1.5 meters (4.9 feet) and bankfull width was around 2.5 meters (8.2 feet). Water depth was approximately 0.10 meter (0.3 feet). Bank heights were approximately 0.8 meter (2.6 feet). Initial assessment of the creek classified the entrenchment of the stream as medium. Longitudinally extensive floodplains were not observed within the reach but some discontinuous slump benches were observed. Some of the banks were undercut. The banks were moderately to heavily vegetated (approximately 70–85%) with grasses and ferns covering the banks where present. Large woody debris is present and serving a variety of functions. A series of small LWD steps were observed within the assessed reach. The out-of-channel area was interpreted to be a low terrace. A higher terrace was observed on river left at the back of the low terrace. Upstream from the bridge, the stream bifurcates (though the river right bifurcation may be ephemeral). A variety of geomorphic channel units were observed within the reach.

**Monitoring Recommendation**—This site is classified as 'Maybe' recommended for monitoring due to its small size and because the NHDhd did not classify it as perennial. If additional sites are added to the monitoring program, this reach is of low priority.

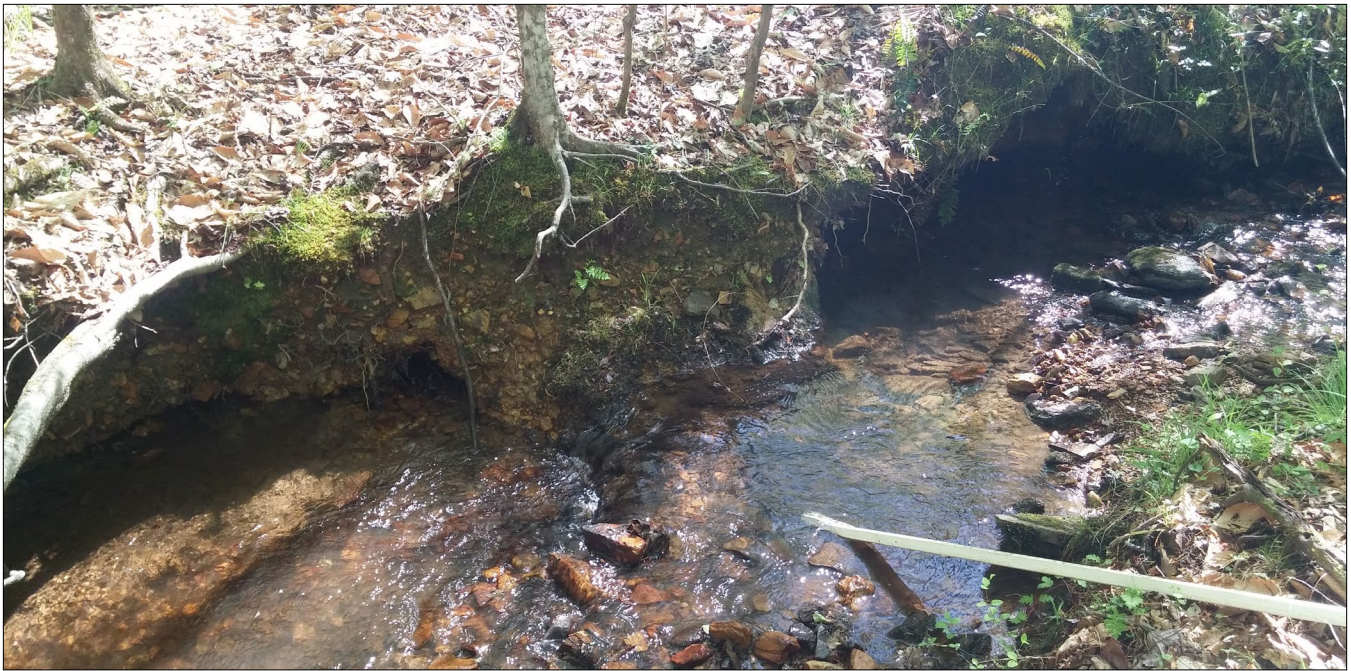
**Park Unit:** HOBE  
**Proposed Site Number:** pH07  
**Stream Name:** 'Pipeflow Creek'  
**Date:** 4.10.2019  
**Time:** 10:15 a.m.  
**Assessed by:** JMM  
**Accessible:** Yes  
**Gate Key Required:** Yes  
**Wadeable:** Yes  
**Recommend for Monitoring:** No

**Site Summary**—'Pipeflow Creek' is a small sized gravelly sand bedded stream. Wetted width was approximately 1.25 meters (4.1 feet) and bankfull width was around 2 meters (6.6 feet). Water depth was approximately 0.1 meter (0.3 feet). Bank heights were approximately 0.55 meter (1.8 feet). Initial assessment of the creek classified the entrenchment of the stream as medium. No floodplain surfaces were observed in the assessed reach. Lots of undercutting was observed. In one area of the assessed reach, an undercut has merged with the channel and flow is piped through the bank back into the channel downstream (see example picture). The banks were sparsely vegetated (approximately 30–50%) with grasses and ferns covering the banks where present. Only a few pieces of LWD were observed within the assessed reach. The out-of-channel area was interpreted to be a low terrace. A variety of geomorphic channel units were observed within the reach. Downstream from the assessed reach, the stream is just an entrenched chute.

**Monitoring Recommendation**—This site is not recommended for monitoring because it is likely just an ephemeral stream that is only flowing because of the wet winter and spring of 2019.

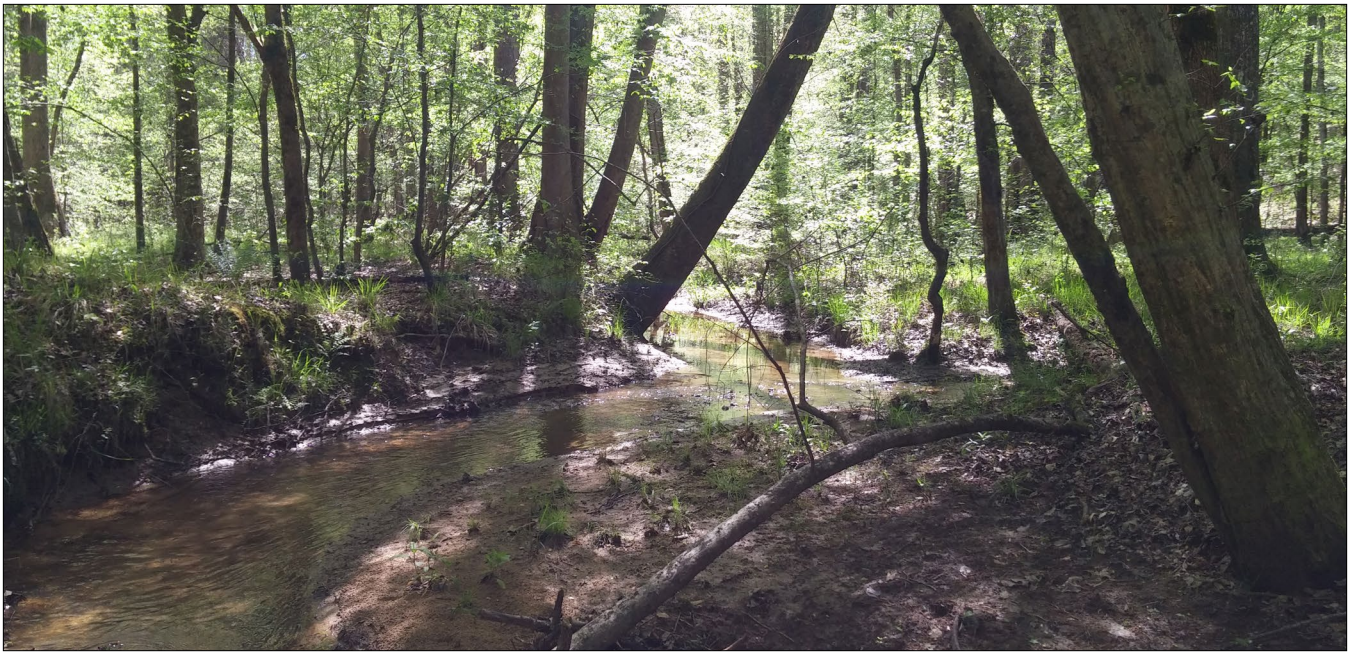
**Park Unit:** HOBE  
**Proposed Site Number:** pH08  
**Stream Name:** 'SandyCreek'  
**Date:** 4.10.2019  
**Time:** 10:20 a.m.  
**Assessed by:** JMM  
**Accessible:** Yes  
**Gate Key Required:** Yes  
**Wadeable:** Yes

**Management Issues Noted:** Potential beaver pond upstream.

**Site Summary**—'Sandy Creek' is a medium sized relatively wide gravelly sand bedded stream. Wetted width was approximately 2.5 meters (8.2 feet) and bankfull width around 3.5 meters (11.5 feet). Water depth was approximately 0.15 meter (0.5 feet). Bank heights were approximately 0.65 meter (2.1 feet). Initial assessment of the creek classified the entrenchment of the stream as low. Some floodplains have developed within the reach (especially where side drainages enter the stream). A few low sandy bars were observed within the assessed reach (see example picture). The banks were moderately vegetated (approximately 50–70%) with grasses and ferns covering the banks where present. Only a few pieces of LWD were observed within the assessed reach. A few riffles were observed within the reach but it was lower energy than expected (runs and pools were observed alongside the riffles). Downstream from the assessed reach, the stream is just an entrenched chute. While there were only a few pieces of LWD in the reach, there were a large number of overhanging trees that may provide LWD to the reach in the future.

**Monitoring Recommendation**—This site is classified as 'Maybe' recommended for monitoring because it is likely just an intermittent stream that is only flowing because of the wet winter and spring of 2019. The relatively well-developed floodplain areas within the assessed reach suggest that this stream may flow more often than the relatively small drainage area suggests.

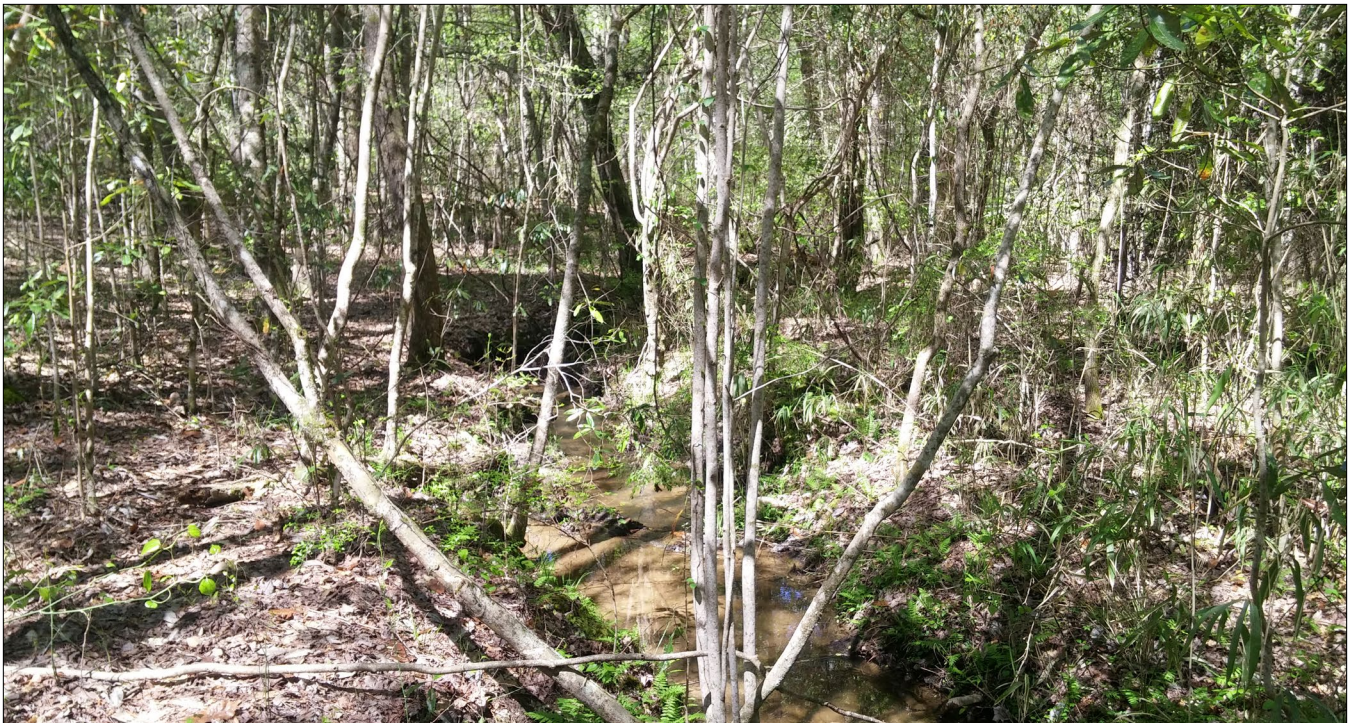
**Site Summary**—'Ditch Creek' is a small sized sand bedded stream. Wetted width was estimated to be approximately 1 meter (3.3 feet) and bankfull width around 1.5 meters (4.9 feet). Water depth was approximately 0.1 meter (0.3 feet). Bank heights were approximately 0.5 meter (1.6 feet). Initial assessment of the creek classified the entrenchment of the stream as medium. No floodplain surfaces have developed within the assessed reach. Based on the morphology of the reach, this stream is ephemeral and is likely just a developed small gully feature. The banks were moderately vegetated (approximately 50–70%) with grasses, ferns, privet, and river cane covering the banks where present. Only a few pieces of LWD were observed within the assessed reach. A variety of geomorphic channel units (riffles, pools, and steps) were observed within the reach. Some bank slumping was also observed.

**Monitoring Recommendation**—This site is not recommended for monitoring because it is just an ephemeral channel that is flowing because of the wet winter and spring of 2019.
