# Climate and Groundwater Monitoring at Casa Grande Ruins National Monument, 2017

Casa Grande Ruins National Monument (/cagr/)

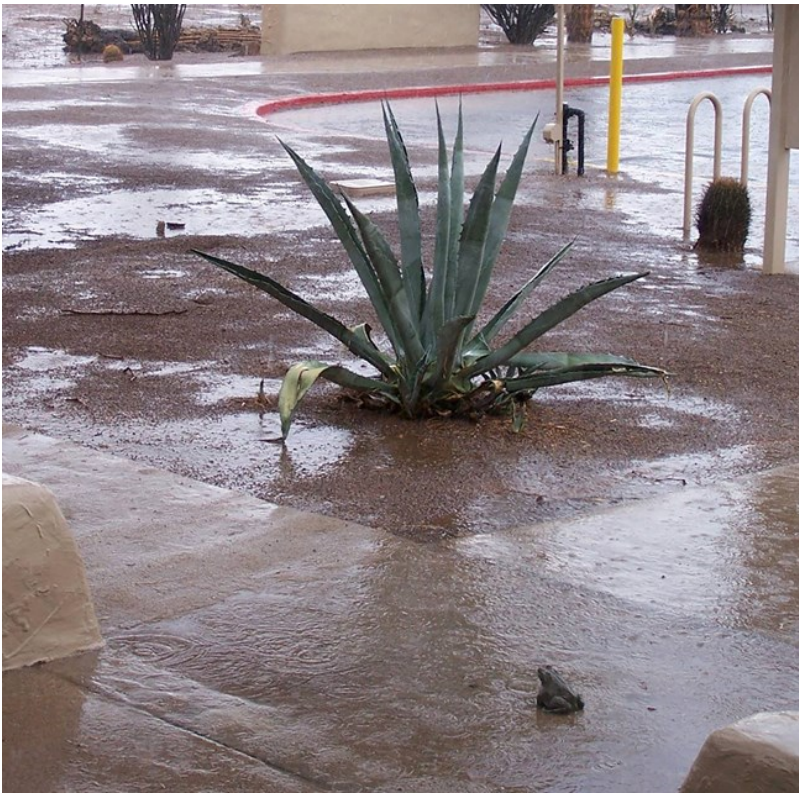
*Rainfall was below normal at the monument in water years 2016 and 2017.*

**Precipitation.** Annual precipitation at Casa Grande Ruins NM was only 73% of normal (6.73" vs. 9.18") in WY2017, and 72% of normal (6.57" vs. 9.18") in WY2016 when compared to normalized climate data for 1981–2010. Precipitation was below normal (69%, -1.68") for the fall and winter of WY2017. Winter rains tapered off early, and February and March rainfall was less than 39% and 35% of normal, respectively. An extremely dry spring and September resulted in total rainfall for the warmer months being 80% of normal despite slightly above-normal precipitation in July and August. In WY2016, very little precipitation fell during December, February, and March, which are typically among the monument's wettest months. Yet in June, precipitation was about five times normal (0.25" vs 0.05").
