# Climate and Water Monitoring at Tumacácori National Historical Park, 2018

Tumacácori National Historical Park (/tuma/)

***Climate, groundwater, and surface water are closely related. At Tumacácori National Historical Park, the Sonoran Desert Network monitors all three to track broad-scale change and provide early warning of potential problems.***

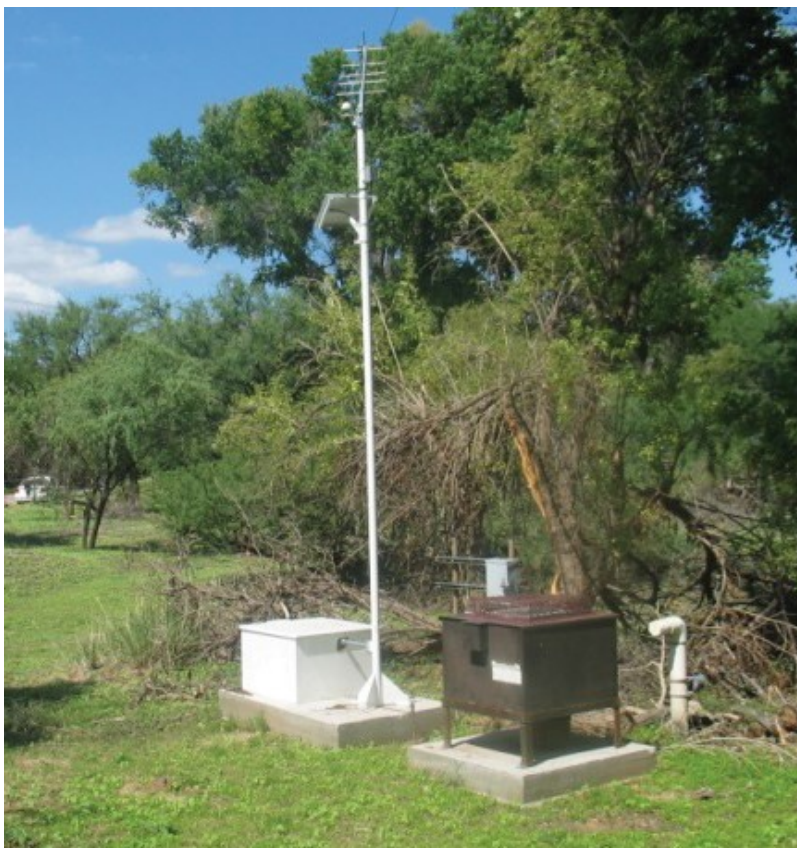
*Groundwater monitoring wells at Tumacácori National Historical Park.*

Groundwater is one of the most critical natural resources of the American Southwest, providing drinking water, irrigating crops, and sustaining springs, rivers, and streams throughout the region. At Tumacácori NHP, groundwater monitoring is conducted via automated and manual sampling of water wells at various depths. Two monitored wells at Tumacácori NHP indicated that mean groundwater levels in WY2018 were higher than the mean of the data record for each well (0.21–1.35 ft). Water levels dropped in response to dry spring conditions, then quickly increased with monsoon precipitation and flow events.

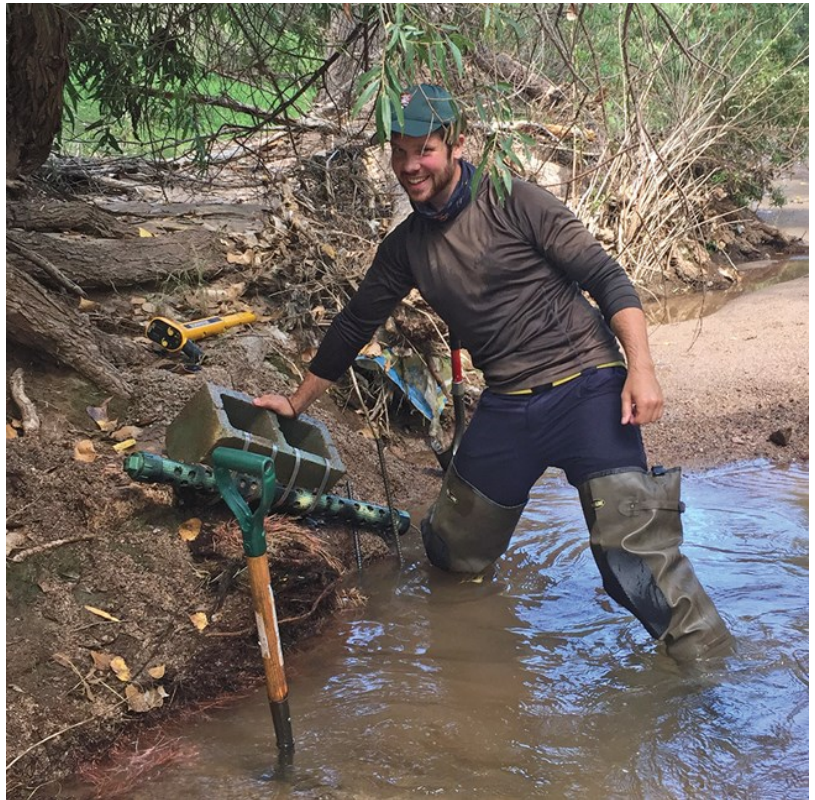
*Retrieving sampling equipment on the Santa Cruz River, Tumacácori National Historical Park.*
