# Climate and Water Monitoring at Tumacácori National Historical Park, 2017

Tumacácori National Historical Park (/tuma/)

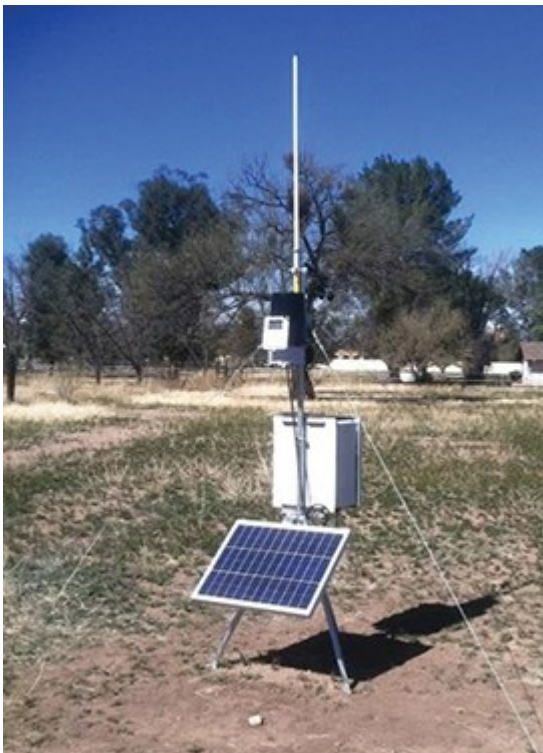
*Climate monitoring station at Tumacácori National Historical Park.*

In WY2017, overall annual precipitation was 68% of normal for Tumacácori National Historical Park (11.26" vs 16.56"). Precipitation in December and January was greater than normal. October, November, February, and March were extremely dry. The monsoon was strong for three weeks in July, but tapered off quickly, a pattern seen throughout the Sonoran Desert. Air temperatures were generally 2–8°F warmer than normal, with the exception of the mean maximum temperature in January. The extended regional drought that began in 2000 continued through WY2017. Additional information can be found at

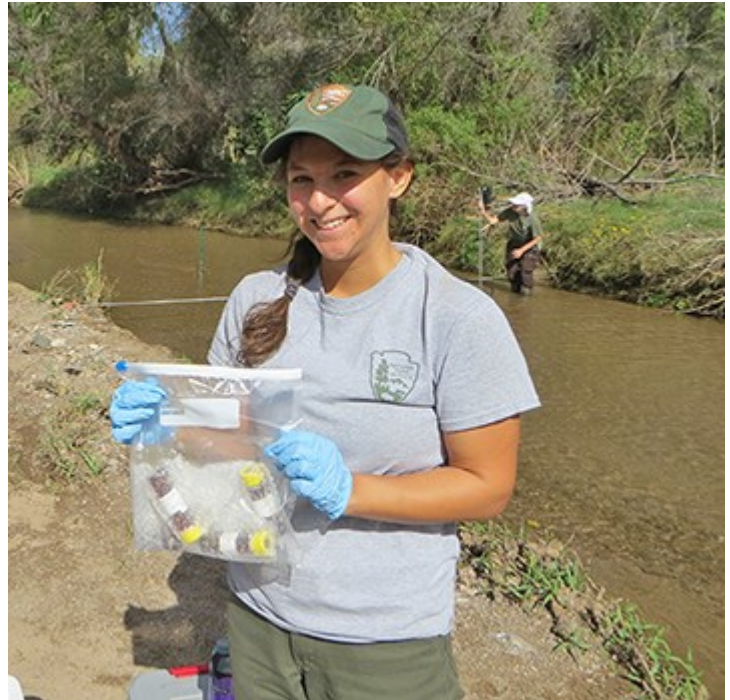
*Sonoran Desert Network staff display water quality samples (foreground) and monitor streamflow (background).*

Streamflow data for this report were recorded at U.S. Geological Survey gauge 09481740, five kilometers downstream from Tumacácori National Historical Park. Streamflow during WY2017 was slightly above the 25th percentile for a majority of WY2017. Spring and early summer discharge was below normal, with drying/no flow events likely occurring during the end of June and early July. The WY2017 monsoon was generally above average, providing average flow into the fall. A majority of the annual amount of water flowing into the Santa Cruz River system comes from monsoon storms.

Water quality monitoring occurred ~150 meters downstream from the southern boundary of the park, at the Santa Gertrudis index site. There was one exceedance of state water quality standards for *E. coli* during WY2017, resulting in an average of 99% overall compliance with state standards. However, it is likely that *E. coli* estimates exceeded the state standards on more than this single occasion, especially during and after precipitation events.
