# Status of Climate and Water Resources at Tonto National Monument

*Water Year 2018*

Natural Resource Report NPS/SODN/NRR—2019/2000

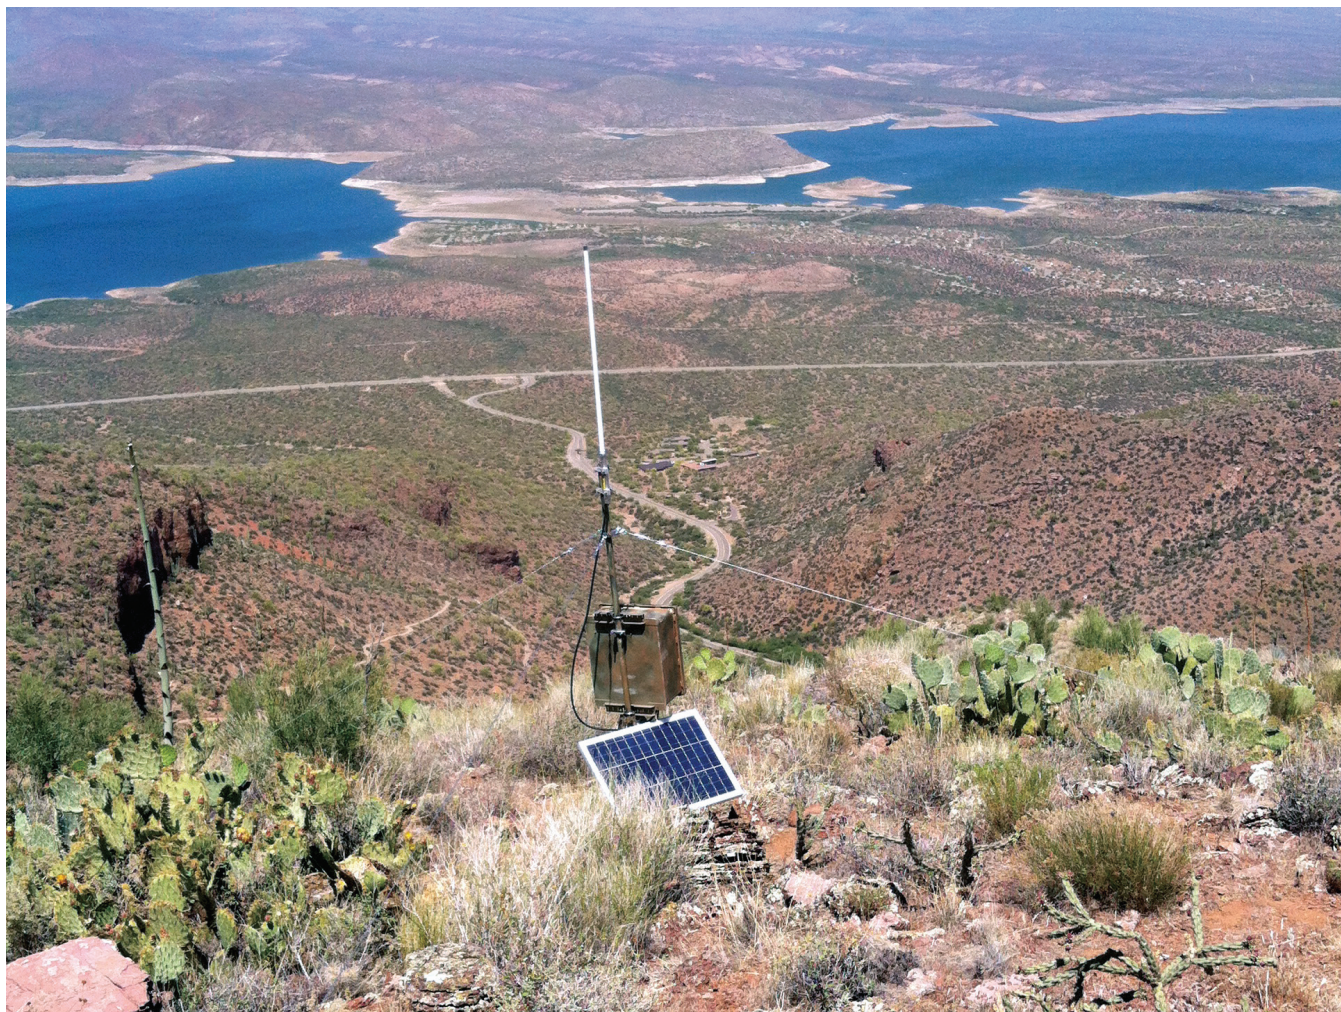
Davis weather station, Tonto National Monument. NPS photo.

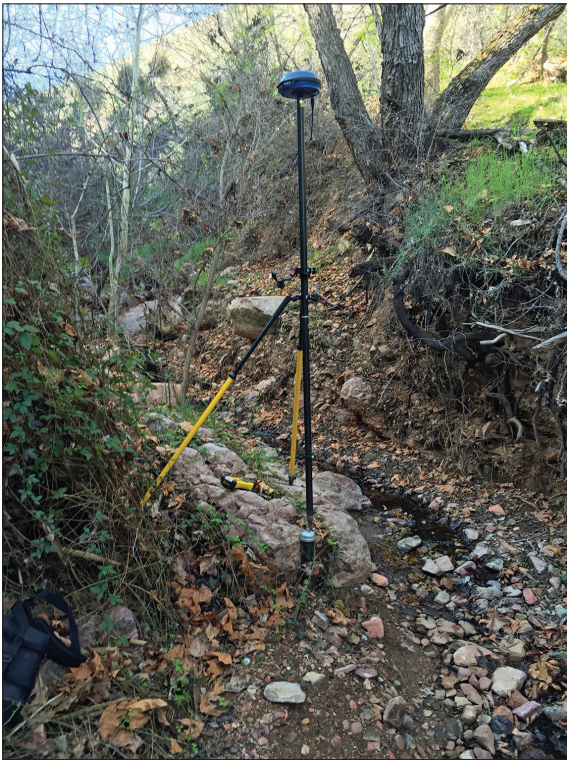
Figure 3-2. Piezometer at the shallow groundwater monitoring site, Cave Canyon Creek, Tonto National Monument. NPS/Jacob DeGayner.

The Cave Canyon site is approximately 30 feet downstream from the current Cave Canyon Spring orifice, at a piezometer adjacent to the creek (Figure 3-2). Since WY2006, pressure transducers have been used to collect automated measurements of the groundwater level every 20 minutes. However, data collection prior to WY2014 was intermittent due to equipment issues. The sensor is 2.31 feet below the ground surface, and approximately 1.15 feet below the channel thalweg.

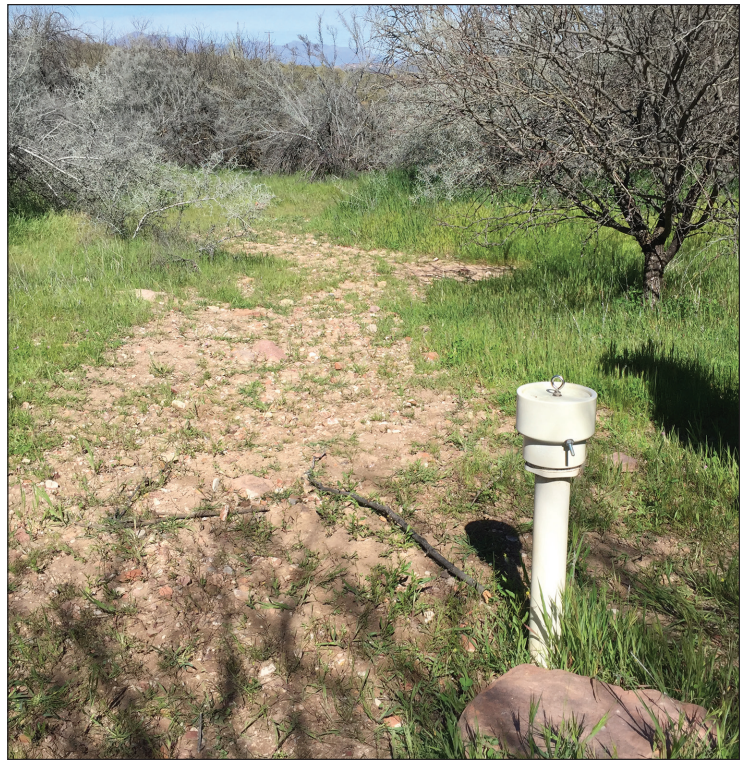
Figure 3-3. Piezometer at the Cinda's Seep monitoring site, Tonto National Monument.

A piezometer was installed at Cinda's Seep in WY2009 (Figure 3-3). A pressure transducer collects automated measurements of the groundwater level every six hours. The sensor is approximately 3.6 feet below the ground surface.

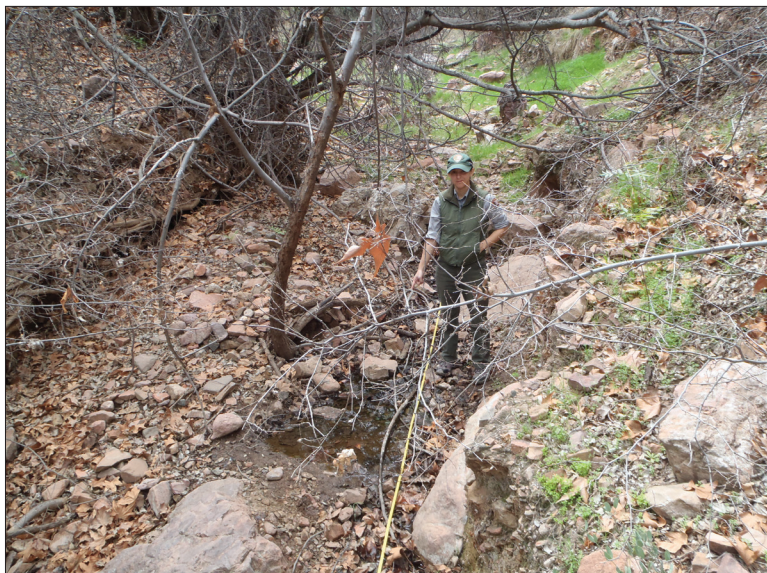
Figure 4-1. Cave Canyon Spring orifice and sampling location, Tonto National Monument, March 2018.

Cave Canyon Spring (Figure 4-1) is a rheochrene spring dominated by run-off discharge. The monitoring orifice is a small pool amidst scattered other pools at the base of an Arizona sycamore in the center of the channel. This pool appears to be the most persistent and largest contributor to flow. The emergence flows slightly with cool, clear water until sinking back into the channel. The location where the water emerges from

the streambed can fluctuate several meters up and down the channel each day. Surface flow ranges from approximately 10 to 30 centimeters. Overall, the substrate majority is sand and silt, with dispersed gravel and boulders.
