# Status of Climate and Water Resources at Gila Cliff Dwellings National Monument

*Water Year 2018*

Natural Resource Report NPS/SODN/NRR—2019/2001

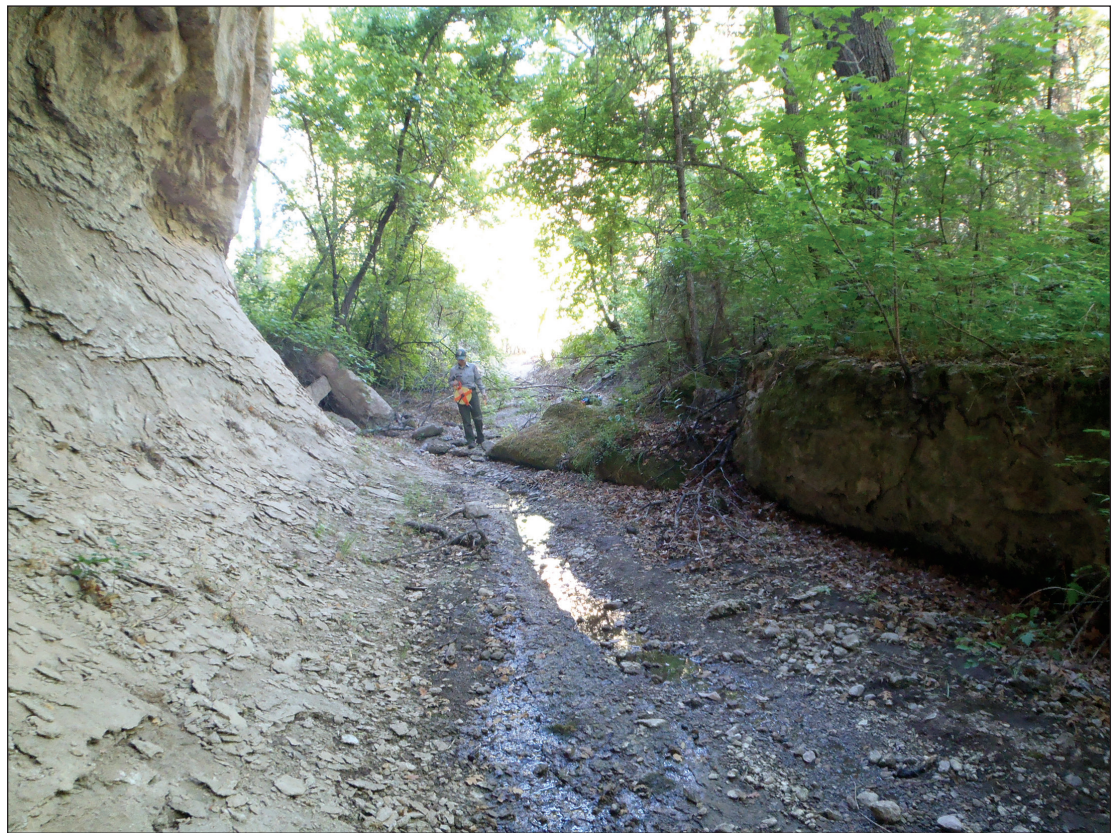
*Cliff Dweller Canyon Spring* (Figure 3-1) is a rheocrene spring dominated by groundwater and surface flow. The spring emerges near a large bedrock wall as a still pool below a boulder. The flow immediately becomes a channelized springbrook, terminating as subsurface flow downstream. The shallow, narrow springbrook is interrupted by scattered pools and small, braided sections. The channel substrate is sand, gravel, and small cobble, with patches of bedrock. The water is uniformly cold and clear, even in pools where flow loses velocity. There does not appear to be surface flow upstream of where the spring emerges from the bed of the ephemeral stream.

Figure 3-1. Cliff Dweller Canyon Spring looking downstream to orifice, Gila Cliff Dwellings National Monument, June 2018.

At *Cliff Dweller Canyon Spring*, disturbance surveys resulted in a median value of 1 = undisturbed for both anthropogenic and natural disturbance. There was no indication of disturbance noted at the site.

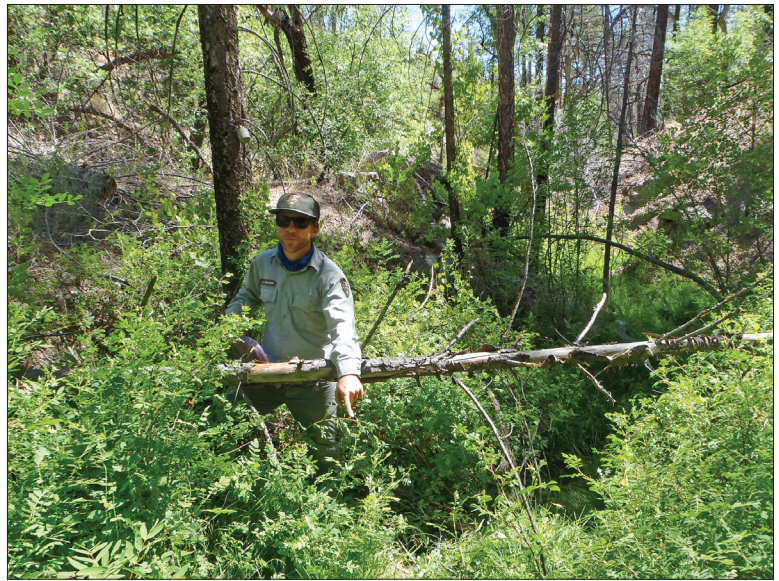
*Hubbard's Bog* (Figure 3-2) is a rheocrene spring dominated by groundwater and

surface flow. The spring emerges in the canyon bottom as a small channel with no obvious flow. It continues downstream as a low-flow springbrook with occasional small pools. Beyond the sampled extent, the channel continues intermittently downstream, though never exhibiting the volume of water, length of channel, or density of riparian vegetation found at the emergence site. Though rarely flowing, the water is cool and clear throughout. The drainage is characterized as primarily a low-angle silt and gravel streambed with occasional boulders and frequent snags. The channel is very narrow. The drainage upstream of the orifice does not appear to contain flowing surface water. Steep canyon backslopes emerge immediately, with no obvious riparian character. Disturbance caused by the 2011 Miller Fire is notable in the form of sedimentation and downed trees.

Figure 3-2. Hubbard's Bog, Gila Cliff Dwellings National Monument, June 2018.

At *Hubbard’s Bog*, disturbance surveys resulted in a median value of 1 = undisturbed for both anthropogenic and natural disturbance. The crew noted that overall the site appeared to be dryer than previous visits; the orifice had moved eight meters downstream from when pilot sampling was done in 2017. Unidentified animal tracks were observed at the site. The crew observed four obligate/ facultative wetland plant genera/ species and one family: monkeyflower (*Mimulus* sp.), spikerush (*Eleocharis* sp.), fowl mannagrass (*Glyceria striata*), willow (*Salix* sp.), and rush (Juncaceae family). Invasive woolly mullein (*Verbascum thaspus*), common across the monument, was noted in scattered patches throughout the springbrook. No invasive wildlife was observed.

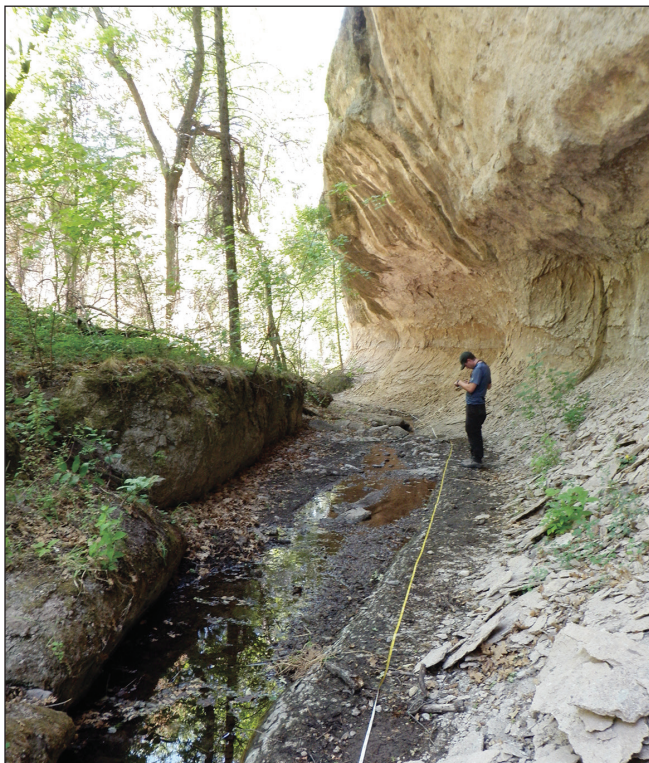
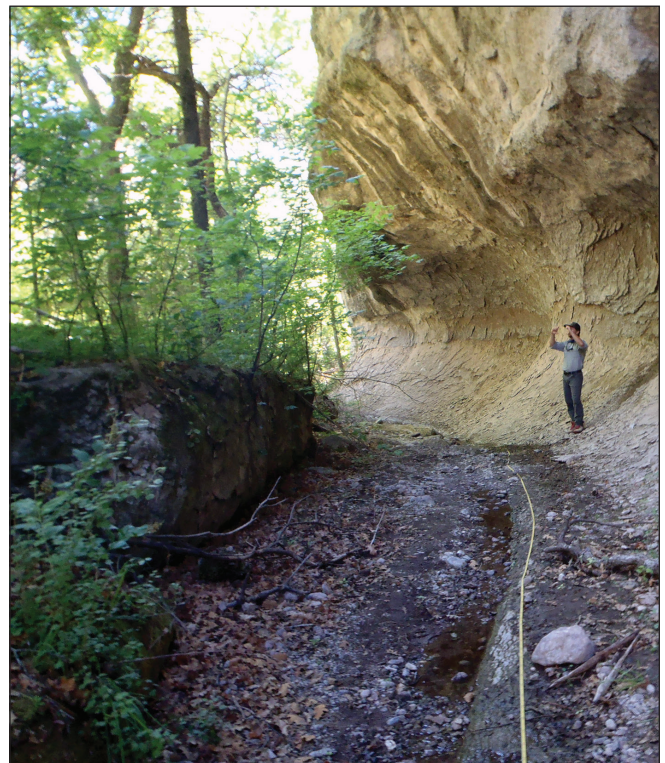
Photos appear to show little difference in condition between the sample of water year 2018 and the inventory performed in 2011 (Figure 3-3 and Figure 3-4). The crew did not observe any facultative/obligate plants, invasive plants, or invasive animals during this sample.

Figure 3-3. Cliff Dweller Canyon Spring looking upstream from orifice, Gila Cliff Dwellings National Monument, May 2011.

Figure 3-4. Cliff Dweller Canyon Spring looking upstream from orifice, Gila Cliff Dwellings National Monument, June 2018.
