# Status of Climate and Water Resources at Amistad National Recreation Area

*Water Year 2018*

Natural Resource Report NPS/CHDN/NRR—2019/2006

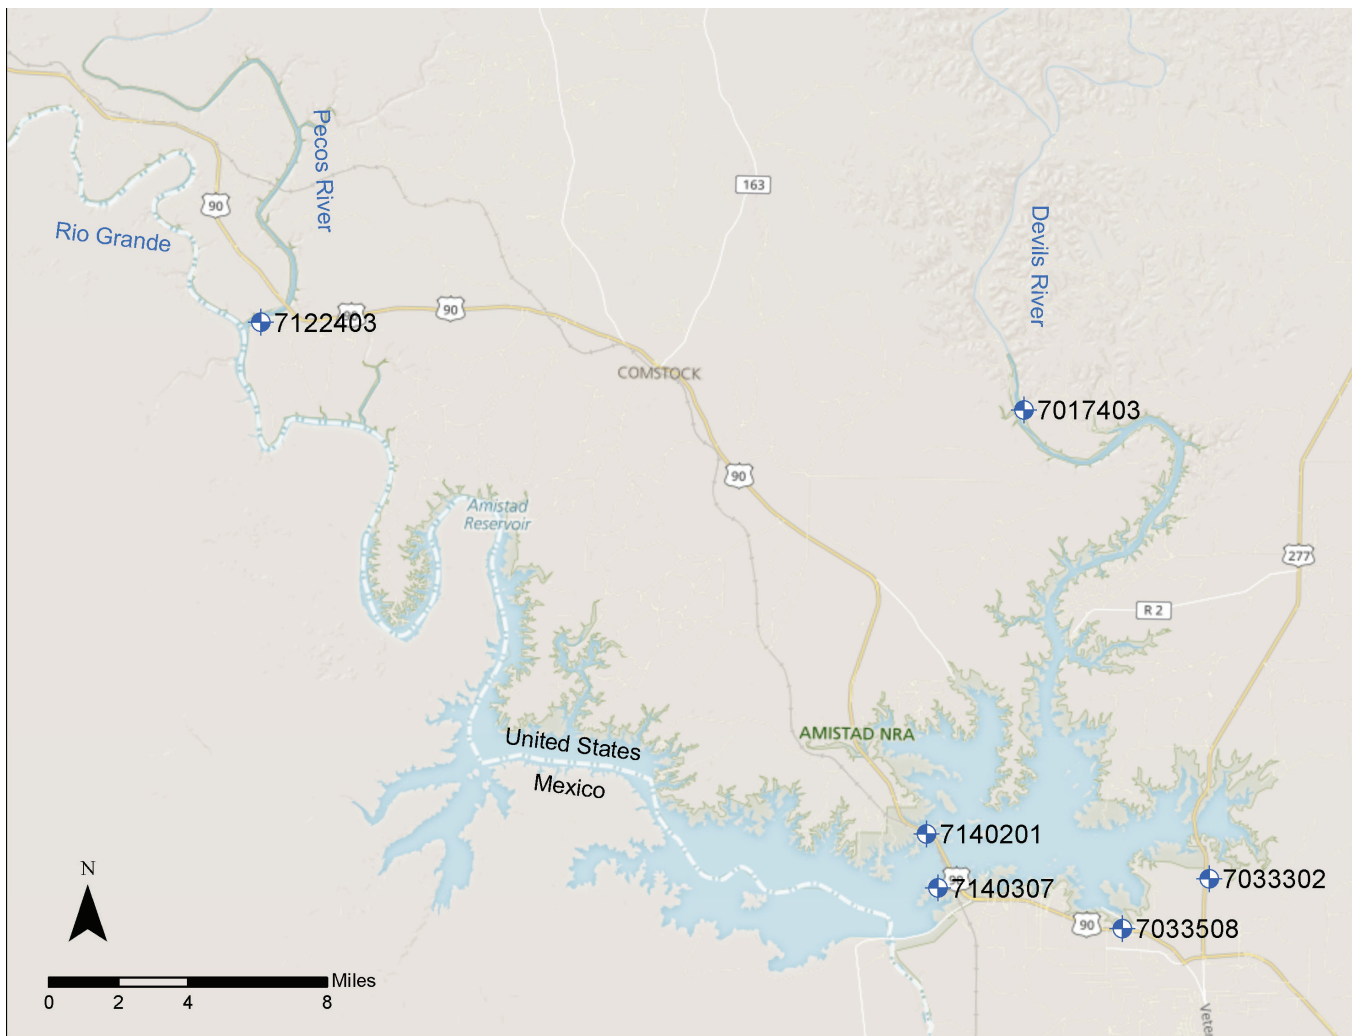
**Figure 4-1. Location of monitoring wells at Amistad NRA.**

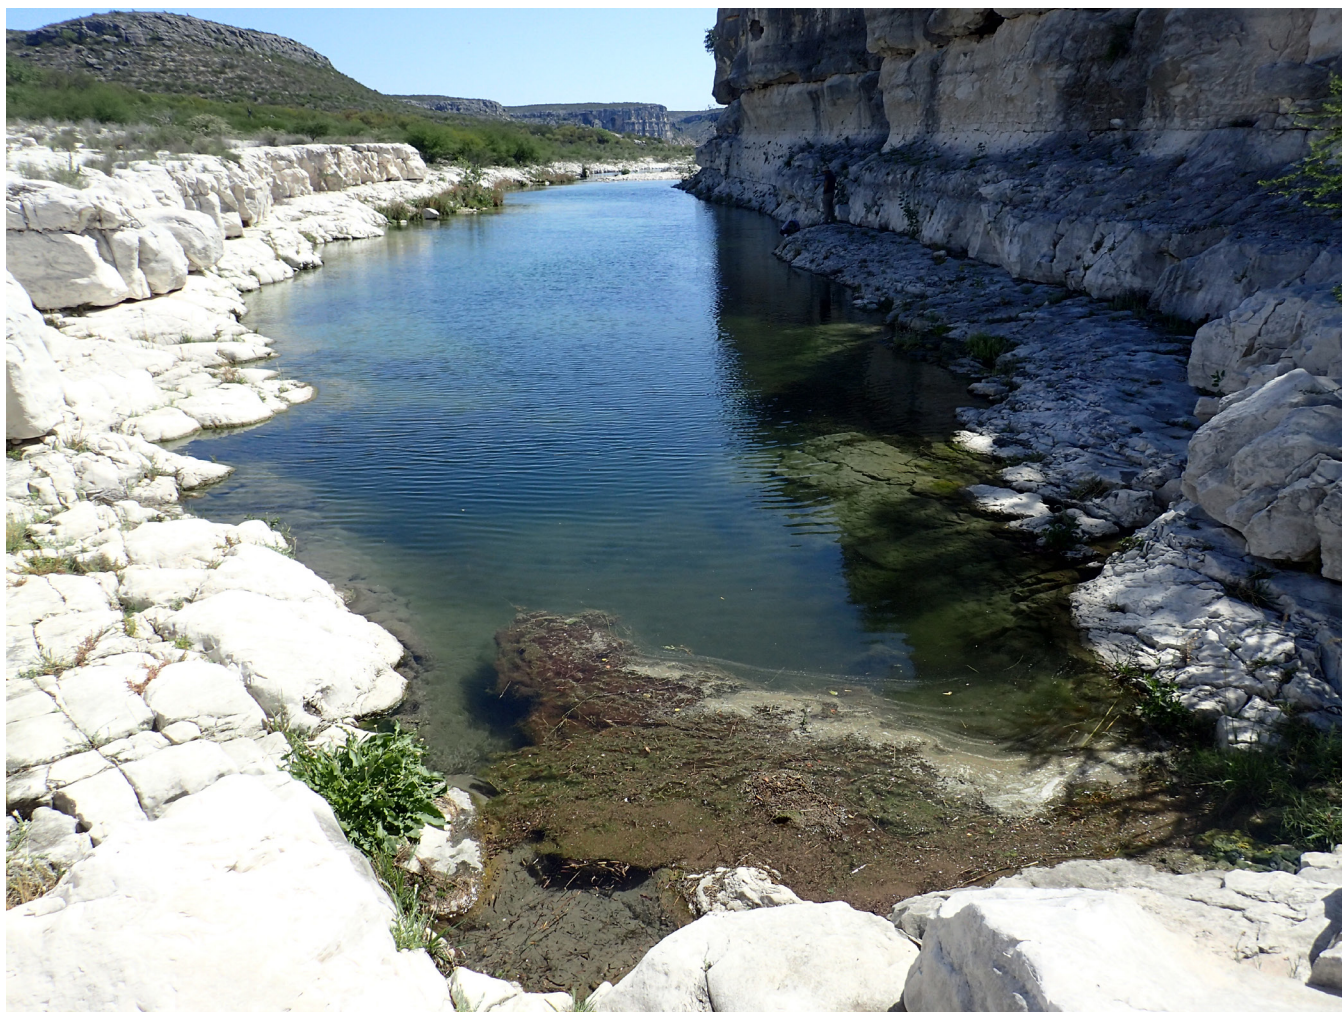
Big Satan Canyon Spring (Figure 5-1) was classified as a rheocrene spring because the water trickles into the highest extent of the lake. The monitoring crew estimated that the water present on April 5, 2018 was dominated by spring discharge. The reservoir level was 333.4m (1093.8ft) amsl on the day of the survey (TWDB 2019a). Big Satan Canyon Spring emerges from a series of six orifices. Orifices A–F gently flow into the lake in a circular pattern. Orifice A is the farthest east and trickles from a 10–20cm (0.3–0.7ft) deep crack. Orifice B is 10–15m (32.8–49.2ft) to the southwest and emerges as a 2–3m (6.6–9.8ft) trickle over bedrock with vegetation. Orifice C is 10m (32.8ft) farther southwest and is within a 30cm

**Figure 5-1. Big Satan Canyon Spring landscape, Amistad NRA, April 2018.**

(1.0ft) deep crack, and almost immediately pours into the lake. Orifice D is at the west edge of the pool and emerges from within 2 cracks within a meter. Orifice E and F are on the north-northwest edge of the canyon. Orifice E is in a deep crack and orifice F emerges from a 1m (3.3ft) square cave-like hole. Water from all orifices is cool and clear and almost immediately flows into the lake. Substrate is bedrock with many fractures, some filled with vegetation.

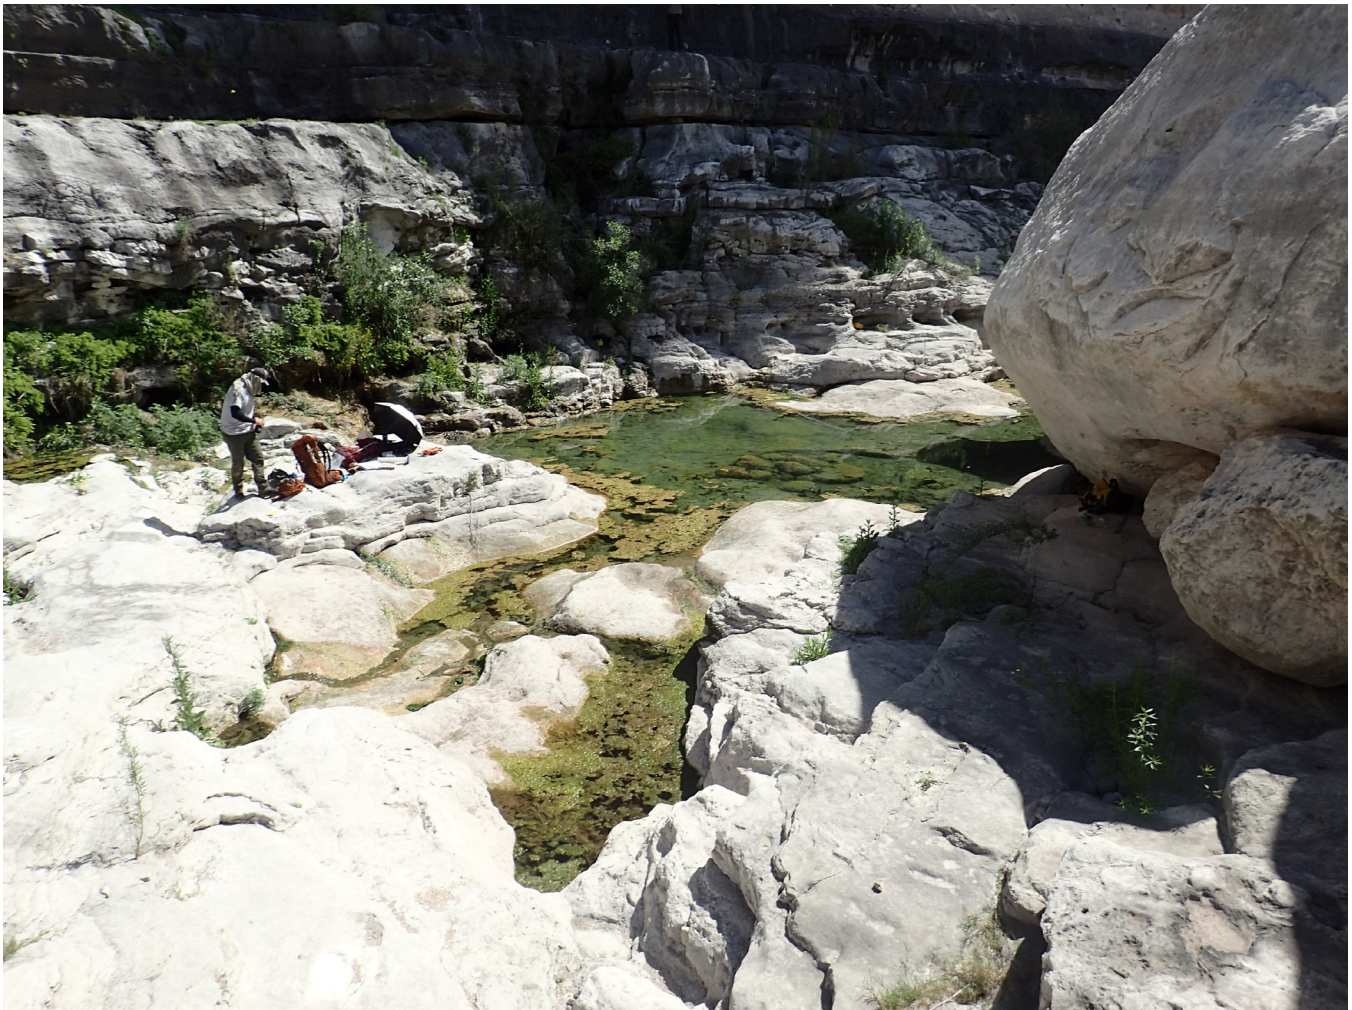
Figure 5-2. Dead Mans Canyon Spring landscape, Amistad NRA, April 2018

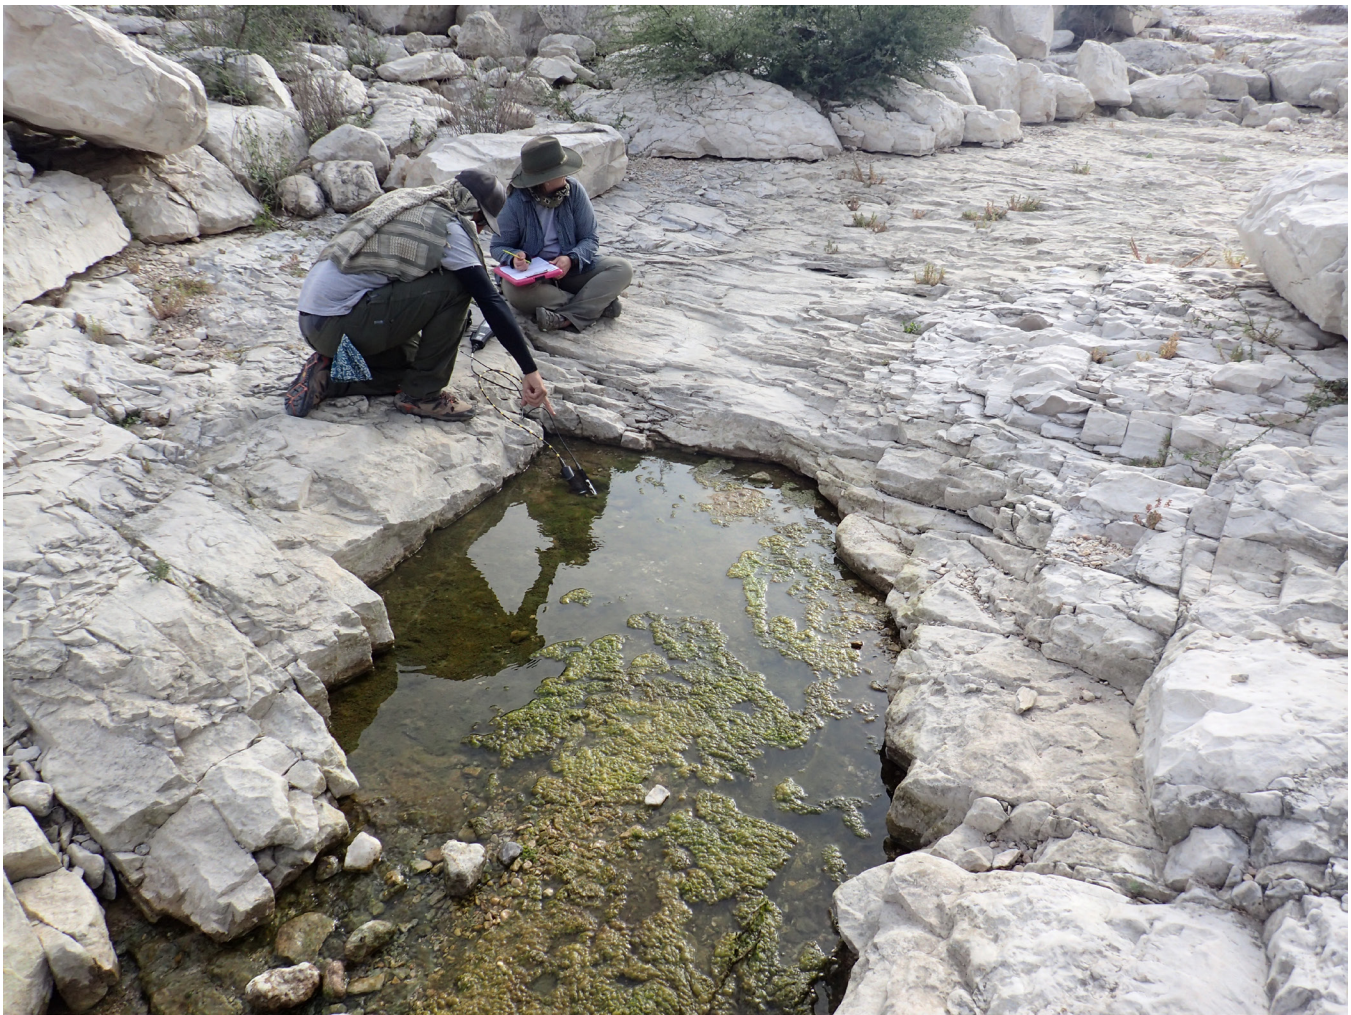
Indian Springs Canyon Spring (Figure 5-4) is a rheocrene spring with a single orifice and the crew estimated that the water present on April 3, 2018 was dominated by spring discharge. The reservoir level was 333.4m (1093.8ft) amsl on the day of the survey (TWDB 2019a). Orifice A emerges from a long bedrock seam with most flow from the northeast corner of the first pool. This flow is cool and clear. The substrate is mainly bedrock with the sides and downstream portion changing to gravel on bedrock. A thick algae mat is present on the surface of much of the pool and submerged algae is found throughout.

Figure 5-4. Indian Springs Canyon Spring orifice A, Amistad NRA, April 2018

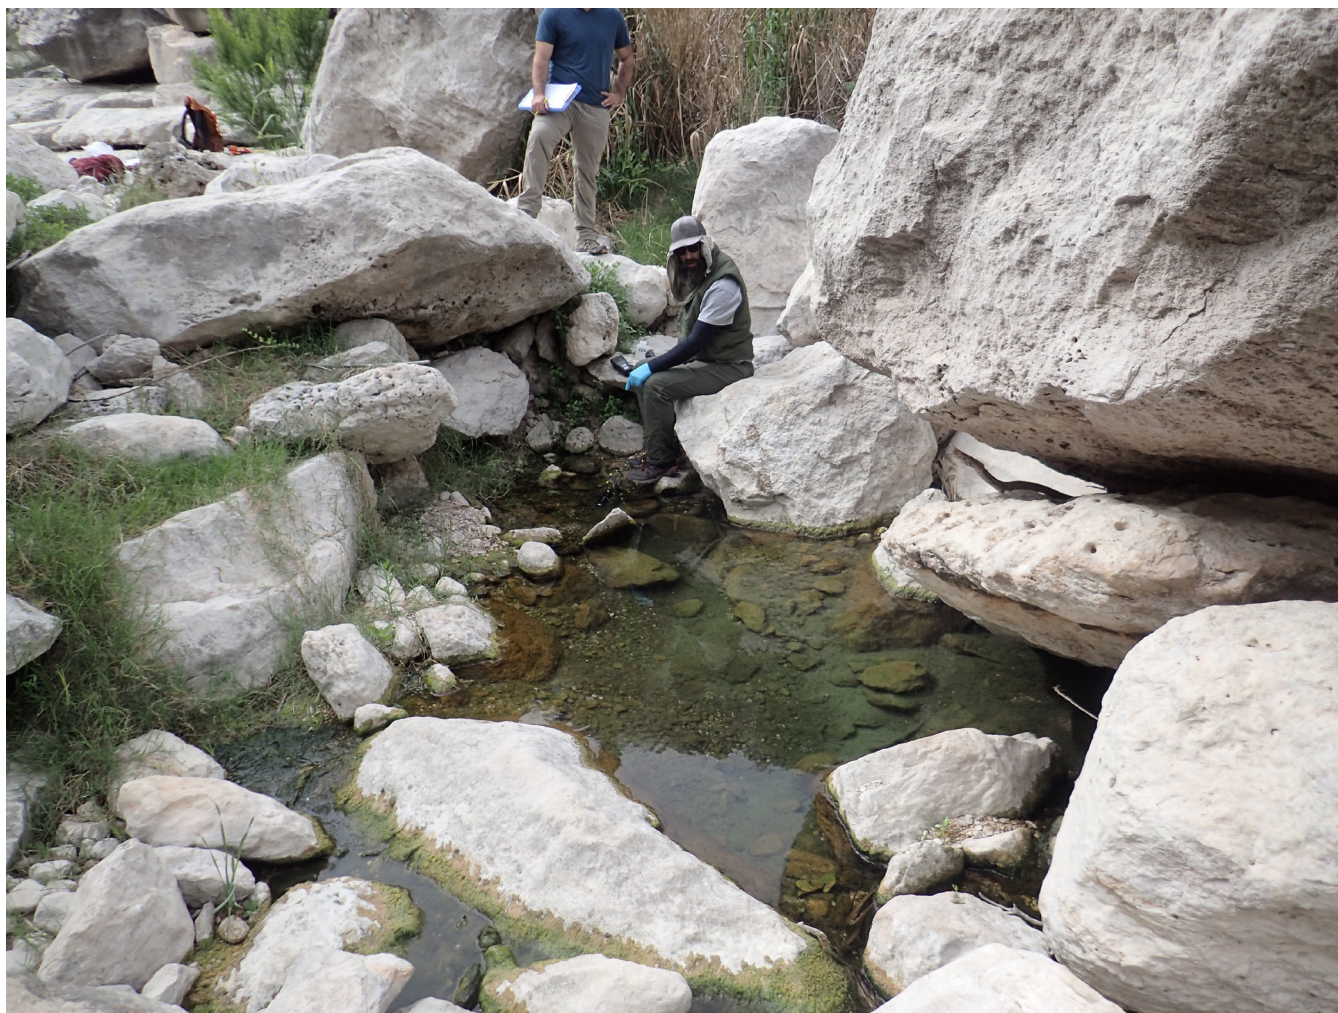
The Mouth of the Pecos Spring (Figure 5-6) is a limnocrene spring with four potential orifices and the crew estimated that the water present on April 4, 2018 was dominated by spring discharge. The reservoir level was 333.4m (1093.8ft) amsl on the day of the survey (TWDB 2019a). The spring emerges as a series of pools and a long heleocrene the last  $\frac{2}{3}$  of the system. Orifice A flows into the first pool. No flow was noted at orifice B, C, or D. Several large boulders separate this pool from the second and

Figure 5-6. Mouth of the Pecos orifice A, Amistad NRA, April 2018

largest/deepest pool. All flow is cool and clear with some algae on the gravel deposits. Boulders impound the spring with gravel and cobbles in the channel. Vegetation makes it difficult to see most of the system.

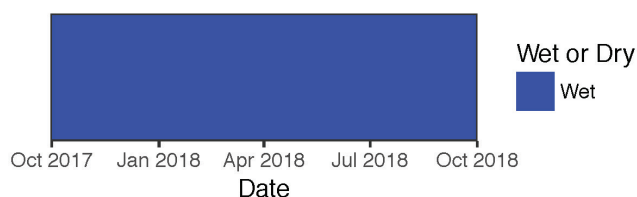
Figure 5-7. Estimated wet/dry days at Mouth of the Pecos.
