# Measuring the Effects of Rainstorm Intensity on Adobe Walls

Tumacácori National Historical Park

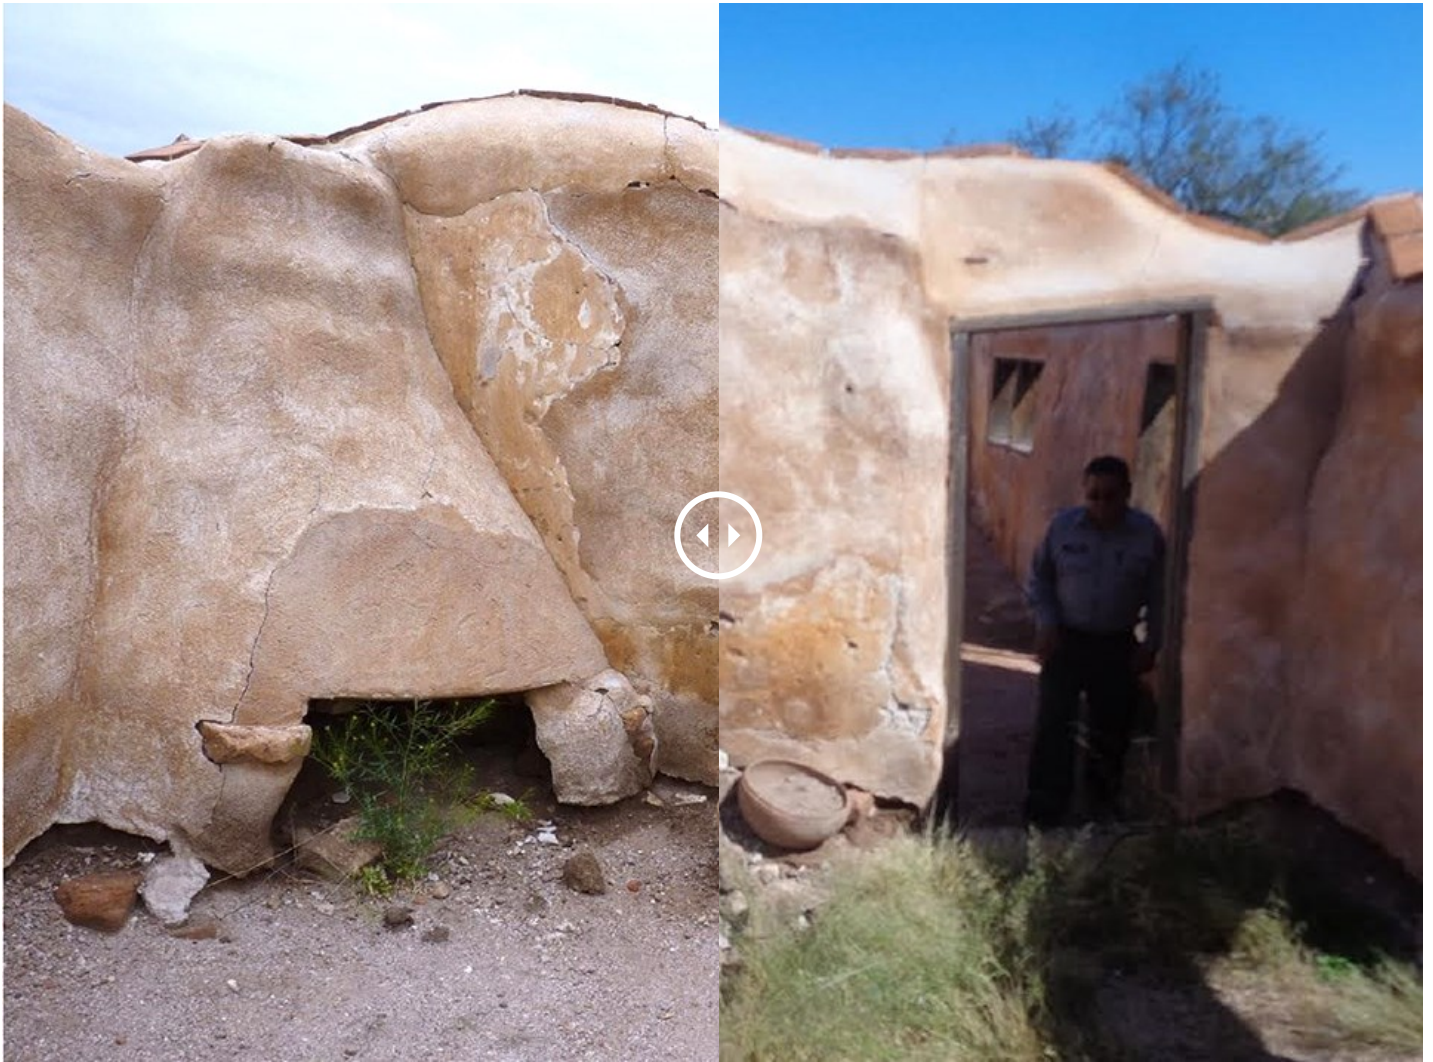
**Left Image:** Fireplace in convento at Tumacácori National Historical Park in March 2015

**Right Image:** Fireplace in convento at Tumacácori National Historical Park in October 2015, after the park received 3.62" of rain in four days.

There hasn't been enough long-term environmental monitoring of cultural resources to say for sure that the damage at Tumacácori was the result of climate change—and other variables, such as preservation treatment histories, building condition, and building materials, would also need to be accounted for. But from 2003 to 2012, mean annual temperatures at the park exceeded **more than 90%** of mean annual temperatures from the preceding century. (Additional information on temperature and precipitation at the park can be obtained from the **Sonoran Desert Network**.)

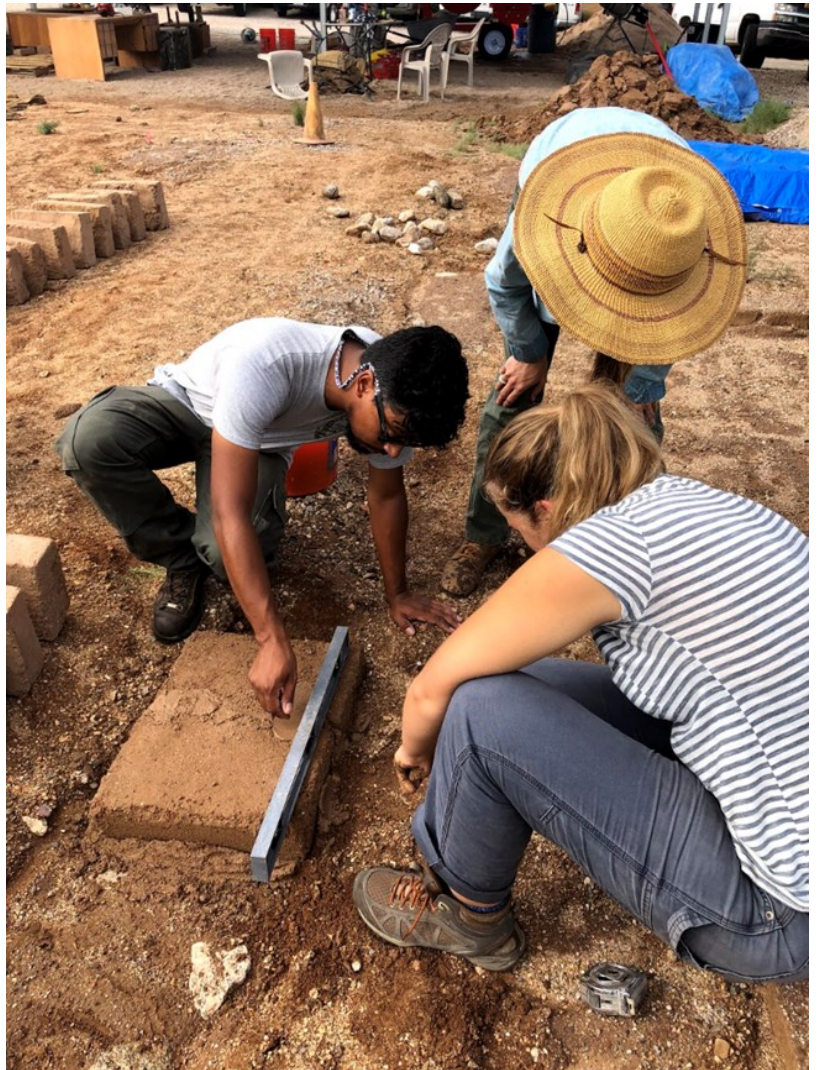
*In the project's first phase, participants learned to make adobe bricks.*

Under a blazing Arizona sun, historic-preservation experts from the NPS, US Forest Service, and Bureau of Land Management taught project participants to mix adobe bricks and pour them into forms to dry and cure for at least four weeks. After that, a few bricks were split open to ensure they were dry inside. The bricks, made of sand, clay, and silt, were sourced from a local materials center, and tested by Tumacácori NHP staff to ensure they were similar to materials used at the park.

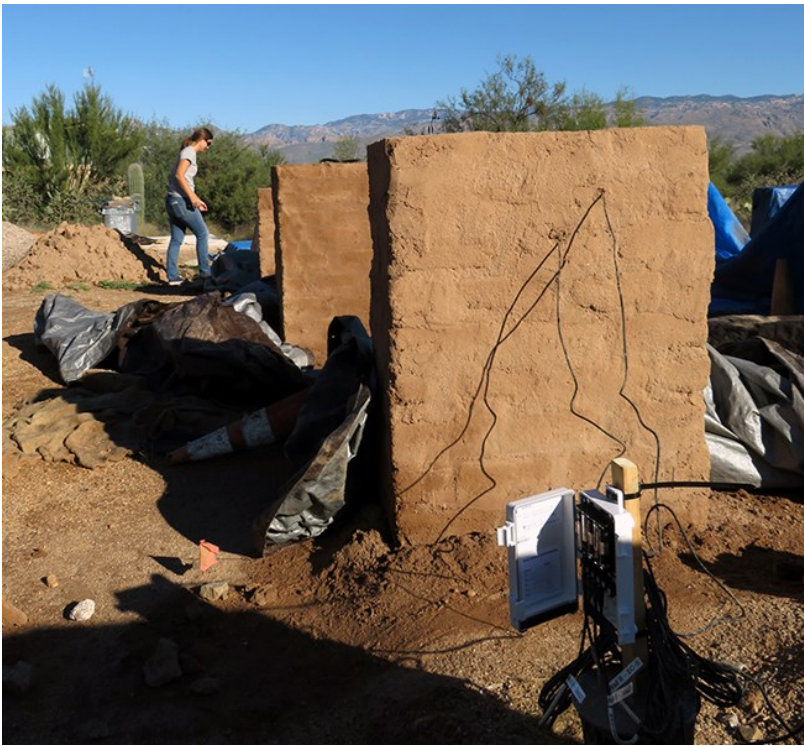
Each wall was fitted with two moisture sensors built into bricks.

Each wall included two special bricks, placed at specific, consistent locations. One brick contained a soil-moisture sensor; the other, a soil water potential sensor. The soil-moisture sensor measured volumetric water content—the amount of moisture in the brick. Soil water potential indicates the force by which water is retained in or transported from soil to other materials; its sensor was intended to provide a measure of how easily the bricks would dry out after the rain.

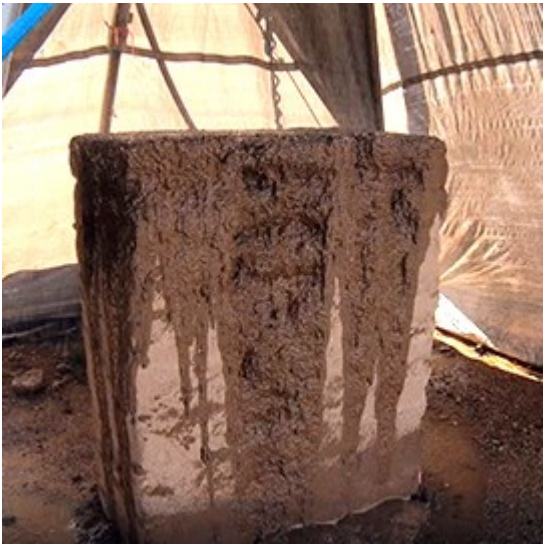
Walls were subjected to simulated rainstorms of different intensity based on the historical climate record.

To simulate showers, staff from the USDA Agricultural Research Service designed and built a portable rain tent from a water nozzle affixed to an oscillating arm (like a lawn sprinkler), set above the wall and fed by a tub filled with water. A computer controlled the sprinkler, telling it how often to spray to simulate one of three intensities representing rain events based on [historical climate data](#) for Tumacácori NHP.

The 20 adobe walls were divided into four sets of five walls each. Three sets were each assigned to a different rainshower intensity. A fourth set of walls, used as a control, was left untreated. The rain tent was moved from wall to wall, simulating a 30-minute shower at each one.

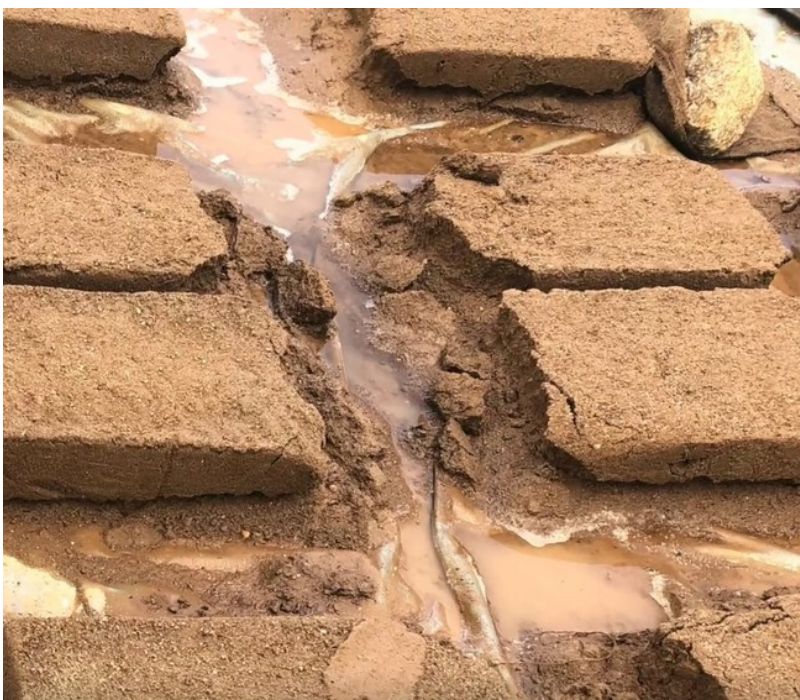
*Protecting the bricks from ambient rainfall turned out to be a major challenge.*

Perhaps ironically, one of the most difficult parts of this project was protecting the walls and bricks from ambient rainfall. Bricks stored in low spots were especially vulnerable to melting in natural rainfall before they were ever subjected to simulated rainfall. Rain tarps turned out to be one of the project's most important pieces of equipment. Making bricks and building walls in winter, and conducting treatments in the spring, would likely reduce the amount of vigilance required to protect the bricks from natural weathering.

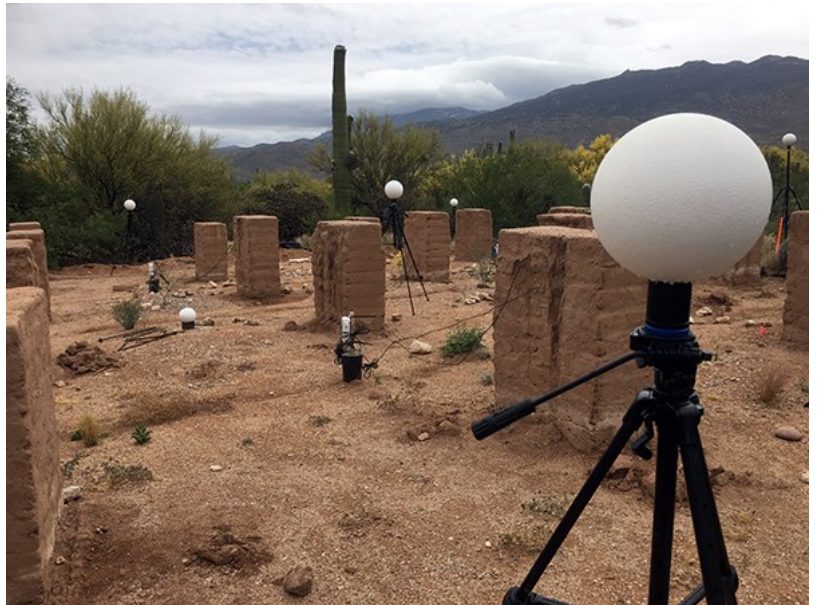
*White globes served as reference points to maximize accuracy during LiDAR scanning.*

In order to make accurate comparisons between rainfall events, it was essential that each LIDAR session be co-referenced as accurately as possible. To accomplish this, we placed five vertical segments of galvanized pipe throughout the site. During each session, a white plastic sphere, 150 millimeters in diameter, was placed atop each pipe segment as a reference point. These spheres, specifically built for this purpose, are treated with a shatterproof coating that increases albedo. The high albedo increases the reflections off the spheres during the LiDAR scanning, which in turn increases the accuracy of the scan. The nature of spheres ensures that the centerpoint of each sphere is located in exactly the same place each time the walls are scanned. This technique resulted in a detectable error threshold of about 4 millimeters.
