# Climate and Water Monitoring at Organ Pipe Cactus National Monument, Water Year 2018

Organ Pipe Cactus National Monument

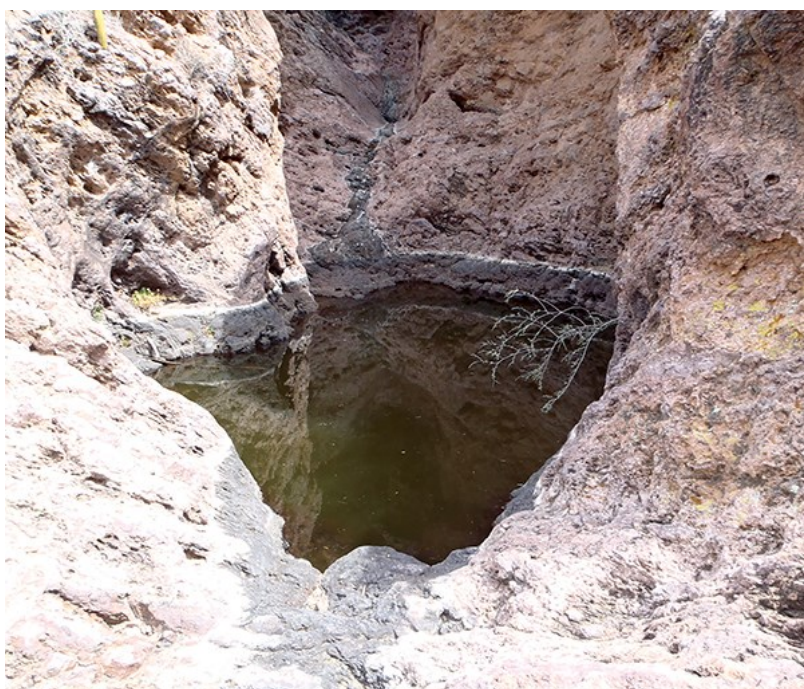
East Arroyo Tinaja.

The Sonoran Desert Network monitors water quantity, water quality, and site condition at four springs and tinajas at Organ Pipe Cactus NM. Dripping Springs and Quitobaquito Spring were wetted throughout WY2018. Sensor displacement prevented collection of reliable data on water quantity at the other two monitored springs. Water-quality measurements fell within the expected range for all springs. Dripping Springs, East Arroyo Tinaja, and Snake Pit Tinaja were classified as undisturbed for both anthropogenic and natural disturbance. Quitobaquito Spring
