# Status of Climate and Water Resources at Carlsbad Caverns National Park

*Water Year 2018*

Natural Resource Report NPS/CHDN/NRR—2019/2039

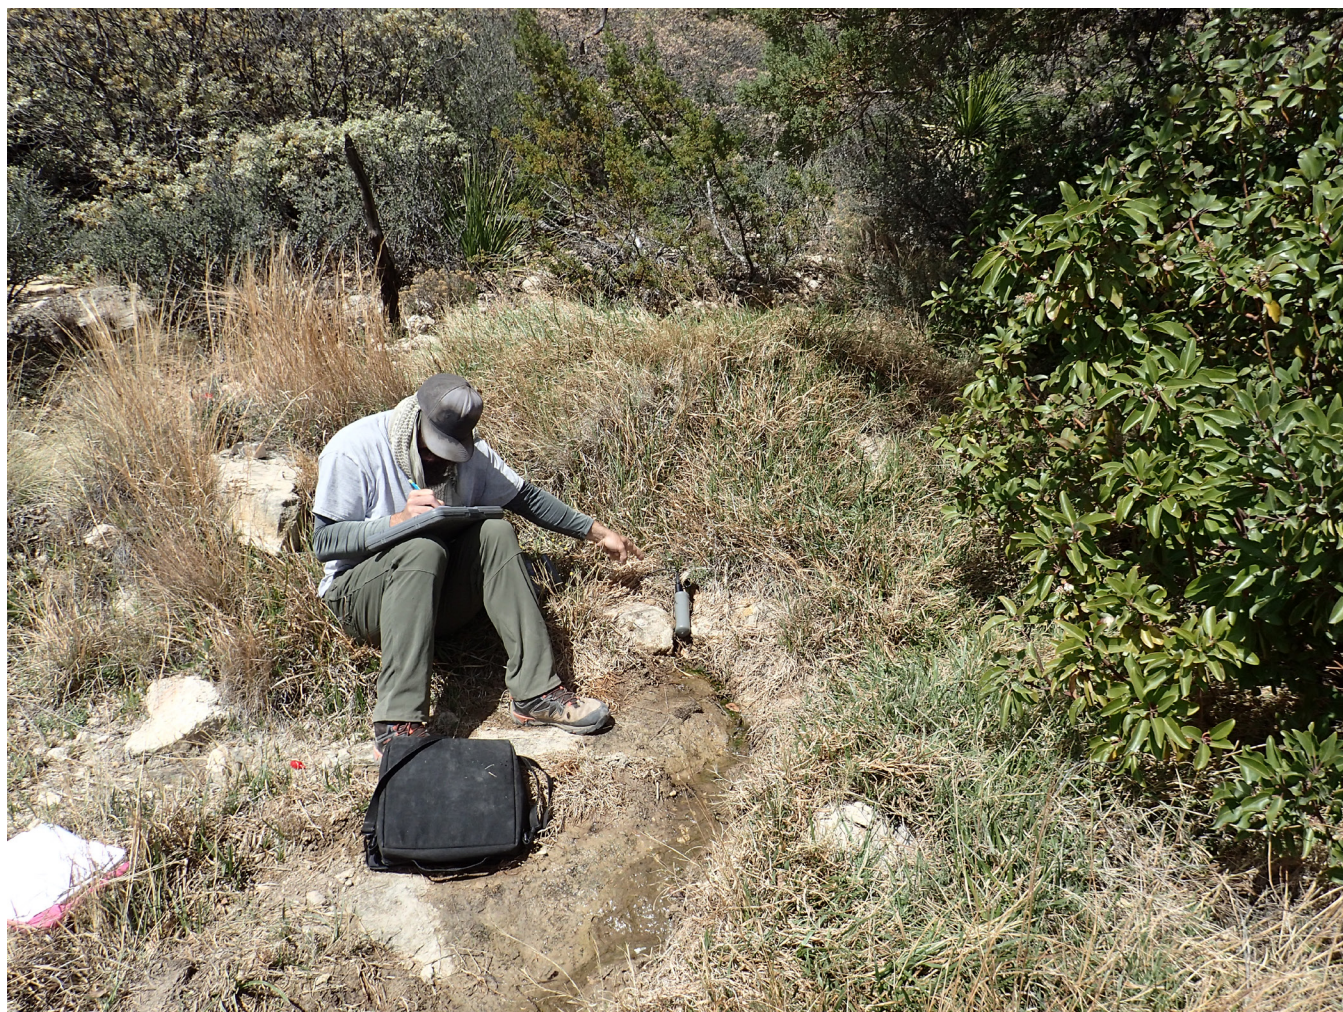
Iron Pipe Seep (Figure 3-1) is a rheocrane spring that was sampled on April 18, 2018. The spring emerges as a small trickle from a 2.5-cm (1-inch) pipe. This flow is cool and clear, and goes into a narrow channel containing seemingly stagnant pools. The substrate is cobble and silt, and the channel is lined by sedges (*Carex* sp.), perennial grasses (including creeping muhly; *Muhlenbergia repens*), and forbs. The channel ends in a 1m (3.3ft) wide by 0.5m (1.6ft) long "pool" which appears to be the result of trampling by feral animals. A somewhat larger remnant pool exists downslope, and was dry during the crew visit.

Figure 3-1. Iron Pipe Seep Orifice, Carlsbad Caverns NP, March 2018

Disturbance surveys resulted in a median value of 1 = undisturbed for both anthropogenic and natural disturbance. The site was highly disturbed by trampling and bedding of animals, most likely Barbary sheep. It was also considered moderately disturbed due to drying. There is a 3m by 2m (9.8ft by 6.6ft) wallow of cracked mud.

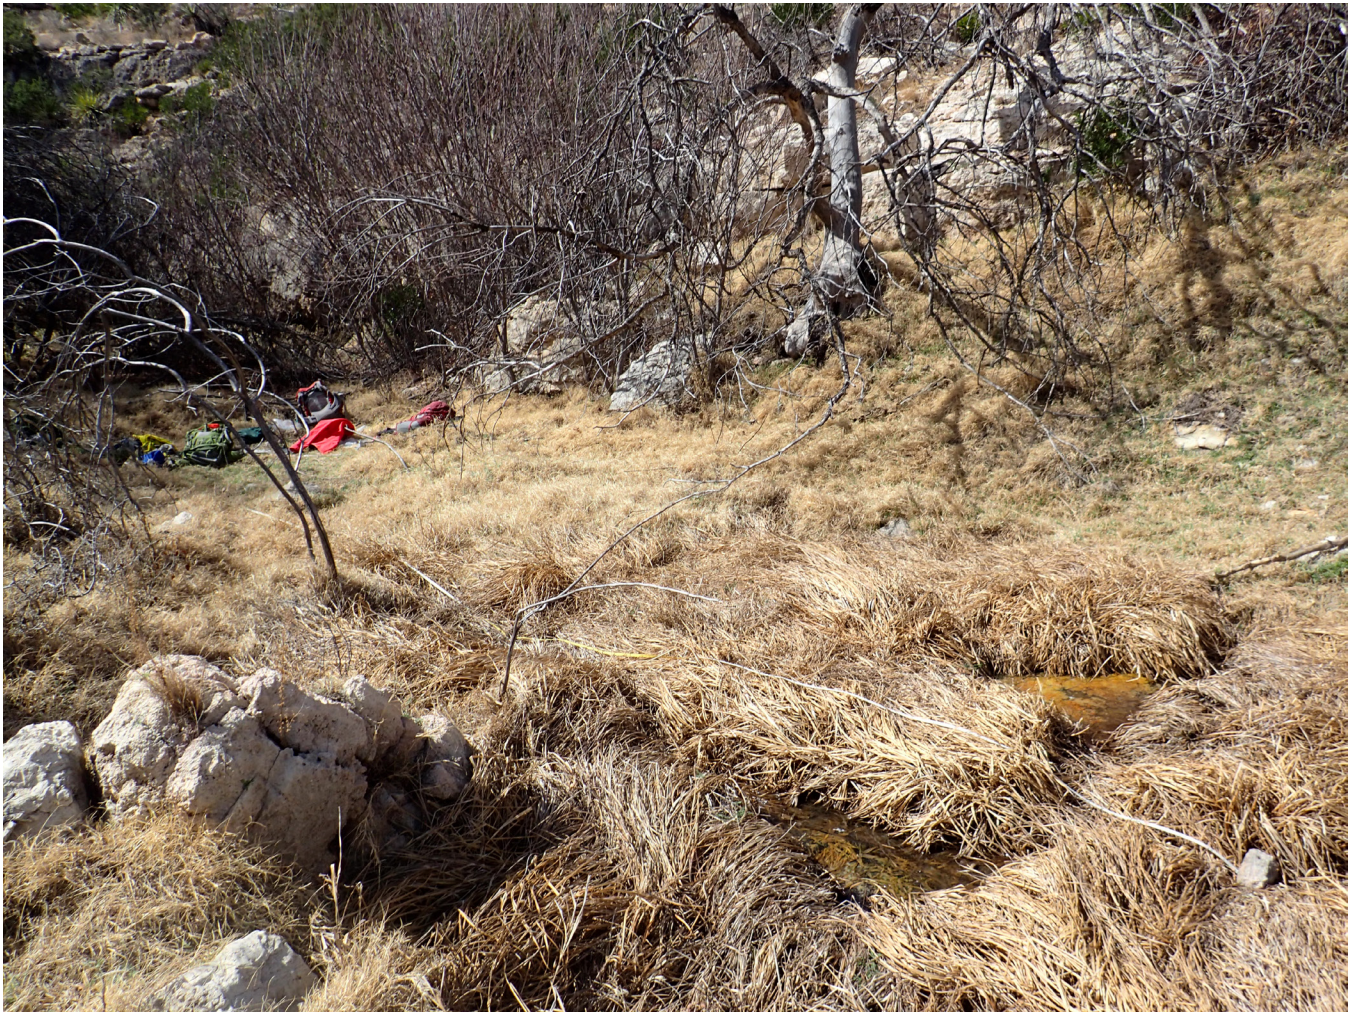
Disturbance surveys resulted in a median value of 1 = undisturbed for both anthropogenic and natural disturbance. Tracks and game trails were observed near the spring causing only slight disturbance. Field crews also noted a shorter intermittent channel, burned snags, and re-sprouts, indicating slight disturbance from fire and drying.

**Figure 3-3. Oak Spring landscape, Carlsbad Caverns NP, March 2018**

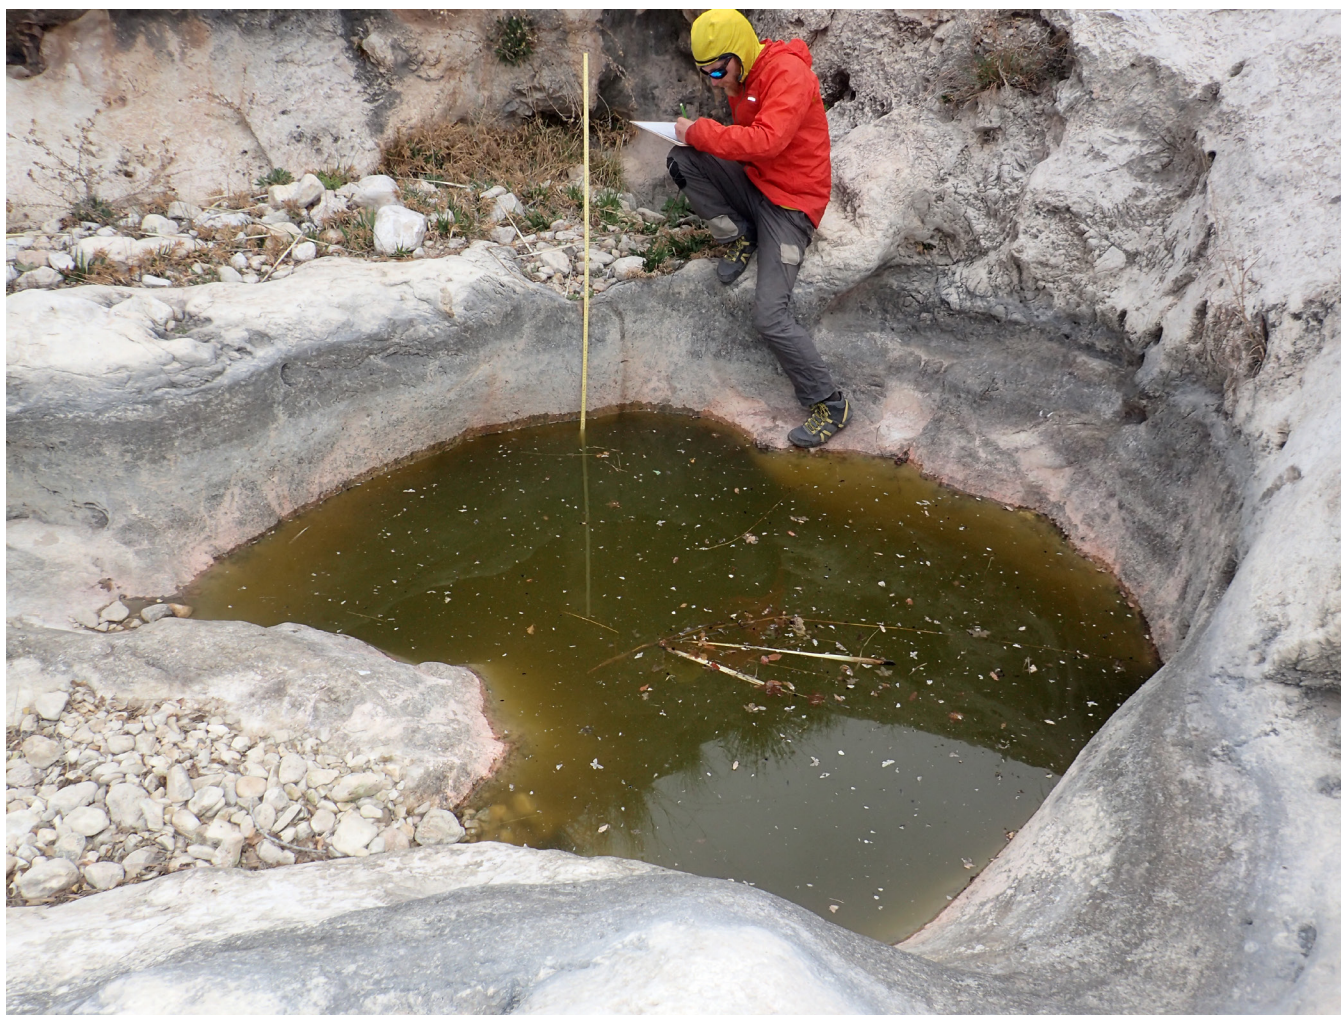
Disturbance surveys resulted in a median value of 1 = undisturbed for both anthropogenic and natural disturbance. A hiking trail passes by the tinaja causing contemporary human visitation; however, the bedrock surface makes disturbance hard to estimate. Crew also noted that the pool is likely used by wildlife, but no disturbance was observed.

Figure 3-5. Slaughter Pothole pool, Carlsbad Caverns NP, March 2018

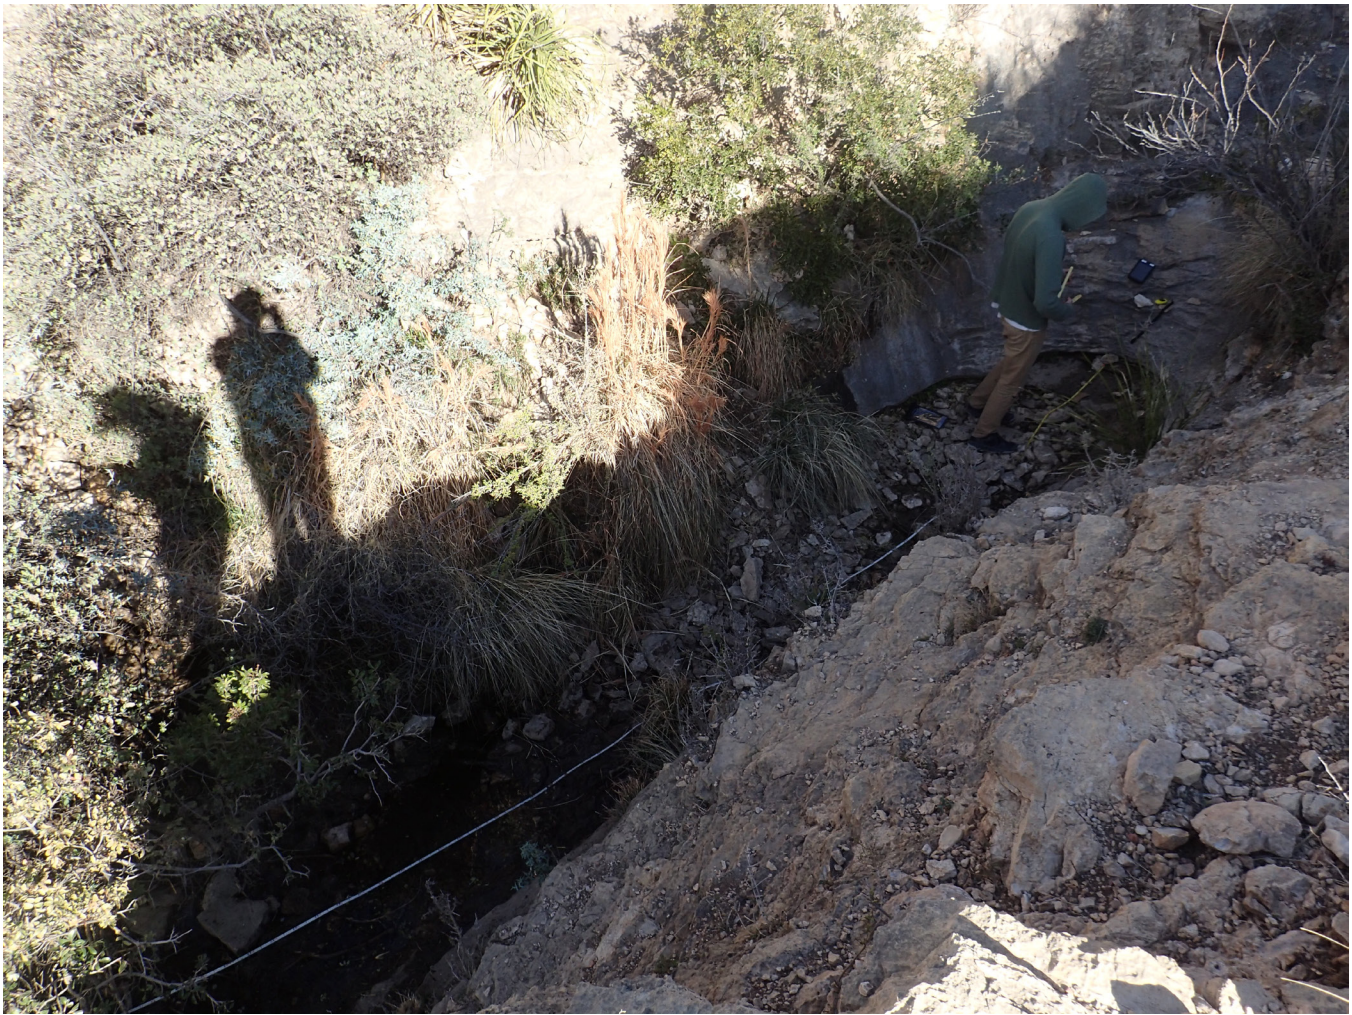
Upper East Grammer Seep (Figure 3-7) is a rheochrene spring that was sampled on March 13, 2018. The seep originates from the bottom of a water-carved limestone groove where a prominent horizontal seam seeps with minimal flow. The upstream end of the seam was considered orifice A; however, water seeps at intermittent intervals along the length of the seam, collecting in the groove until the flow becomes perceptible as laminar flow down a steep slide. As the gradient flattens, the flow continues through deposits of silt and gravel until it catches in a large compacted-substrate pool with clear water and significant algae. Another smaller, more stagnant pool occurs downstream of a gravel dam, likely a result of a robust population of muhly grass (*Muhlenbergia* sp.). The flow spreads out through the muhly and becomes subsurface. These braided dry channels

**Figure 3-7. Upper East Grammer Seep orifice A and landscape, Carlsbad Caverns NP, March 2018**

merge together to drain down a steep bedrock slide into a litter-covered pool that has a silty substrate and minimal standing water.

Disturbance surveys resulted in a median value of 1 = undisturbed for both anthropogenic and natural disturbance. There was evidence of substantial animal use at the site. Many game trails, tracks, and animal dugout beds were observed. The crew could not discern if the animal use was from feral Barbary sheep or native wildlife, though deer were observed near the site. Recent flooding has caused slight disturbance, with gravel deposition at the base of the downstream pool.

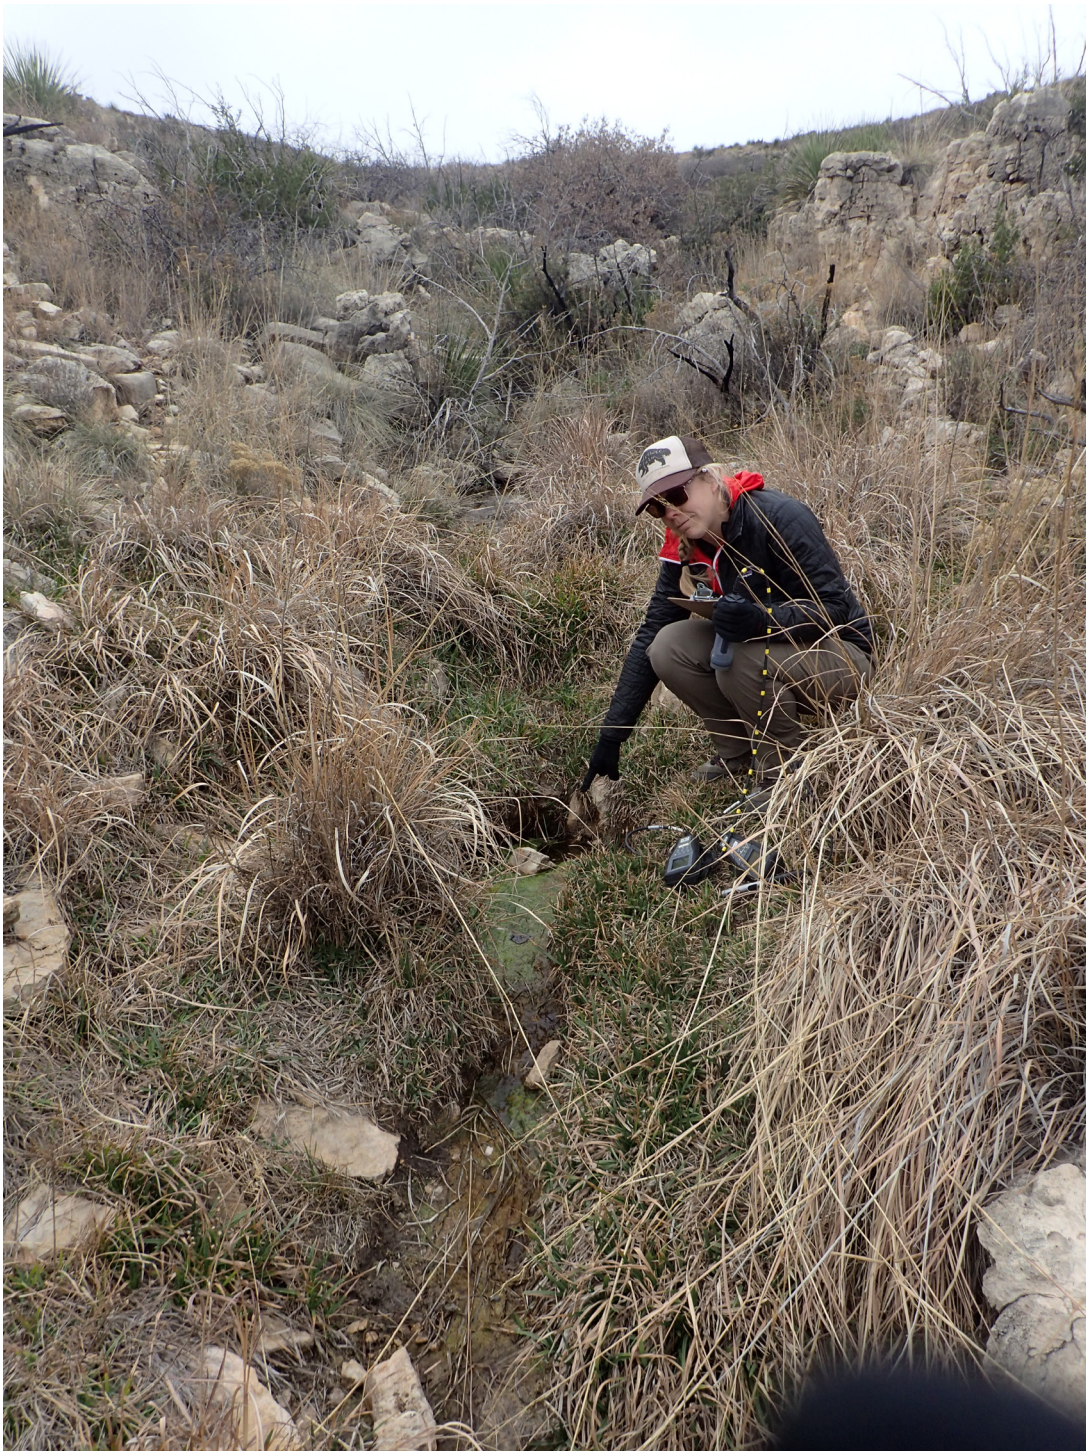
Figure 3-9. Upper Lechuguilla Spring orifice, Carlsbad Caverns NP, March 2018

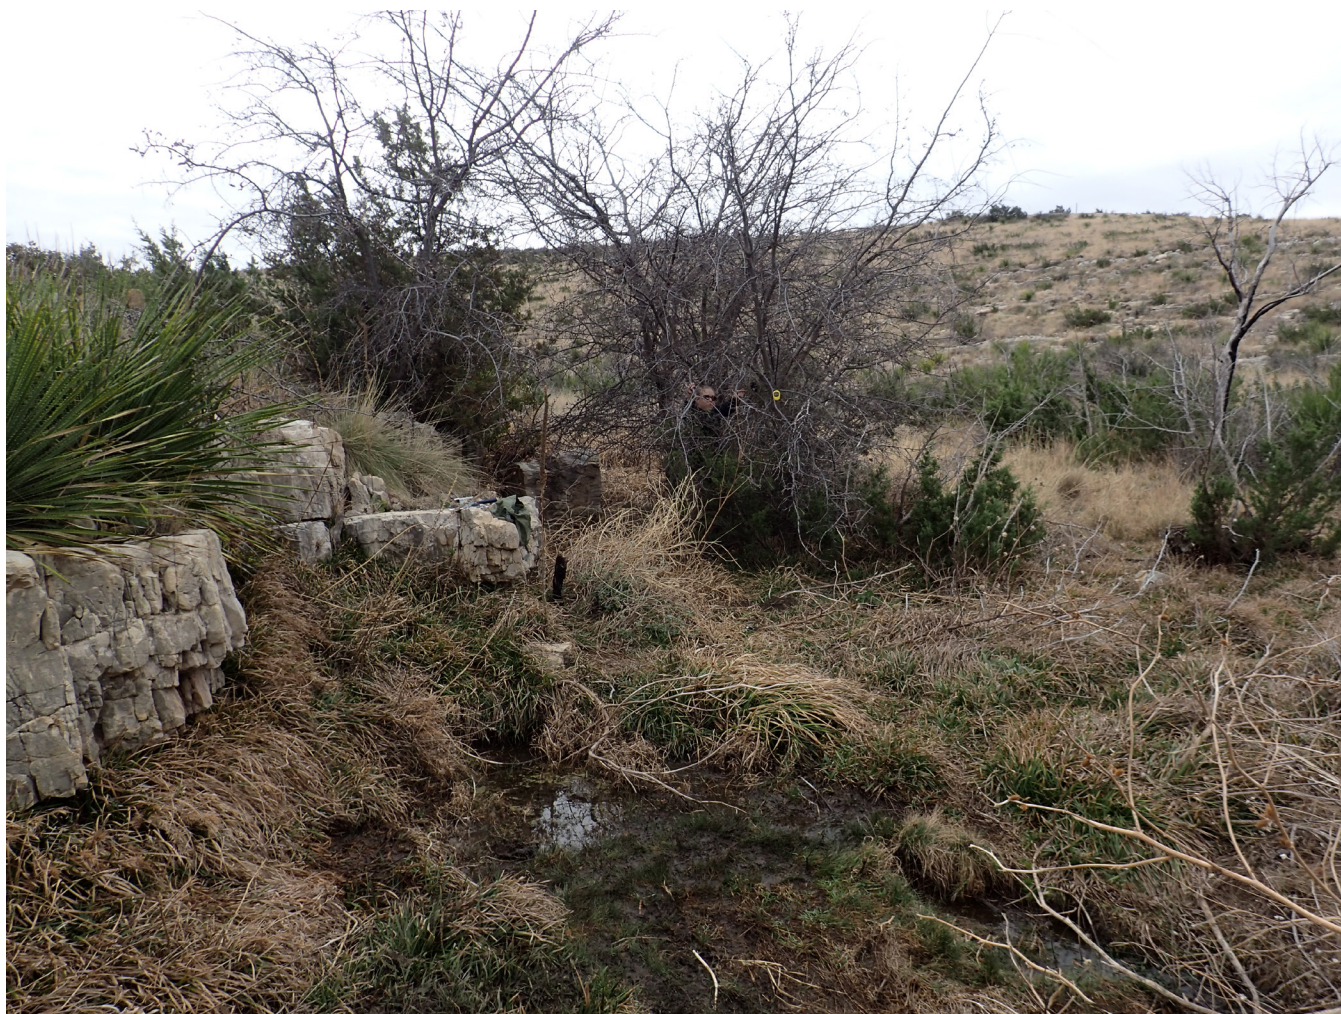
disturbance was likely dominated by Barbary sheep, but may include native wildlife use. The 2011 Loop Fire burned much of the vegetation in the area (rated moderately disturbed), and drying has caused marshy areas of thick riparian vegetation to desiccate (slight disturbance).

Figure 3-11. Small pool at Upper Lowe Ranch Spring, Carlsbad Caverns NP, April 2018
