# Wadeable Stream Habitat Monitoring at Ocmulgee Mounds National Historical Park

## *2017 Baseline Report*

Natural Resource Report NPS/SECN/NRR—2019/2053

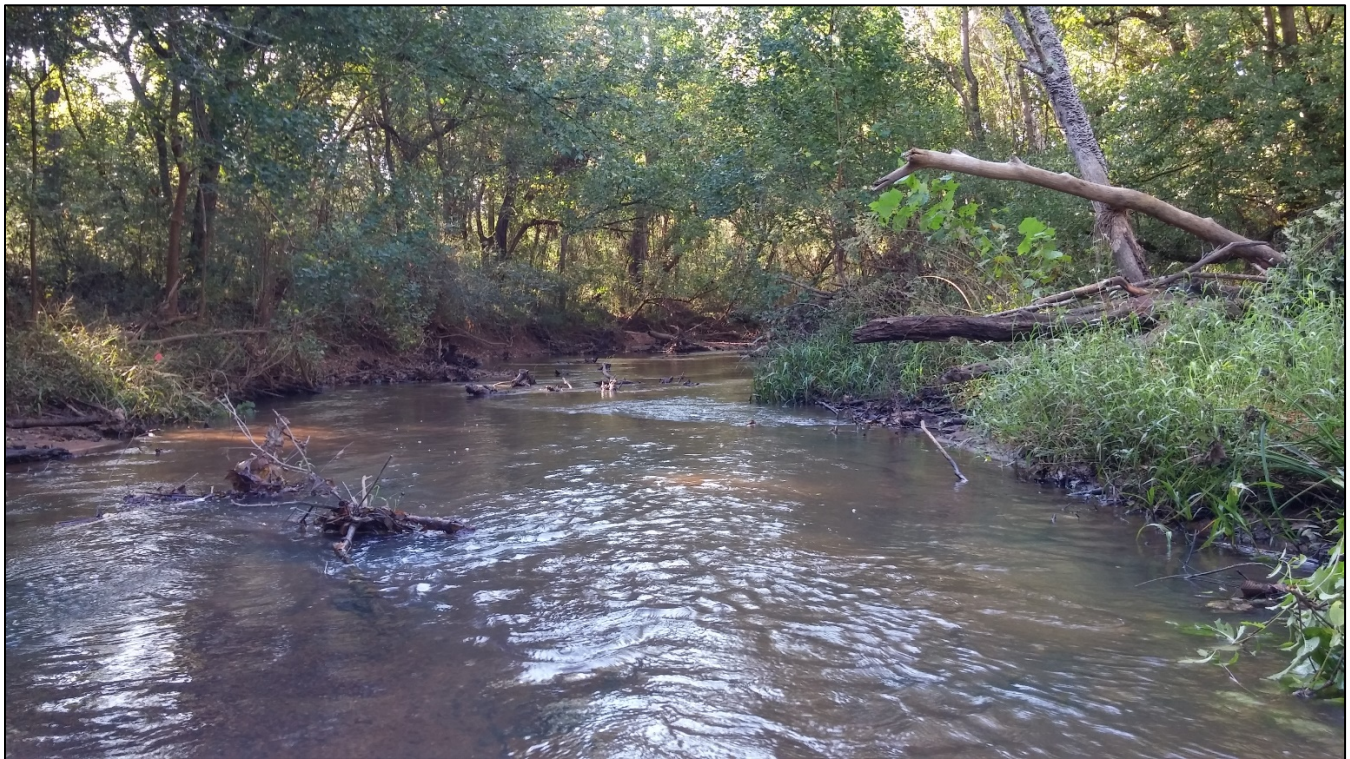
Picture looking downstream on transect 7 at the wadeable stream monitoring site on Walnut Creek (OCMU001) at Ocmulgee Mounds National Historical Park on September 27, 2017. NPS photo / SECN
