# Wadeable Stream Habitat Monitoring at Horseshoe Bend National Military Park

## *2019 Baseline Report*

Natural Resource Report NPS/SECN/NRR—2020/2067

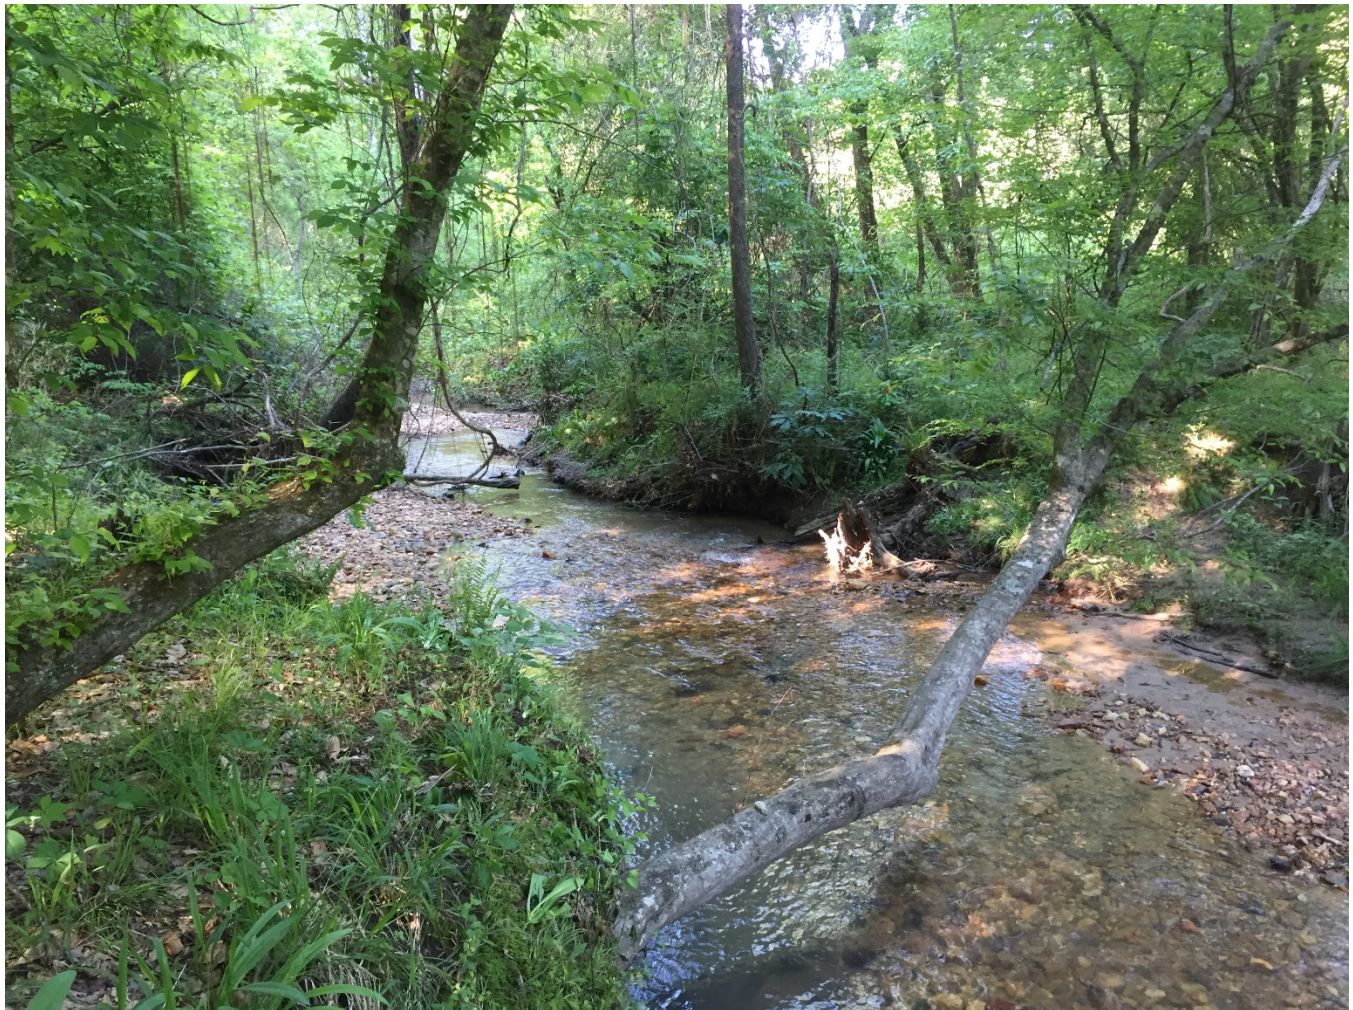
**ON THE COVER**

Picture looking downstream on river left near transect 6 at the wadeable stream monitoring site on “Claybed Creek” (HOBE001) at Horseshoe Bend National Military Park.

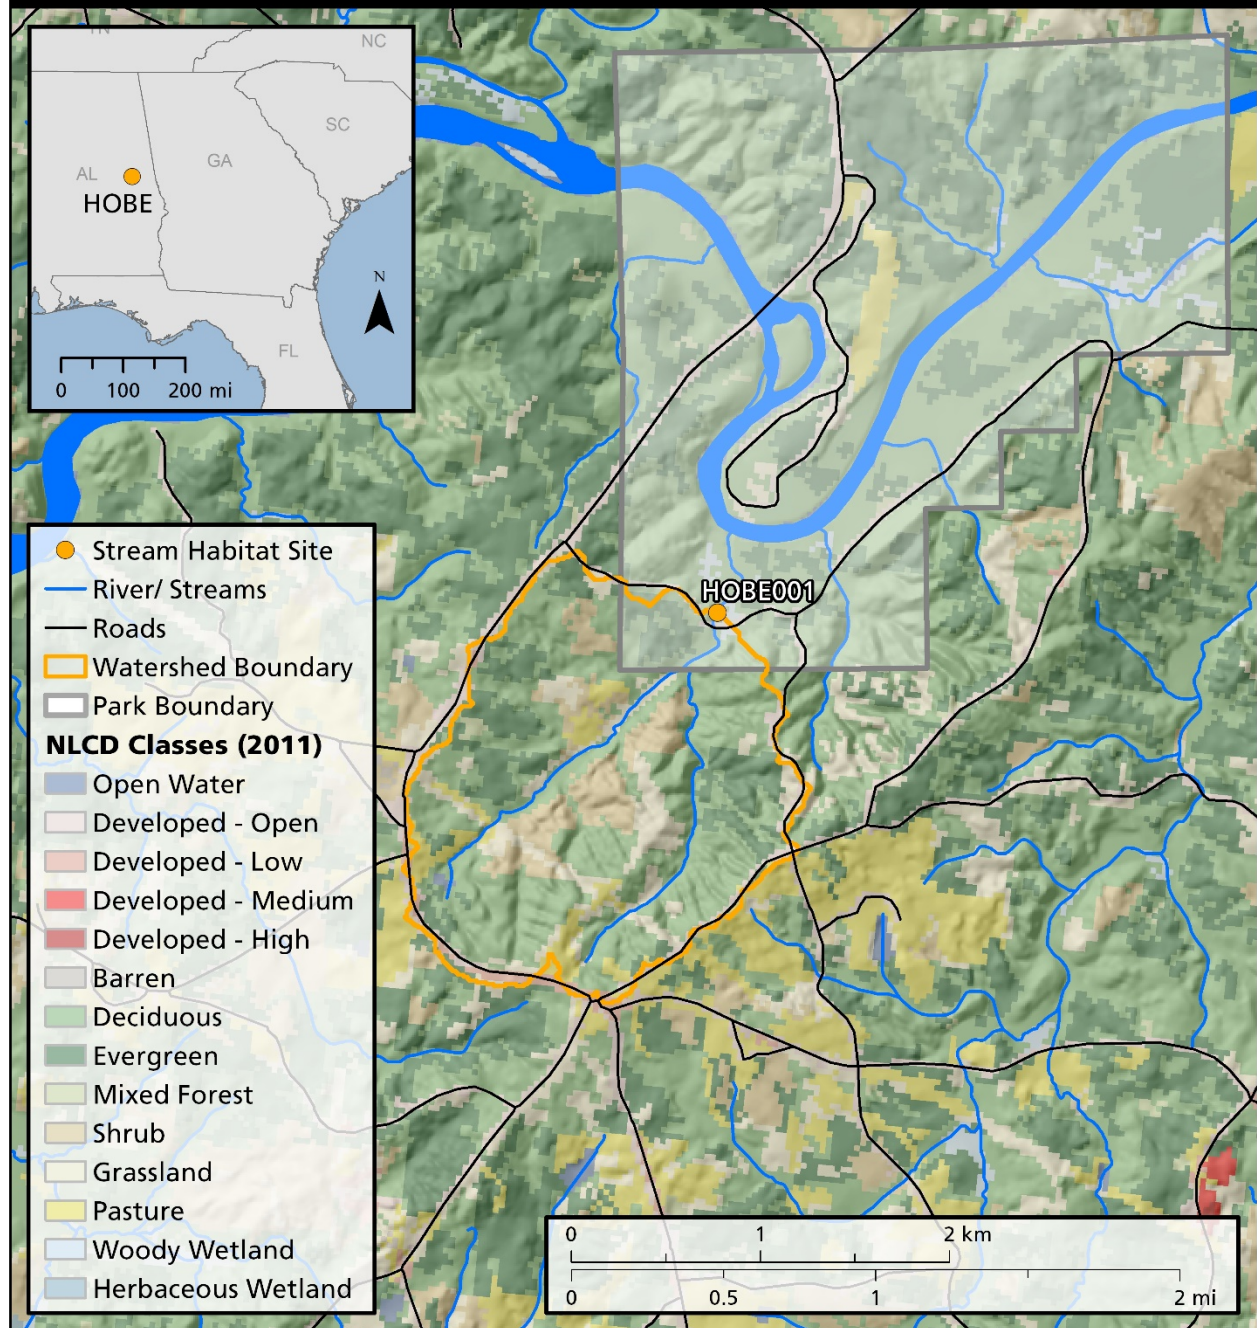
**Figure 2.** Map showing Horseshoe Bend National Military Park and its wadeable stream site (HOBE001). The watershed draining to the study reach is shown to provide a context for the data presented in this report. The land use/land cover (NLCD 2011; Homer et al. 2015) and perennial streams (derived from a 10-meter (32.8 feet [ft]) digital elevation model; data available from the U.S. Geological Survey) in the vicinity of the park are also shown.

Horseshoe Bend NMP is located in eastern Alabama and is made up of 2,040 acres (825 hectares [ha]) of mixed hardwood forest (Figure 2). Most of the park is upland forest, and a portion of the area along the southern bank of the Tallapoosa River is covered by successional forest on historical farmland. Approximately 10% of the area (mostly in depressional areas on the floodplain) is classified as wetlands. The remainder of the park is open areas and fields that commemorate historic battlefronts. Surface-water resources at Horseshoe Bend NMP include the flow-regulated Tallapoosa River, its relatively narrow flood plain, small intermittent streams along the northern boundary of the Tallapoosa, and a small, unnamed perennial stream on the south side of the Tallapoosa River. Reconnaissance surveys, conducted in 2012, indicated that under the drought conditions that existed during fall 2012, most of the park's ephemeral streams ceased to flow (M. B. Gregory, SECN Program Manager, personal observation).

The HOBE001 watershed drains 3.46 square kilometers (1.34 square miles [sq mi]) and is larger than the watersheds draining to the selected streams at Chattahoochee River NRA (1.39–2.67 square kilometers [0.54–1.03 sq mi]; Table 2). Most of “Claybed Creek’s” watershed lies south of the park on private land (Figure 2). The land use/land cover for the watershed draining to HOBE001 is quite different from the watersheds draining to the CHAT streams (Table 3). HOBE001 has far less development (4% versus 56–71%), more forest cover (68% versus 27–40%), and far more pasture/grassland (16% versus 0–5%). Unlike the CHAT watersheds, a large portion of “Claybed Creek’s” watershed is covered in shrubland (11%; Table 3). “Claybed Creek” at HOBE001 is a second-order stream in its stream network. All four of the comparison streams from Chattahoochee River NRA are also second-order streams in their respective stream networks. NPS manages approximately 6.7% of the watershed draining to HOBE001. The drainage density of “Claybed Creek’s” watershed (1.33 km/km<sup>2</sup>) is second lowest out of the streams compared in this report (Table 3). HOBE001’s watershed had the highest entire stream gradient (0.0311 m/m), the lowest segment gradient (0.0075 m/m), and the second lowest channel gradient (0.0068 m/m; Table 4). HOBE001’s watershed has moderate slope (8°), the lowest variability in watershed slope (CV = 0.61°), the highest drainage shape (0.36), the second highest basin relief ratio (0.028), and the most variability in elevation (elevation standard deviation = 17.64 meters [57.87 ft]; Table 2).
