# Monitoring of Water Surface Area in Alaska's Arctic National Parks

*Update with 2019 data*

Natural Resource Data Series NPS/ARC/NRDS—2020/1263

February 2020

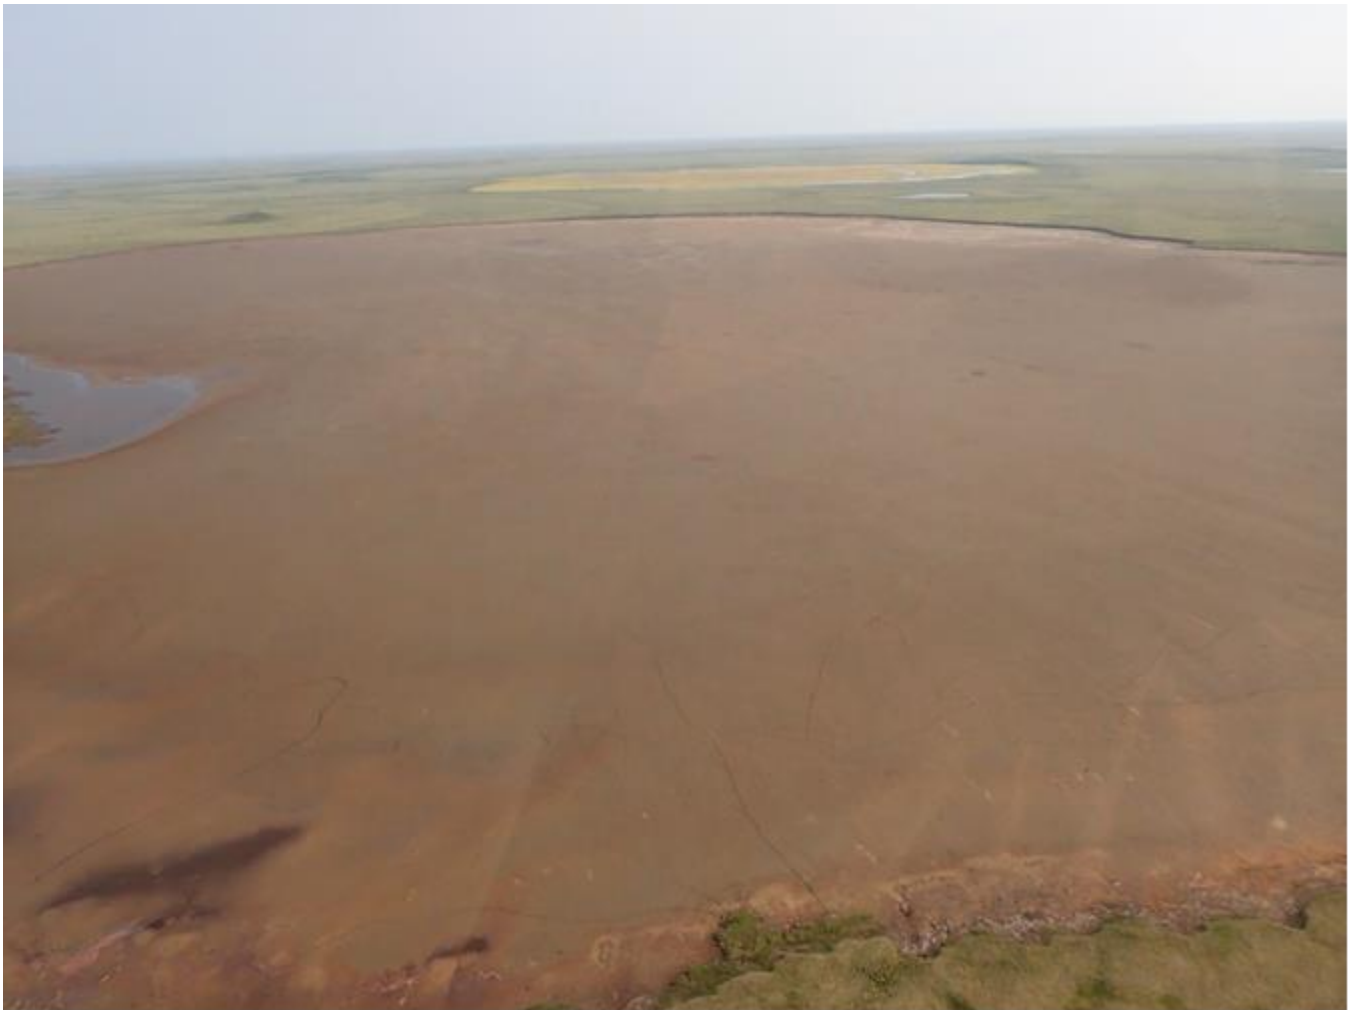
#### **ON THE COVER**

The bed of a lake that drained in 2019 in northern Bering Land Bridge National Preserve. This lake was ice- and snow-covered on a May 15<sup>th</sup> Landsat image and then drained prior to the next cloud-free Landsat Image on June 15. In the background is a lake that drained in 2018, with yellow color due to flowers of the annual plant *Senecio congestus*. Photo date 10 July 2019, camera location latitude 66.572765°, longitude -164.123988°

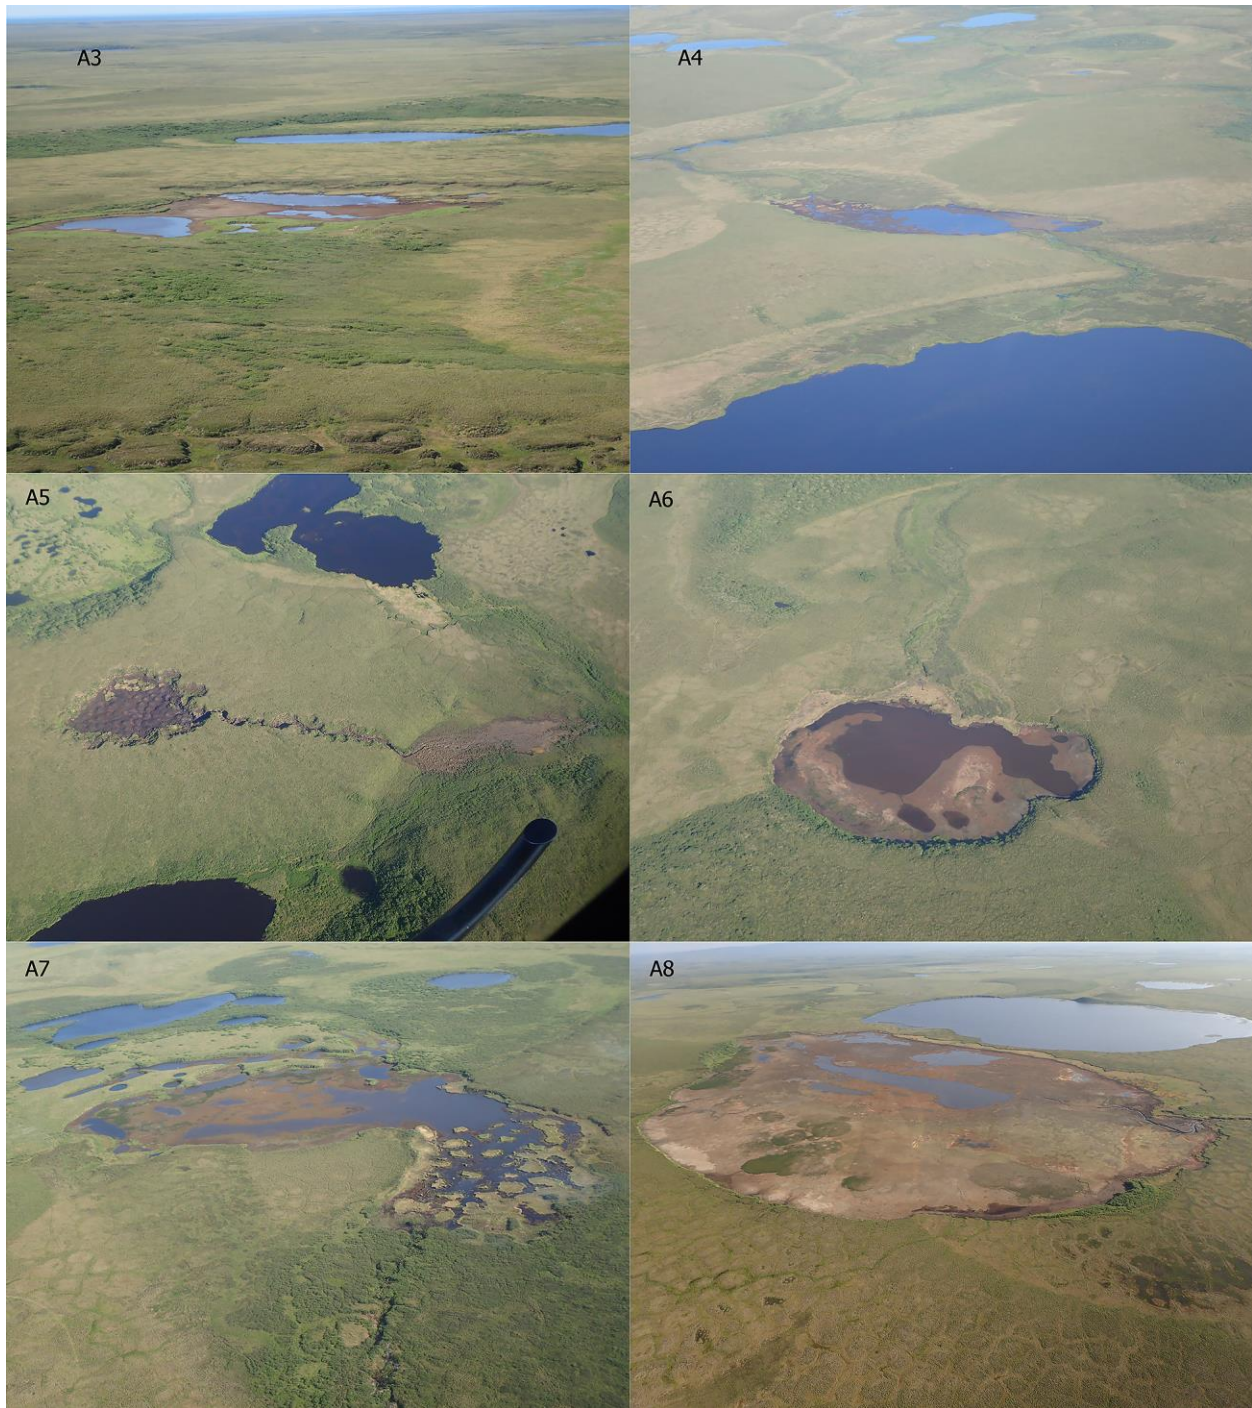
**Figures A3-A8.** Oblique aerial photographs of lakes in northern BELA with mud exposed due to lowered water levels.

This Appendix contains oblique aerial photographs of lakes that had mud exposed in July 2019 as a result of lowered water levels (figures A1 through A14). These photos were taken opportunistically by the author in July 2019 as a part of other projects in northern BELA and do not represent a systematic effort to locate all of the drained lakes present. The locations of the camera for each photo (taken from the camera's internal GPS) are shown in Figure A15, along with the locations of lakes that my analysis of satellite image data later showed to have drained in 2019. Dates, locations, and orientations of the cameras for these photos are given in Table A1. Some photos are of the lakes that were identified as drained by the satellite image analysis (A2, A8, A10, A11, A13), while the others were not, probably because the amount of drainage visible on the available Landsat images had not progressed far enough to meet the criterion for a “drained lake” (loss of 50% of surface area). The vast majority of lakes in northern BELA were filled to bankfull in 2019, and those showing exposed mud flats often had an obviously eroded new outlet visible during a cursory fly-by. Thus even the partial drainages depicted here are probably due to thermoerosion of new outlets and not simple evaporative drying.

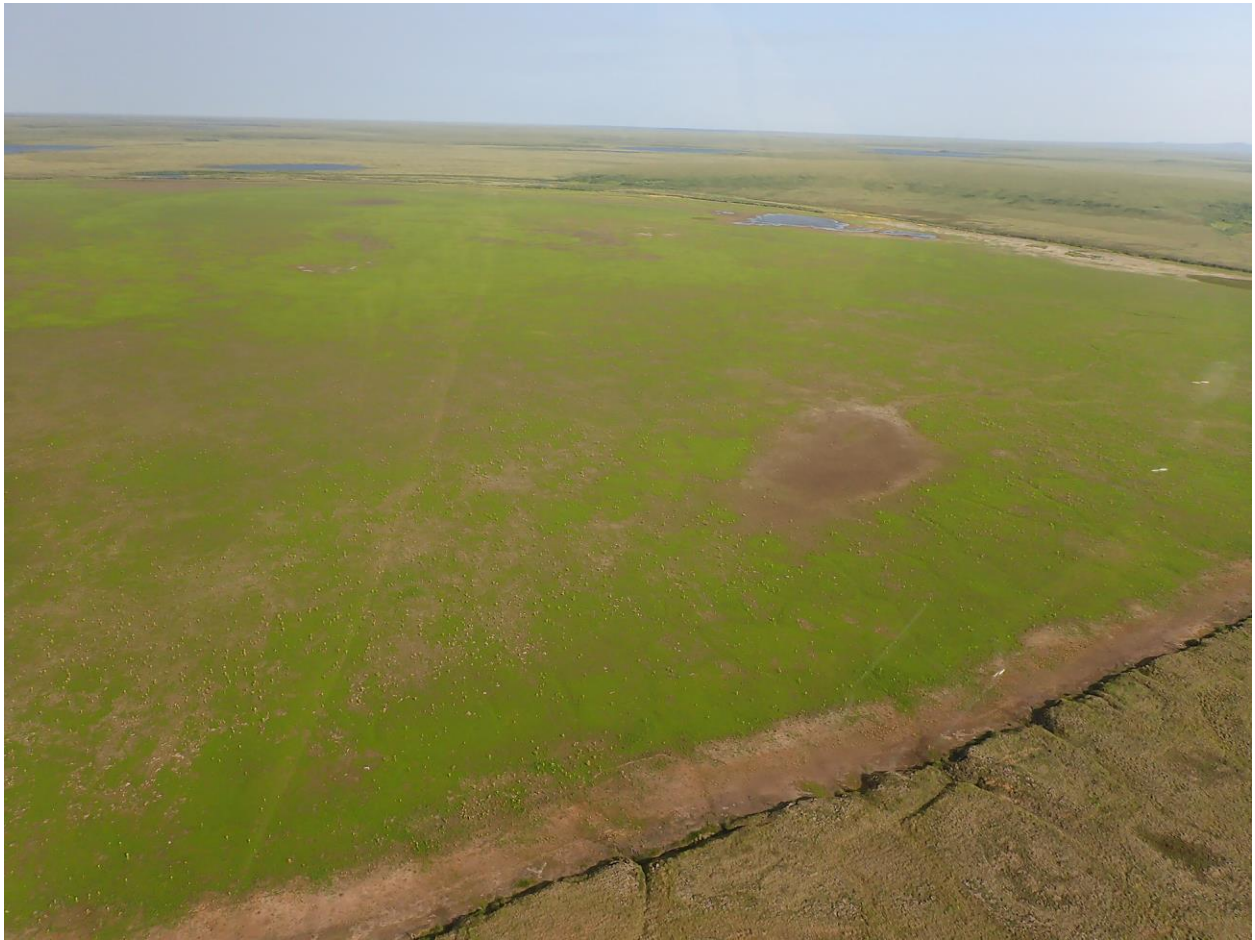
**Figure B1.** Aerial view of drained lake 128.

This lake appeared from the air to be uniformly green with new vegetation, except for some bare mud patches mostly around the margins (Figure B1). On-the-ground examination of the green area showed it to be a nearly solid lawn of *Equisetum scirpoides* (Figure B2). An estimate of the cover by species near the photo point (Figure B2) was: *Equisetum scirpoides* 75%, *Acrophila fulva* 2%, *Senecio congestus* <1%, *Salix* cf. *glauca* <1%, *Rorippa palustris* <1%, bare mud 5%.

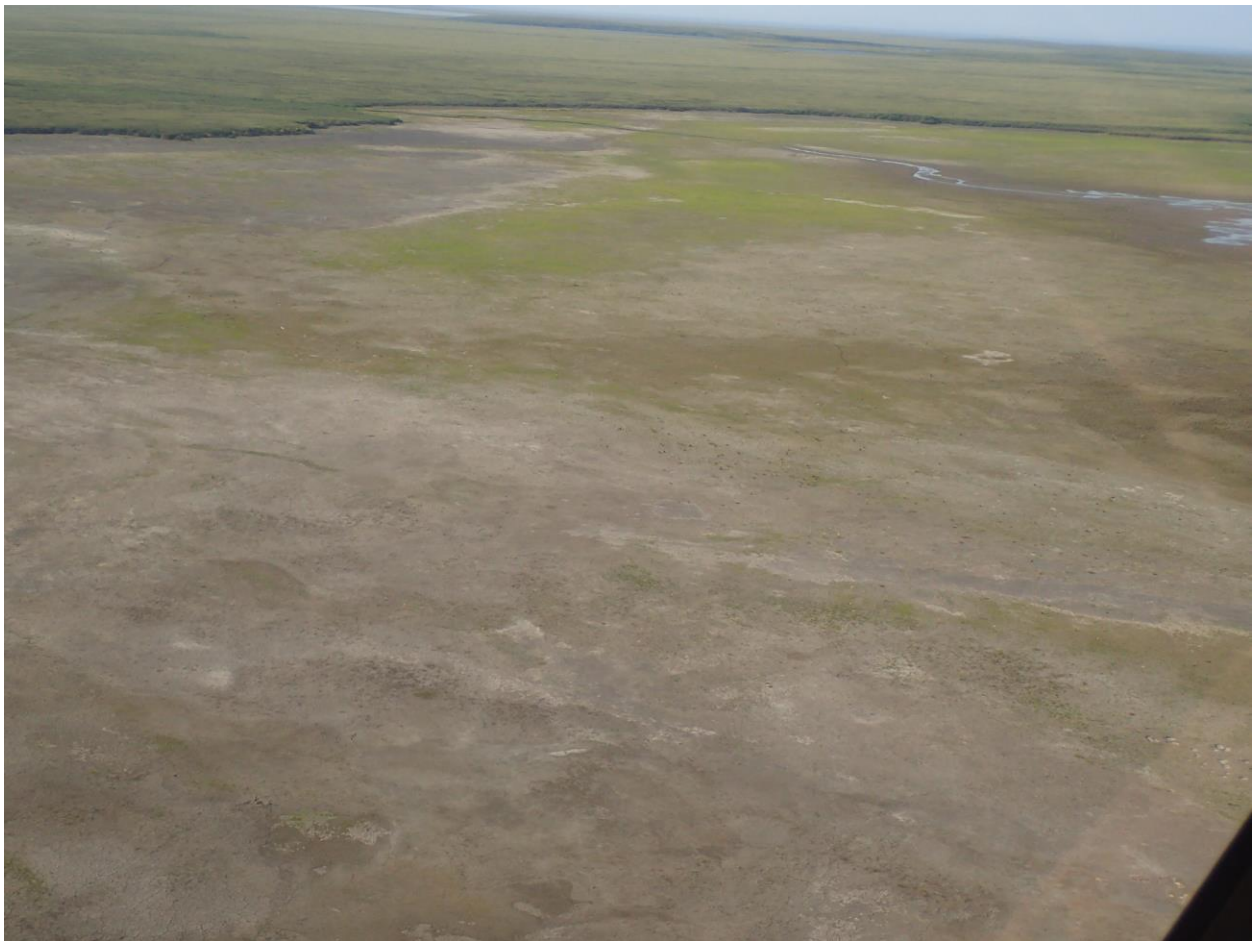
**Figure B3.** Aerial view of drained lake 314.

This lake had extensive areas of sparsely vegetated mud (Figure B3). The species composition was similar to the other lakes we visited, but with much lower plant cover. Near the photo point (Figure B4) the cover by species was: *Eleocharis acicularis* 5% (1 patch); *Senecio congestus* 1%, *Arctophila fulva* 1%, *Rorippa palustris* <1%, *Equisetum scirpoides* <1%, unidentified moss <1%, bare mud 95%. The mud had desiccation cracks and a probable salt crust. The *Eleocharis palustris* had an unhealthy brownish color in places (see Figure B4, south), presumably due to desiccation or soil chemical issues (e.g. salinity). There were curving parallel lines of mollusk shells deposited along shorelines during the lake's recession, and seedlings of *Rorippa palustris* were concentrated there, suggested a floating seed source. We observed fairly dense stands of *Hippuris vulgaris* near the lake margin that probably represent pre-drainage stands.

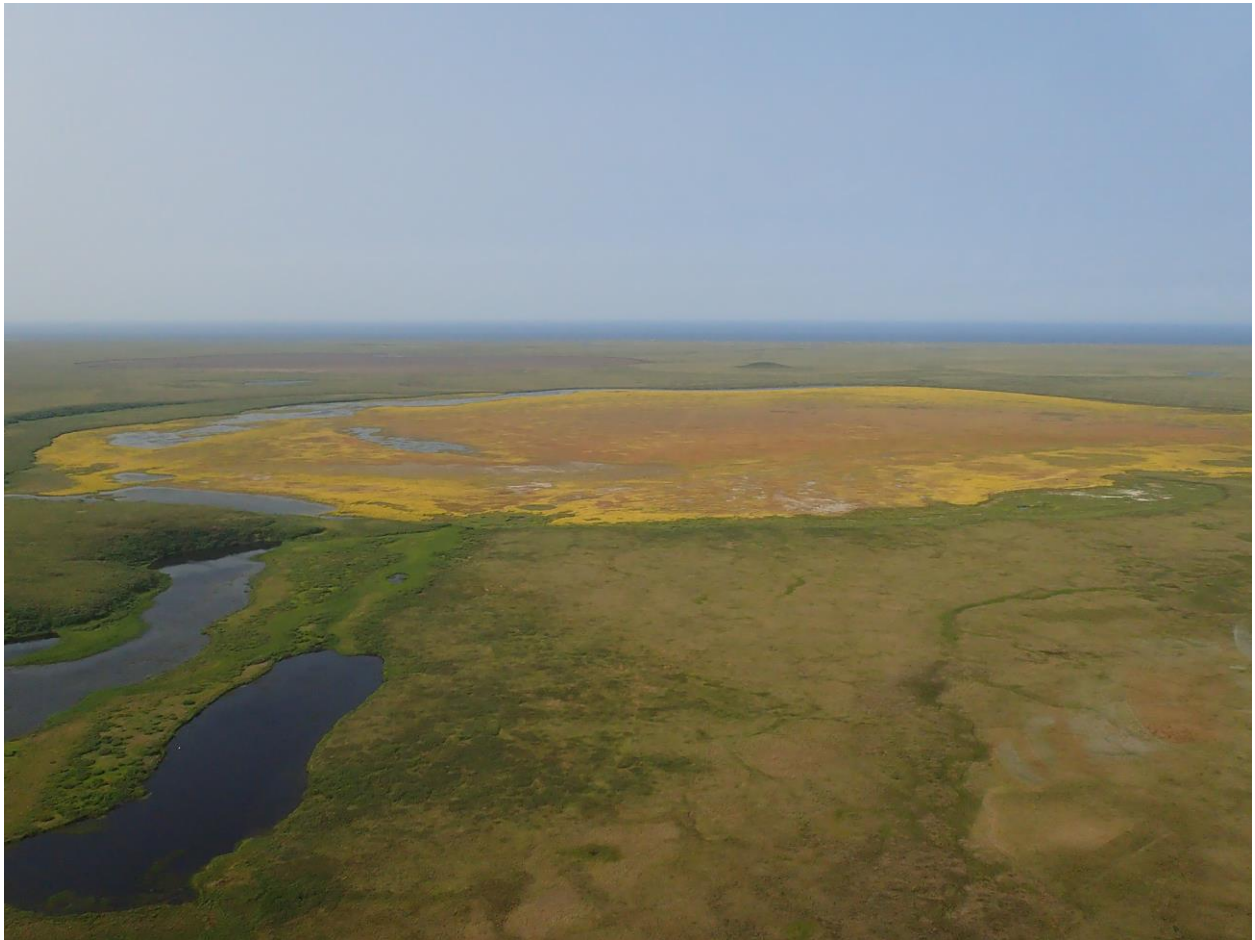
**Figure B5.** Aerial view of drained lake 154

This lake appeared bright yellow from the air due to a profusion of flowers (Figure B5). On-the-ground inspection revealed these to be *Senecio congestus*, over a dense sod of *Eleocharis acicularis* (Figure B6). The *Senecio congestus* was denser nearer to the former lakeshore (Figure B6) than at the GPS photo point more in the center of the former lake (Figure B7). The plant cover by species near the GPS point was *Eleocharis acicularis* 90%, *Senecio congestus* 8%, *Rorippa palustris* <1%, bare mud 3%.

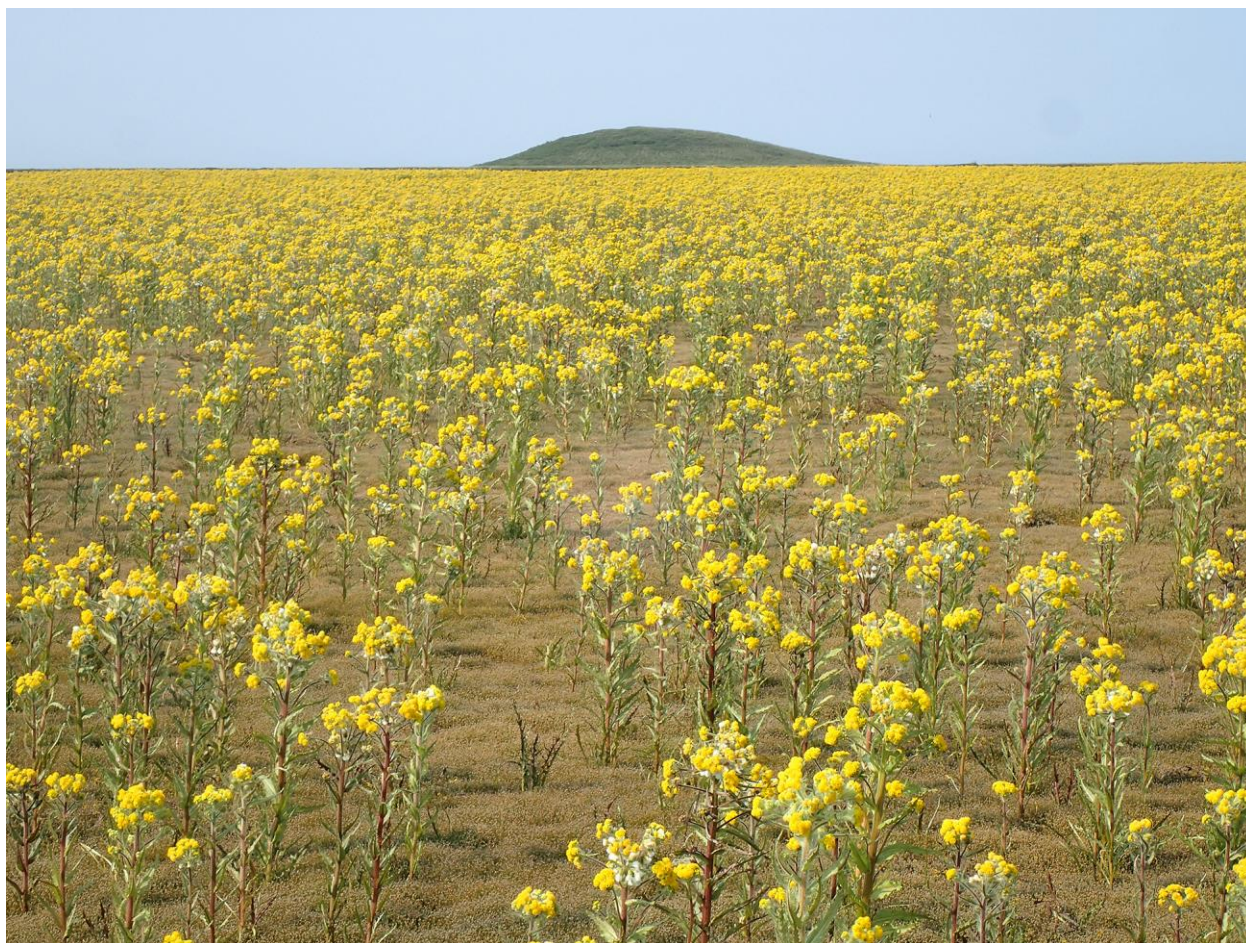
**Figure B6.** Vegetation of drained lake 154, in area of dense *Senecio congestus* flowers. The sod below is *Eleocharis acicularis*. A pingo is visible in the background. Latitude 66.552105°, longitude -164.0792167°
