SATALA CEMETERY RESTORATION TREATMENT REPORT RFP -036-2010 June/July 2010  
Monument Conservation Collaborative LLC, Norfolk, CT 06058

Satala Cemetery June 21, 2010

Attached is our report describing the conservation and restoration to the Satala Cemetery after the damage caused by the Tsunami of September 29, 2009.

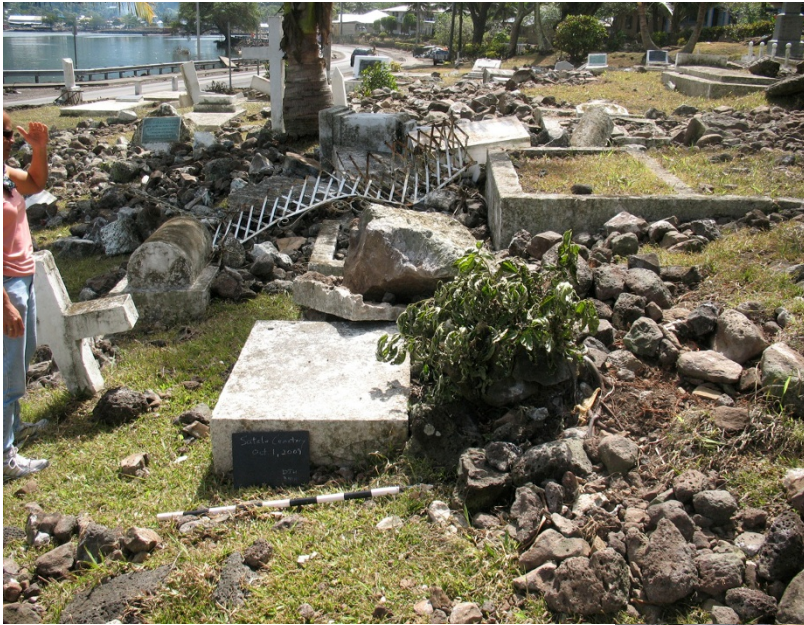
Oct 1, 2009, Two days after  
the Tsunami.  
*Photo: David Herdrich*

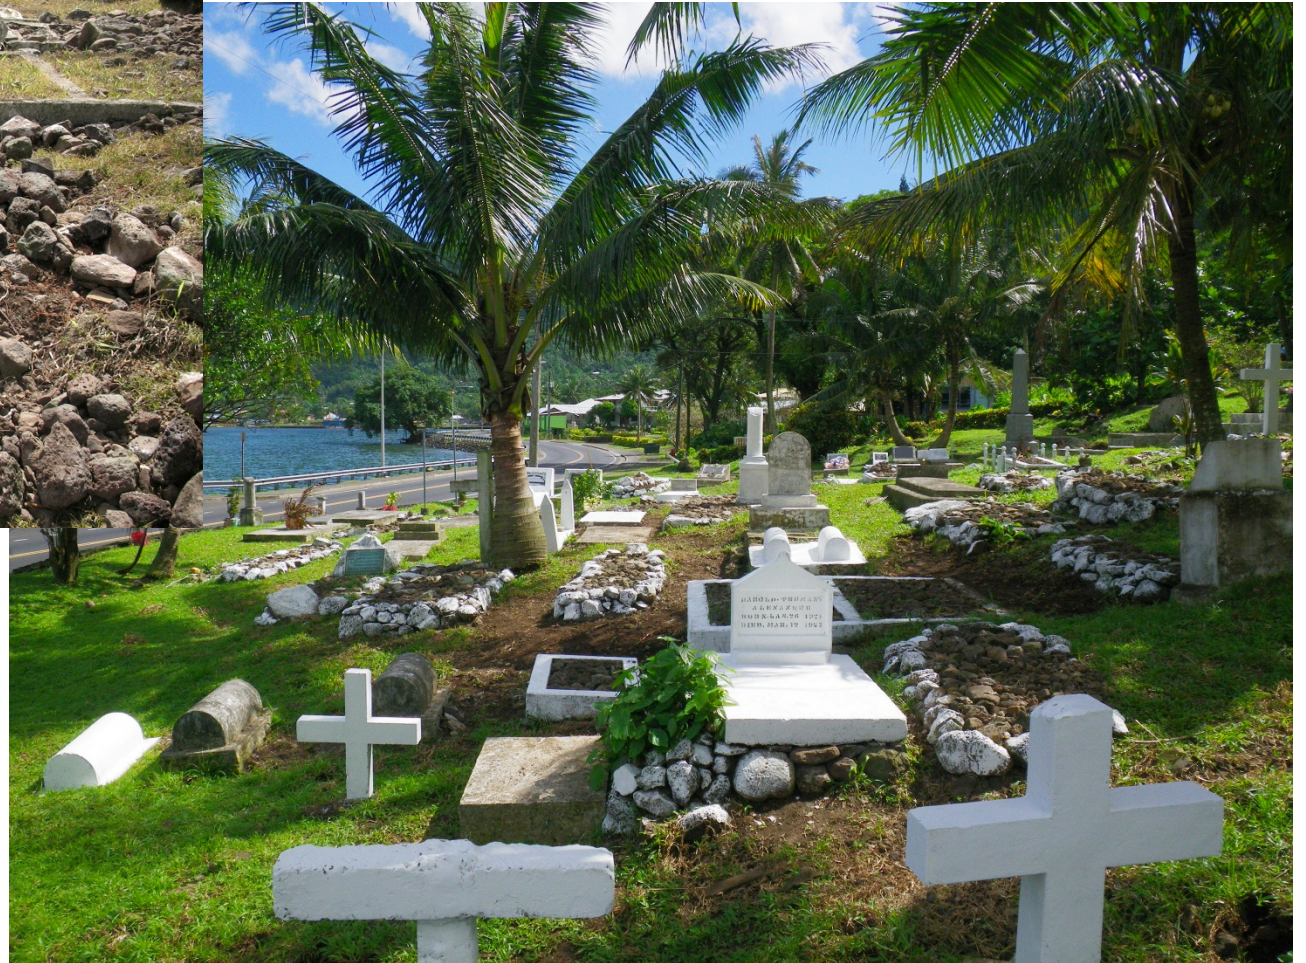
Restored July 2010

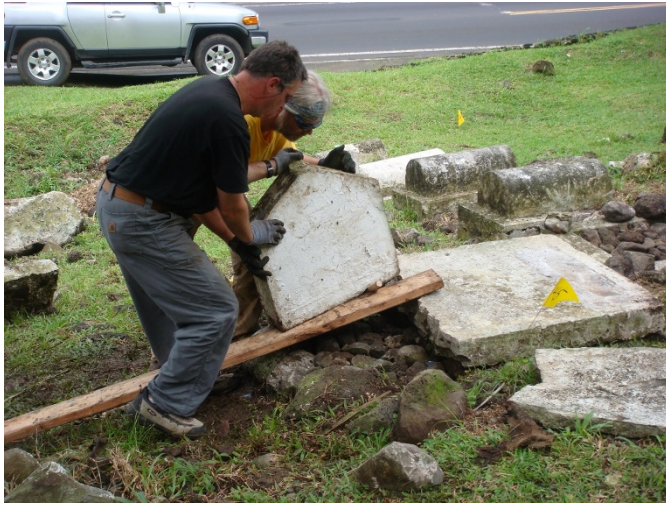
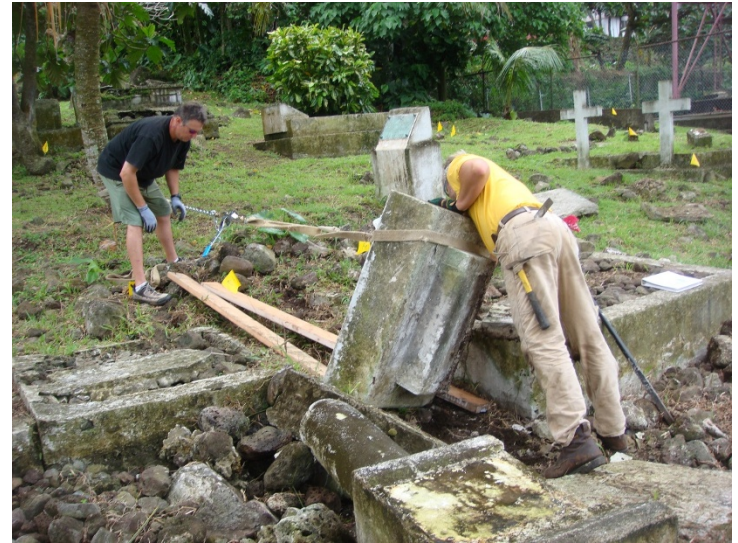
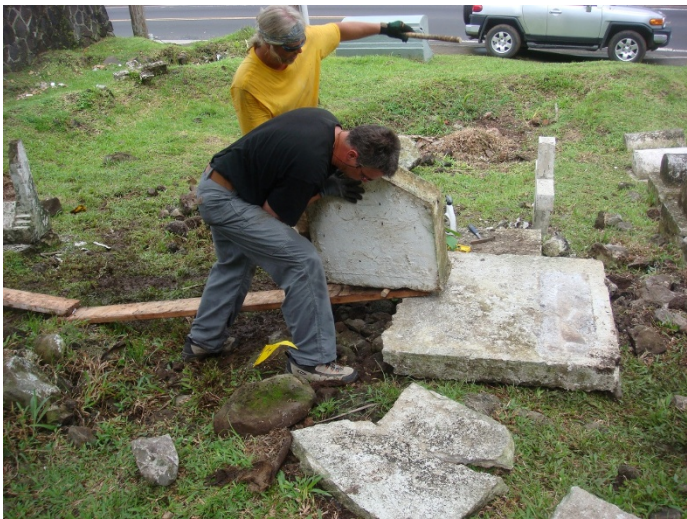
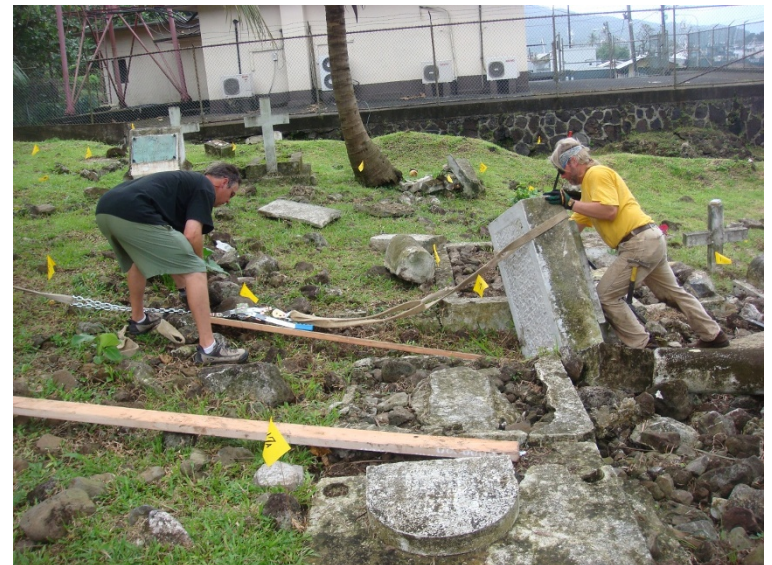
Monuments and fragments were moved into location by hand.

Larger fragments were moved with rollers on planks, sometimes assisted with a mechanical advantage such as a come-along or hydraulic jacks.

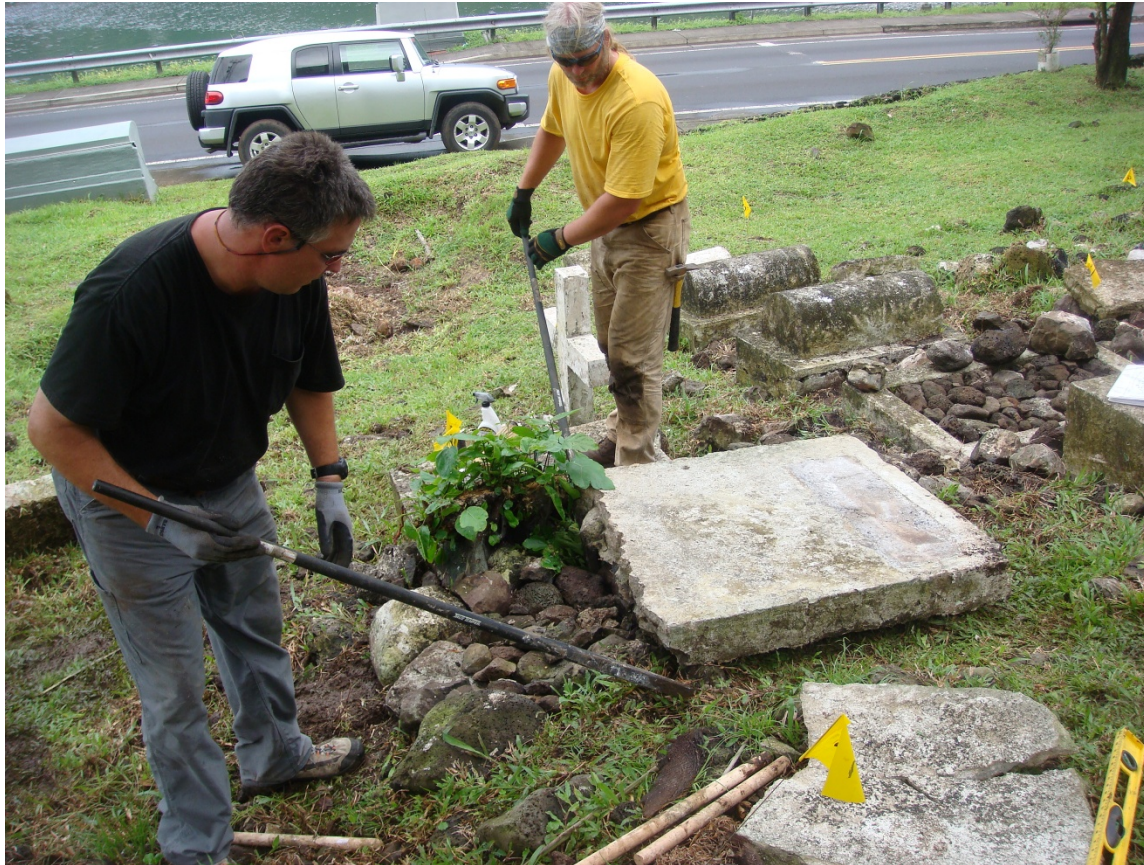
Leveling a large fragment from #15 onto a bed of stone

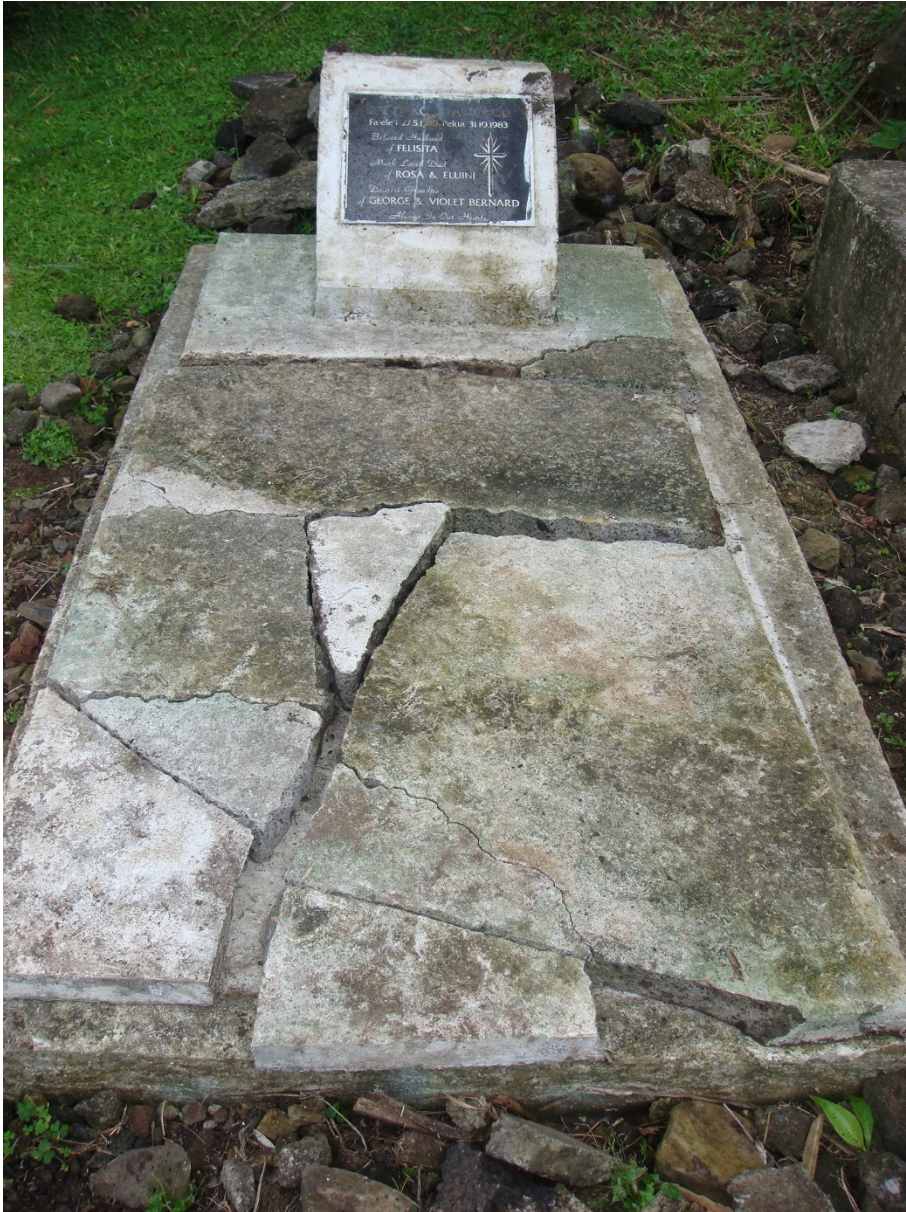
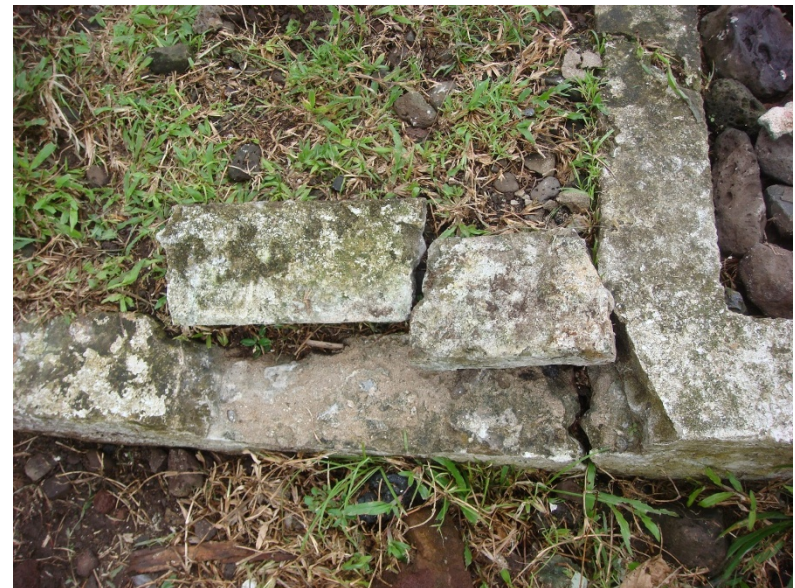
#135 to left, #16/44 below

With the exception of small missing pieces, which may be buried or have shattered, fragments were eventually located for almost all losses.

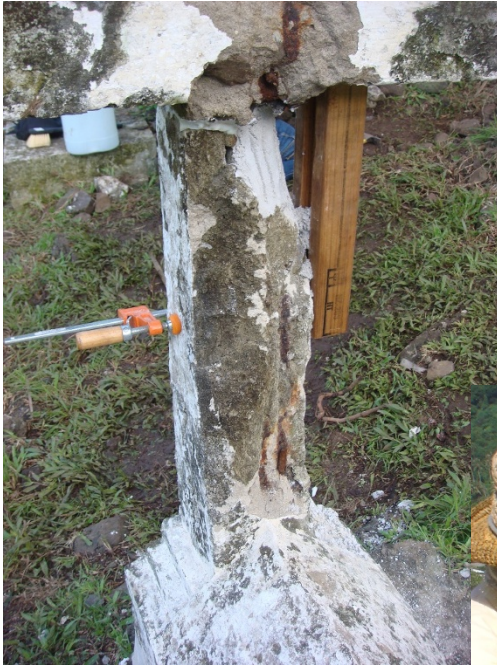
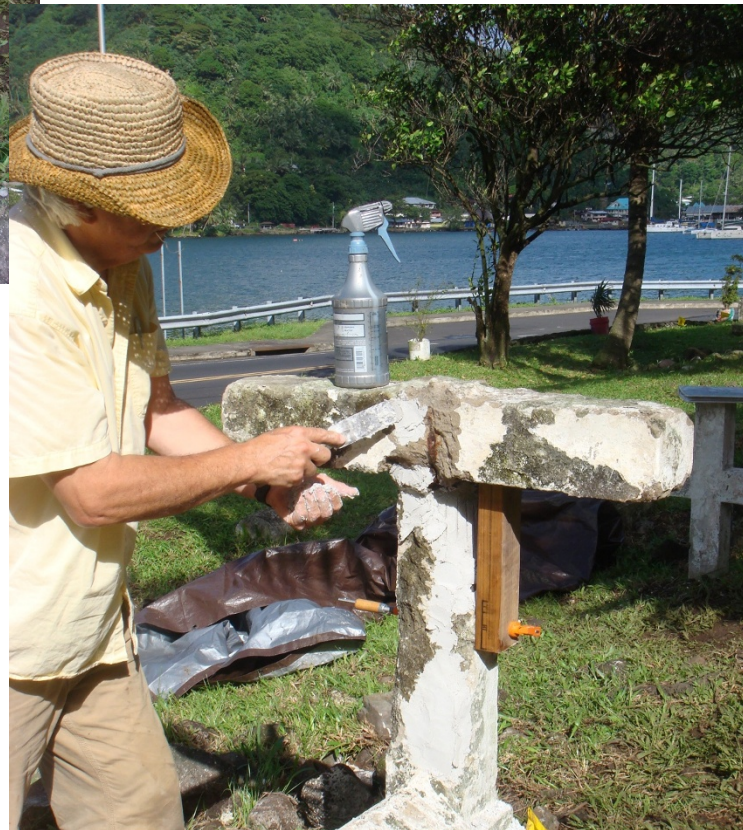
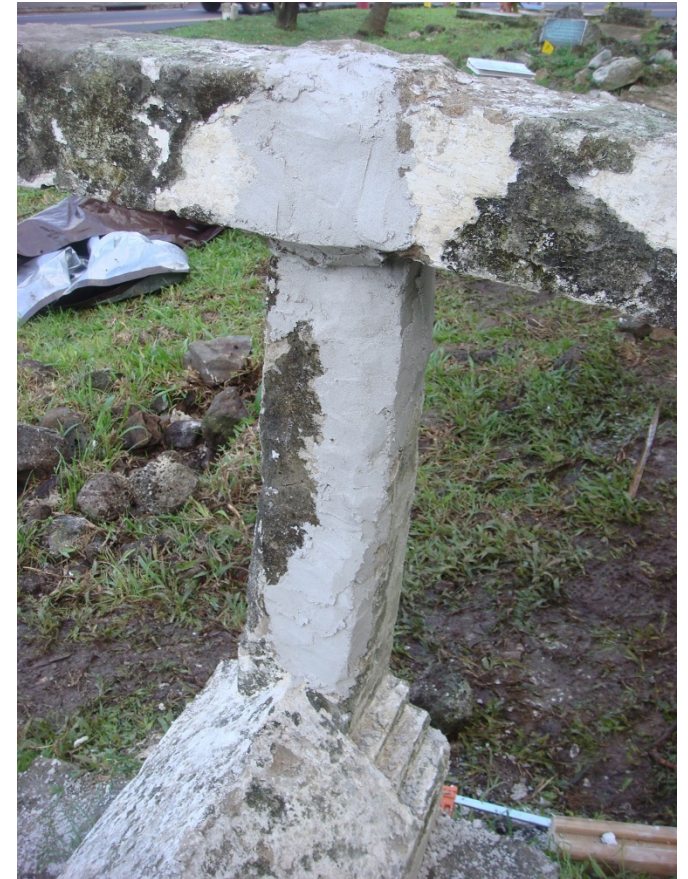
On the left, fragments attached but with losses.

Below, filling losses with Jahn M-90 cementitious mortar.

On the right, the filled and shaped areas prior to painting.

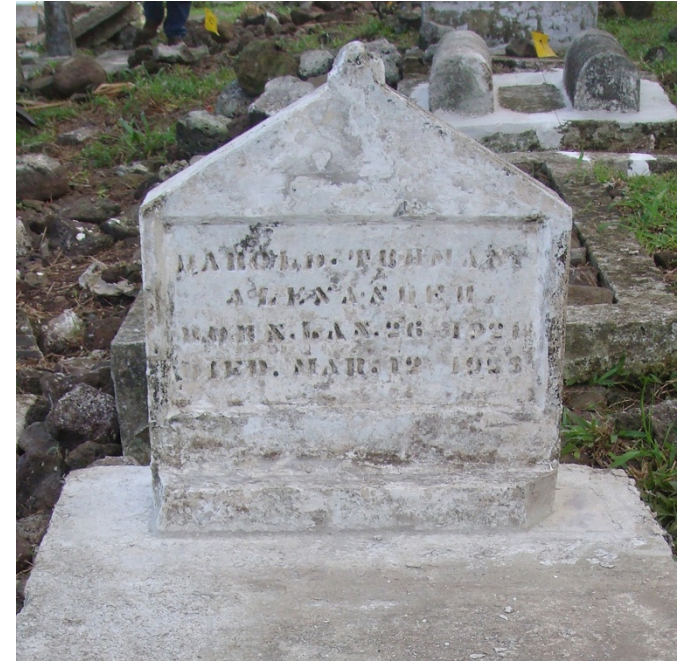
#15 After removing loose layers of paint

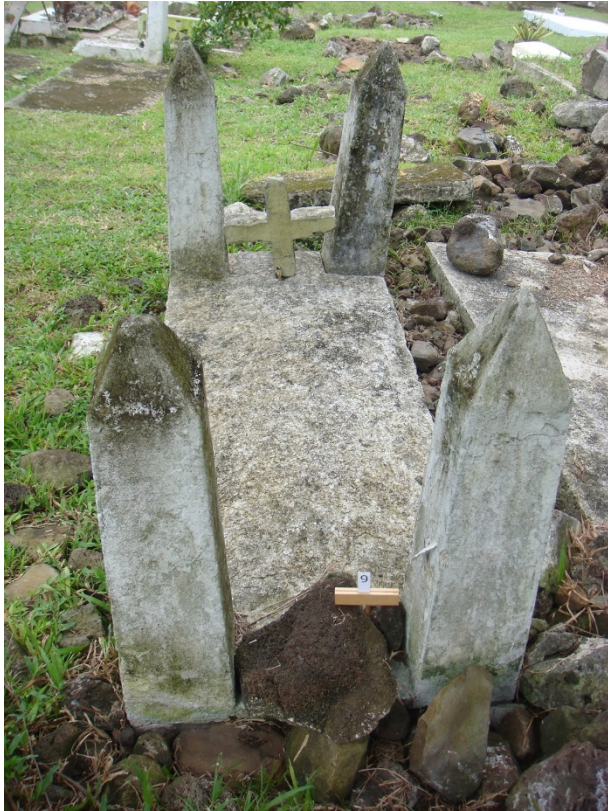
**#9** A previously broken off pillar was displaced from the baseline angle.

**#9 ASHPO** Concrete monolith detached from corner of monument  
Restore monolith to corner from which it was detached.

Pillar relocated to base line. Setting area and base of pillar treated with D/2 Biological Solution. When dry, pillar was re-set with pointing mortar. Loose paint scraped off and monument treated with D/2 Biological Solution prior to painting

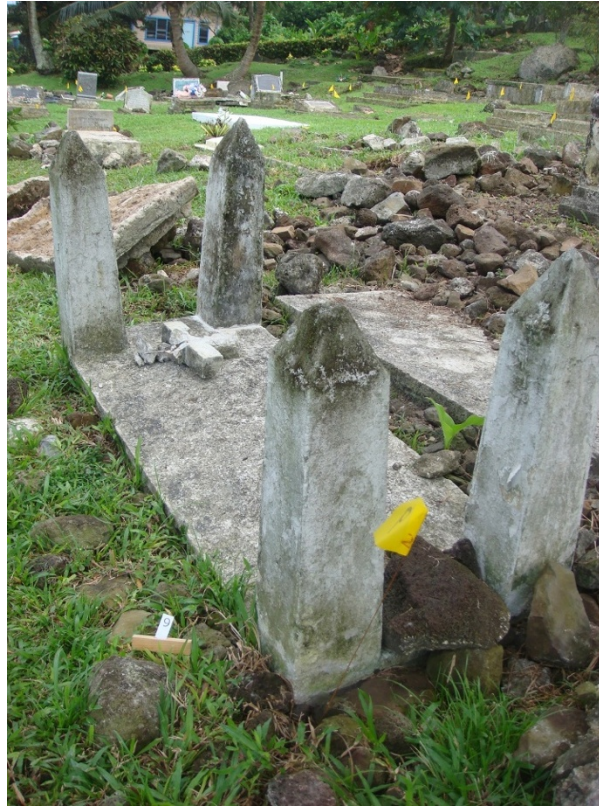
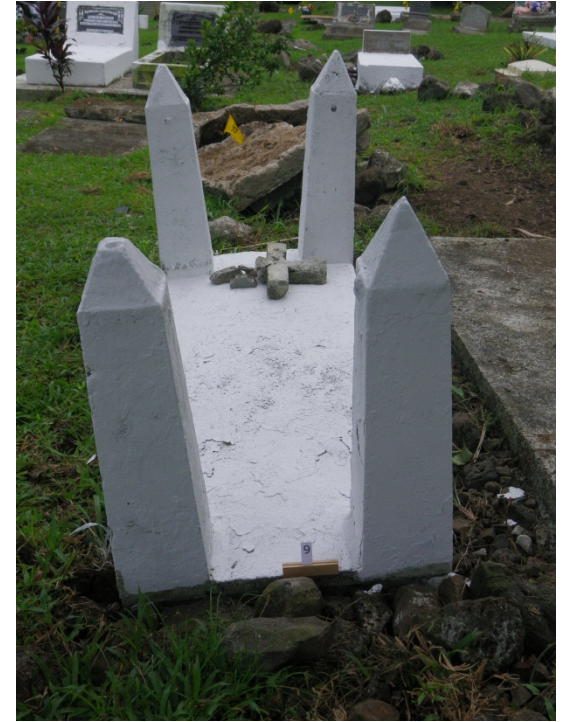
**#9** Restored and painted

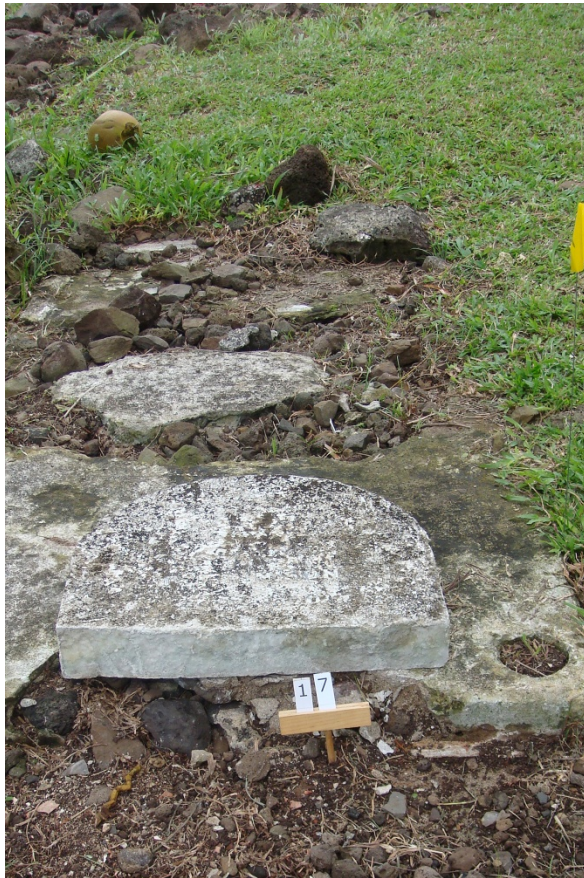
#17. **ASPHO** Headstone broken in half

Intermediate base reset onto large base (#17A) with 000 grout. Marble fragments attached with structural epoxy. Crack filled with Replical crack filler. Because this is a marble monument it was not painted.

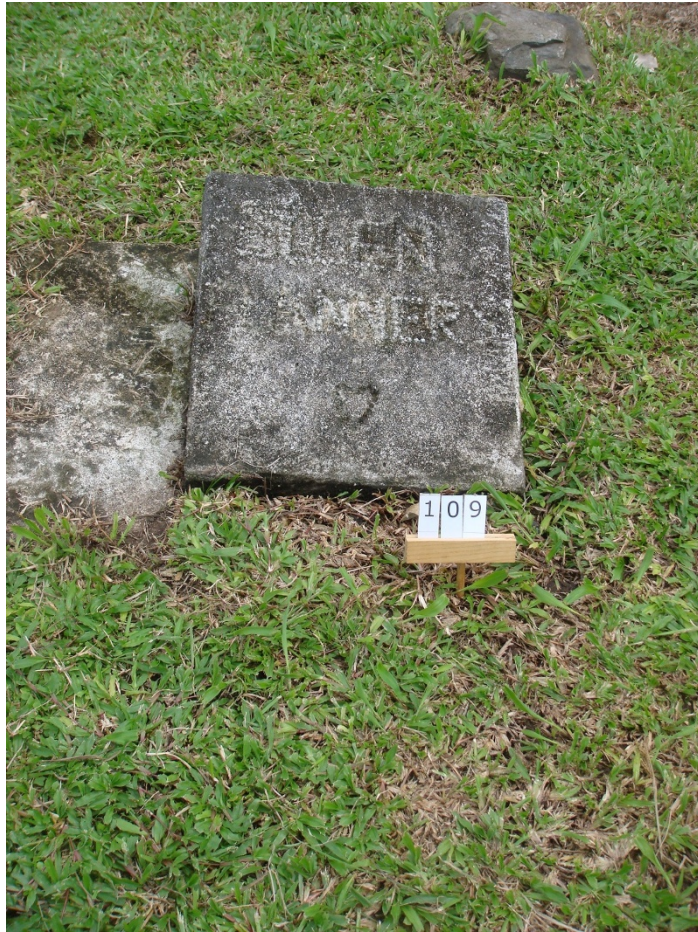
# **109 ASHPO** Headstone not securely fastened to base

Secure headstone to base with epoxy

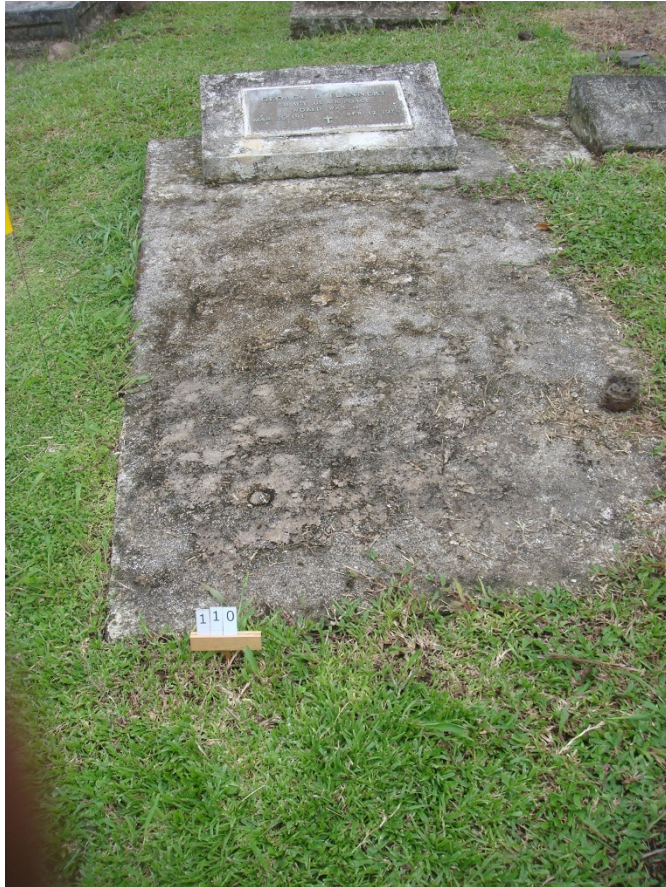
# **110 ASHPO** Headstone not securely fastened to concrete slab.

Secure headstone to concrete slab with epoxy

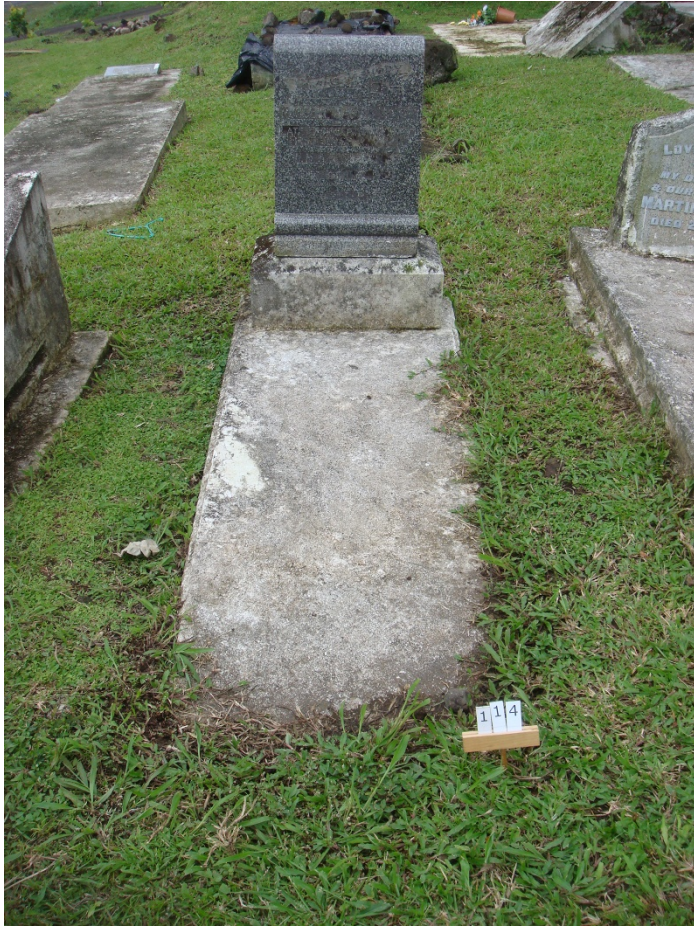
# **114** Headstone displaced from the base line site.

**ASHPO** Concrete slab monument is not level, is settling into the ground on one side

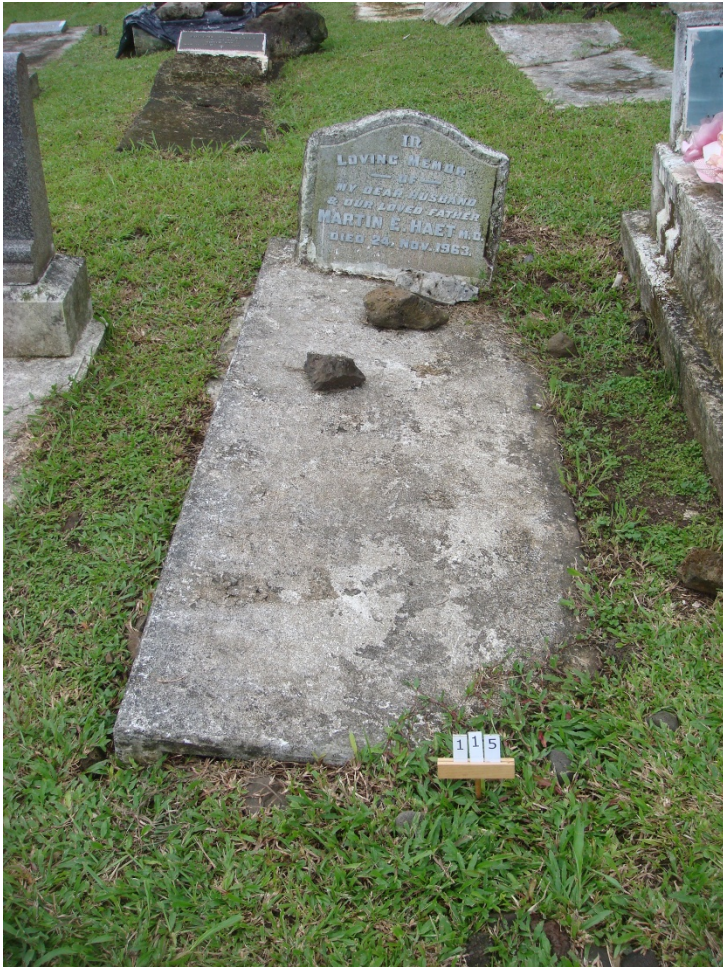
Contract description  
# **115 ASHPO** Concrete slab monument is not level, is settling into the ground on one side. Level concrete grave monument slab.

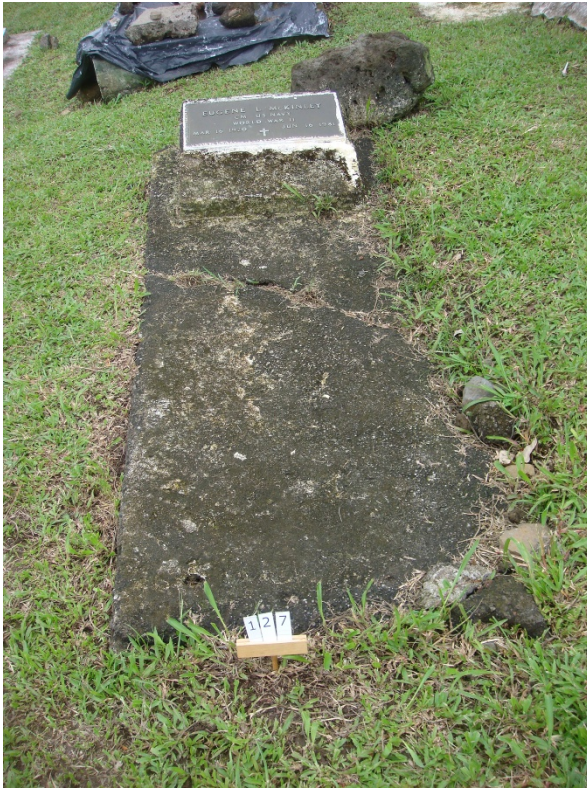
Contract description  
#**127** **ASHPO** Concrete slab is cracked and is not level. It is settling into the ground on one side

Treatment description  
Fractured concrete slab found to be unsound. New level base poured using Sakrete premixed concrete mix. When cured all surfaces were painted

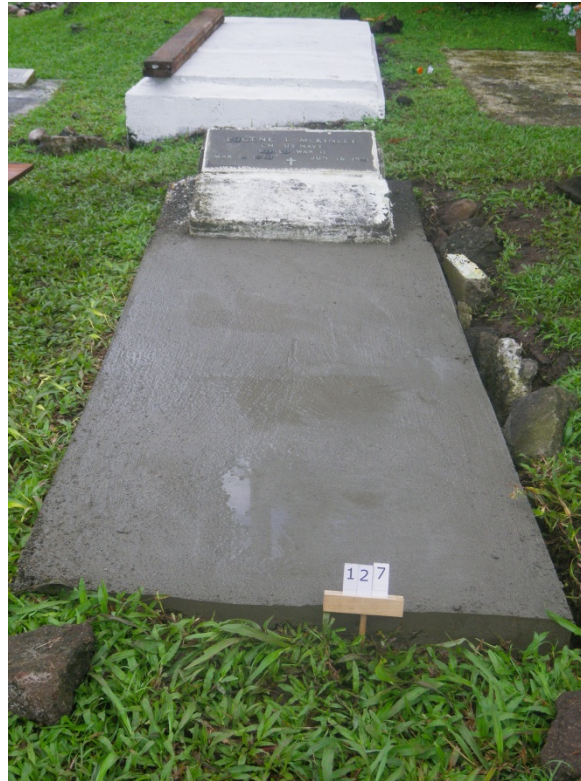
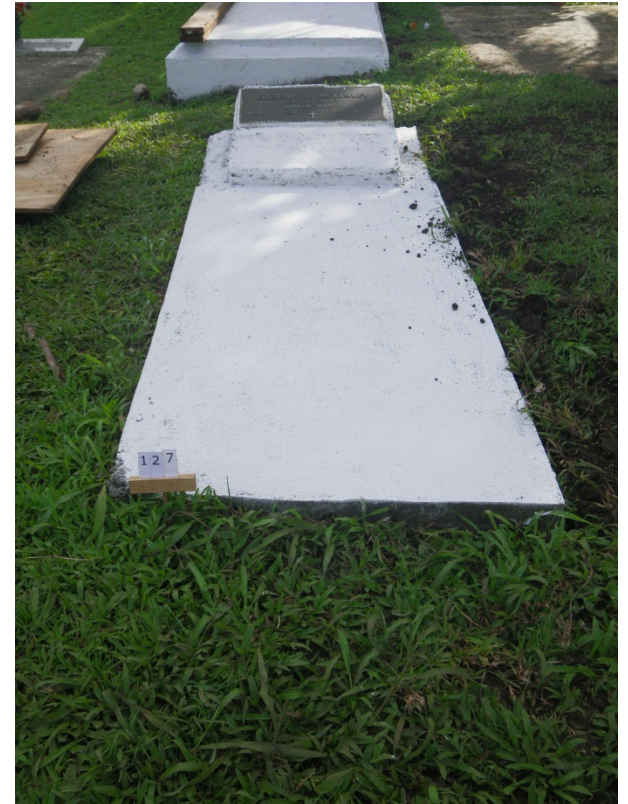
#**127** Restored and painted
