**GUAM HISTORIC PROPERTIES INVENTORY**  
**GHPI DATA FORM**

1. Date: 7/31/2014
2. Guam Historic Properties Inventory Number: **66** - \_\_\_\_\_ - \_\_\_\_\_  
*This number is assigned by DPR-GHRD GuamSHPO* (Quadrangle) (Greater than 1300)
- 3a. Historic Property Name (as assigned or concurred by GHRD-DPR): Herrera House
- 3b. Local and/or Traditional Place Name/s of Property: n/a
- 3c. Other Property Name/s: n/a
4. Type of survey relating to Identification and Evaluation: ☒ Reconnaissance ☐ Intensive  
Inventory ☐ Windshield. Indicate other types of survey: ☐ Data Recovery  
☐ Other: \_\_\_\_\_

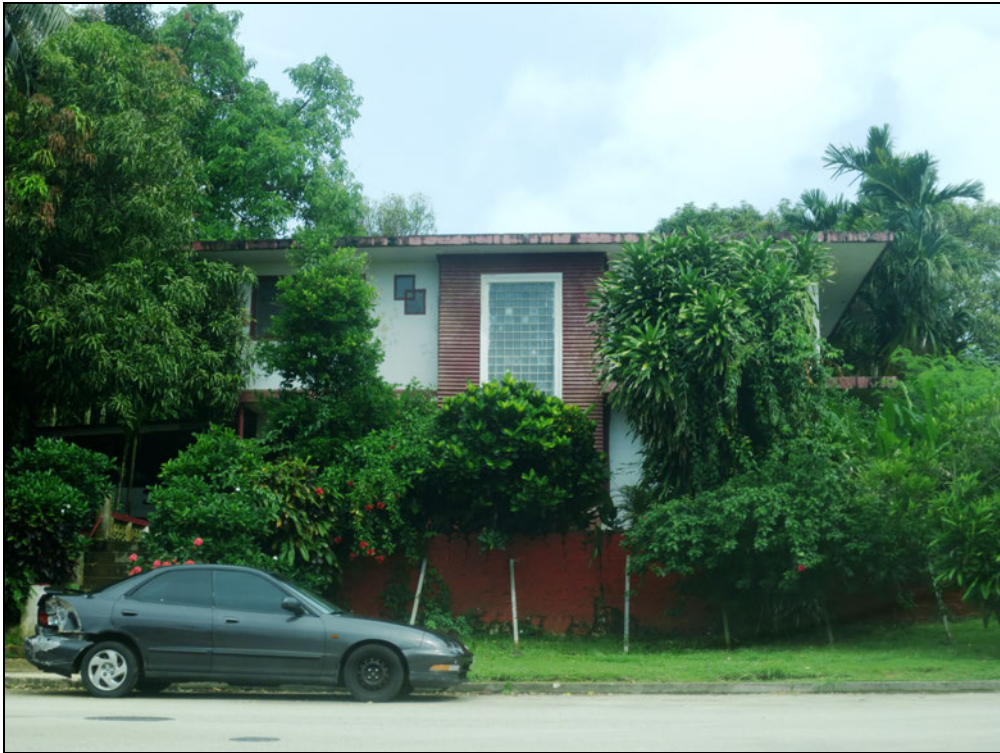
The house is perched on a hillside overlooking the ocean to the west. The residence has a square footprint measuring approximately 38 by 38 feet, and features a reinforced concrete foundation, walls, and flat concrete slab roof with a wide overhanging eave. Lush vegetation surrounds the building. A concrete retaining wall at the bottom of the hillside features a wave design and serves to inhibit erosion. A set of concrete steps with metal pipe handrails provides access to the western facade.

**Figure 2. Herrera House, northwest elevation.**

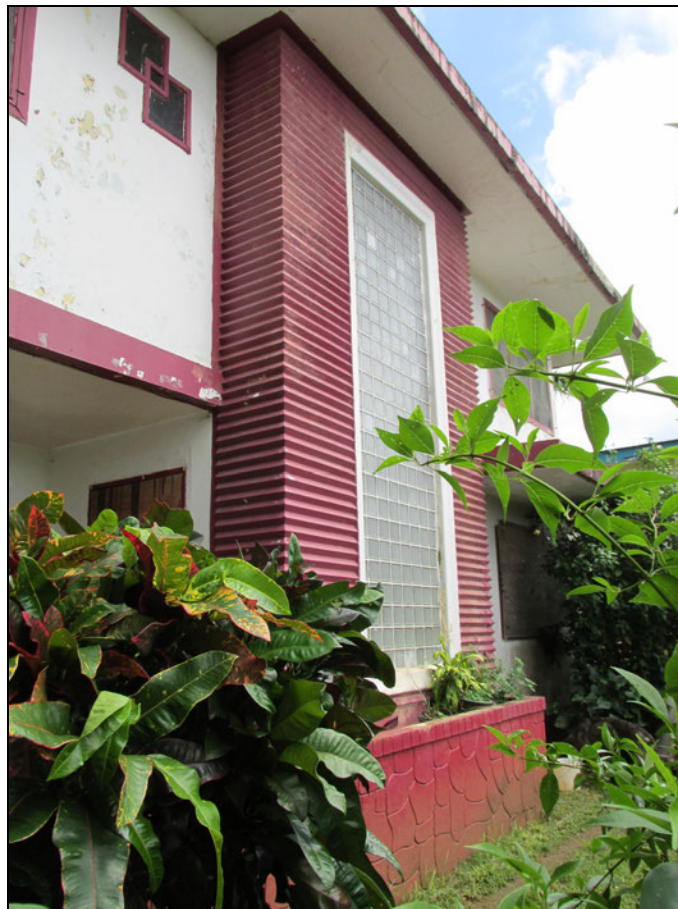
The building expresses several contemporary design elements including contrasting wall materials and textures. Centered on the facade, a wide concrete pilaster projects from the wall and exhibits an embossed horizontal linear design. The pilaster flanks a rectangular expanse of small, square glass-block windows. Below the windows, a concrete planter box extends to the north and forms a wall divider. It features an embossed pattern that resembles a slate veneer. A cantilevered projection is present on the south end of the facade and south elevation. Ribbons of triple louver windows accentuate the upper floor of the house. A small window configuration, consisting of two square, overlapping windows with a small square window in the center is featured at the north side of the pilaster.

**Figure 3. Herrera House with view of concrete pilaster.**
