# Conserving Energy in Historic County Courthouses

National Association  
of Counties

By  
Gerri Hill

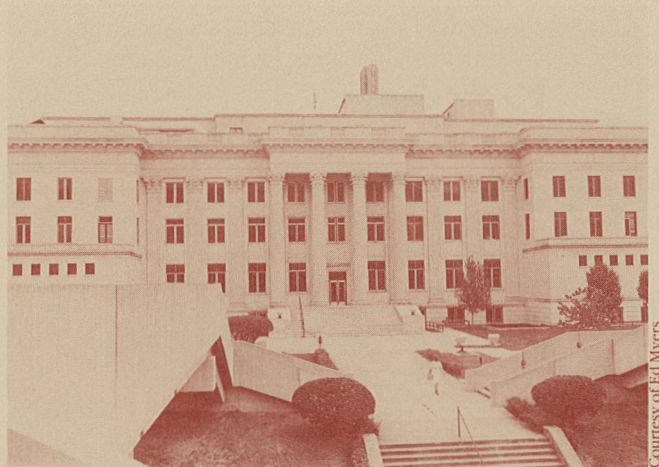
*Mecklenburg County Courthouse*

Mecklenburg County has incorporated energy-conservation measures in the restoration of its courthouse. Solar screens cover approximately 98 percent of the exterior windows. These very fine venetian blinds of anodized aluminum have the appearance of copper and are compatible with the architectural character of the building. The louvers allow the low-lying winter sun to enter, providing supplementary heat. In the summer, when the sun is relatively high, these louvers block the sun's rays, reducing the air conditioning load.

Other initiatives include insulating exposed ducts in the basement corridor and steam piping in the return air chase. As part of the HVAC renovation, the dual duct system was converted to a variable air volume system. This new system allows the boilers to be turned off

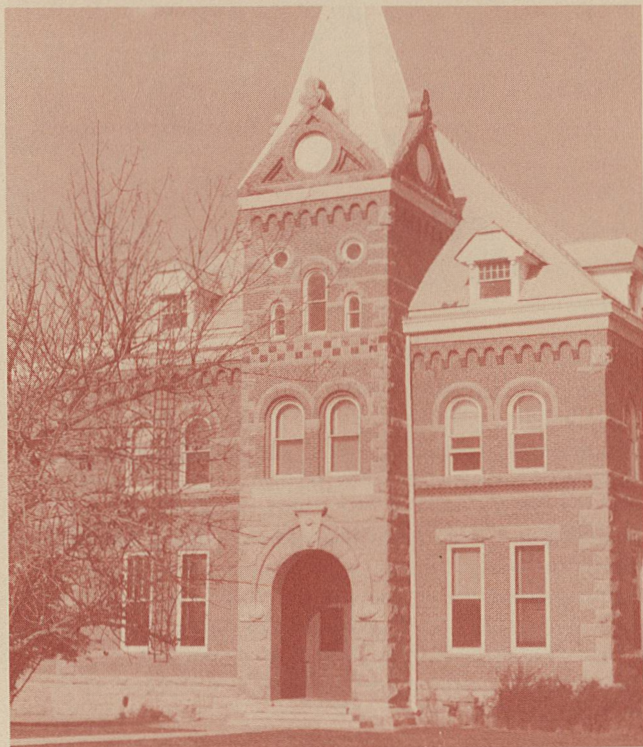
*Jefferson County Courthouse*

The Jefferson County Courthouse—a Boulder, Montana, landmark—stands today much as it did when built in 1889. Designed in Gothic revival style, this five-story building features red brick masonry with gray stone quoins and a gable roof.

The Jefferson County Courthouse is functioning as it was intended. Energy-conserving features such as heavy masonry walls, operable windows, and roof-top ventilators provide a reasonably comfortable working atmosphere, without the use of mechanical air conditioning. Storm windows have been installed, improving the thermal performance of existing windows during the winter. The county has also installed insulation in the floor of the attic. And recently, an engineering firm inspected the heating system to ensure its efficiency.

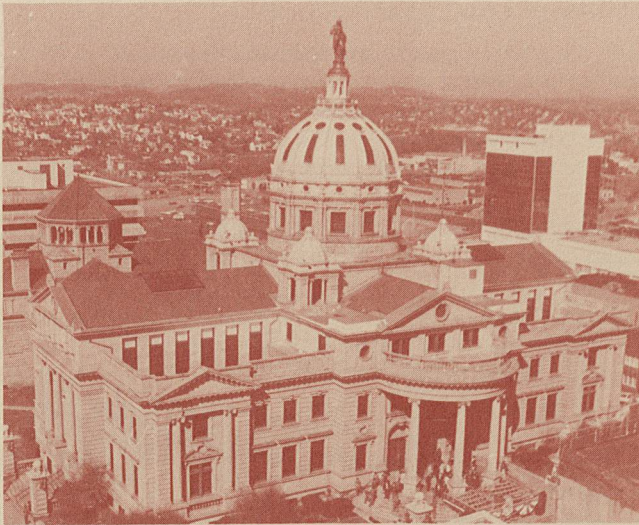
### *Washington County Courthouse*

Washington County's courthouse retrofit project began with new thermal pane windows. The double-hung windows are made operable by an anodized aluminum frame sash of bronze, which blends with the sandstone color of the building. The new windows have a minimal impact on the appearance of the building. The original windows were severely deteriorated which warranted replacement. Rigid insulation was later installed under a new clay tile roof. In July, 1981, the county conducted an energy audit to identify other retrofit opportunities. The county has already begun to convert the courthouse from oil to gas.
