# Status of Climate and Water Resources at Guadalupe Mountains National Park

*Water Year 2018*

Natural Resource Report NPS/CHDN/NRR—2020/2132

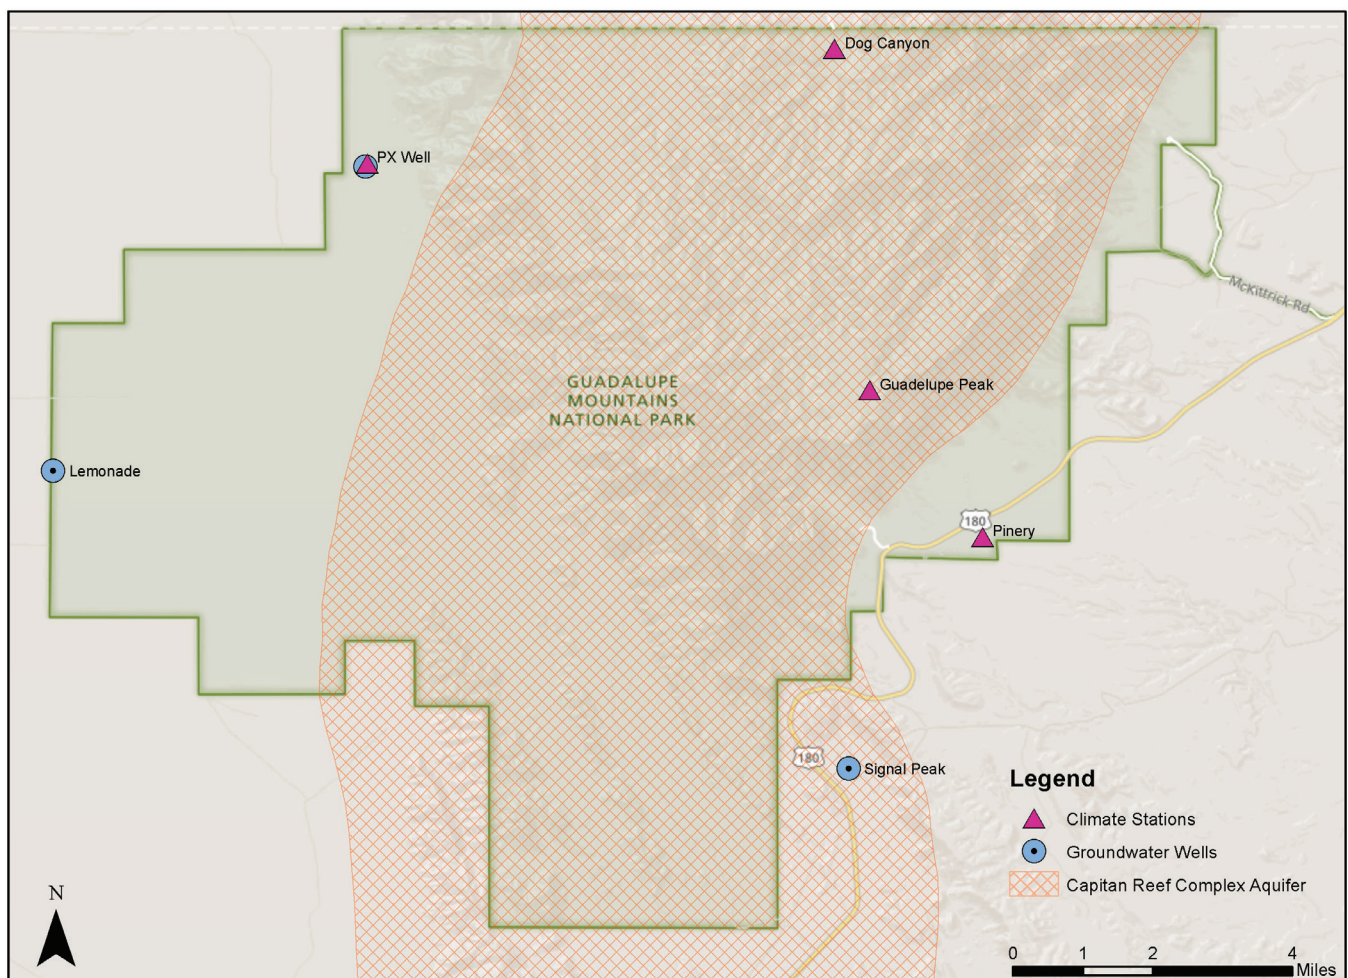
**Figure 2-1. Climate stations and monitoring groundwater monitoring wells at Guadalupe Mountains National Park**

Guadalupe Mountains NP has four Remote Automated Weather Stations (RAWS) (Figure 2-1). The Guadalupe (sic) Peak RAWS (GDBT2) is at an elevation of 7,755 ft (2,364 m) and has been in operation since 2003. The Dog Canyon RAWS (DGCT2) is at 6,262 ft (1,910 m) and has been in operation since 2010. The Pinery RAWS (PSGT2) is at 5,381 ft (1,640 m) and has been in operation since 2001. The PX Well RAWS is at 3,873 ft (1,180 m) and has been in operation since 2010. The station data were obtained from [Climate Analyzer](#) (Walking Shadow Ecology 2019a; 2019b; 2019c; 2019d), a website that allows users to make on-demand tables and graphs with data from weather stations that are updated daily (Walking Shadow Ecology 2019e). Previously, the National Park Service operated two National Oceanic and Atmospheric Administration (NOAA) Cooperative Observer Program (COOP)

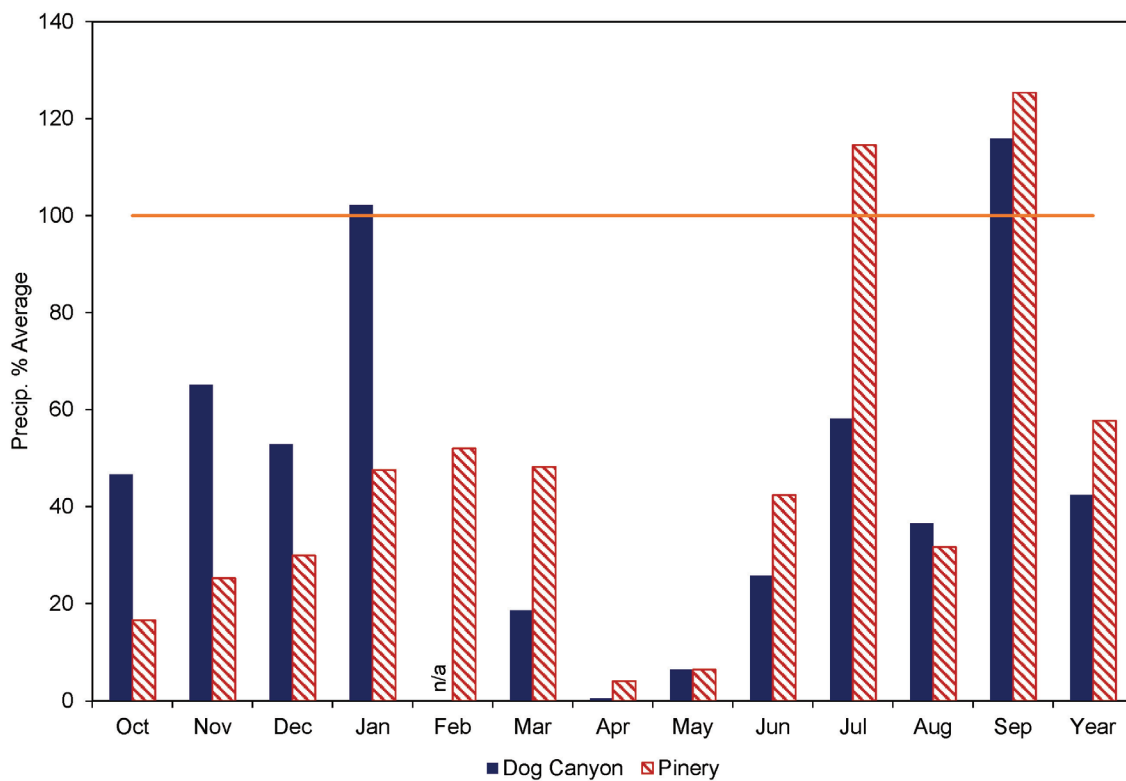
**Figure 2-2. Departures from 30-year (1981–2010) normal monthly precipitation at the Dog Canyon and Pinery RAWs, Guadalupe Mountains NP, water year 2018 (October 2017–September 2018). “n/a” = insufficient data to generate reliable data.**

Overall, annual precipitation in WY2018 was below normal for Guadalupe Mountains NP: 58% of normal for Pinery (10.37 in vs. 17.97 in) and 42% of normal for Dog Canyon (8.99 in vs. 21.24 in). Precipitation at Dog Canyon is likely underrepresented due to missing data.

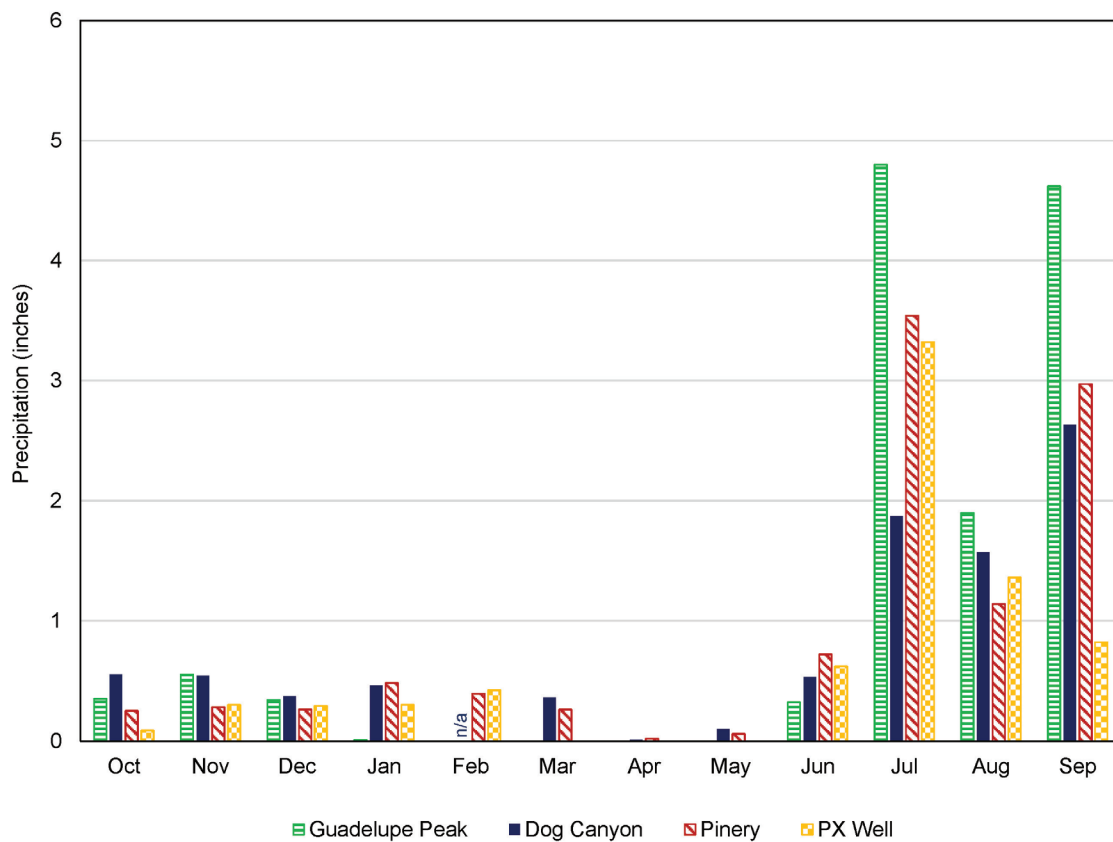
**Figure 2-3. Monthly precipitation for Guadalupe Mountains NP, water year 2018 (October 2017–September 2018). “n/a” = insufficient data to generate reliable data.**

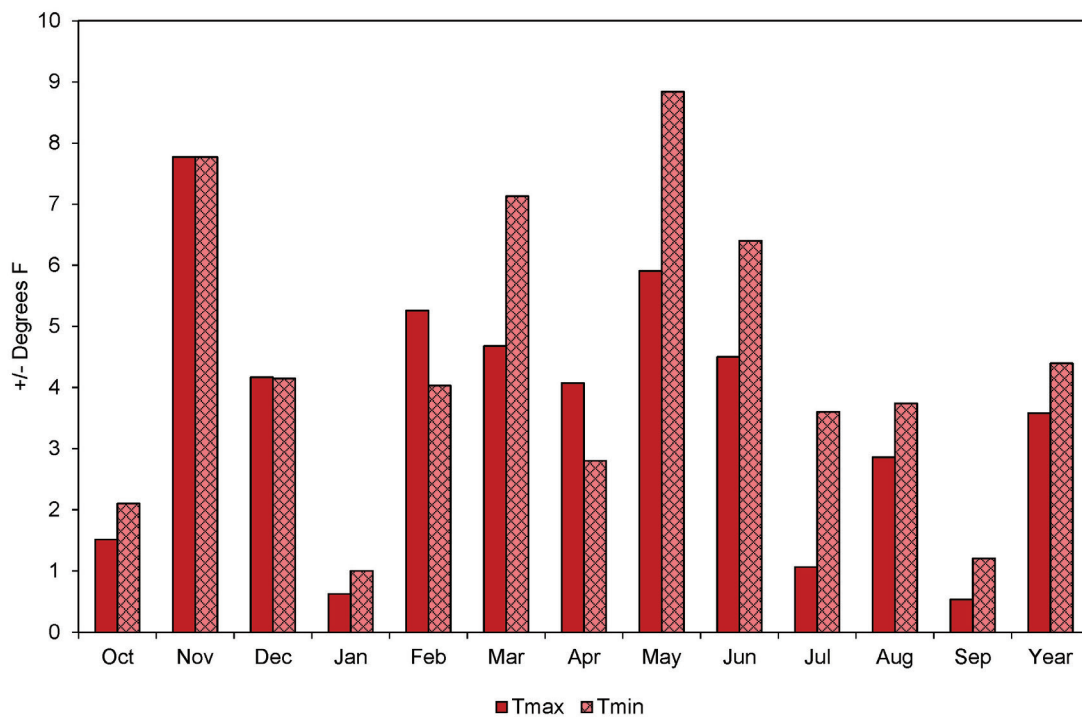
Figure 2-4. Departures from 30-year (1981–2010) normal monthly minimum and maximum air temperatures at the Pinery climate station, Guadalupe Mountains NP, water year 2018 (October 2017–September 2018).

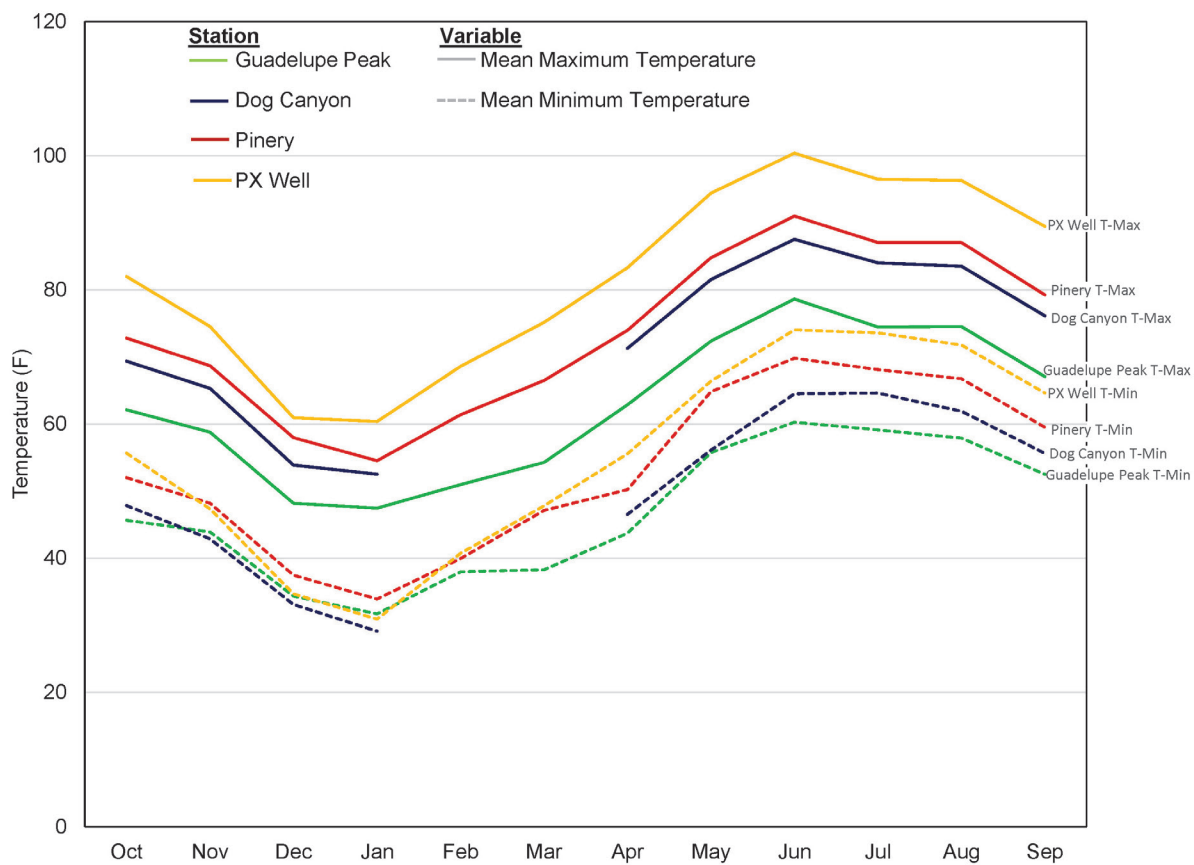
Figure 2-5. Mean monthly minimum and maximum air temperatures for Guadalupe Mountains NP, water year 2018 (October 2017–September 2018).

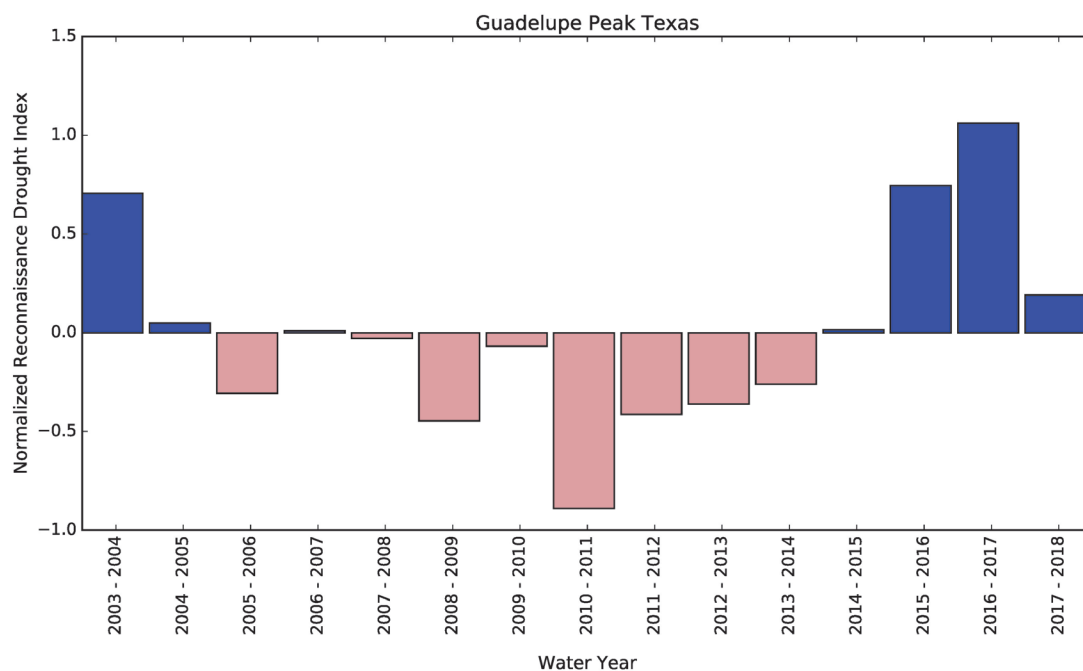
**Figure 2-6. Reconnaissance drought index (RDI), Guadalupe (sic) Peak RAWS, Guadalupe Mountains NP, water years 2004–2018. Graphic generated by [climateanalyzer.org](http://climateanalyzer.org) (Walking Shadow Ecology 2019a).**

Reconnaissance drought index (RDI; Tsakiris and Vangelis 2005) provides a measure of drought severity and extent relative to the long-term climate based on the ratio of average precipitation to average potential evapotranspiration over shorter periods of time (seasons to years). The RDI at the Guadalupe Peak RAWS indicated that WY2018 was the fourth consecutive year with wetter conditions compared to the average for WY2004 through WY2018 (Figure 2-6). The RDI at the Pinery RAWS indicated drier conditions in WY2018 based on the average for WY2002 through WY2018 from the perspective of precipitation and evaporative demand (Figure 2-7). The RDI was not calculated for the Dog Canyon RAWS and PX Well RAWS due to their limited monitoring record.

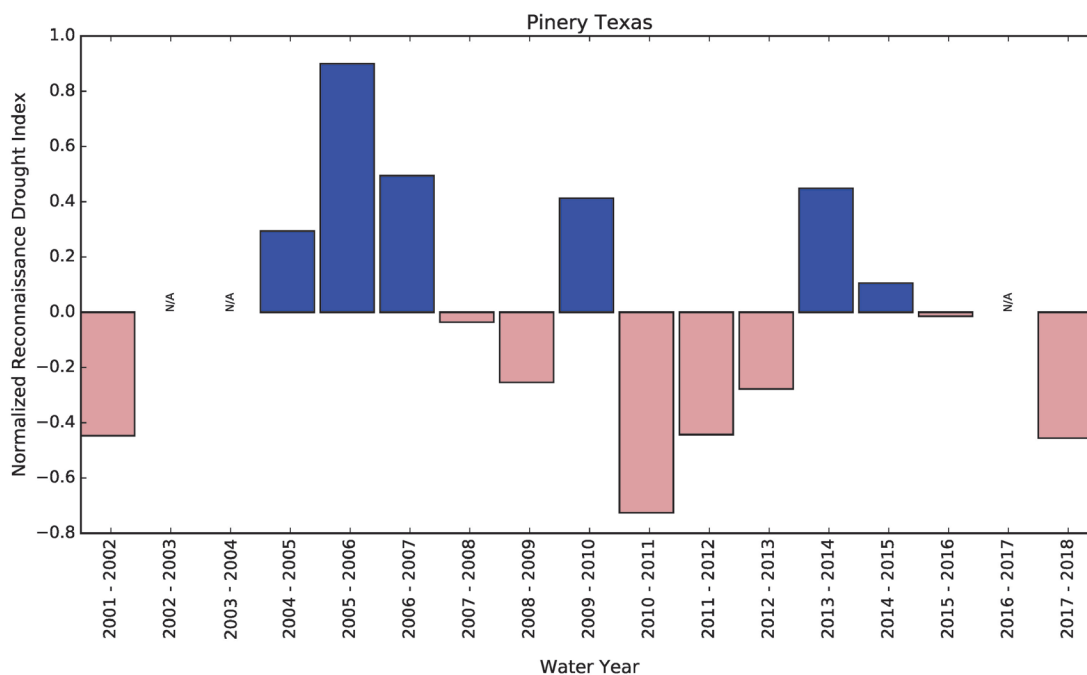
**Figure 2-7. Reconnaissance drought index (RDI), Pinery RAWS, Guadalupe Mountains NP, water years 2002–2018. “n/a” = insufficient data to generate reliable data. Graphic generated by [climateanalyzer.org](http://climateanalyzer.org) (Walking Shadow Ecology 2019c).**

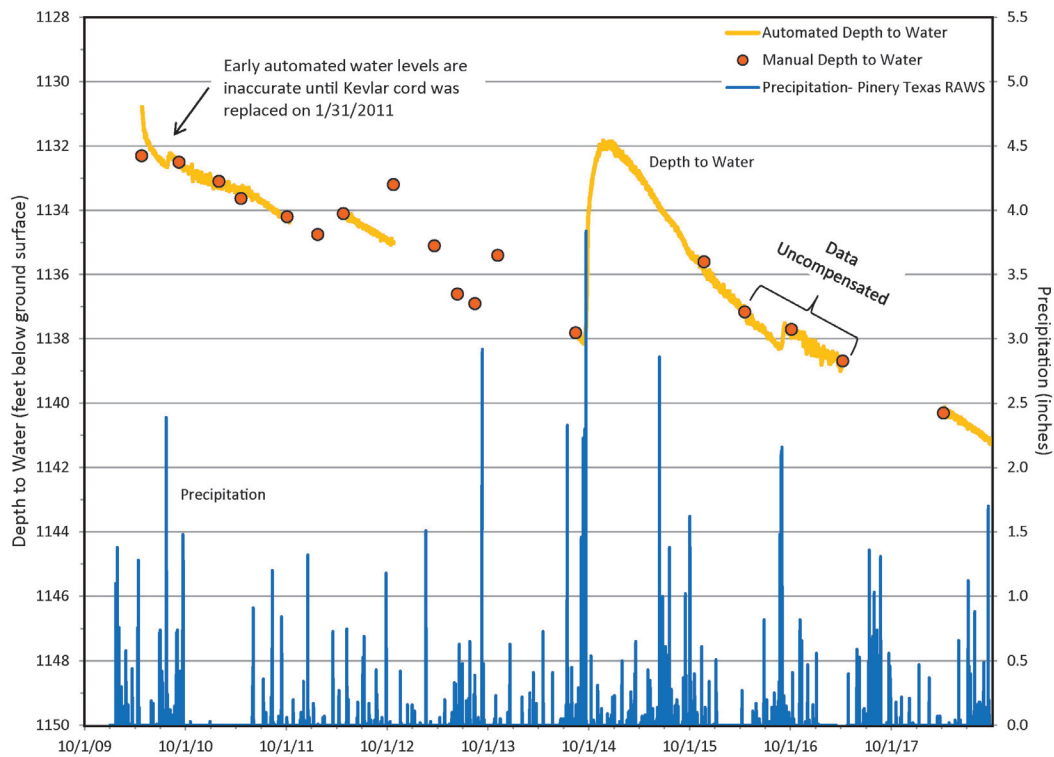
**Figure 3-1. Depth to water below ground surface (bgs) at Signal Peak Well with daily precipitation from the Pinery RAWS, water years 2010–2018, Guadalupe Mountains NP**

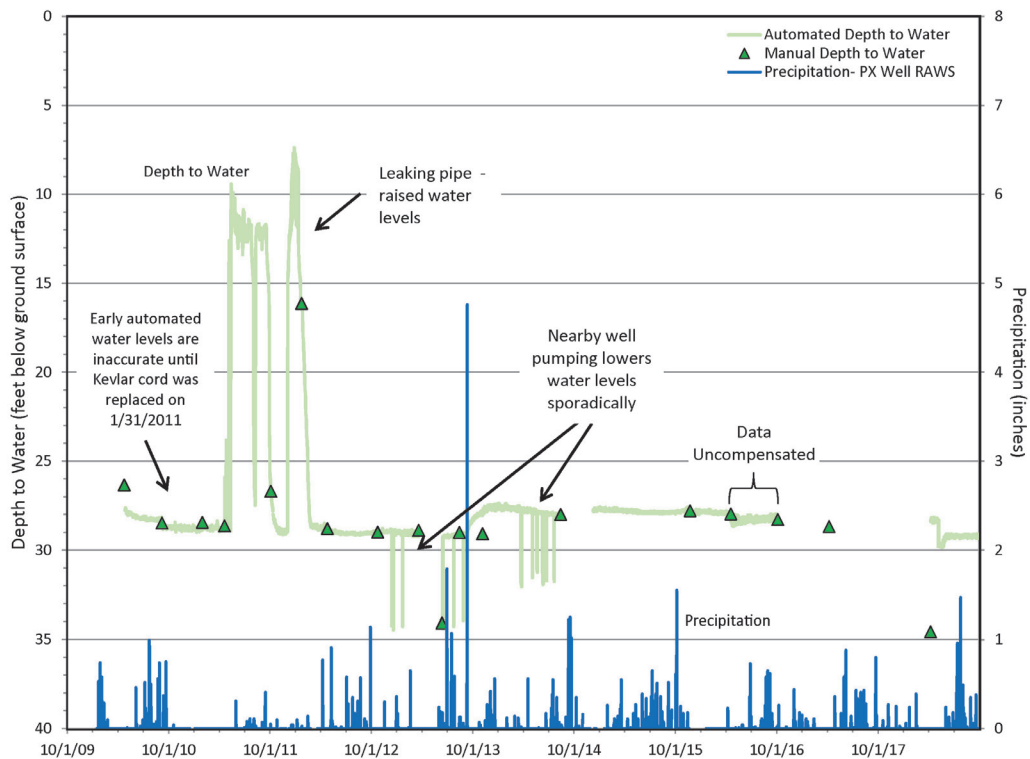
**Figure 3-2. Depth to water below ground surface (bgs) at Lemonade Well with daily precipitation from the PX Well RAWS, water years 2010–2018, Guadalupe Mountains NP**

Depth to water at Lemonade Well on April 9, 2018, was 28.38 ft bgs (Figure 3-2). In May, the water level dropped approximately 1.4 ft and then increased 0.5 ft. This step down and step up is unusual in the record and its cause is unclear. However, from June to the end of WY2018, the water level remained

relatively static, ending at 29.22 ft bgs, 0.54 ft lower than the manual measurement in WY2017. The water level in Lemonade Well has been variable over the monitoring record due to nearby groundwater pumping and leaking pipes (C. Filippone, pers. comm.). However, excluding these periods, water levels have been relatively static, only varying within a range of approximately 1.5 ft. The largest increase occurred in September and October 2013 following a 4.76-in rain event recorded at the PX Well RAWS.

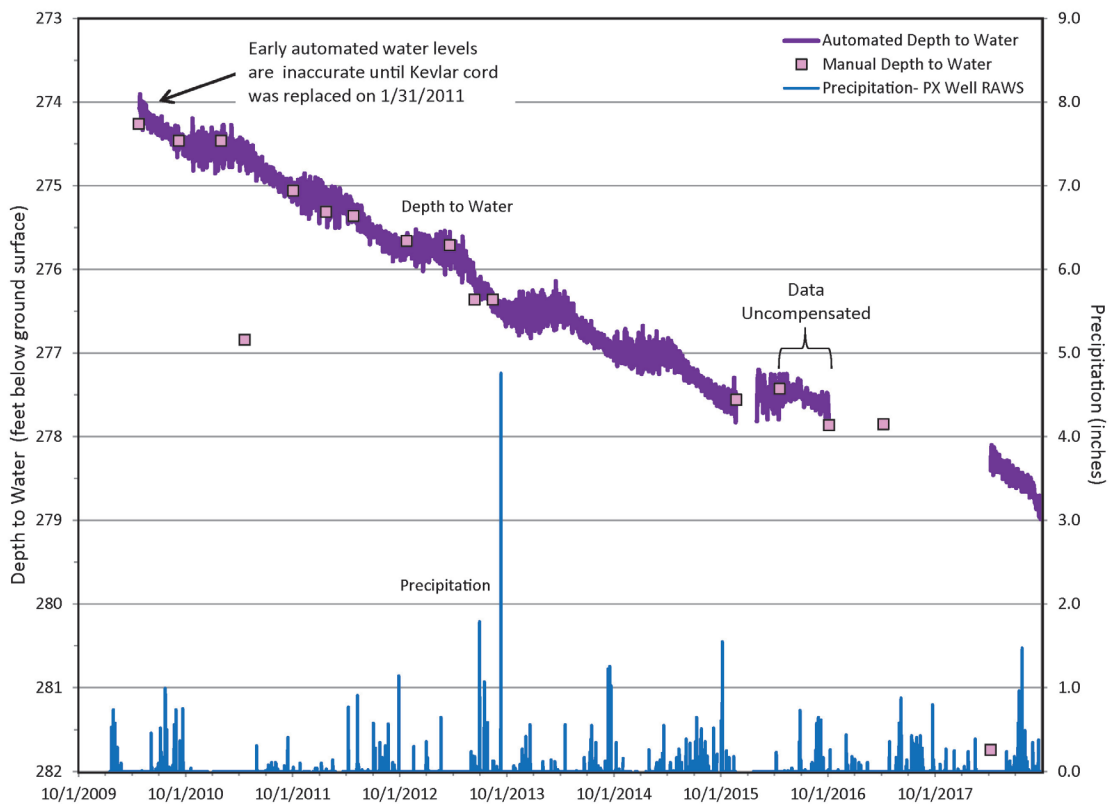
**Figure 3-3. Depth to water below ground surface (bgs) at PX Well with daily precipitation from the PX Well RAWs, water years 2010–2018, Guadalupe Mountains NP**

Depth to water at PX Well on April 9, 2018, was 278.40 ft bgs (Figure 3-3). Water level continued to decline throughout the rest of WY2018, with the lowest water level of the monitoring record on September 26, 2018, at 278.98 ft bgs. This indicates a net decline of 4.91 ft since monitoring began in WY2010. Water levels in PX Well demonstrate seasonal variability: stable or slightly increasing water levels in fall and winter, followed by declining water levels in spring and summer, creating an overall downward trend.

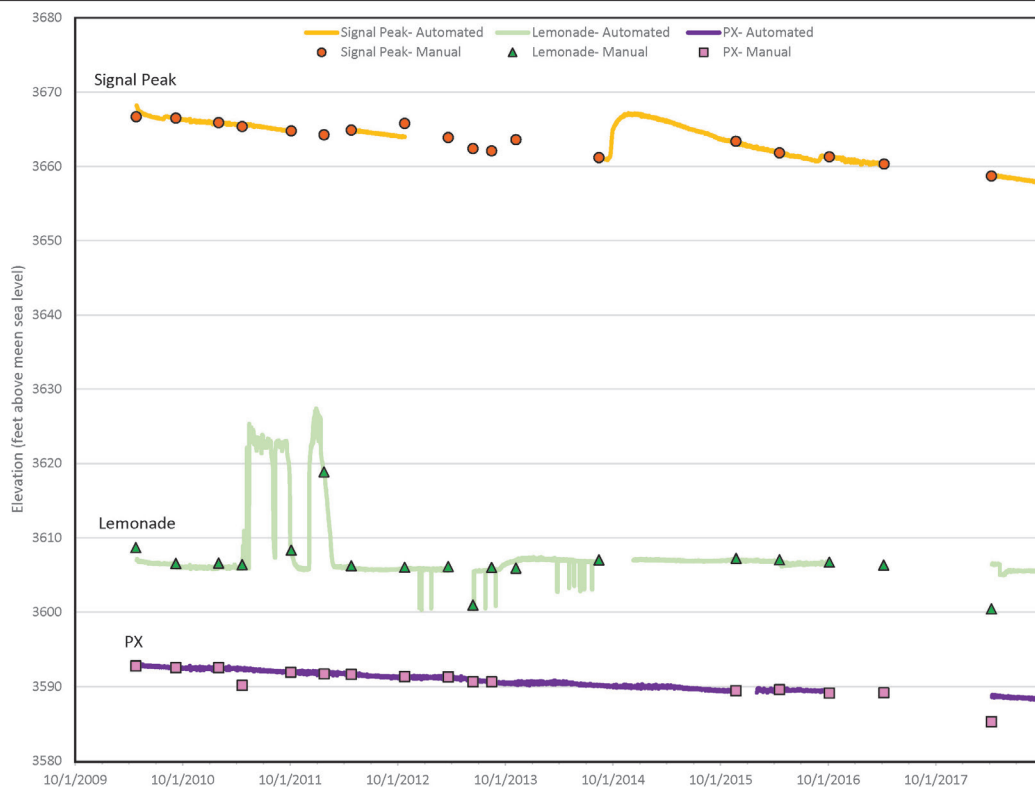
**Figure 3-4. Water level elevation at three groundwater monitoring wells, water years 2010–2018, Guadalupe Mountains NP**

Water level in the three wells were within 80 ft of elevation for the entire monitoring period (Figure 3-4). The aquifers that the three wells are completed in are hydraulically connected, but they also show localized responses to withdrawals and recharge, as observed in Lemonade and Signal Peak wells.

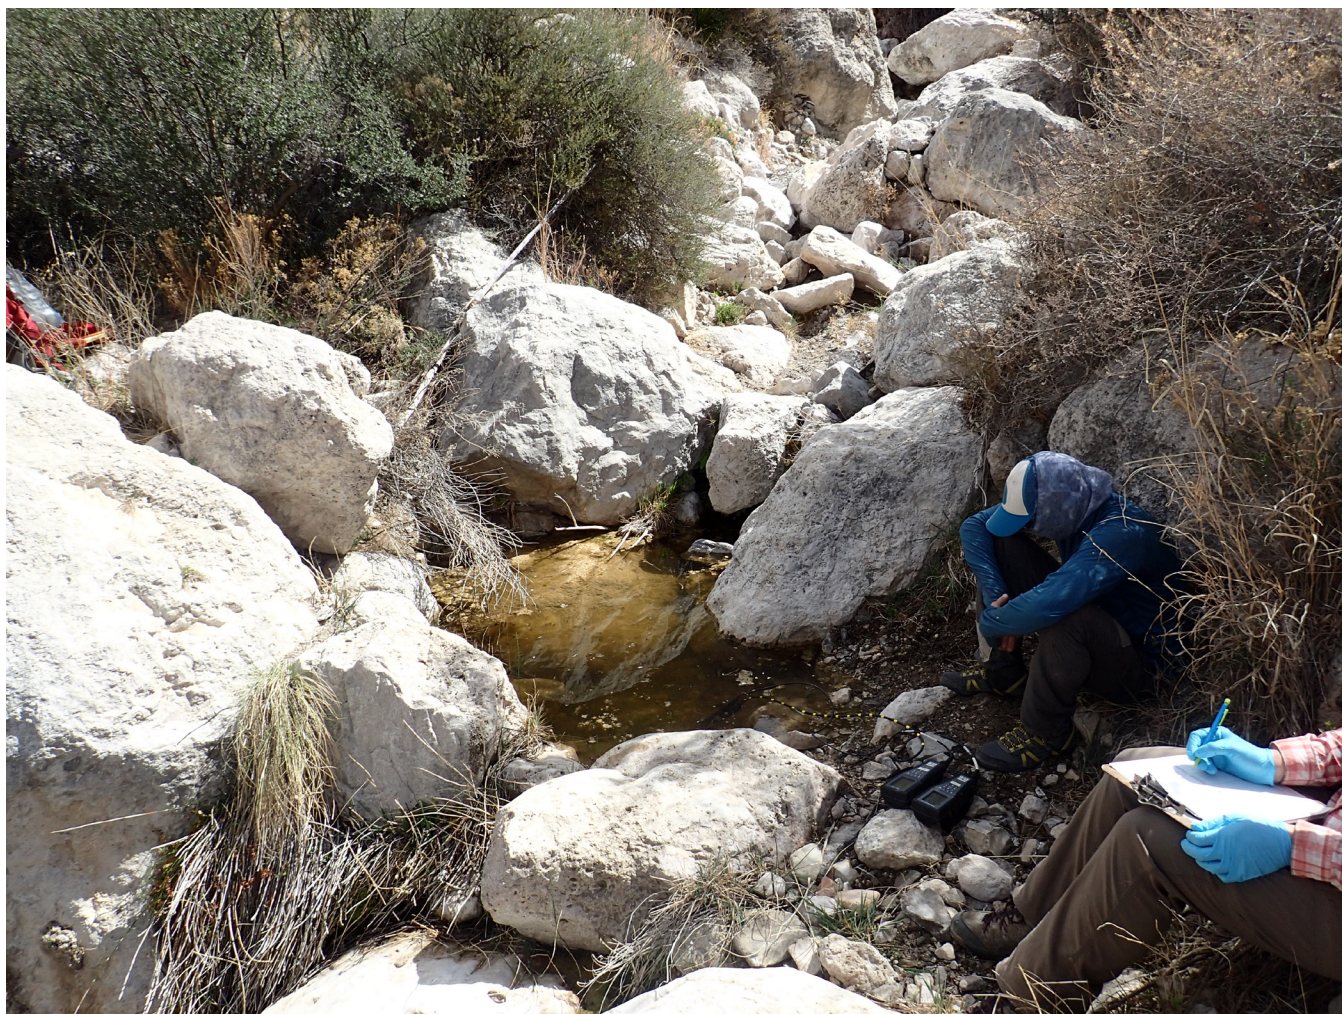
Figure 4-1. Bone Spring orifice, Guadalupe Mountains NP, March 2018

Bone Spring (Figure 4-1) is as a rheocrene spring (a spring that emerges as a flowing stream) in a larger drainage. It was visited on March 24, 2018. The spring emerges between two medium boulders as a small trickle among maidenhair ferns (*Adiantum* sp). The cool and clear flow spills into a plunge pool, the first of many interspersed along the springbrook (of which the first 100 m (328 ft) were measured per the protocol). Most of the pools range from a surface area of 2 m<sup>2</sup> (21.5 ft<sup>2</sup>) to 4 m<sup>2</sup> (43.1 ft<sup>2</sup>) and a depth of 0.5 m (1.6 ft) to 1.0 m (3.3 ft). The substrate is dominated

by boulders with gravel deposits present in flatter sections of the system. Some areas of the springbrook are incised and there is evidence that runoff events in the drainage affect the overall system.

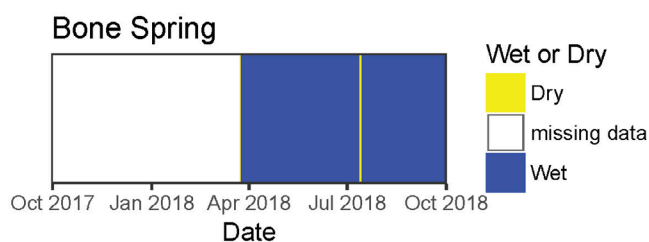
**Figure 4-2. Estimated wet/dry days at Bone Spring, Guadalupe Mountains NP, WY2018**

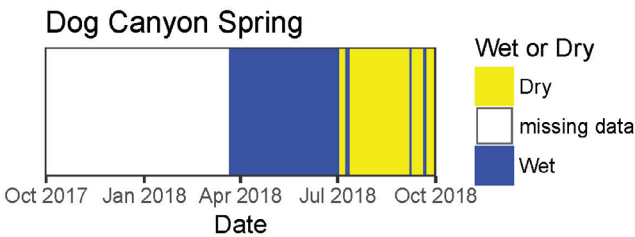
Figure 4-3. Estimated wet/dry days at Dog Canyon Spring, Guadalupe Mountains NP, WY2018

Temperature sensors indicated that the spring was wetted until early July and was generally dry for the remainder of the water year (Figure 4-3). The sensor was found approximately 0.3 m (1 ft) above the water in 2019, and the dry readings in the last quarter of WY2018 may not represent actual conditions. Sensors were not deployed in 2017 and there are no data available from October 2017 to March 2018. Discharge was not measurable in this limnocrene system. Due to the inaccessibility of the pool, the crew measured a single length and width to roughly estimate the size of this rectangular pool: length was 288 cm (9.4 ft) and width was 350 cm (11.5 ft).

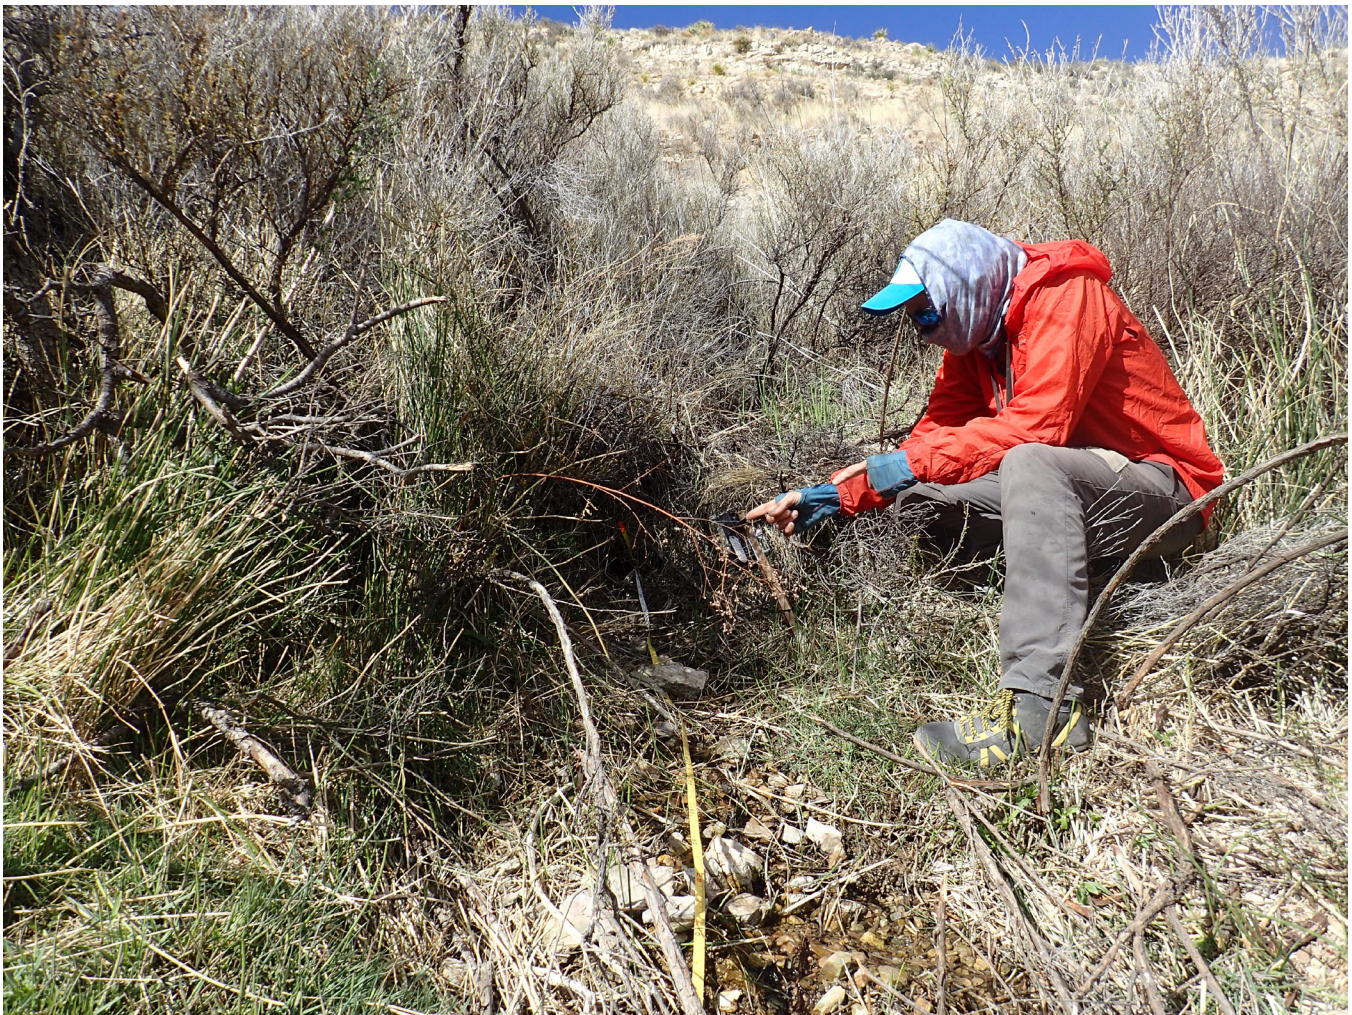
Figure 4-4. Guadalupe Spring orifice A, Guadalupe Mountains NP, March 2018

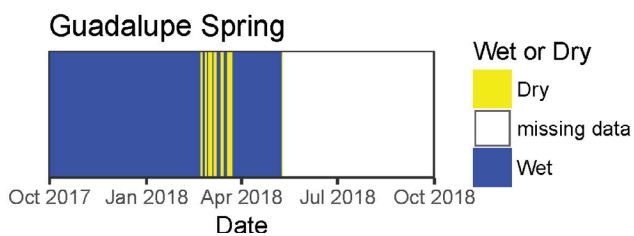
Figure 4-5. Estimated wet/dry days at Guadalupe Spring, Guadalupe Mountains NP, WY2018

Temperature sensors indicated that the spring was wetted for the majority of the sampled interval (October 2017–May 2018) with drying events in the spring (Figure 4-5). Data from the latter half of the year are missing due to sensor failure. Discharge from orifice A was estimated at 19.9 ± 0.4 L/min (5.3 ± 0.1 L/min). The channel length was not measured but was estimated to be 200–500 m (656–1640 ft). The first 100 m (328 ft) had a mean wetted width of 76.6 cm (2.5 ft) and mean depth of 1.8 cm (0.1 ft).

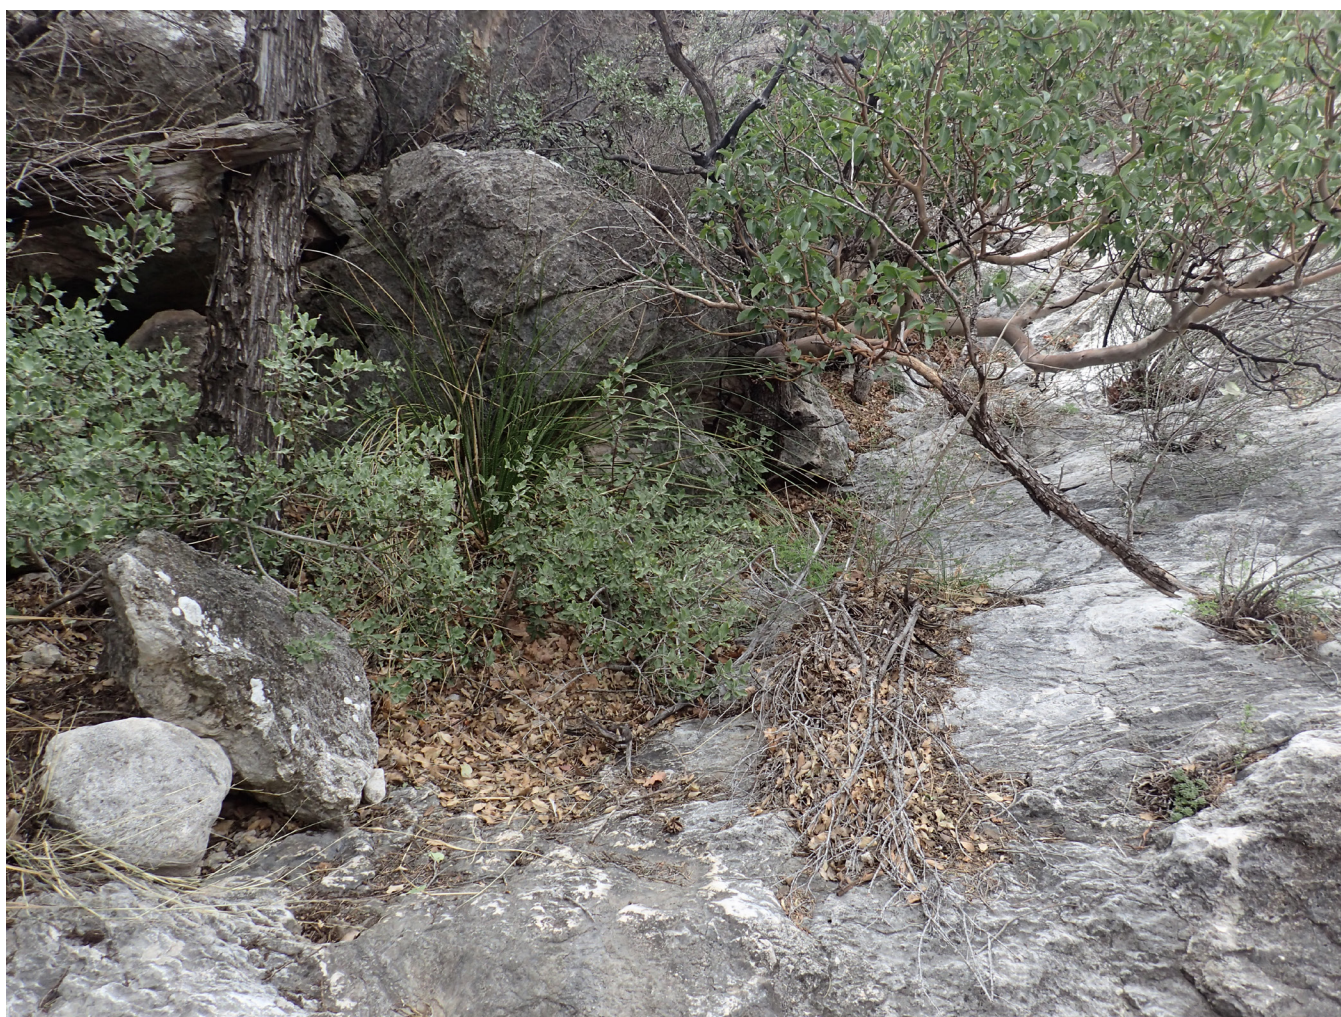
Figure 4-6. Sharp Rock Spring orifice, Guadalupe Mountains NP, March 2018

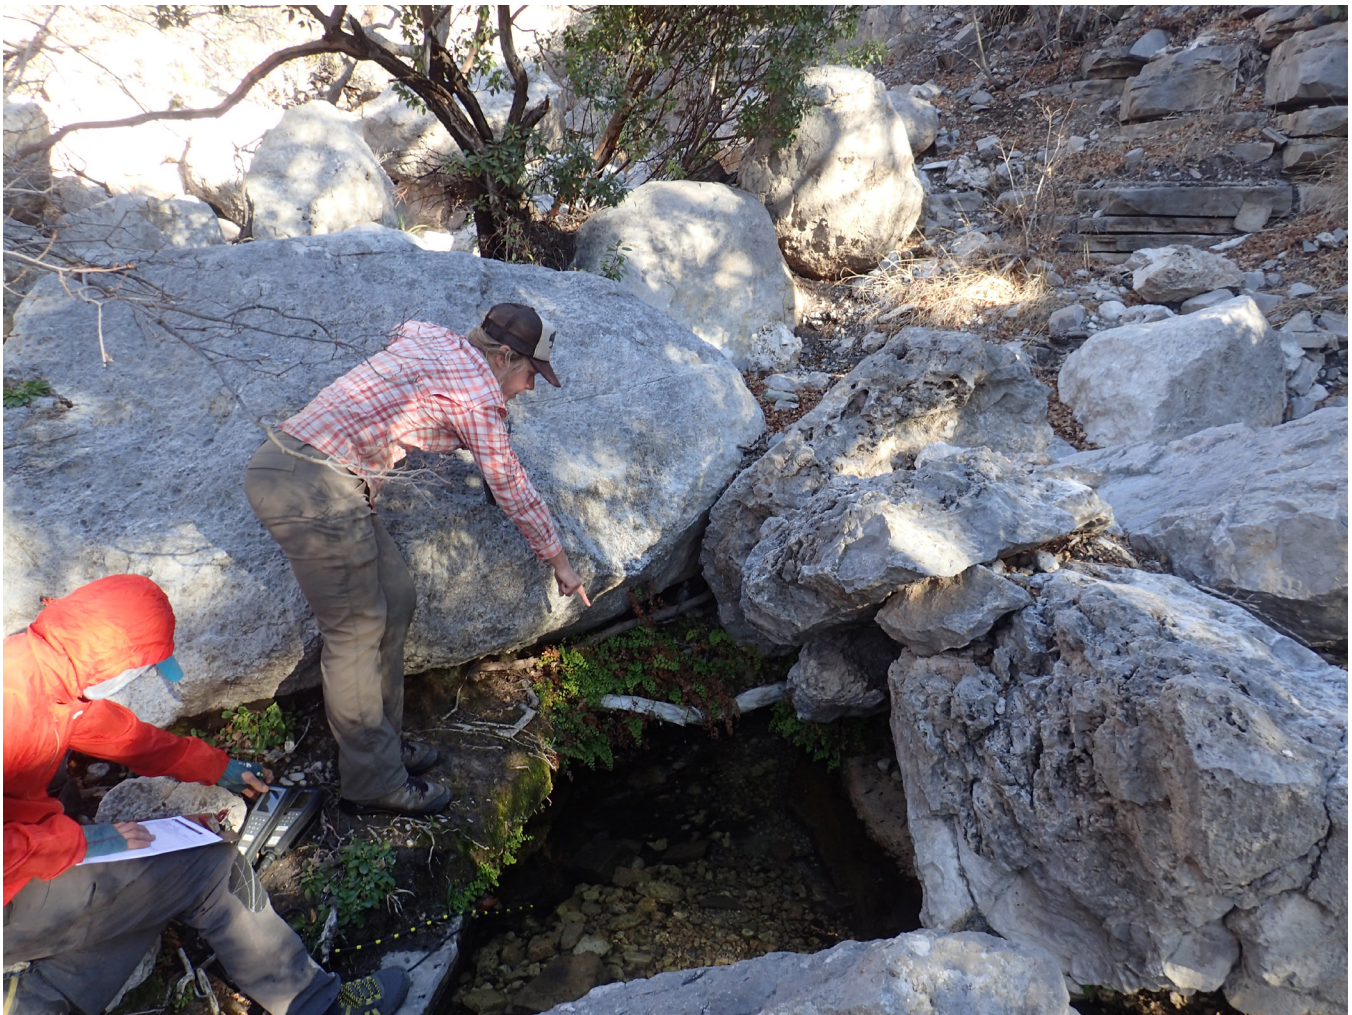
**Figure 4-7. Smith Spring orifice A, Guadalupe Mountains NP, March 2018**

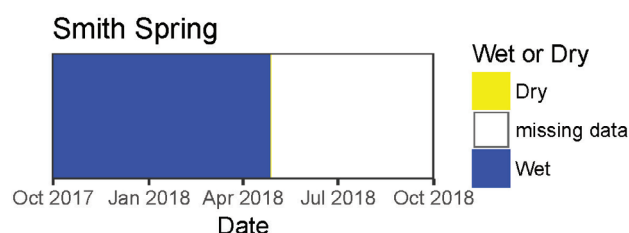
**Figure 4-8. Estimated wet/dry days at Smith Spring, Guadalupe Mountains NP, WY2018**

The temperature sensor indicated that the spring was wetted for the entirety of the sampled period (October 2017–April 2018). The sensor failed on April 28, 2018, and the one dry day estimated was near that failure and may not indicate actual conditions (Figure 4-8). Discharge was measured at three locations. Discharge was  $101.2 \pm 1.8$  L/min ( $26.7 \pm 0.5$  gal/min) at 2.5 m (3.2 ft) downstream of orifice A, and  $65.4 \pm 1.8$  L/min ( $17.3 \pm 0.5$  gal/min) at 2.5 m (8.2 ft) downstream from orifice B. Approximately 35 m (114 ft) downstream of orifice A, which is downstream of where flow from the two orifices join, discharge was  $138.8 \pm 2.1$  L/min ( $36.7 \pm 0.6$  gal/min). The first 100 m (328 ft) of the springbrook had a mean wetted width of 140 cm (55.1 in) and mean depth of 3.6 cm (1.4 in).

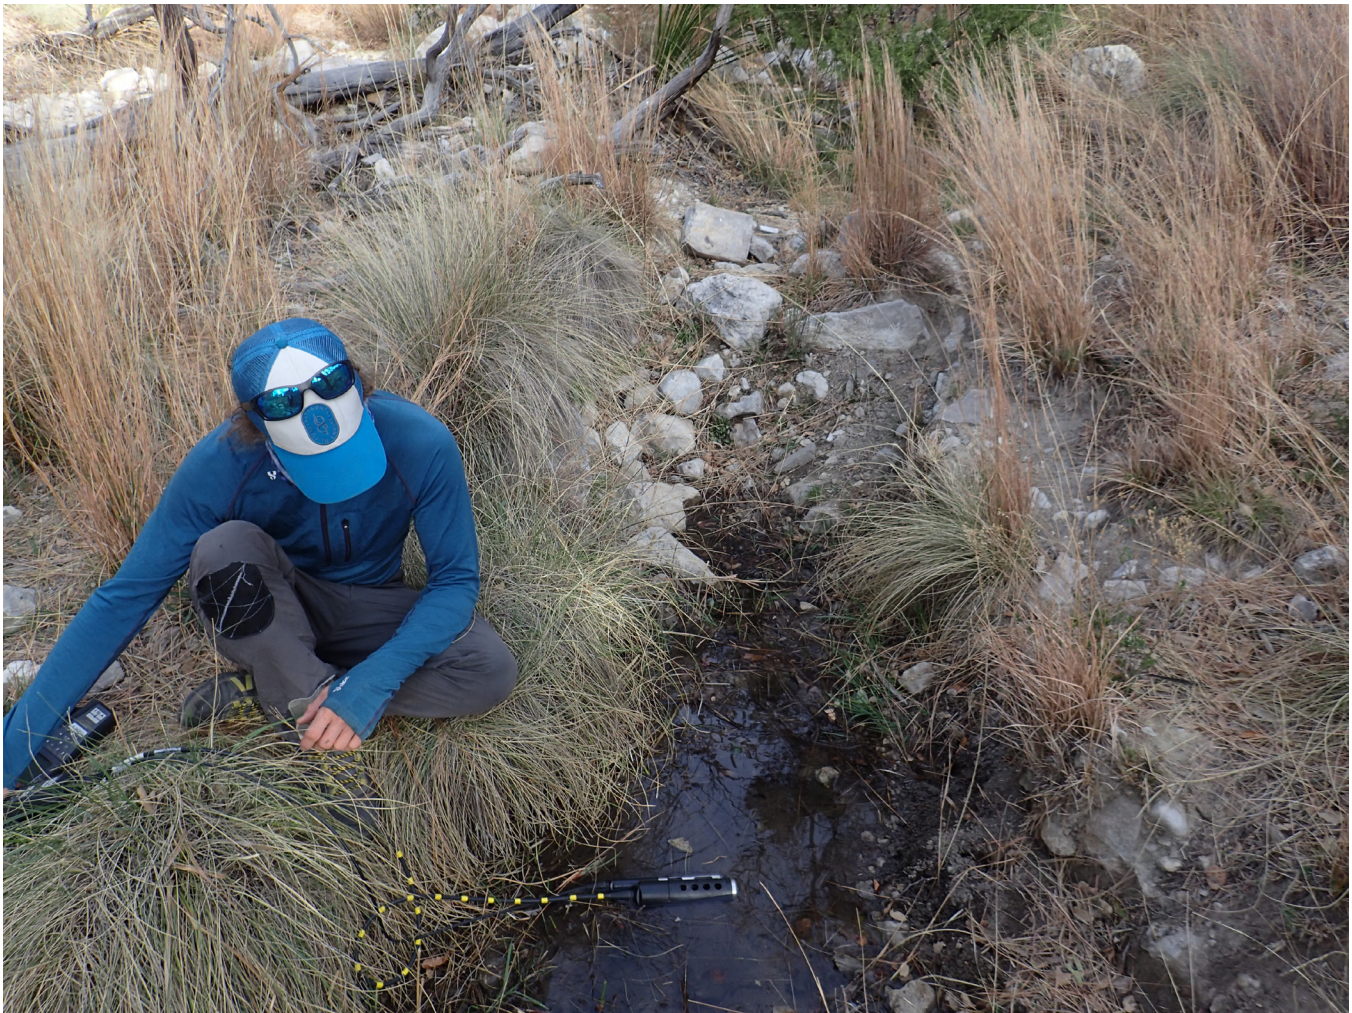
**Figure 4-9. Upper Pine Spring orifice A, Guadalupe Mountains NP, March 2018**

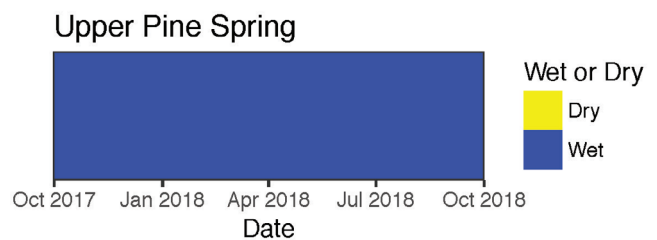
**Figure 4-10. Estimated wet/dry days at Upper Pine Spring, Guadalupe Mountains NP, WY2018**

The temperature sensors indicated that the spring was wetted throughout WY2018 (Figure 4-10). Discharge from orifice A was estimated at  $1.2 \pm 0.02$  L/min ( $0.3 \pm 0.005$  gal/min). Discharge from orifice B was not estimated. The 73-m (240-ft) springbrook had a mean wetted width of 65.2 cm (2.1 ft) and mean depth of 8.2 cm (0.3 ft).
