# **National Register of Historic Places Registration Form**

Historic name: Security State Bank of Dante

Street & number: 320 Main Street

City or town: Dante State: SD County: Charles Mix

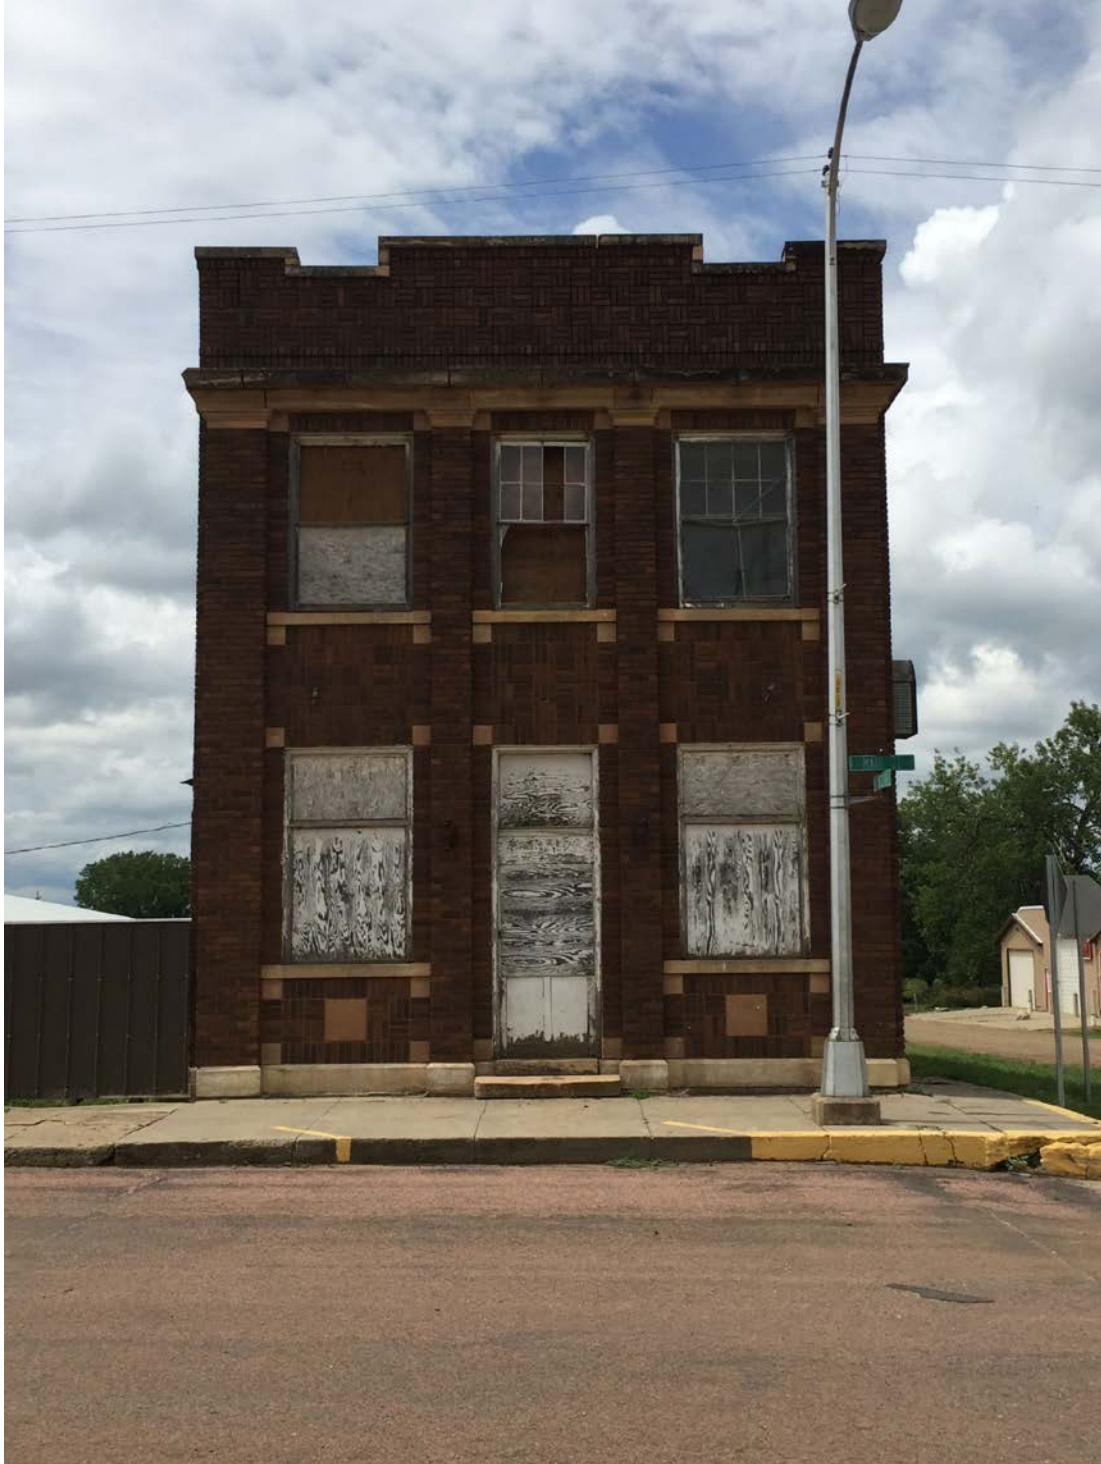
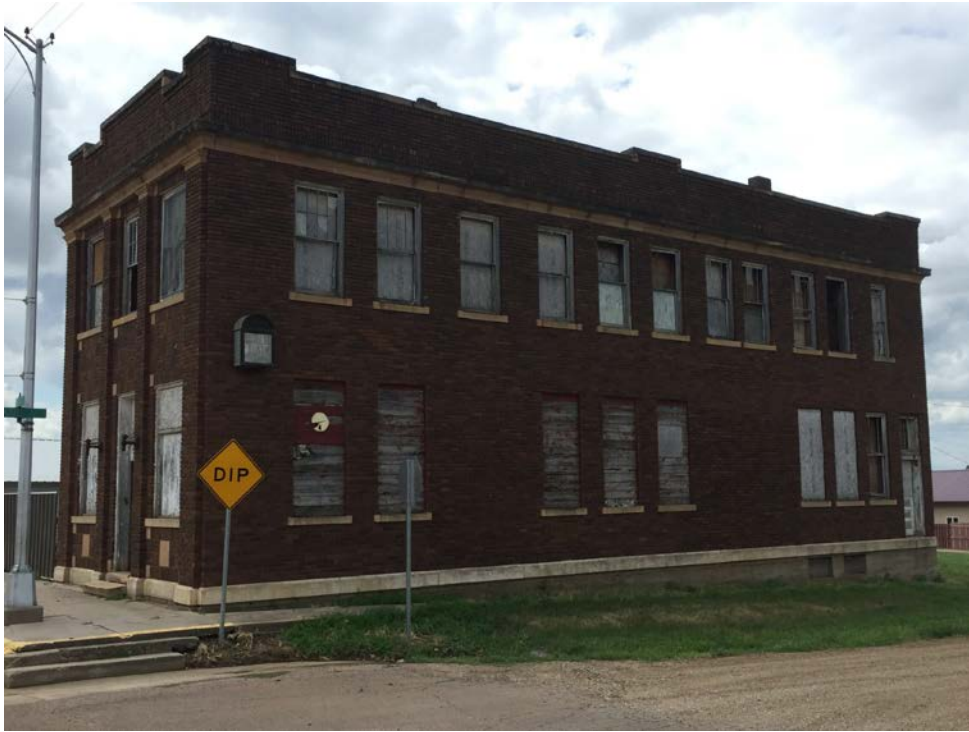
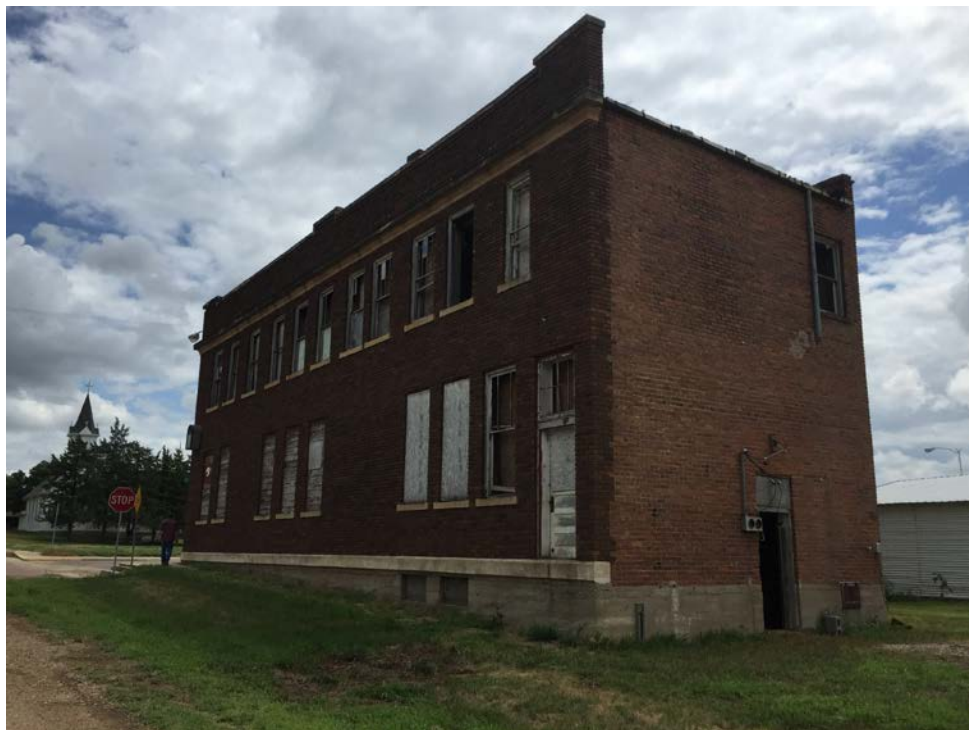
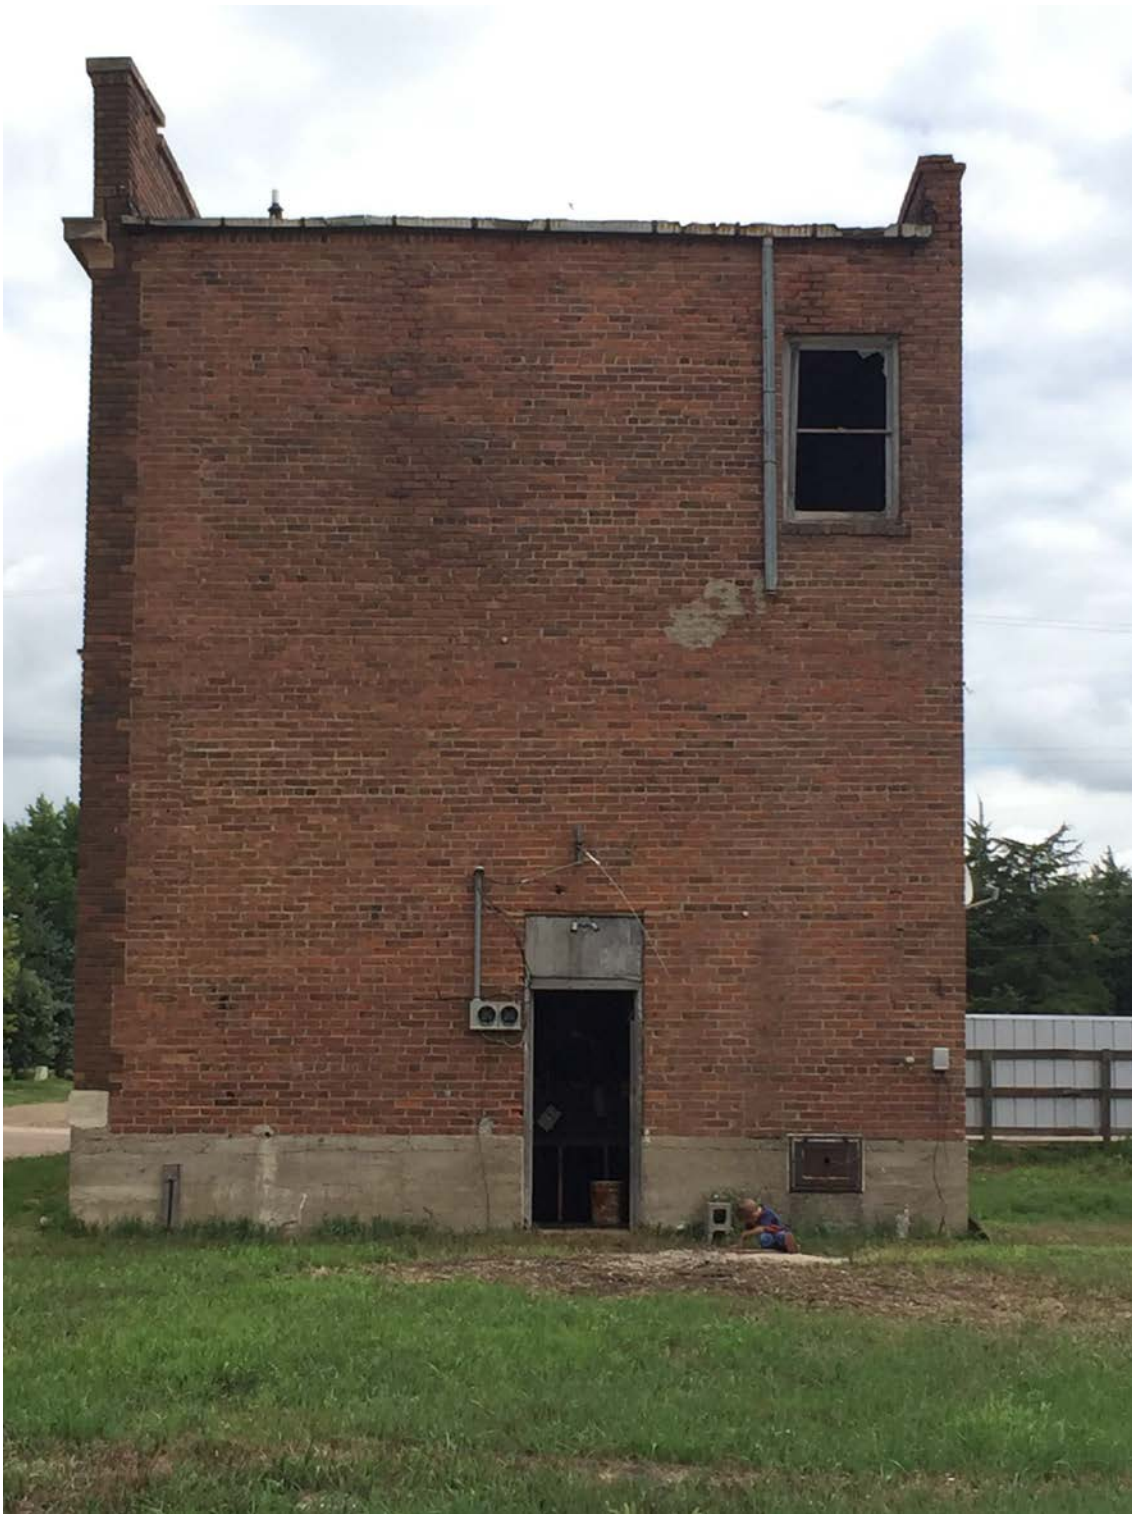
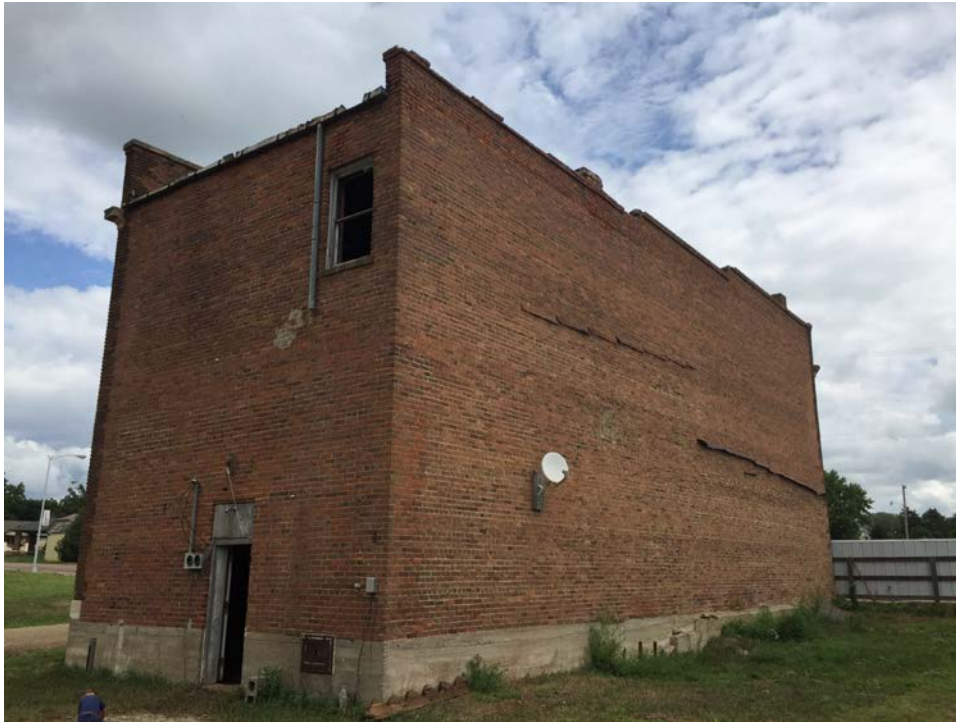
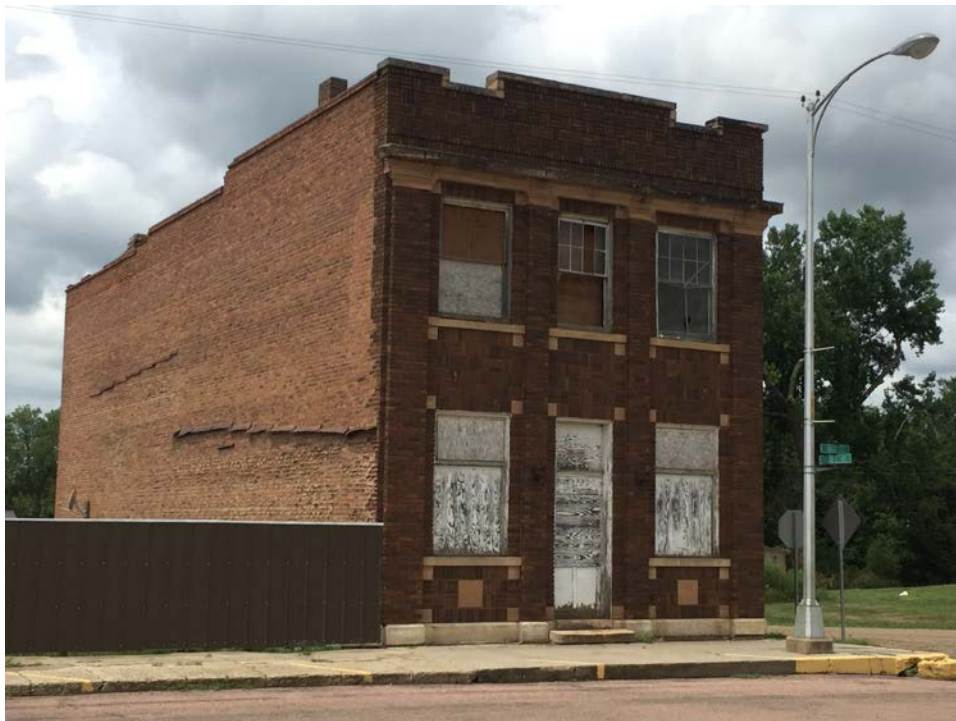
The Security State Bank of Dante is a two-story plus basement masonry commercial building built in the Craftsman Style in 1920. The exterior walls are brick, ornamented with limestone details. The brick at the east and north façades are dark brown, with a reddish-brown mortar. The brick at the west and south façades is lighter, with a white mortar providing a clear distinction between primary and secondary façades. The building has a flat built-up roof, flanked with a tall parapet extending from the north, south, and east façades. The primary façades face east towards Main Street, and north towards Haskell Street, with the secondary facades facing west and south (Photos 1-6).

The east (front) façade facing Main Street contains the single-door front entrance centered to the building with an original bronze lighting bracket on each side. The fenestration consists of two large windows on the first level, at either side of the front entrance, and three large windows at the second level. All windows have a wide limestone window sill. Flanking the fenestration and

entrance is a series of stretcher bond patterned brick pilasters with limestone capitals and bases. The pilasters extend from the base of the building up to a limestone entablature that continues to wrap around the north façade. Above the entablature is a tall parapet with a basket weave brick pattern and limestone coping stones. The basket weave brick pattern with soldier headers is present throughout the first and second level of the east façade, ornamented with square limestone details.

The east façade is most representative of the Craftsman Style due to the basket weave brick pattern and square limestone decorative features. The four pilasters flanking the door and windows can be seen throughout other Craftsman examples. The pilasters and entablature are also representative of Classical elements commonly applied to the design of bank buildings of the late 19<sup>th</sup> and early 20<sup>th</sup> century.

The north façade facing Haskell Avenue continues some of the features present on the east. The entablature and tall parapet are present; however, the parapet bricks are laid in the stretcher bond pattern. The fenestration clearly marks the first and second levels. On the first level there are two sets of tall rectangular windows grouped in threes and one grouped in two. Each window has its own limestone window sill. Above, a series of tall rectangular windows matching the first level is placed throughout the entire length of the façade. There are windows that align directly above the first level windows, and the others are spaced randomly throughout the remainder of the façade. As with the rest, each window has its own limestone sill. Other than the limestone entablature, the north façade is minimally ornamented. The stretcher bond pattern found in the parapet is continued throughout the north façade. Still present on the north façade is the original burglar alarm. There is a single wood door painted white at the most west corner with a tall square transom above. Due to the height of the door from the ground, it appears that a staircase once providing access has been removed. The concrete basement structure is visible from the slant of ground, containing two single sash rectangular windows near the west end.

All windows on the north and east façades appear to have been double sash, with an eight over one configuration. Many windows have lost their glass panes, mullions, lower or upper sashes, or the window has entirely been lost. Several intact examples are representative of the double sash with an eight over one configuration.

The west (rear) façade exterior brick wall has a single door opening at the center at ground level and a single window opening at the top right corner (providing light to the second level corridor). Unlike the others, this window has a brick sill. Both the window and the door have been removed and have not been boarded. No limestone details are present, and the concrete

The south façade exterior brick wall contains no windows or doors. Like the west façade, the brick is lighter than the north and east façades and is generally laid in the 7<sup>th</sup> course common bond pattern. Based on remaining metal flashing attached to the building, a single-story structure with two varying rooflines was once attached. The concrete foundation can be seen at the base of the building.

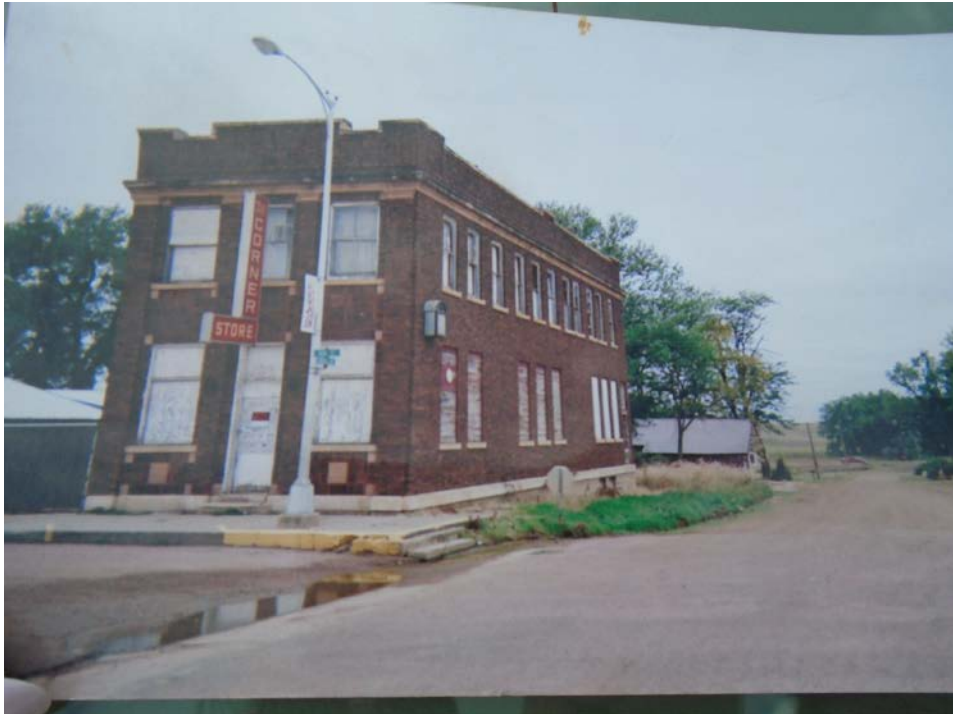
Photo 7

Both the east and north façades have undergone minimal alterations. The original bank sign was removed at some point, and for a period the building had a "Corner Store" sign located above the entrance door (Photo 7). Some of the original window fabric has been lost due to damage, though all appear to maintain the original casings and sash frames.

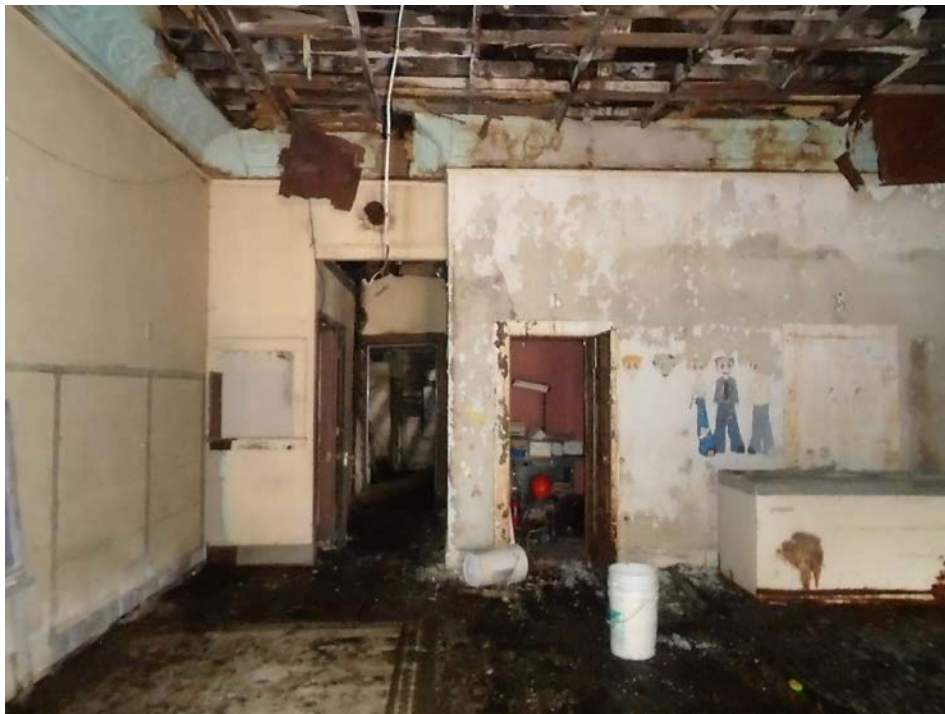
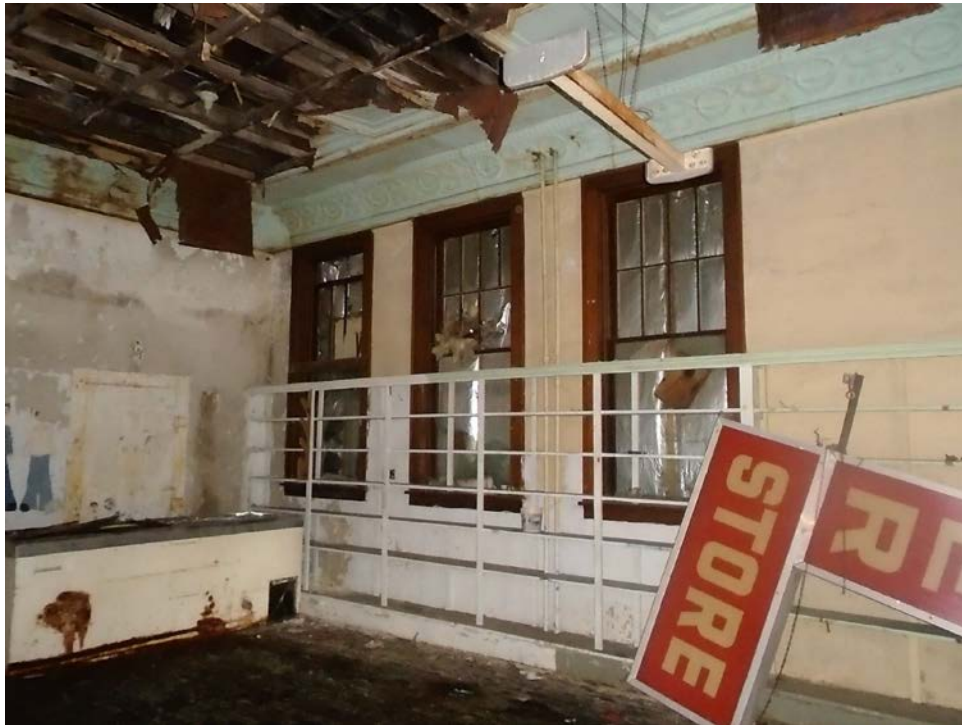
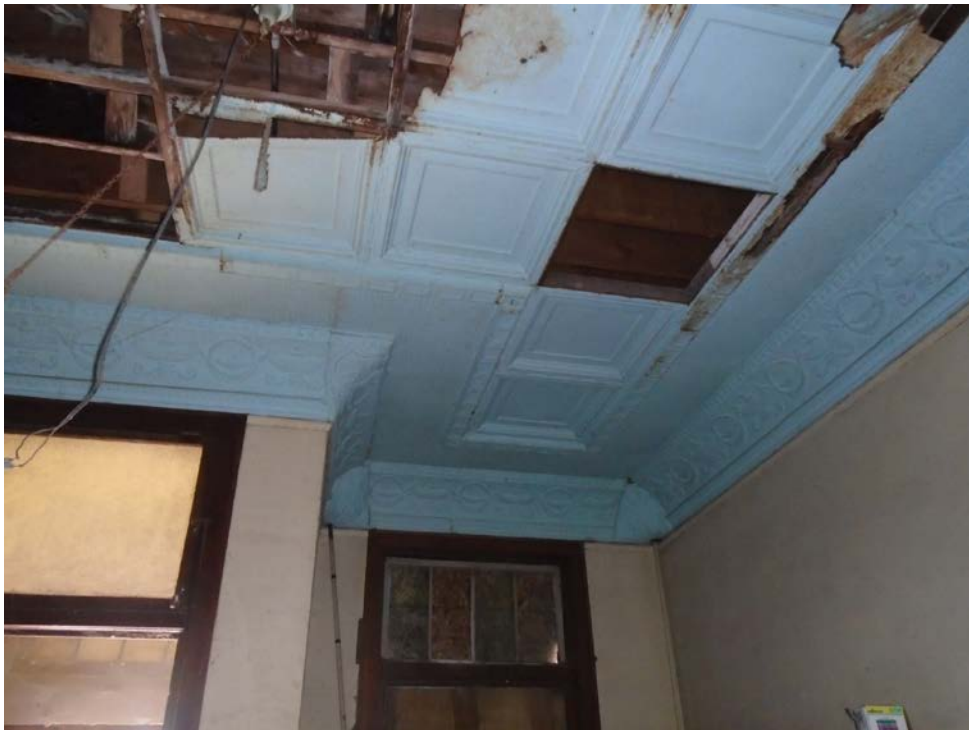
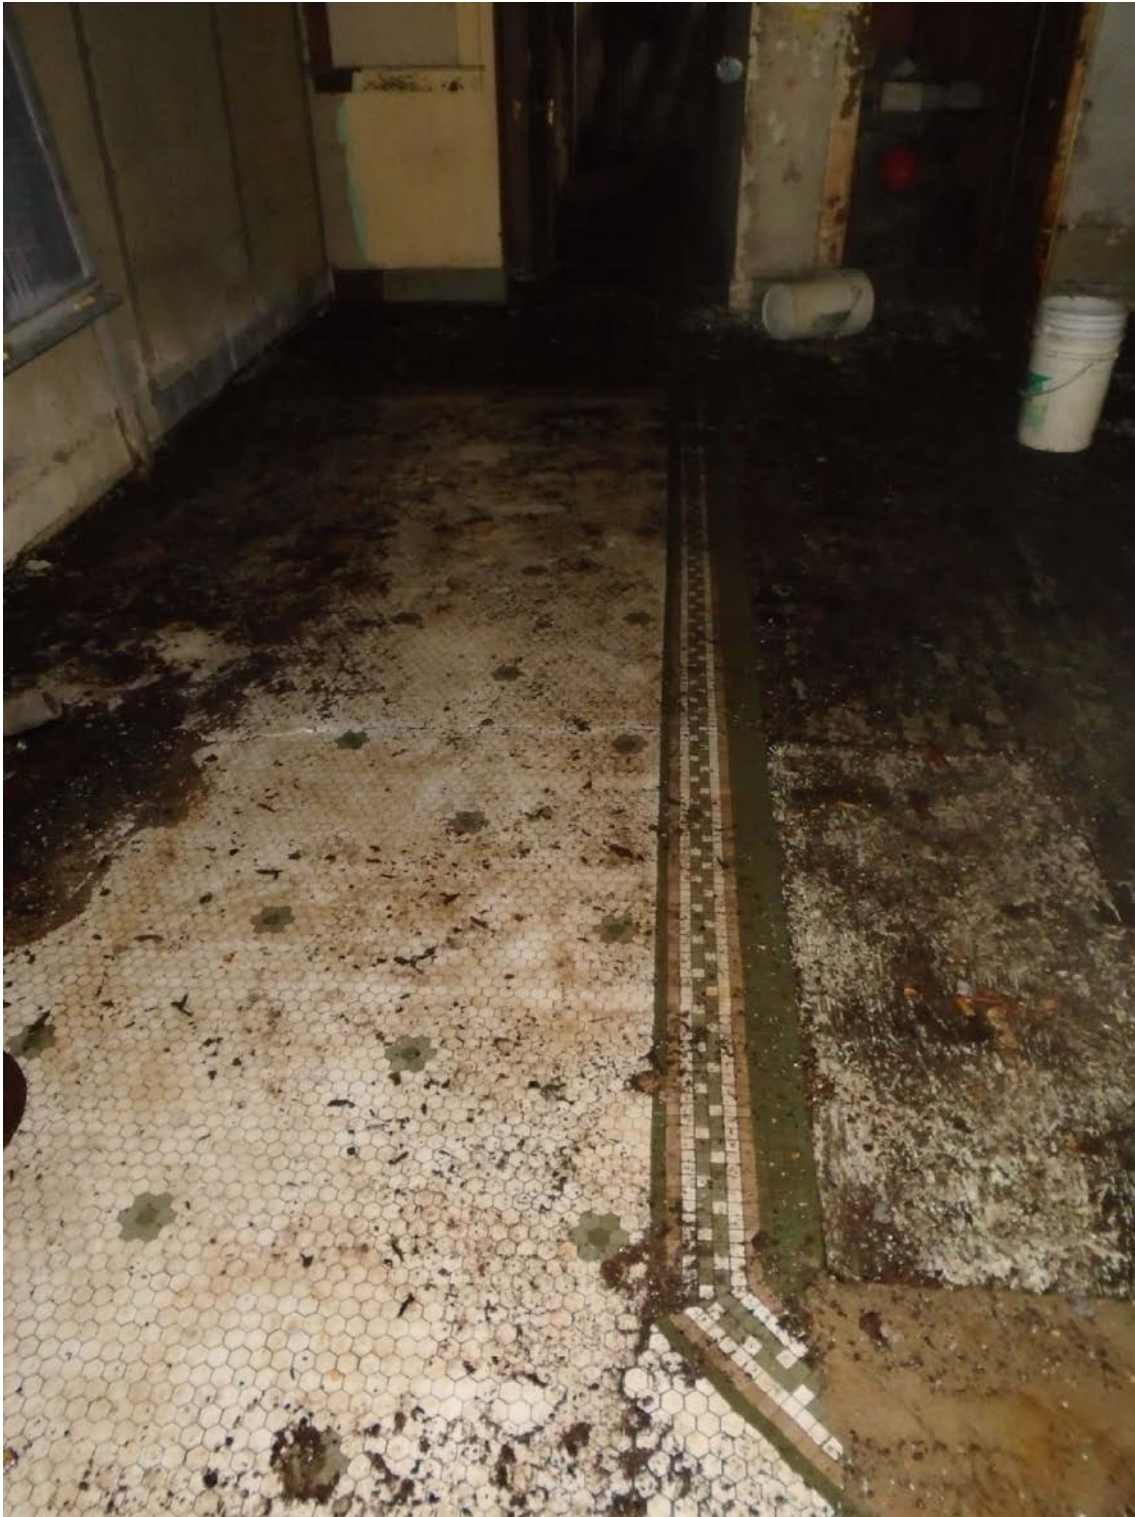
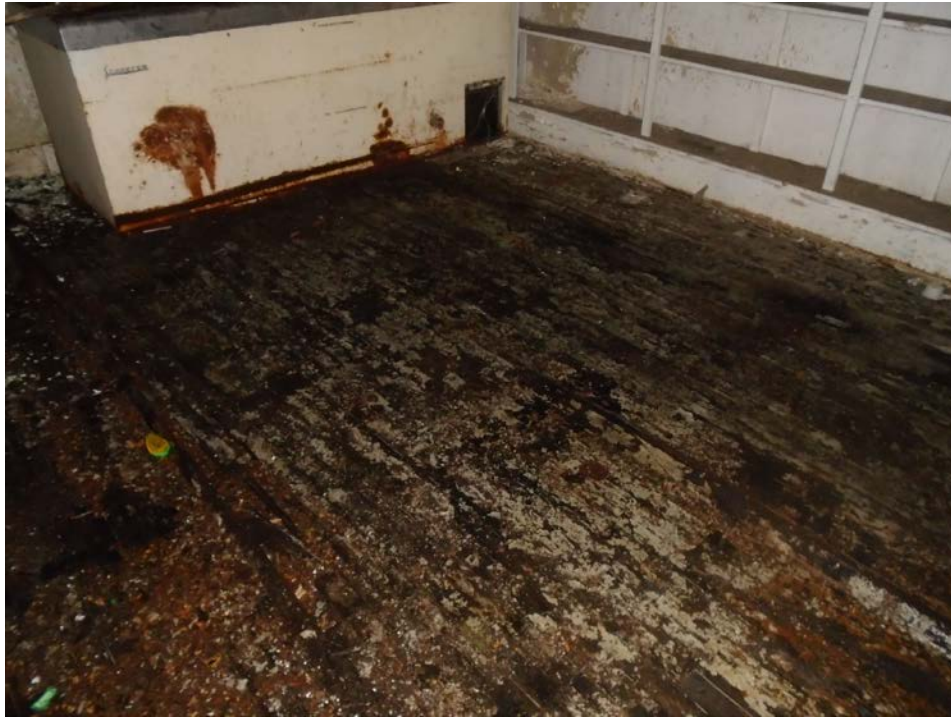
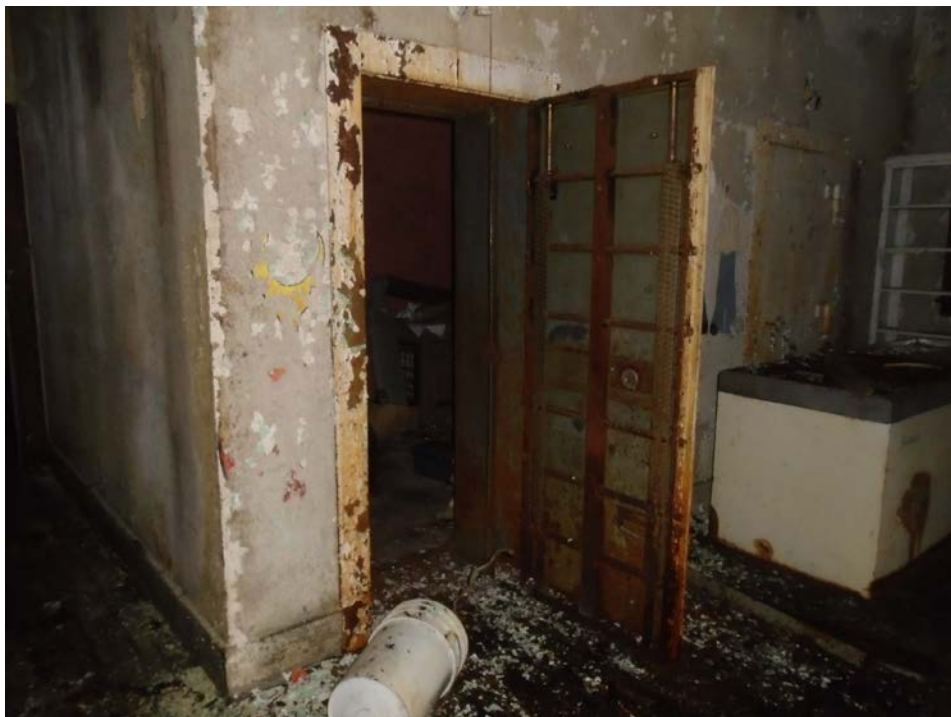
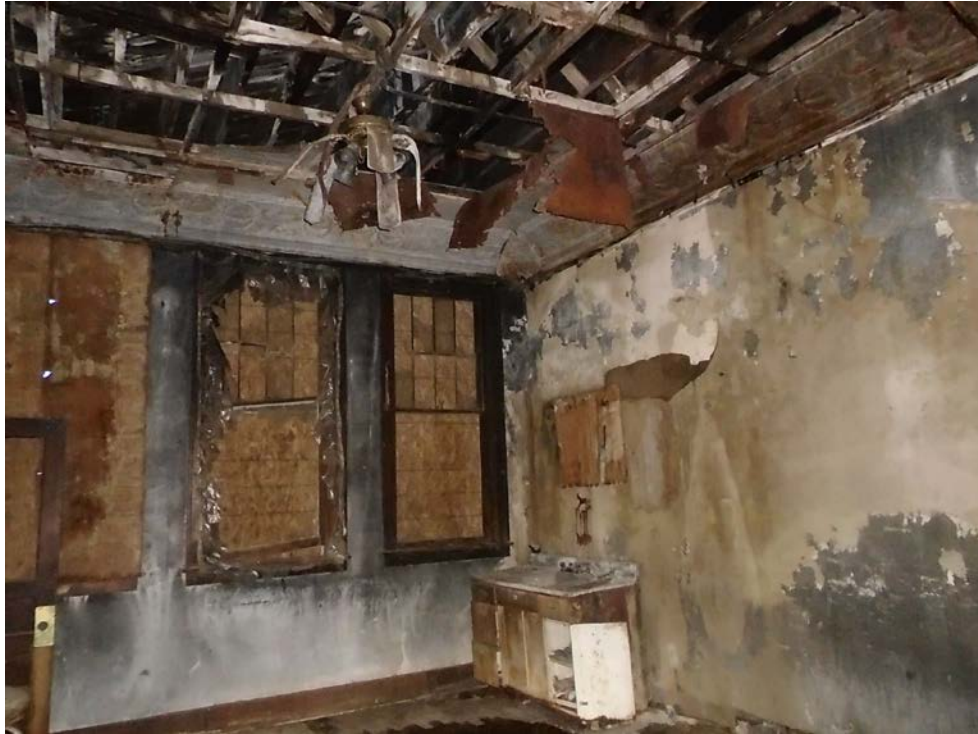
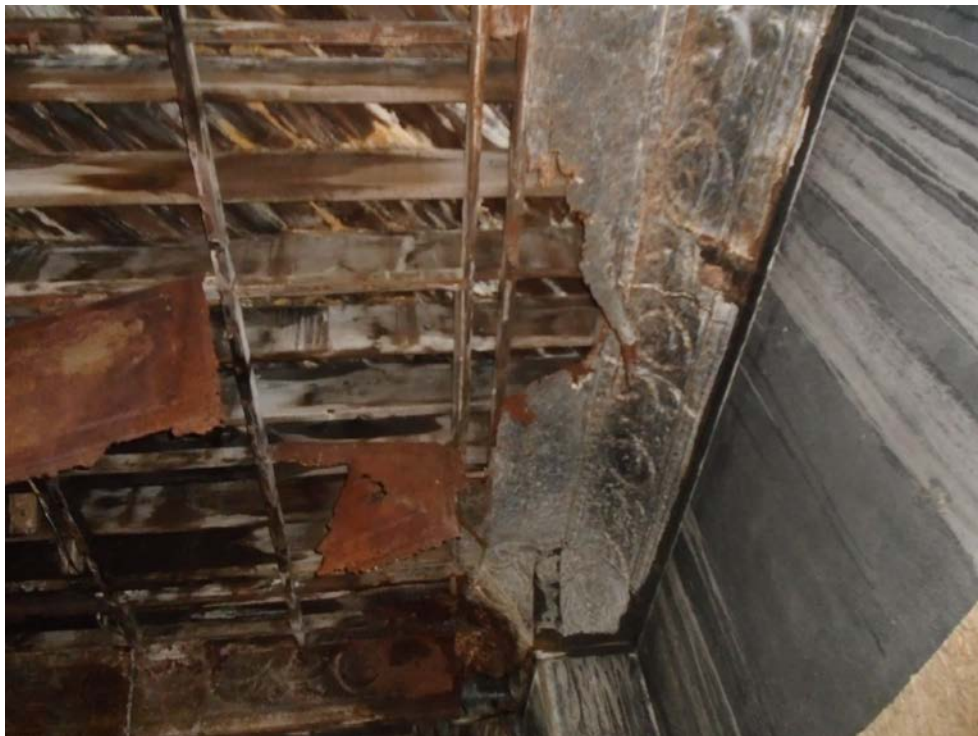
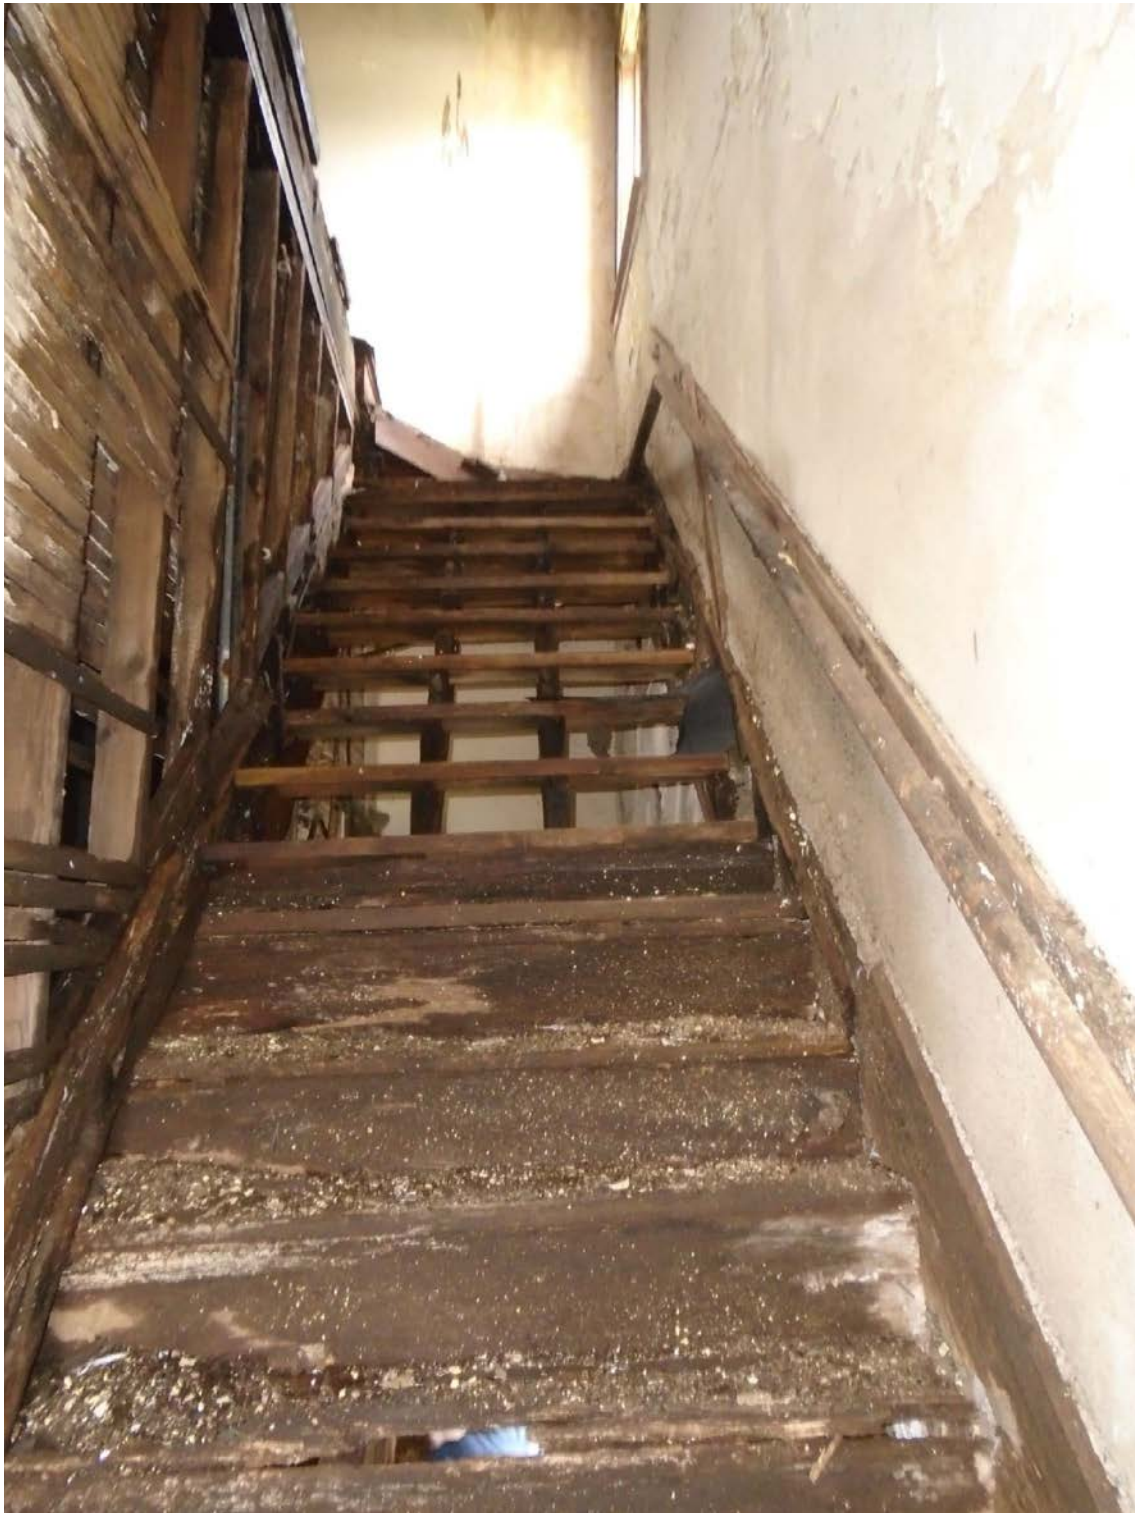
The interior of the building (Photos 8-16) has been significantly damaged due to water infiltration and fire damage. The fire damage is believed to have occurred sometime in 2000 or 2001. Though damaged, original architectural features can be seen throughout the first and second levels. Upon passing through the main entry door, there is a small vestibule with a decorative hexagon tile floor. The vestibule leads to an open room spanning the width of the building that originally housed the banking room and public space. Wood shelving lines the north and south walls, which was installed when the building was used as a corner store. The floor provides a clear definition between the public space and the banking room of the original space. The decorative hexagon tile from the vestibule continues through the south side of the room. The hexagon tile flooring creates an "L" like shape that extends from the front entrance to the next room of the first level. This was likely the public space for customers to access the teller line and the rear of the building, as better finishes were generally used in bank public spaces. Adjacent to the hexagon tile floors is hardwood, some of which has been lost with the subfloor exposed. At the west wall of the teller line are the original metal vault doors, one located at each side. The walls appear to be finished with original plaster that have since been painted. The original pressed tin ceiling can be seen, most prominently at the crown of the room that has been painted light blue. Most of the pressed tin ceiling has been lost due to significant moisture infiltration.

The remainder of the first floor is comprised of the safe, a restroom, closet, and a large room at the rear of the building that houses the staircase to the second level. This rear room was likely used for private offices to meet with customers, and has experienced significant damage to the ceiling, floor, and walls. Like the front room, there are remnants of a pressed tin ceiling, much of which is gone due to water infiltration and fire damage. The original wood floors have begun to rot due to water infiltration. The north, south, and east walls have largely retained the original plaster, but are largely stained due to smoke damage. The west wall of the room has most of the lath and plaster missing, exposing the second level staircase.

side. The original interior finishes of the second floor appear to have been largely functional, with plaster walls, wood floors, and wood doors. The walls, ceiling, and floors have been significantly damaged due to water infiltration. Despite the damage, the second level provides evidence of the original interior doors and windows in some locations.

The staircase opening to the basement is located directly under the staircase to the second level. At some point, the staircase was removed. The basement is exposed to the structural concrete walls, has a concrete floor, and is exposed to the first level wood floor structure.

The interior of the building has fallen into a state of disrepair due to significant water infiltration and fire damage. Despite its current state, minimal alterations to the building have been made throughout its life, providing a glimpse to the original floor plan and interior finishes. The most prominent original features that have been retained, though in poor or unsalvageable condition, are the interior wood window casings, wood doors, hexagon tile flooring, tin pressed ceilings, and the two original vault doors. Further assessment would need to be conducted to determine whether the interior features are salvageable.

| Photograph 14 of 17 | | | | | |
|---|---|---|---|---|---|
| Description | Interior, photo taken from the middle of the first level rear room facing northeast, showing the damaged walls and ceilings. | | | | |
| Description | Interior, photo taken from the middle of first level rear room, facing upward towards the damaged ceiling and remnants of the original pressed tin ceiling. | | | | |
