# Post Hurricane Hanna Assessment of Beach/Dune Morphology at Padre Island National Seashore.

*Jeff Bracewell, Gulf Coast Network Inventory and Monitoring Program, August 2020*

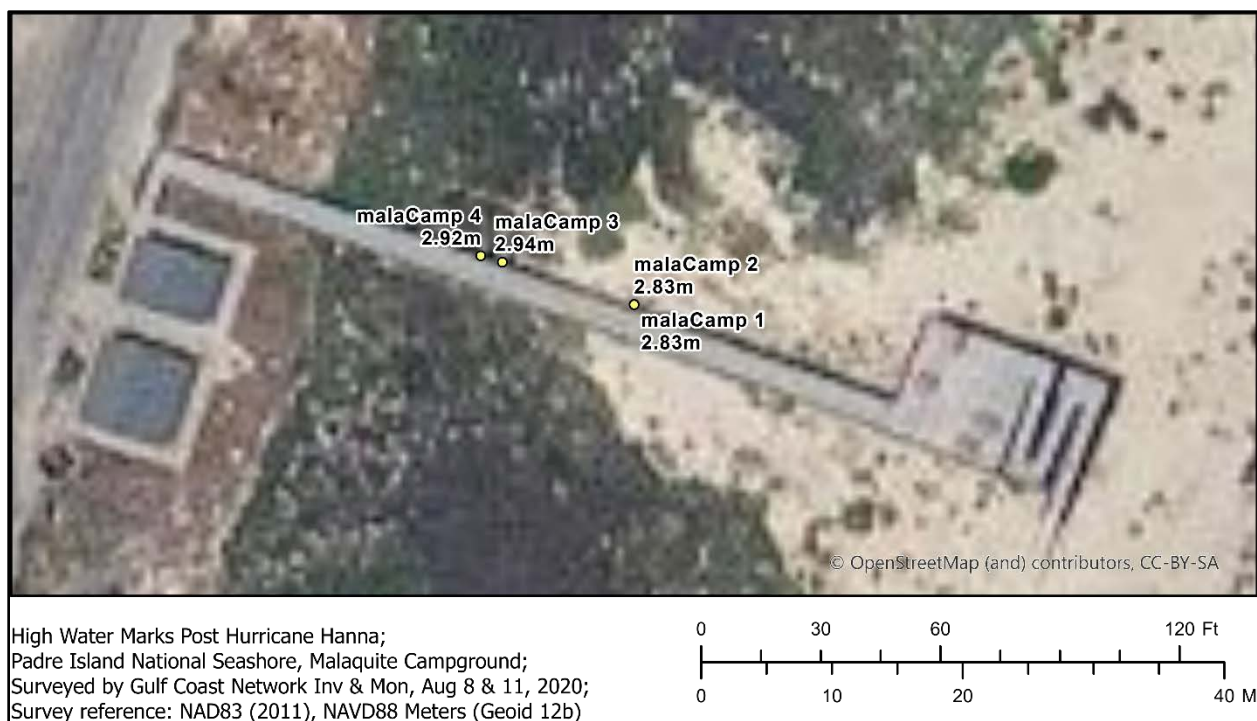
**High Water Marks:** High water mark elevations were consistent between and within survey areas and reasonably well interrelated with maximum water levels recorded at Bob Hall Pier. Seaward elevations of HWMs were around 10cm lower than those of their landward counterparts (Figures 5 and 6). This is possibly the impact from wave run-up forcing water across the topographic incline and/or increasing downslope hydrologic force as water levels recede. Landward elevation marks are likely more accurate in representing maximum storm inundation in these areas.

Figure 5. High water mark elevations at Malaquite Campground.

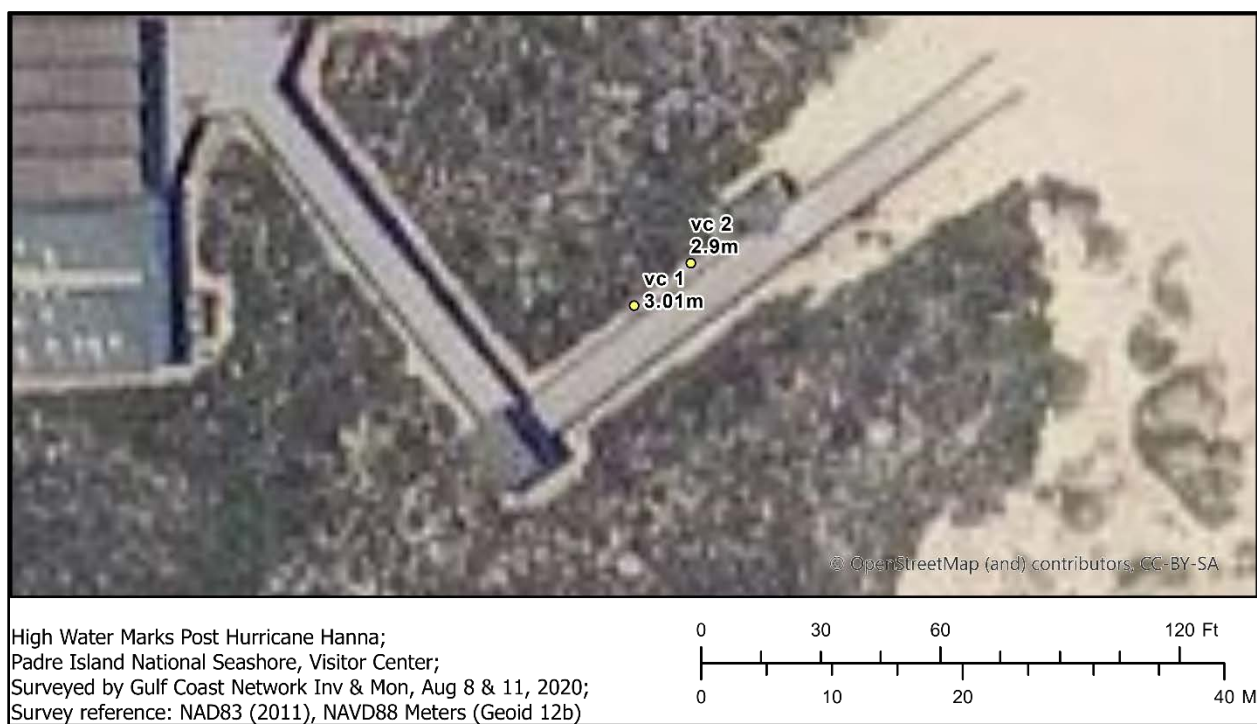
Figure 6. High water mark elevations at PAIS Visitor Center.

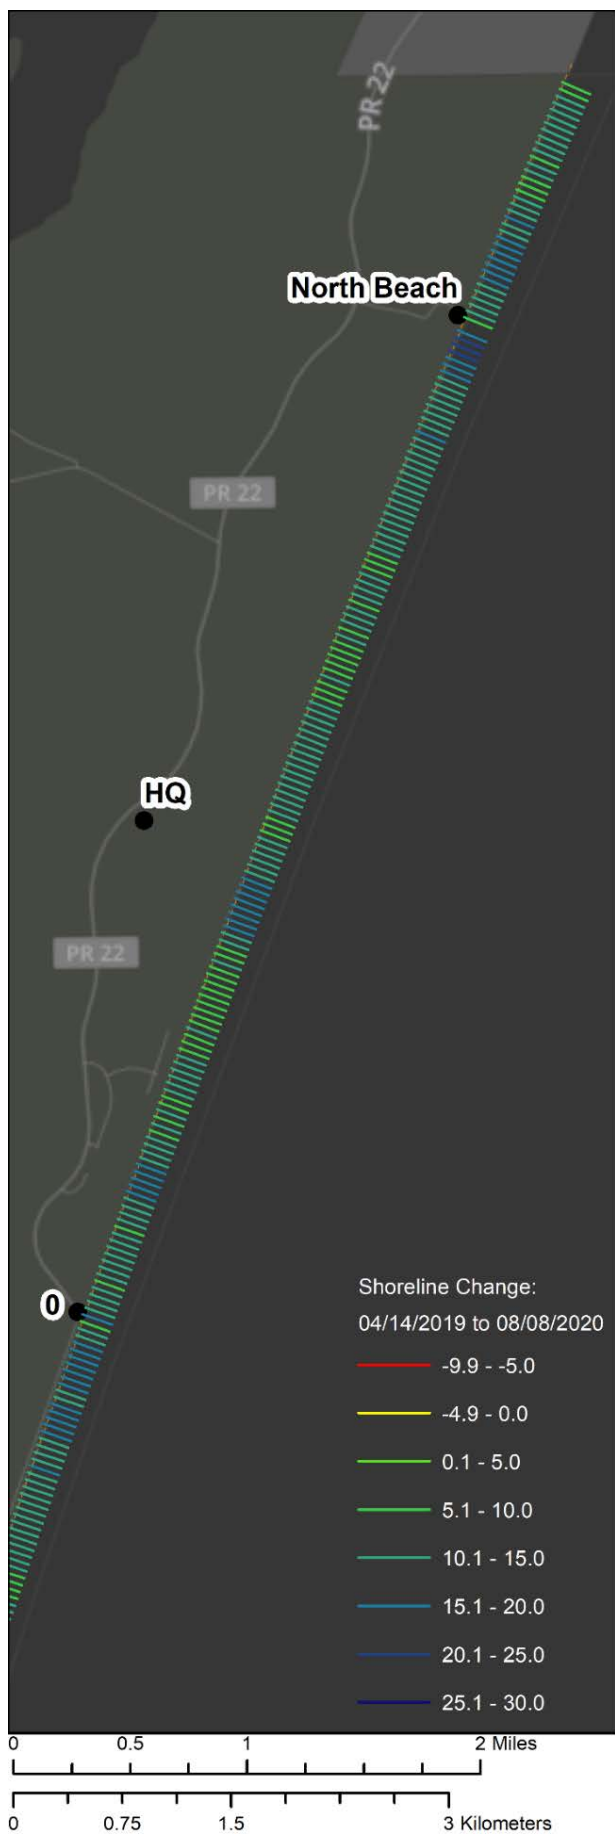
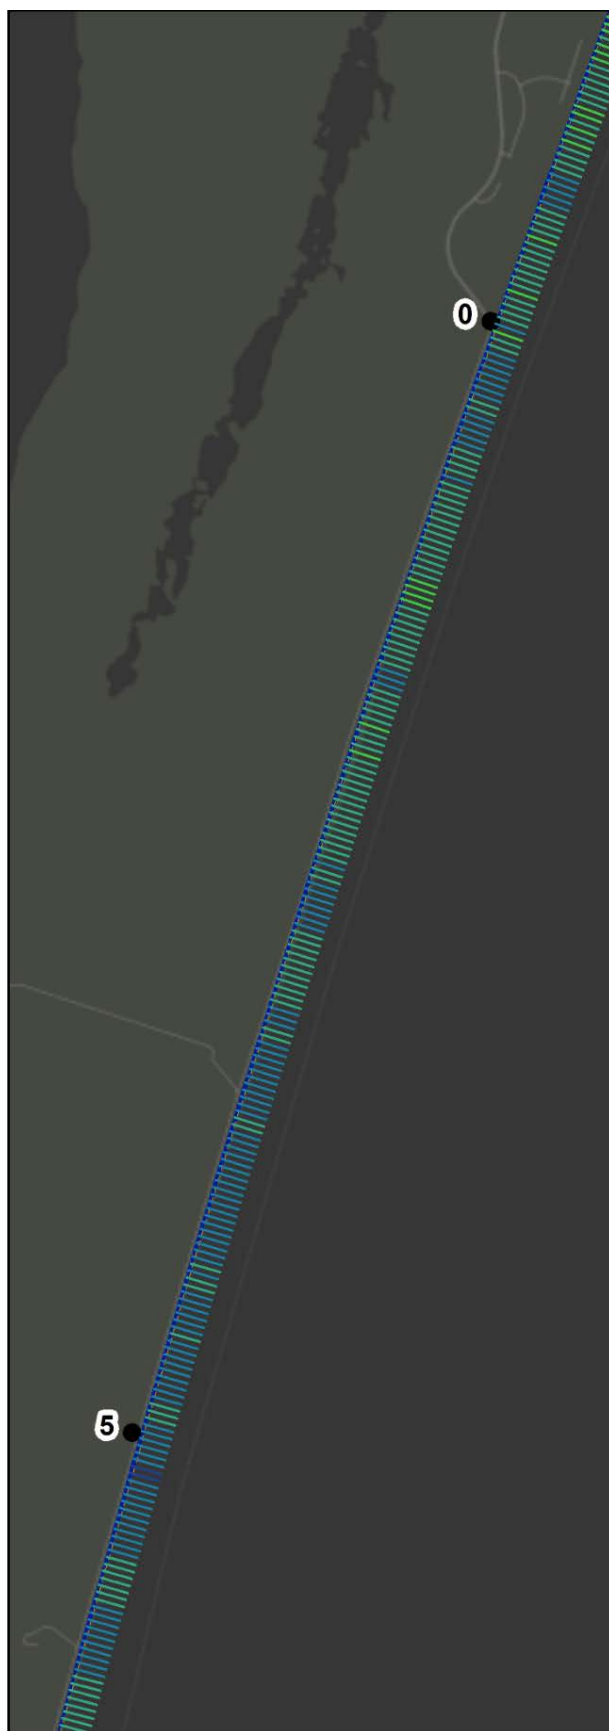
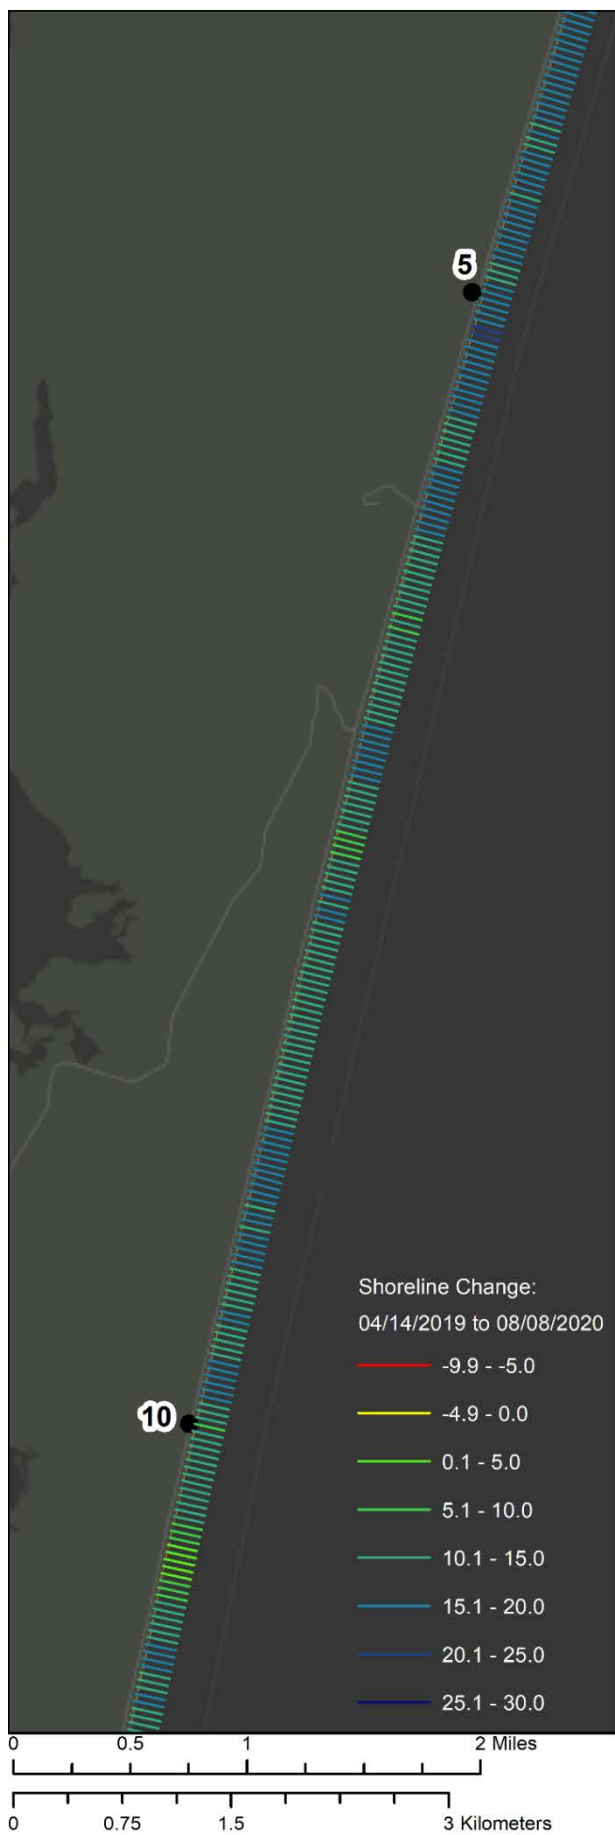
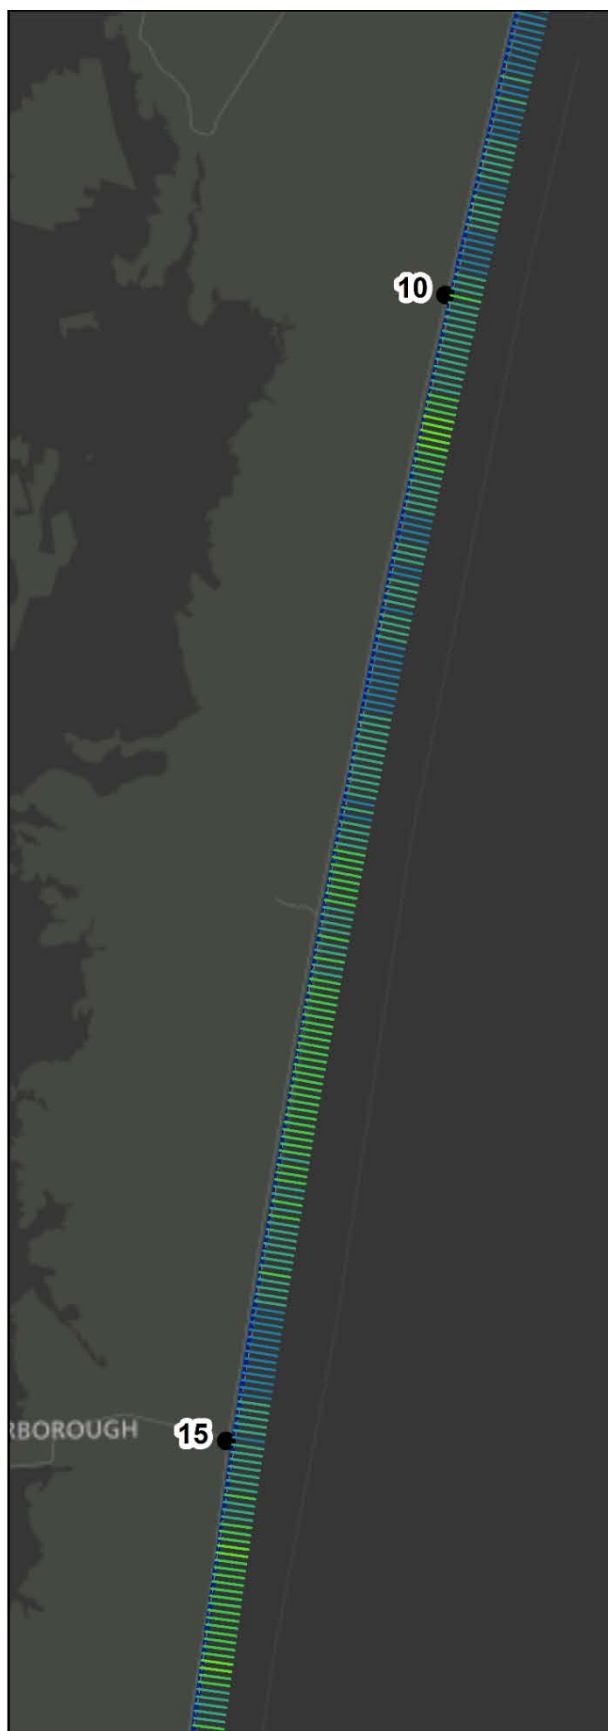
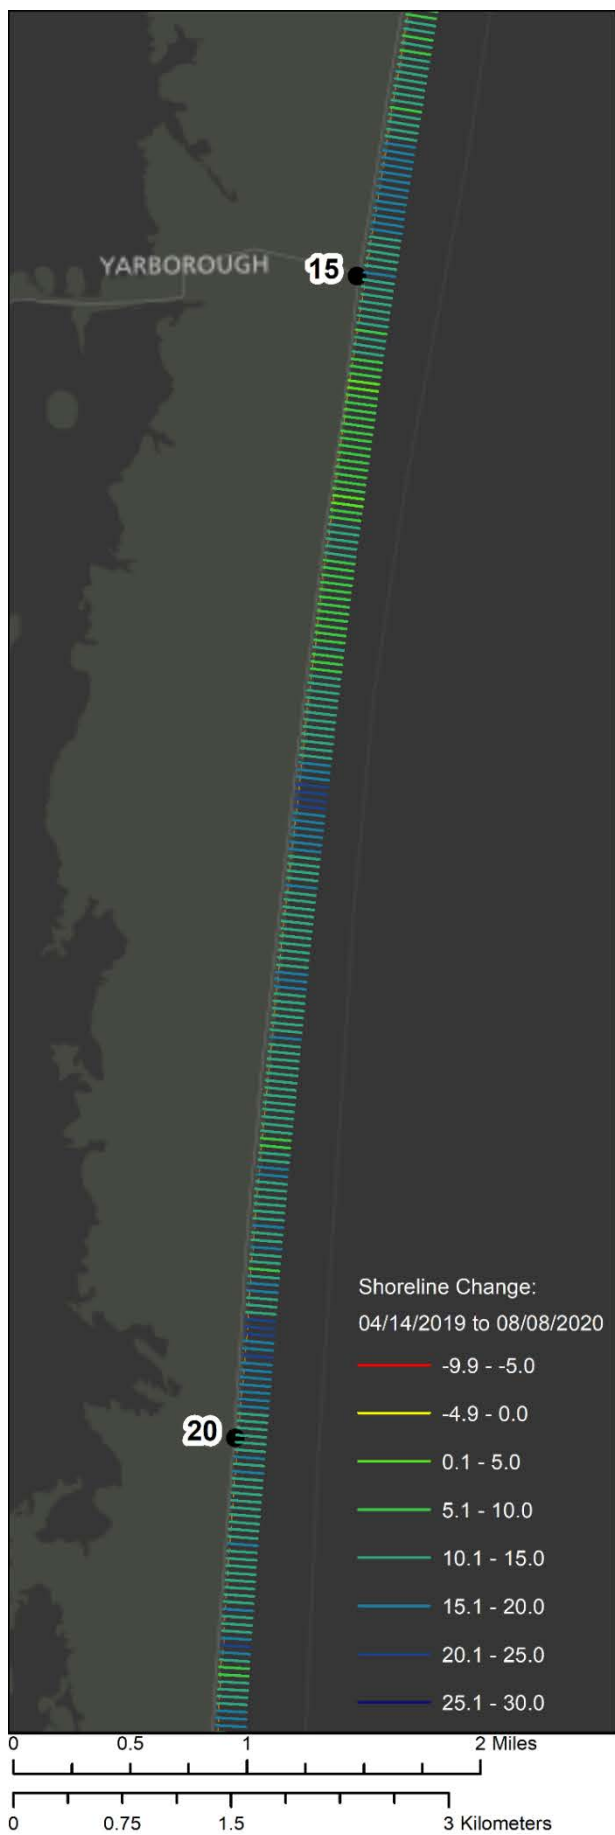
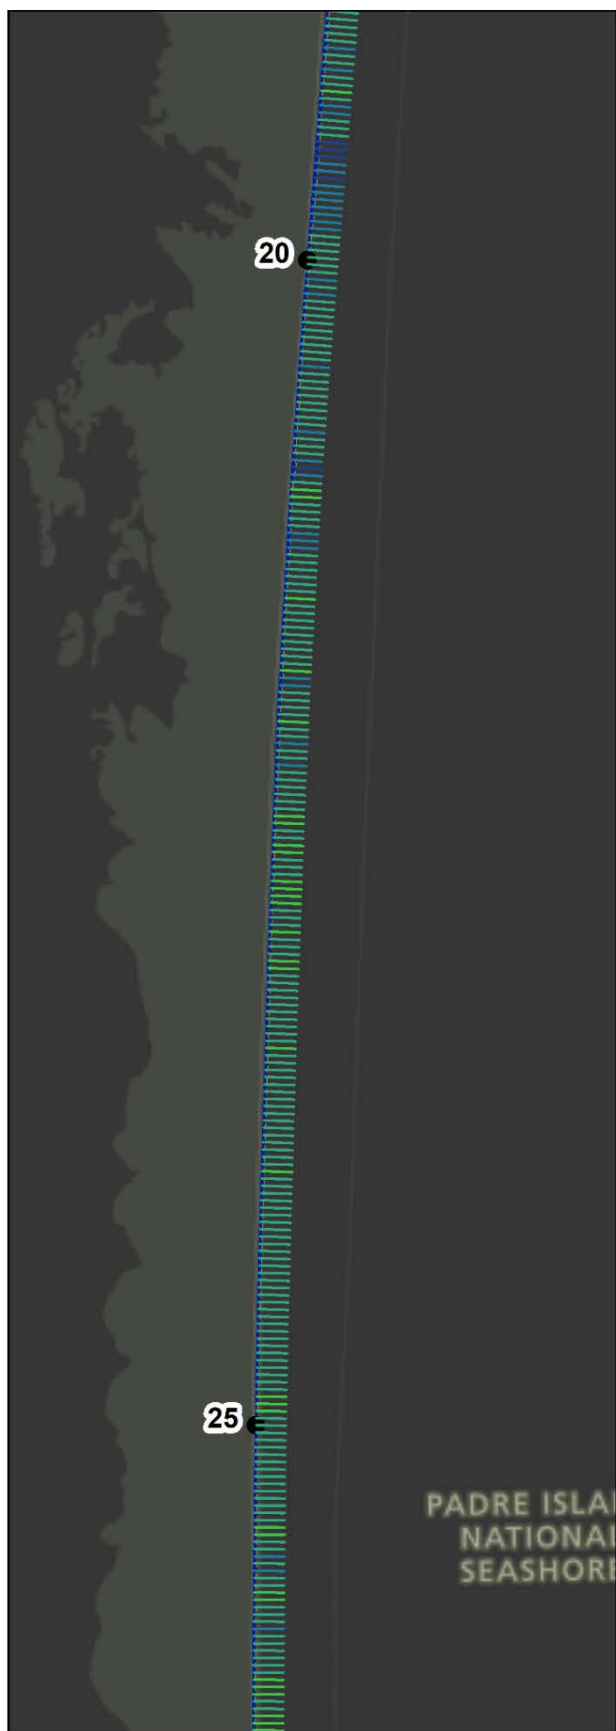
## **Appendix B. Shoreline Displacement Maps**

Maps represent the change in shoreline position between April 2019 and August 2020, following Hurricane Hanna. Displacement is measured in meters and transect colors are scaled from red to blue indicating degree of shoreline retreat or advance.

**Shoreline Position:** Contrary to what many might expect, the shoreline generally advanced seaward. As alluded to in the previous section, this outcome is a result of the collapse of backshore and foredune features, and the subsequent seaward movement of sediment. Summarizing shoreline change in 5-mile groups, advance was greatest on the northern extent of the seashore, the greatest of which occurred between mile markers 0 and 10 (Table 4). The least amount of net advance occurred between mile markers 45 and 50. Only about 6 percent of individual shoreline position transects exhibited retreat, and less than 1 percent of transects retreated more than 5 meters.
