# Emergency Stabilization & Rehabilitation Plan

## CALDWELL FIRE

Lava Beds National Monument, California

**September 2020**

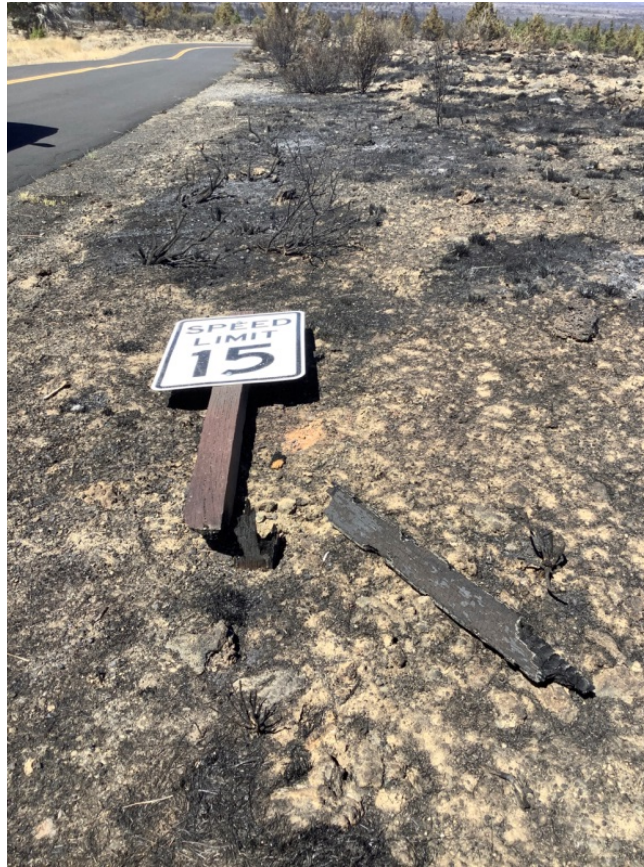
Burned Regulatory Sign along 10 Road

- LABE staff identified 14 regulatory signs that were burned over and need replacement
- The primary road (10 Road) within the monument extends for 17.6 miles; of that, 7.5 miles burned on both sides of the road and 10.1 miles burned on just one side of the road. Thus, fire extends along the entire length of the 10 Road within the monument.

*ES-3, Public Safety and Resource Protection*: This specification addresses the mix of public safety and sensitive resource protection concerns that the burn has created within the park. One piece of this treatment is to simply replace all the regulatory signs that were burned, in-kind. Sign materials and labor cost to install these signs are included.

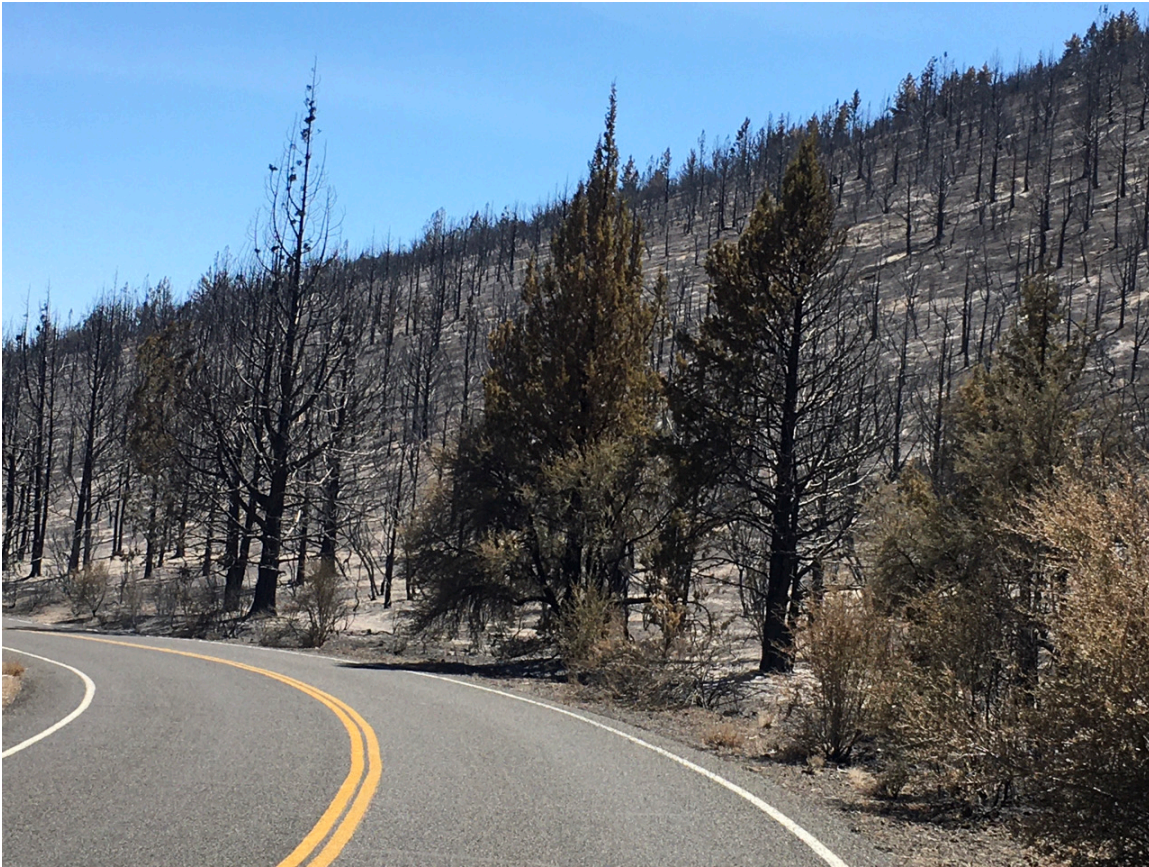
- Caldwell Butte: The BARC map identified “moderate” soil burn severity here, and onsite soil testing places it at most at the “low” end of moderate soil burn severity. The FS soil scientists concluded that some slope movement will occur, which in fact happened on August 11, 2020 during a rain event that dropped 0.17” of rain over a 3-hr period – some soil debris came down the slope and onto the 10 Road below. This indicates that larger rain events will bring material downslope and onto the road, perhaps for up to 3 years. They concluded that due to the lower soil burn severity, herbaceous vegetation will readily grow back on the slope; woody vegetation will likely take longer.

Burned Slope, Caldwell Butte

Finally, the fifth need addressed is to purchase four hazard warning signs that will be placed at each end of the two slope erosion areas of concern – Caldwell Butte and Devil's Homestead/Gillem's Bluff. These signs will warn drivers to be mindful of potential rock and/or debris that may have moved onto the 10 Road following rainfall events before park crews can clear the debris. This need is closely aligned to another specification (*ES-5, Storm Patrol/Road Cleanup*), but is placed here given the similar nature of the work to other pieces of this spec.

This treatment of waiting for storm events to initiate downslope movement of material and then hauling it away is supported by the evolving understanding of successful (or unsuccessful) treatments for hillslopes following fire (Robichaud, et al, 2010), as well as by the recommendations from the two soil scientists who surveyed the Caldwell Butte site.

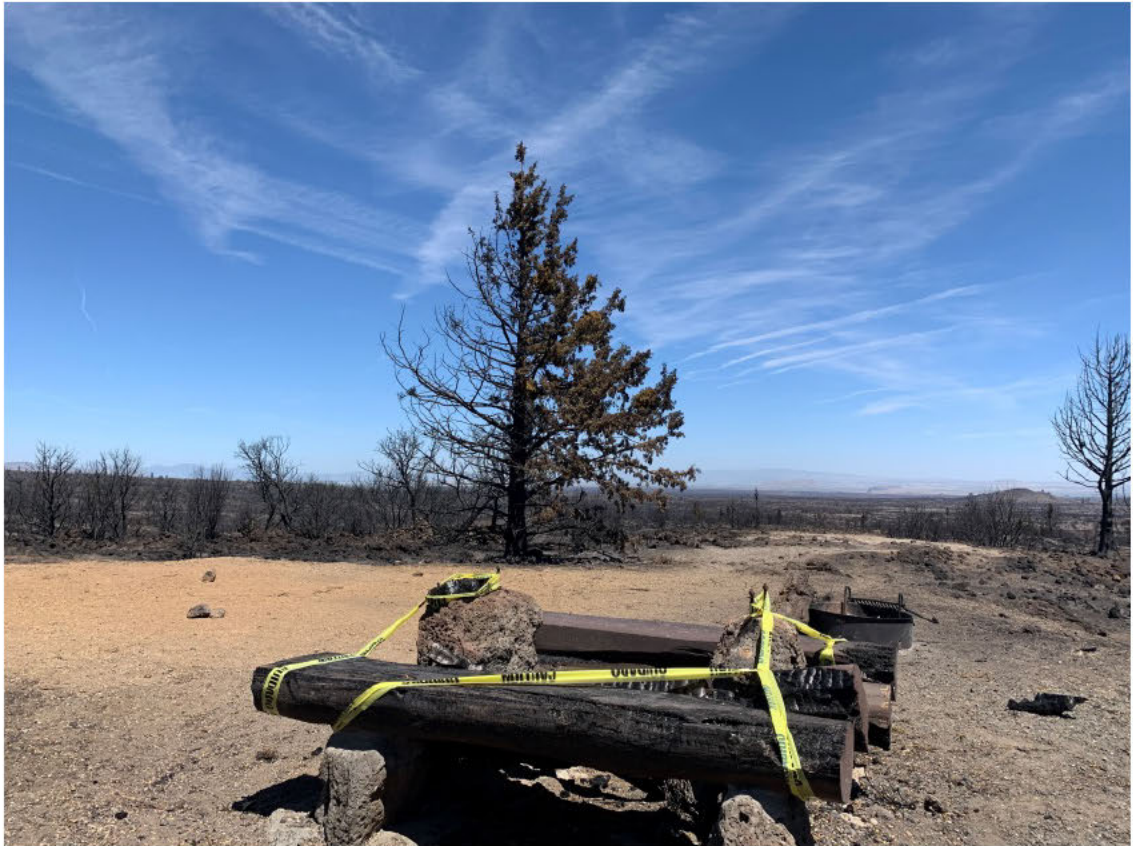
The table below indicates where burned minor facilities were located and generally what the burned facility or asset included. As noted above, the inventory of burned regulatory signs is accounted for in the Public Safety and Resource Protection Assessment, and costs included in the *ES-3 Public Safety and Resource Protection* specification.

**Fire Damaged CCC Picnic Table**

- **BAR-1, Repair/Replace Minor Facilities:** This specification funds the in-kind repair or replacement of fire-damaged minor facilities as appropriate in FY21.
- **BAR-2, Increased Trail Maintenance:** This specification finances an experienced trail crew from Crater Lake National Park (or another NPS unit) to perform increased trail maintenance for up to three years post-fire.

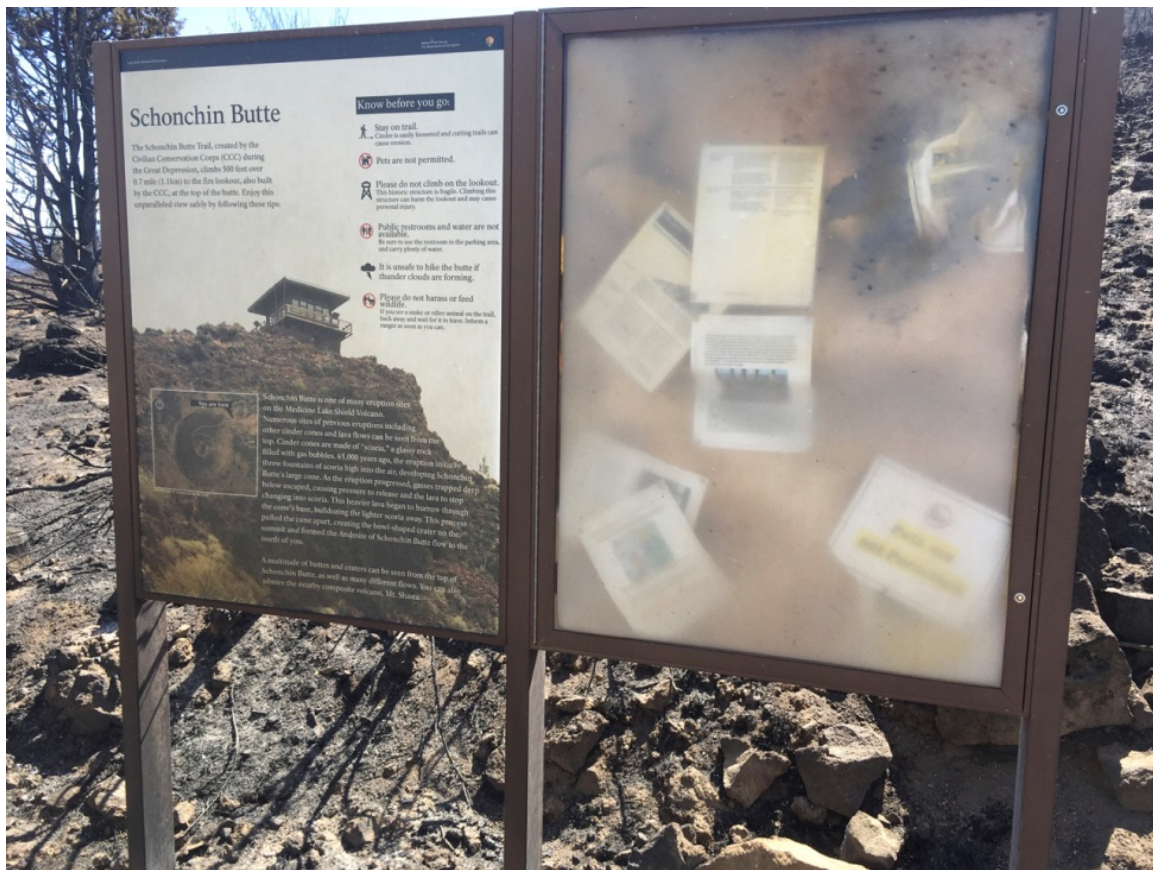
| <b><i>Location</i></b> | <b><i>Facilities or Asset Burned/Damaged</i></b> |
|---|---|
| Schonchin Butte Trail | Interpretive bulletin board at trailhead; wooden benches along trail |

**Schonchin Butte Trailhead Bulletin Board**

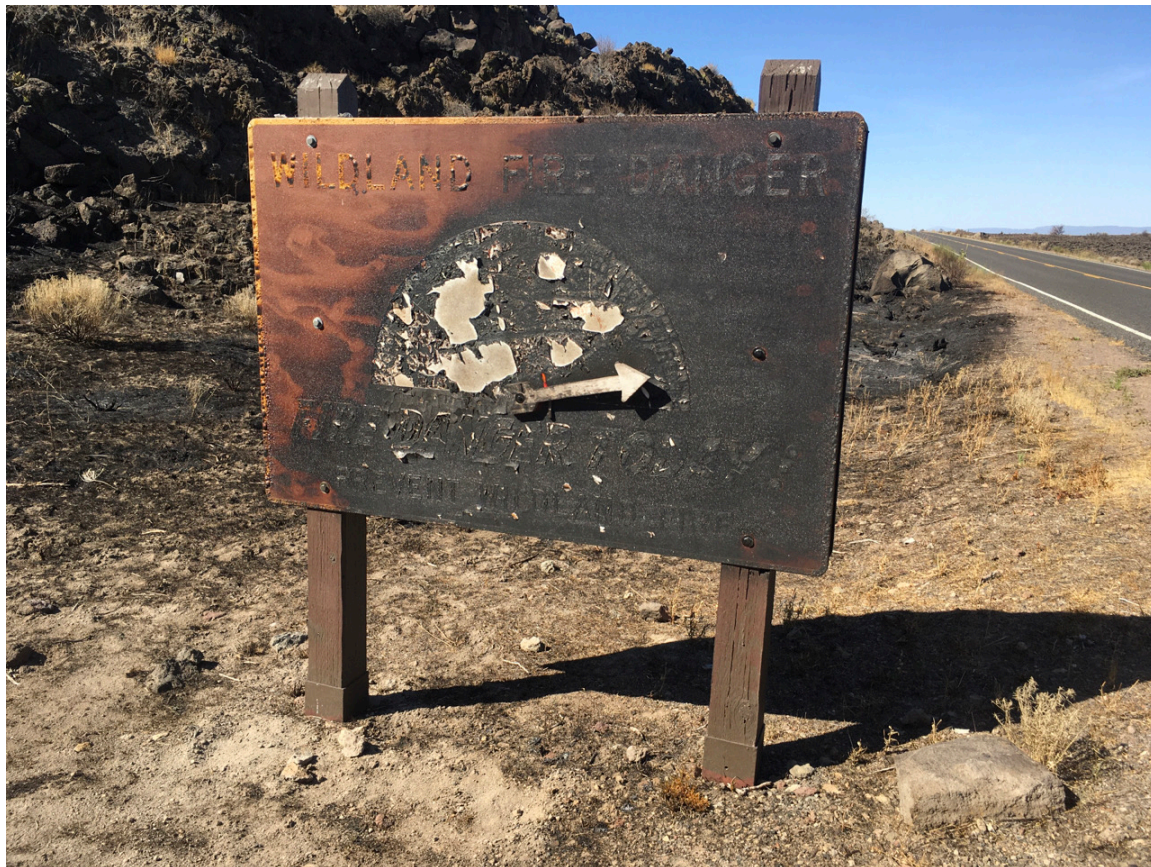
| <b><i>Location</i></b> | <b><i>Facilities or Asset Burned/Damaged</i></b> |
|---|---|
| Gillem’s Bluff | Wildland Fire Danger sign |

**Wildland fire danger sign**
