# COTTONWOOD CREEK FIRE BURNED AREA REHABILITATION PLAN

September 11, 2020

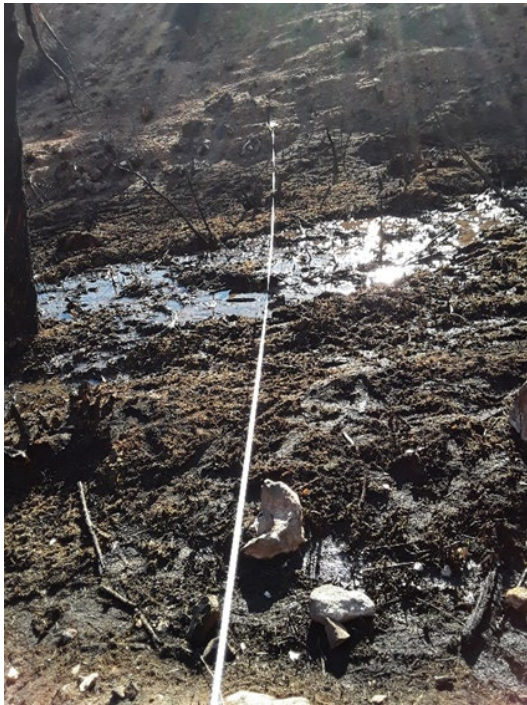
Figure 4. Burned riparian area (02/20/2020)

Based on the BARC, the impacted riparian area experienced low to moderate burn severity. In the riparian zone, 100+ Fremont cottonwood (diameter at breast height (DBH) ranged from 14 cm – 44 cm and tree height ranged from 7.62 m or 25 ft. to 10.36 m or 34 ft.), numerous seep willow, and an unknown number of shrubs, grasses and forbs were killed or damaged by the fire. In late April of 2020, minimal to moderate vegetative regeneration and unstable soils were documented in the impacted riparian zone. Coyote willow (*Salix exigua*), seep willow (*Baccharis emoryii*), dogbane (*Apocynum cannibum*), cattail (*Typha angustifolia*), and sedges (*Carex* spp.) were noted re-sprouting in areas where the burn was less severe; however, cheatgrass and red brome were invading the edge of riparian zone in some areas. On 07/23/2020, rushes (*Juncus* spp.), sedges, reeds, willow (*Salix* spp.) and California redbud (*Cercis orbiculata*) were re-sprouting in the stream reaches with shallow to flowing water (A. Springer, pers. comm., 07/24/2020). In reaches with no flowing water or wet soil, no re-sprouting had occurred and only 5 Fremont cottonwood seedling re-sprouts were documented in the burned riparian zone (A. Springer, pers. comm., 07/24/2020).

To repair and improve lands impacted by the fire, the following stabilization and rehabilitation actions will be implemented in the burned riparian zone: installation of 300 Coyote willow stakes (FY 2021), out-planting of 200 Fremont cottonwood trees (FY 2023), installation of temporary fencing around cottonwood plantings to discourage herbivory by mule deer (*Odocoileus hemionus*) (FY 2023), and invasive non-native plant control (FYs 2021 – 2023). Between 2021 and 2023, the following stabilization and rehabilitation actions will be implemented in the burned upland area: reseeding areas that are prone to erosion or lack natural regeneration (as needed), reseeding species critical to monarch butterfly (*Danaus plexippus*) conservation efforts installation of log erosion barriers on highly erodible slopes (if needed), and invasive non-native plant management focused primarily on annual non-native bromes (e.g. red brome and cheatgrass). Plant materials for rehabilitation and stabilization actions will be collected at nearby source populations containing equivalent habitat types (Mijnsbrugge et al. 2009). Target species for seed collection and reseeding will include species known to compete well with annual non-native bromes such as squirreltail (*Elymus elymoides*) (Stevens et al. 2014), species relatively tolerant to Imazapic such as sideoats grama (*Bouteloua curtipendula*) (Mealor et al. 2013), and species critical to monarch butterfly conservation efforts such as antelope horns milkweed (*Asclepias asperula*) (Nabhan et al. 2015). In addition, reseeding efforts will include shrub species such as fourwing saltbush (*Atriplex canescens*) that can effectively establish through direct seeding.

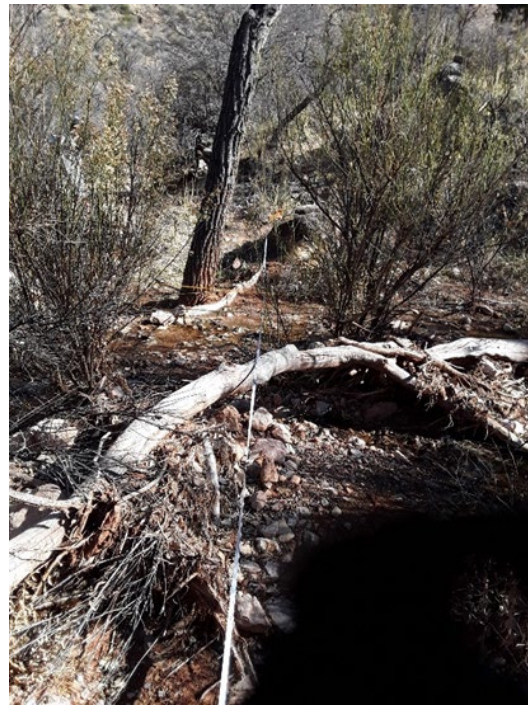
Figure 5. Adjacent unburned riparian area (02/20/2020)

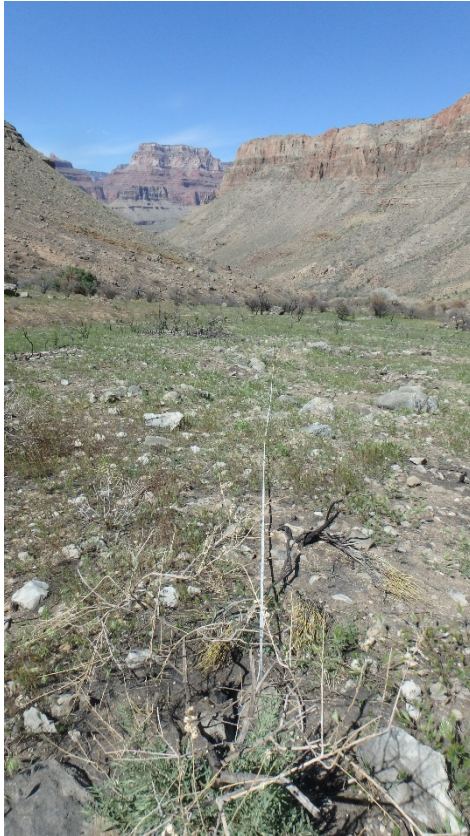
Figure 6. Dense red brome colonization along burned upland area transect # 3 (04/27/2020)

The Cottonwood Creek Fire burn area and adjacent undisturbed lands are at risk of rapid invasion and expansion of cheatgrass, red brome, and other invasive non-native plants. Vegetation monitoring efforts in February, March, and April of 2020 revealed that cheatgrass and red brome were rapidly colonizing the burned upland area, and both species were also detected in the burned riparian zone. On 04/27/2020 and 04/28/2020, red brome (see Figure 6) was observed every 25 cm to 45 cm along burned upland area vegetation transects. Recent data collections confirm that conditions are favorable for rapid invasion and expansion of invasive non-native plants inside and directly adjacent to the burn area. Additional invasive non-native species documented within 0.75 miles of the fire perimeter that are considered medium to high priorities include common sowthistle (*Sonchus oleraceus*) and horehound

Mechanical, chemical, and/or cultural (e.g. seeding grasses that are highly competitive with annual brome species) control methods will be used to treat high priority invasive non-native plant species (NPS 2009) within and directly adjacent to the burn area. Treatments will be implemented in the spring, summer, and/or fall. Treatment will begin in the summer of 2021 and occur annually through 2023. An estimated three to five acres will be treated annually.

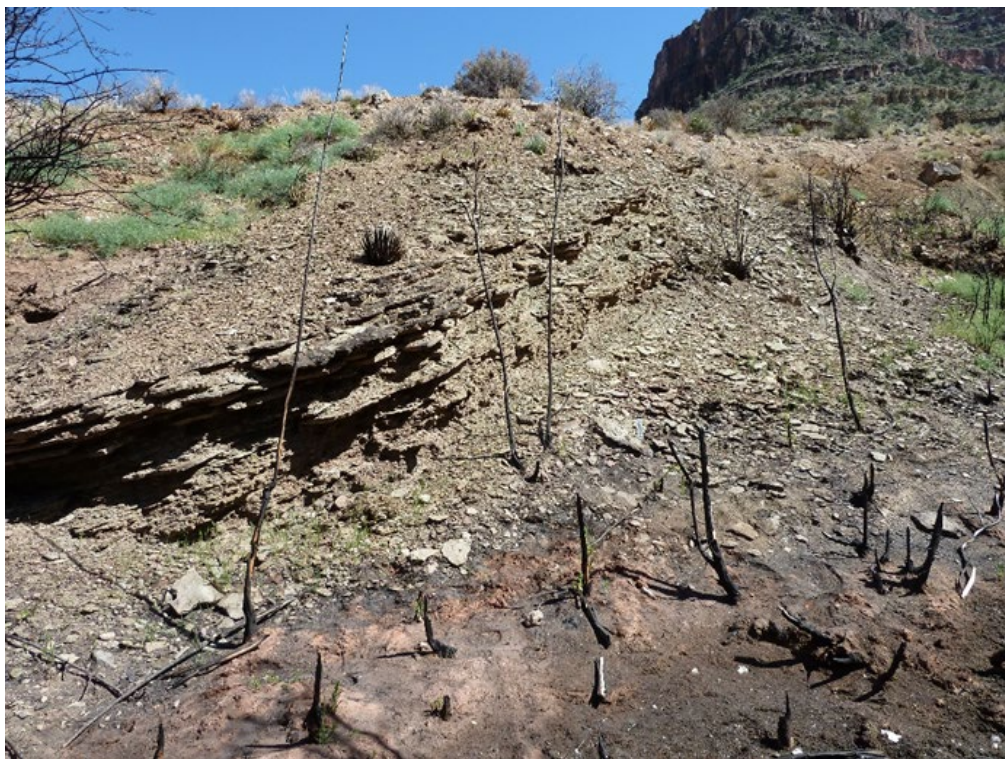
The slopes that come out of the outcrops are unstable, but this is a common characteristic for the Bright Angel Shale. Most of the instability of the slope appears to occur nearest to the creek bed where the sediment has been charred. This area was surveyed most thoroughly for significant fossil specimens. Collection of these specimens was the only mitigation needed. These outcrops could be more thoroughly surveyed on a future monitoring trip for continued exposure and weathered out material, especially for significant fossils like trilobites or other more unique trace fossils.

**Figure 11. First Bright Angel Shale outcrop next to creek**

The Bright Angel Shale is particularly vulnerable to erosion, and this would be exacerbated by a lack of vegetation on burned slopes [REDACTED]

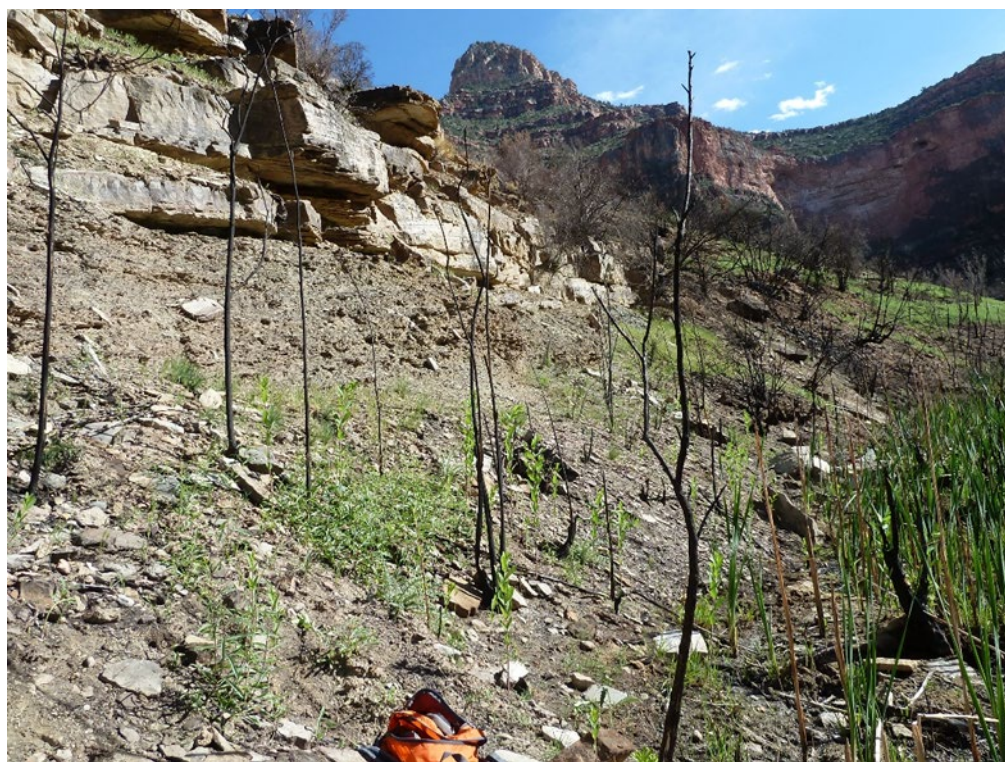
**Figure 12. Second Bright Angel Shale outcrop next to creek.**

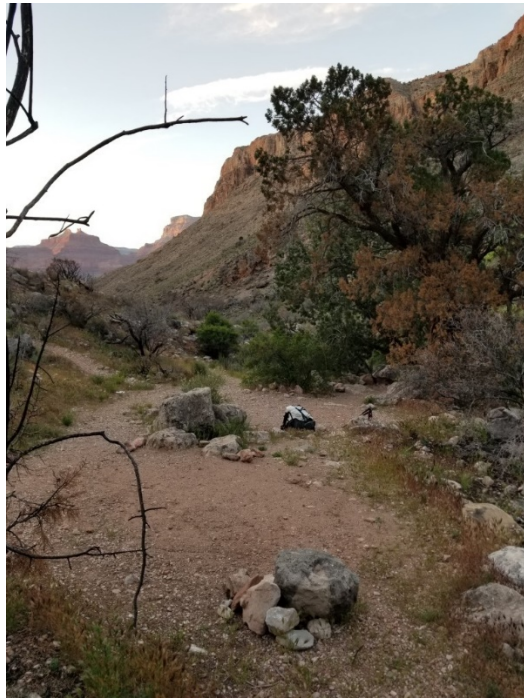
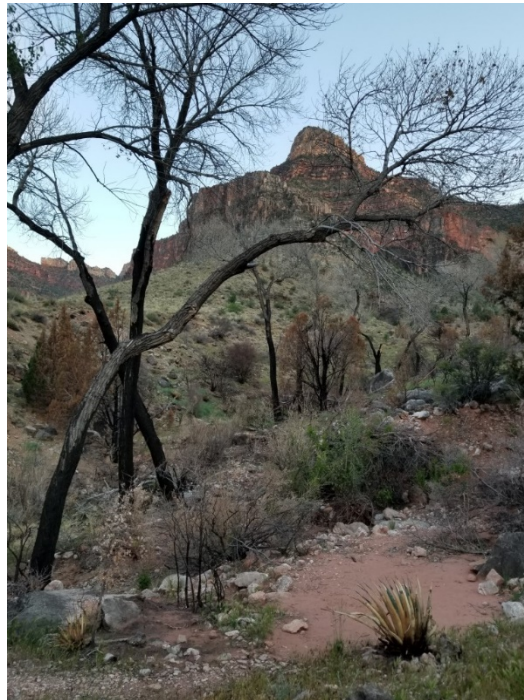
Fig. 17. Cottonwood Creek Use Area BG9\_12 Fig. 18. Cottonwood Creek Use Area BG9\_24

The Use Area was monitored on April 22<sup>nd</sup> and 23<sup>rd</sup> of 2020, where it was found that cores BG9\_12 and BG9\_24 were impacted by this fire. Both are primarily impacted by hazard trees, shown in the photographs (Figures 17 and 18). BG9\_12 is a large core on the west side of the creek and trail. It is partially covered on the south side by a large Utah juniper that appears to be drying out and dying. The north side of the core is framed by a tree and a bush that could easily snap and could be removed. BG9\_24 is a small core approximately 15 meters upstream from BG9\_12. It is directly beneath a dead cottonwood that would pose serious risk to campers. Neither site seems to be impacted by soil stability and would be otherwise be unimpacted if not for the hazard trees and vegetation.

The identified hazard trees near BG9\_12 and BG9\_24 will be assessed and treated as necessary.
