## Emergency Stabilization and Burned Area Rehabilitation Plan

### Cameron Peak Fire

**November 3, 2020**

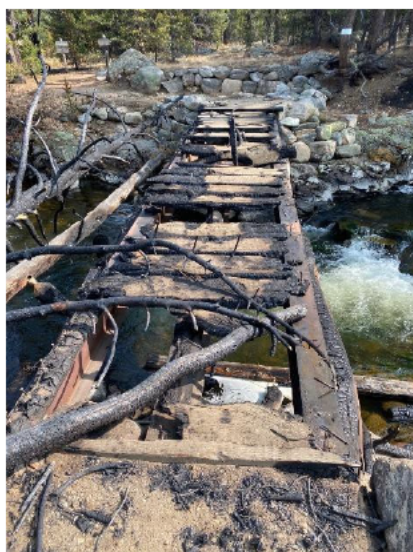
The Corral Creek multi-use bridge was observed to be burned and no longer usable, while the second multi-use trail bridge located in the burned area appeared, from aerial reconnaissance, to

**La Poudre Pass bridge post fire.**

| VAR | ISSUE | Recommendation(s) |
|---|---|---|
| Trails | Bridges | Replace Corral Creek Bridge<br>Spec ES #7 |
