# Spanish-American War Battery Cultural Landscape Report and Environmental Assessment Volume I: Cultural Landscape Report

**Spanish-American War Battery**

**Timucuan Ecological and Historic Preserve**

**Cultural Landscape Report and  
Environmental Assessment**

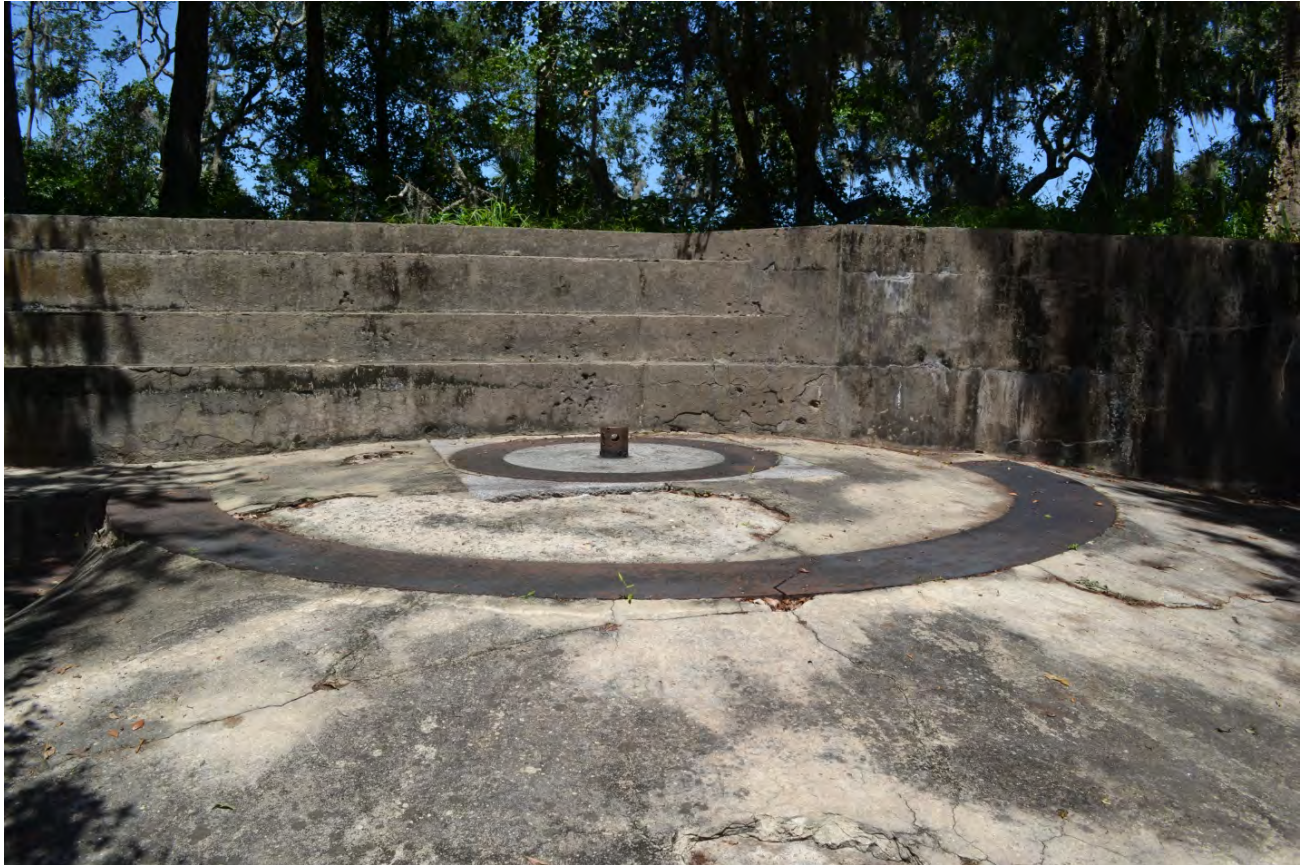
**FIGURE 1.** One of the gun emplacements associated with the Spanish-American War Battery overlooking the St. Johns River near Jacksonville, Florida, 2019. (Source: all photographs by the authors unless otherwise noted)

Spanish-American War of 1898. The battery, which consists of two concrete gun emplacements and a munitions magazine, was built to emplace two 8-inch breech-loading rifles on a strategic river bluff to protect Jacksonville, Florida, from naval attack (Figure 1). Following the end of the conflict, the battery was decommissioned, and the guns were sent to Pensacola.<sup>1</sup> The concrete battery

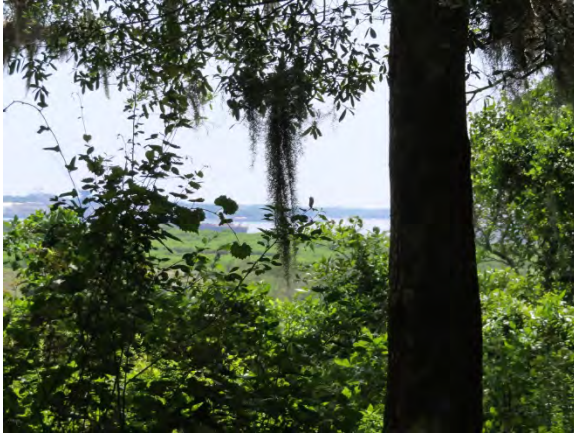
**FIGURE 2.** Views from the top of the bluff adjacent to the Spanish-American War Battery to the St. Johns River are partially blocked by woody vegetation, 2019.

At the top of the bluff, views to the St. Johns River are recommended to be reestablished and maintained as open and clear of woody trees and shrubs at eye level. At the same time, a protective barrier is recommended at the top of the bluff to protect visitors from accessing the steep and dangerous slope. The intended character proposed for the barrier would have a limited visual effect on the historic property.

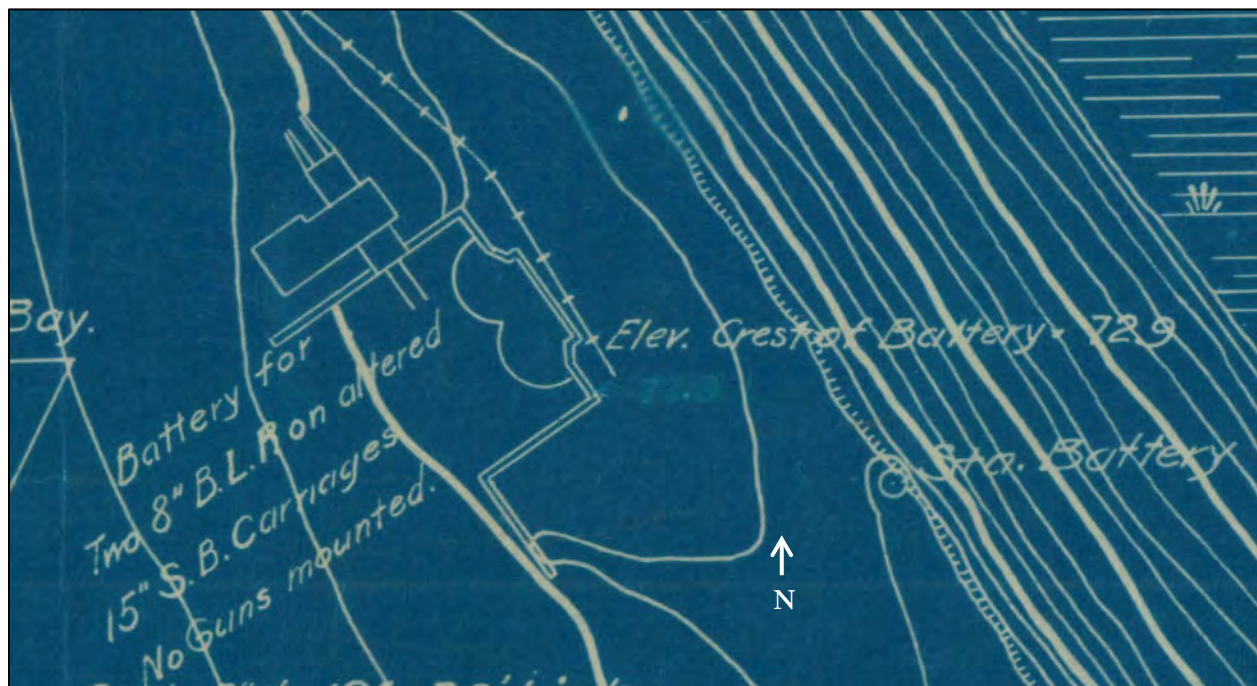
**FIGURE 14.** Layout of Spanish-American War Battery and bombproof magazine in December 1899. (Source: Benyaard, 1899 [March])

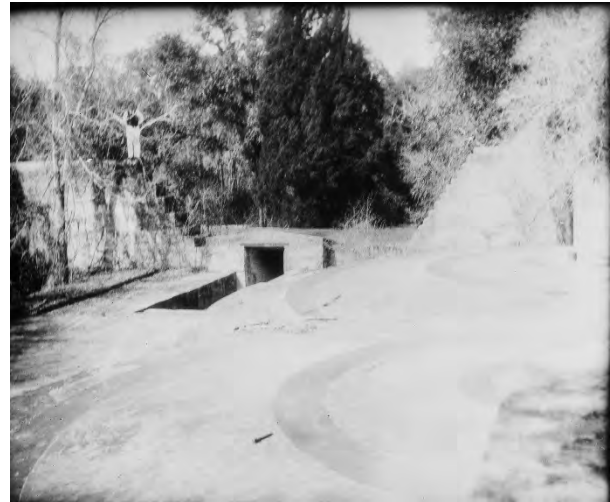
**FIGURE 22.** Spanish-American War Battery, St. Johns Bluff in 1934. (Source: HABS FL-15-2)

The Historic American Buildings Survey documented the Spanish-American War Battery in 1934 (Figure 22 and Figure 23).<sup>254</sup> Two additional photographs of the battery were taken circa 1940 (Figure 24 and Figure 25). These photographs capture the pre-World War II conditions of the battery and the surrounding tree cover. On August 18, 1943, the St. Johns Bluff – Fort Caroline, Inc., acquired the military reservation.<sup>255</sup> No development had occurred within the military reservation during first period of private ownership. A 1943 aerial photograph of St. Johns Bluff shows a northeast-southwest road (current Fort Caroline Road) extending from the northeast corner of the bluff to the main road to the south (Mt. Pleasant Road, Figure 26).<sup>256</sup> The Spanish-

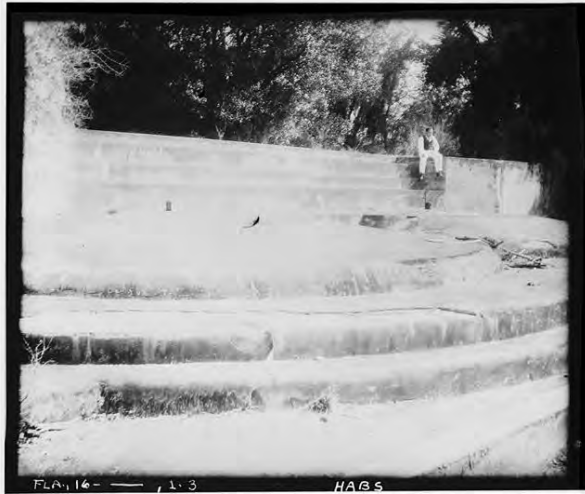
**FIGURE 23.** Spanish-American War Battery, St. Johns Bluff in 1934. (Source: HABS FL-15-2)

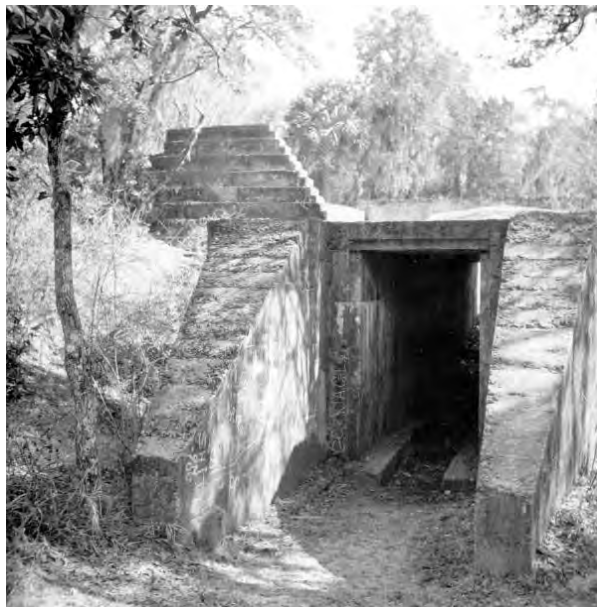
**FIGURE 24.** Magazine of the Spanish-American War Battery, St. Johns Bluff circa 1940. (Source: State Archives of Florida)<sup>257</sup>

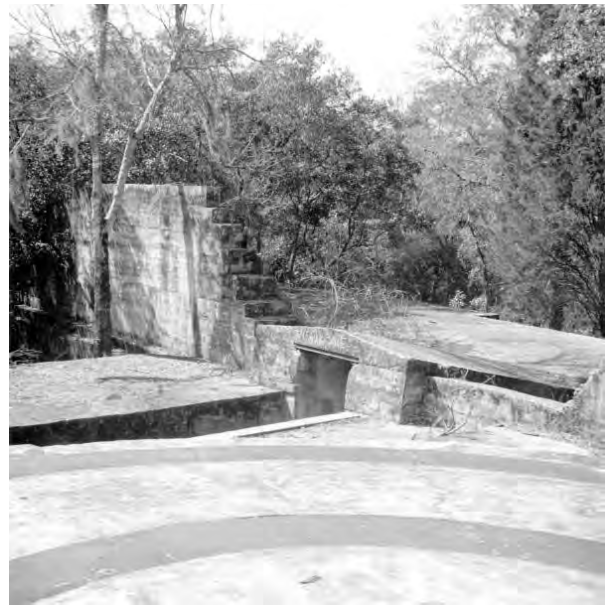
**FIGURE 25.** Spanish-American War Battery, St. Johns Bluff circa 1940. (Source: State Archives of Florida)<sup>258</sup>

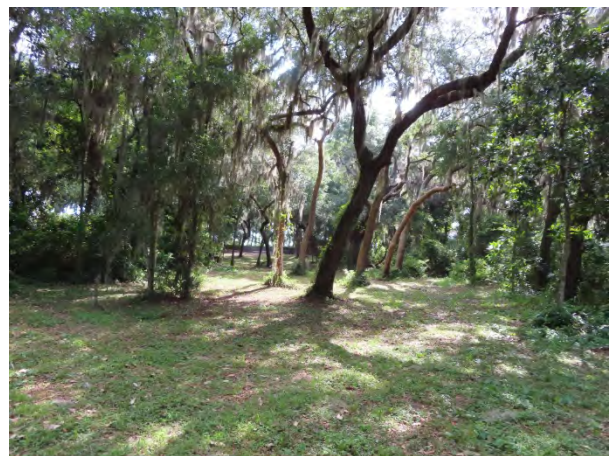
Most of the property is wooded (Figure 38). Mature live oak (*Quercus virginiana*) trees cast dappled shade over the land as it slopes upward to the northeast toward the concrete gun emplacement platform and other features of the Spanish-American War Battery located near the top of the bluff. Also found on the property are

**FIGURE 38.** Wooded character of the Spanish-American War Battery parcel.

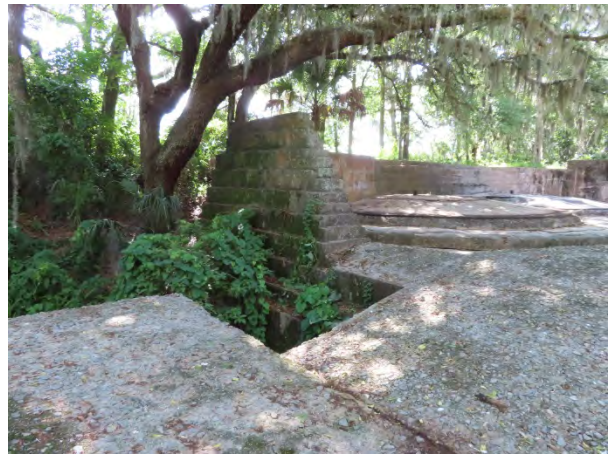
The battery is composed of the concrete gun emplacement platform, which measures approximately 170 feet in length and is 7 feet 7 inches tall, edged to the north and east by retaining walls. Two iron gun mounts face the northeast elevation 23 feet apart. To the northwest of the gun emplacement is a partially buried concrete magazine that contains two large rooms and a tunnel providing access into the space from the gun emplacement platform (Figure 39). The tunnel continues past the rooms to the west to an arched entrance or exit (Figure 40).

**FIGURE 39.** View northeast toward the gun emplacement platform of the Spanish-American War Battery from the magazine.

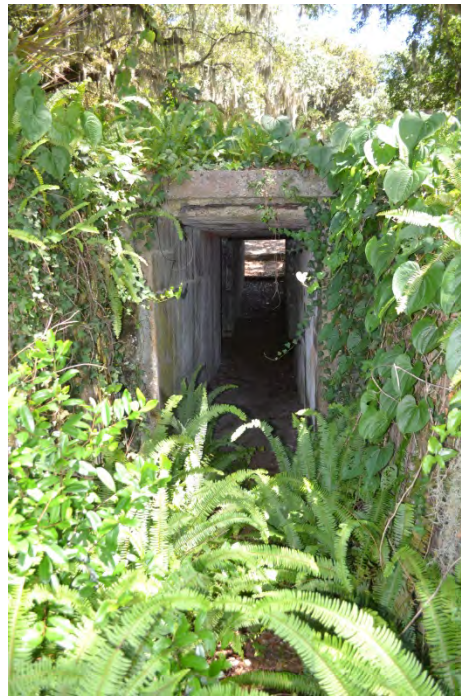
**FIGURE 40.** View northeast of the tunnel leading to the Spanish-American War Battery from the adjacent residential property.

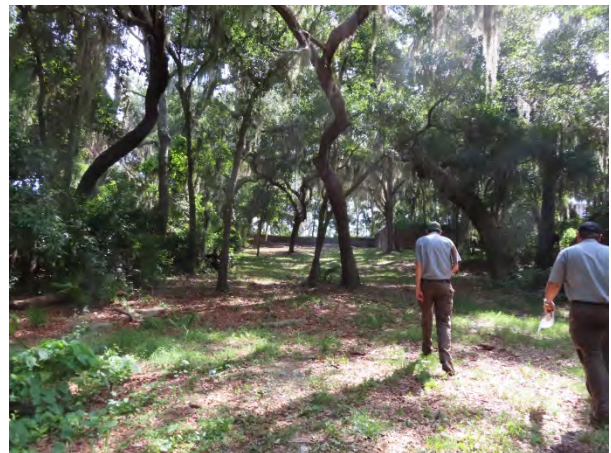
**Gently sloped landform rising to St. Johns Bluff.** From the property boundary along Fort Caroline Road to the concrete structure of the Spanish-American War Battery, the topography of the parcel rises steadily yet gently at a slope of approximately 3 percent near the road, and 8 to 10 percent as it approaches the battery structure (Figure 42). The concrete gun emplacement platform is set at the base of a concrete retaining wall set near the apex of St. Johns Bluff with an elevation at the southwestern side of approximately 60 feet AMSL and at the northeastern side of approximately 70.6 feet AMSL.

**FIGURE 42.** The topography of the Spanish-American War Battery parcel slopes gently upward between Fort Caroline Road and the concrete gun emplacement platform.

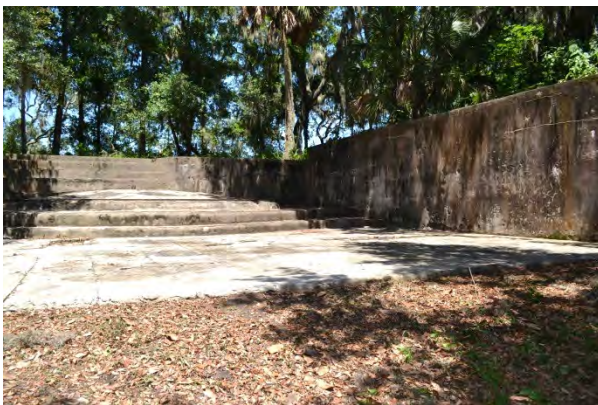
**Spanish-American War Battery structure built into the bluff.** The Spanish-American War Battery is generally rectangular in form and is sited parallel to the bluff. The structure is set below the brow of the hill behind a concrete retaining wall (Figure 43). The wall was designed to protect the guns of the battery from view from the river while allowing for the guns to be raised and fired over top of the wall toward an approaching enemy.

**FIGURE 43.** The concrete gun emplacement platform of the Spanish-American War Battery is set below a concrete retaining wall set into the slope near the top of the bluff.

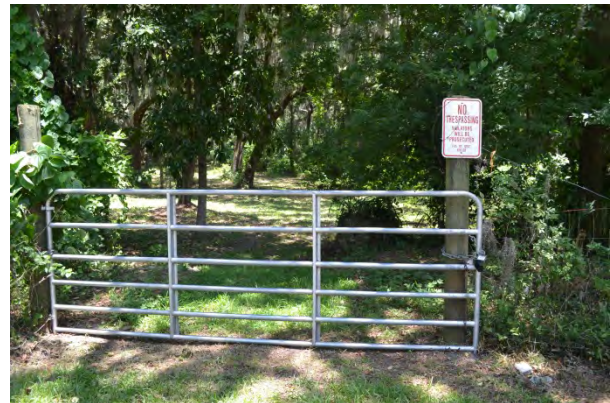
**Access to the Spanish-American War Battery from Fort Caroline Road.** Entry into the Spanish-American War Battery property occurs via a metal gate set within the fence that marks the boundary along Fort Caroline Road (Figure 44). The gate is locked to discourage trespassing. There are no roads or paths within the property.

**FIGURE 44.** Access to the Spanish-American War Battery occurs via a metal gate set within a fence along the property boundary at Fort Caroline Road.

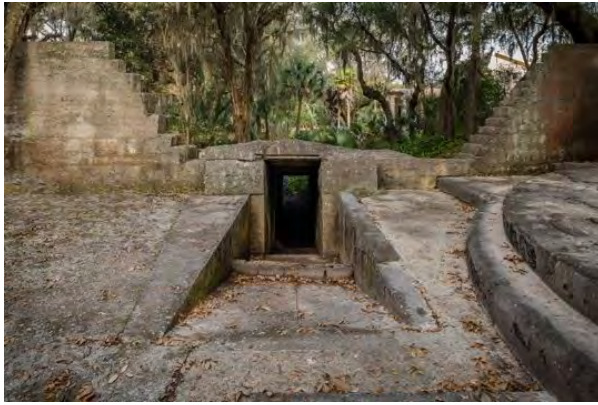
**Tunnel leading between the gun emplacement platform, the magazine, and the west entrance.** A concrete tunnel connects the concrete gun emplacement platform behind the two gun emplacements with the covered interior of the magazine to the west (Figure 45). The tunnel also leads to an arched opening that serves as a western entrance or exit to the battery that closely abuts the residential property on Lot 32.

**FIGURE 45.** The Spanish-American War Battery contains a concrete gun emplacement platform and a concrete magazine. A concrete tunnel links the two features and continues to a western arched opening.

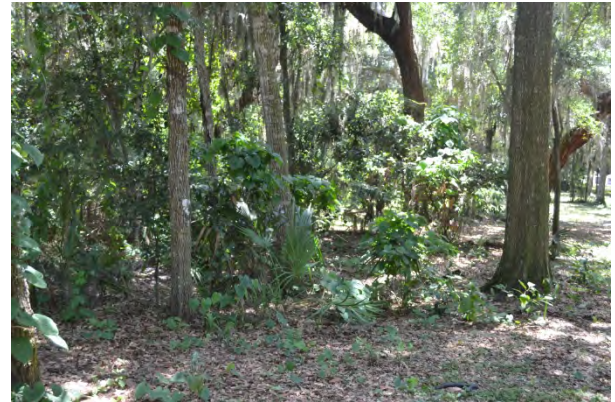
**FIGURE 46.** A hammock woodland community dominated by live oak trees characterizes much of the Spanish-American War Battery property.

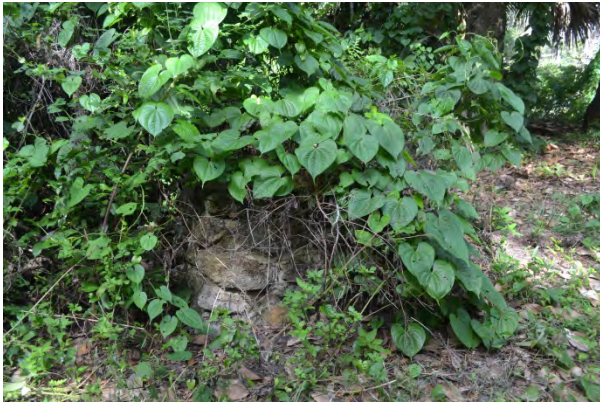
**FIGURE 47.** Air potato vine growing on one of the masonry columns at the Spanish-American War Battery property.

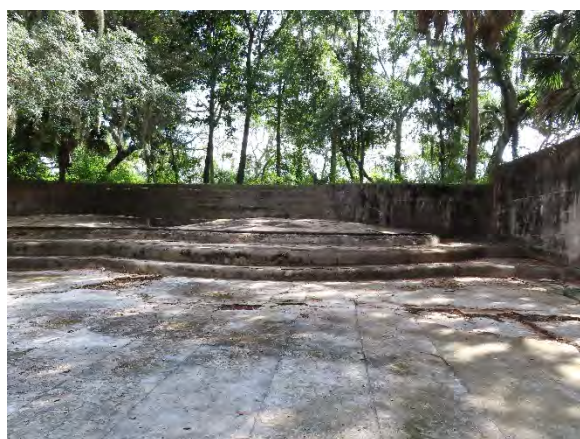
The battery consists of a concrete magazine to house ammunition; pylons; two concrete gun emplacement platforms; a concrete parapet; and a concrete traverse wall (Figure 48 through Figure 52). The base concrete used to construct the battery features a large granite aggregate. On exposed surfaces, the concrete walls are covered with a 3/8-inch-thick cementitious layer with fine aggregate. A concrete topping approximately 1/2 inch thick, with fine aggregate and a smooth finish, is present over most of the slabs and horizontal surfaces.

**FIGURE 48.** Overall view of the gun mounts and parapet wall.

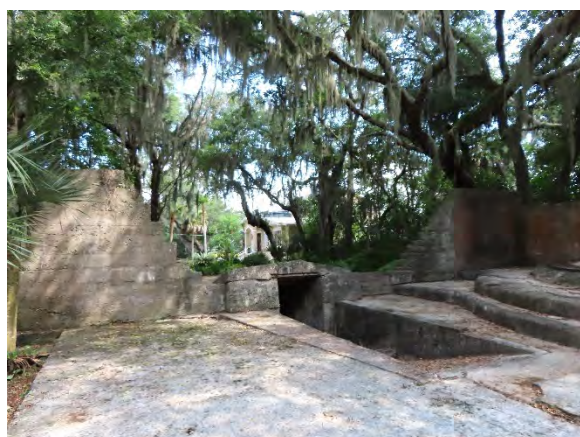
**FIGURE 49.** The ramp leading down to the battery's magazine. Note the major and minor pylon visible in this photo.

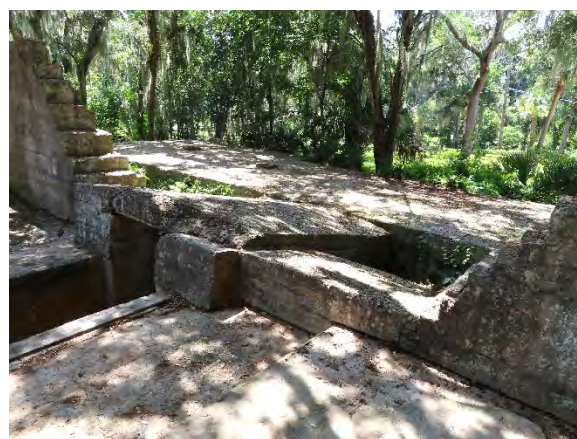
**FIGURE 50.** A view of the magazine from one of the gun platforms.

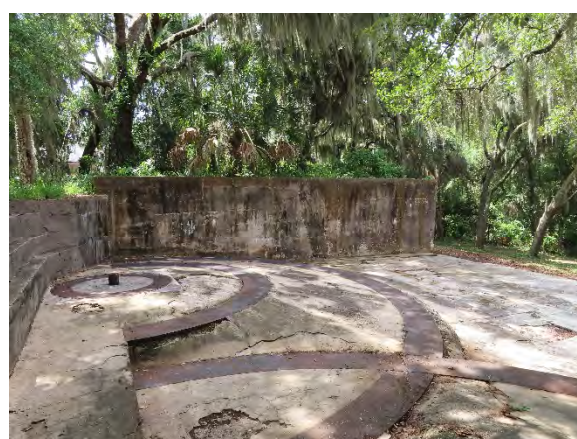
The southeast side of the battery has a traverse wall approximately 50 feet in length running southwest to northeast. The wall turns to the southeast and continues 43 feet, near the edge of the concrete slab.

**FIGURE 51.** A view to the southeast of the traverse wall and a gun platform.

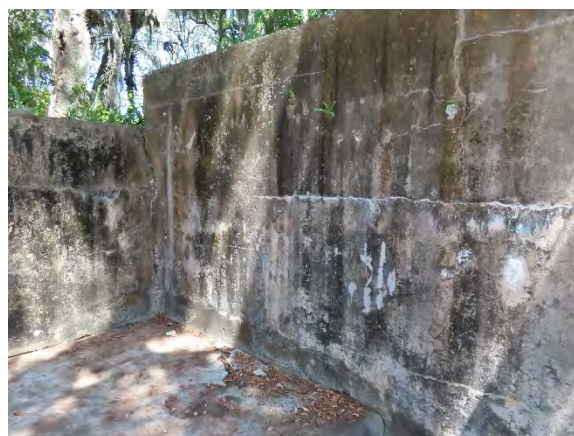
**FIGURE 53.** Horizontal cracks at cold joints in the traverse wall. Vertical cracking and efflorescence are also visible.

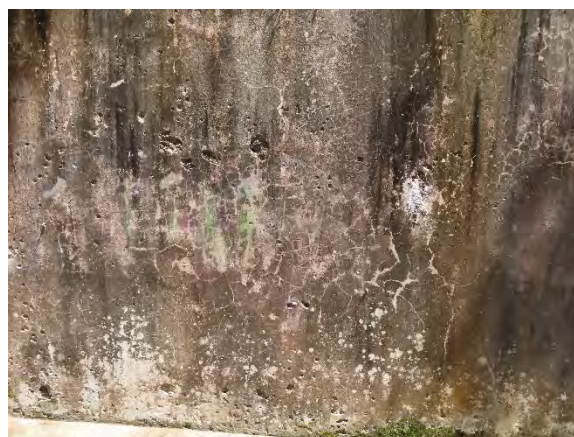
**FIGURE 54.** Map cracking in the traverse wall and efflorescence.

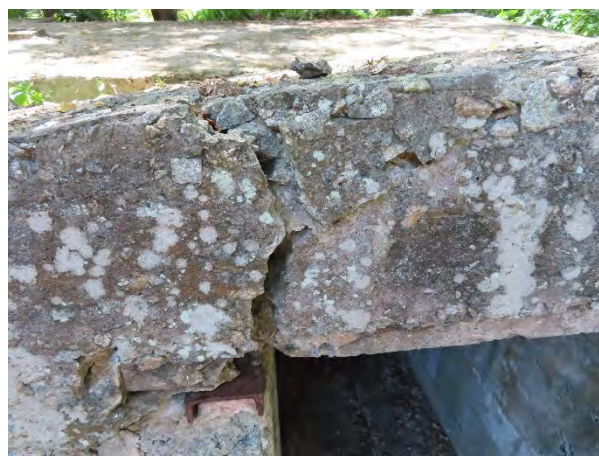
**FIGURE 55.** Cracks at the roof of the ramp leading to the magazine. Also visible is the corroded iron channel.

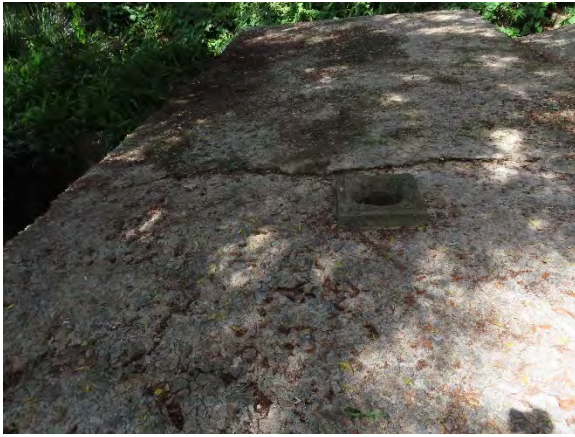
**FIGURE 56.** A large crack extending along the roof of the magazine. Also visible is the vent shaft located in the roof.

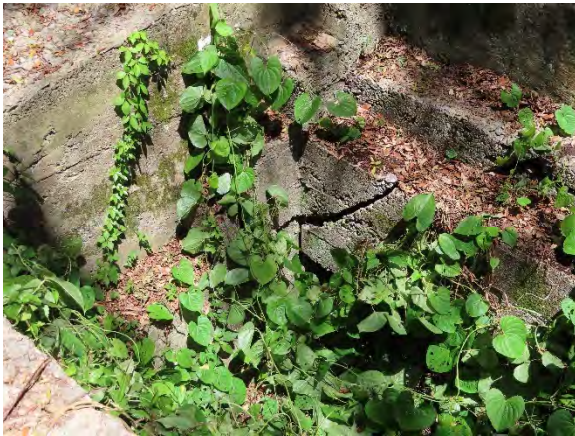
**FIGURE 57.** A crack observed in the base of the major pylon as seen from the roof of the magazine.

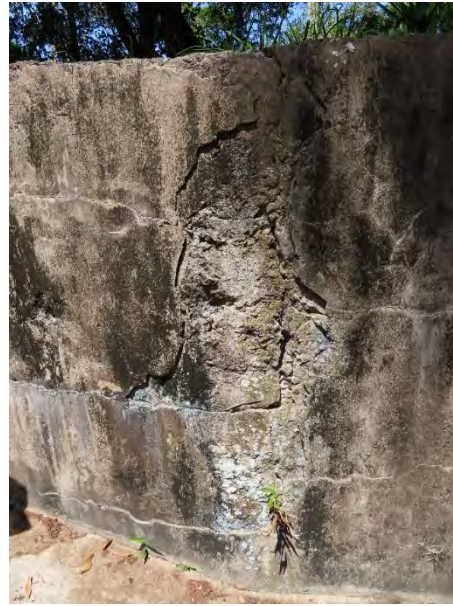
**FIGURE 58.** A large spall in the wall of the parapet.

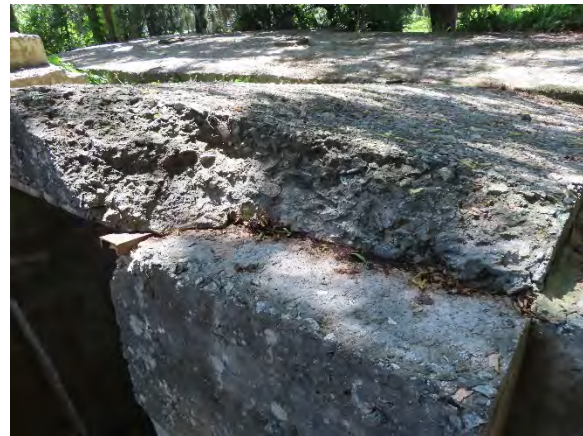
**FIGURE 59.** A large spall observed at the corner of the roof of the ramp leading to the magazine.

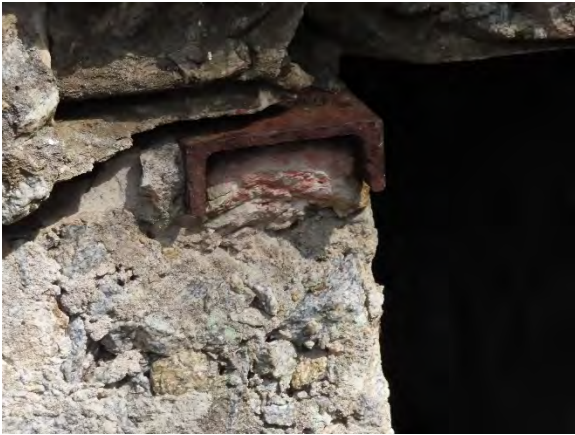
**FIGURE 60.** Corroded channel at the southwest side of the roof of the ramp to the magazine. Staining of the concrete is also visible beneath the channel.

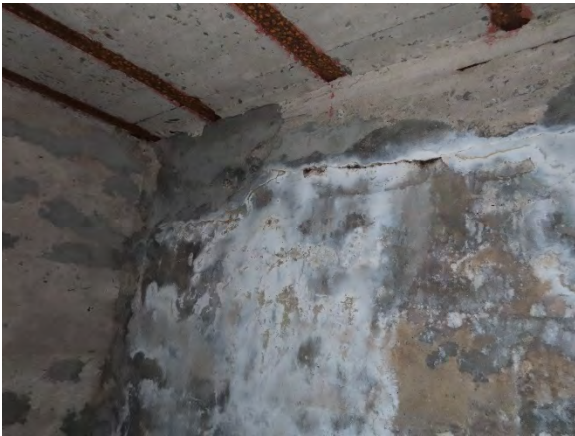
**FIGURE 61.** Efflorescence on the interior of the magazine. Corrosion of the exposed reinforcing in the ceiling is also visible.

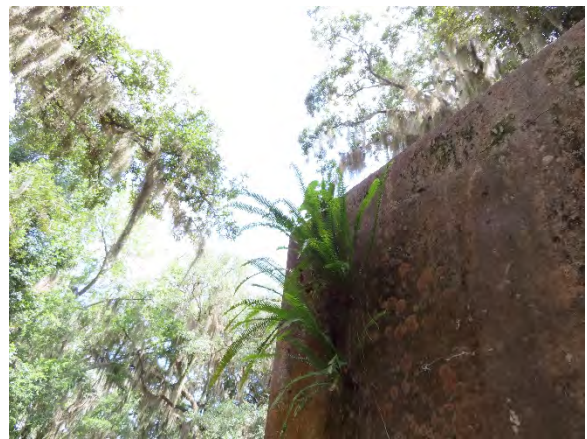
**FIGURE 63.** Vegetation growing through a crack in the traverse wall.

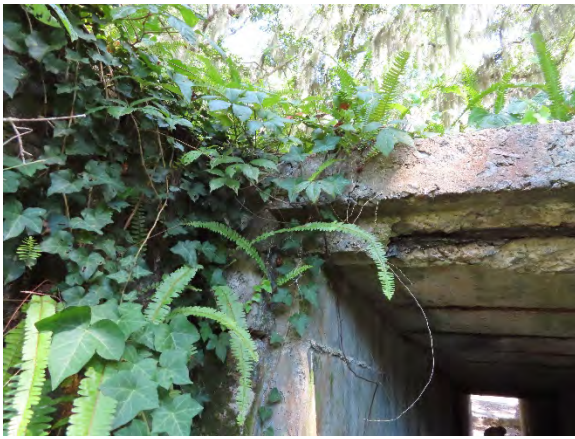
**FIGURE 64.** Vegetation growing over the entrance to the magazine.

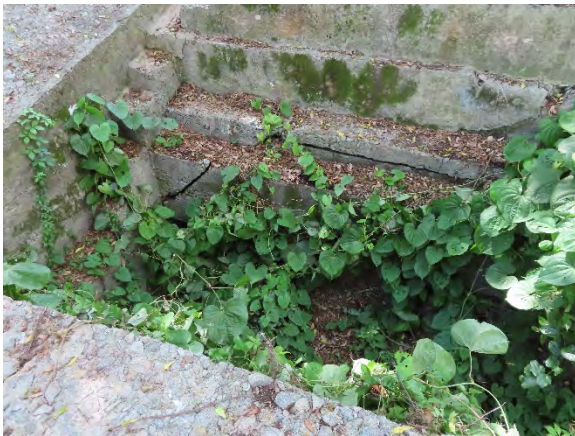
- At the northwest entrance to the magazine, vegetation was observed growing from the cracks in the roof and walls (Figure 64).
- Moss and other vegetation were observed on the major and minor pylons (Figure 65).
- Plants were growing in the vertical cracks along the exterior of the magazine. Biological growth was present in various areas of the battery on the surface of the concrete. The growth varied in color from green and orange to black (Figure 66).

**FIGURE 65.** Organic growth present on the surface of the major pylon.

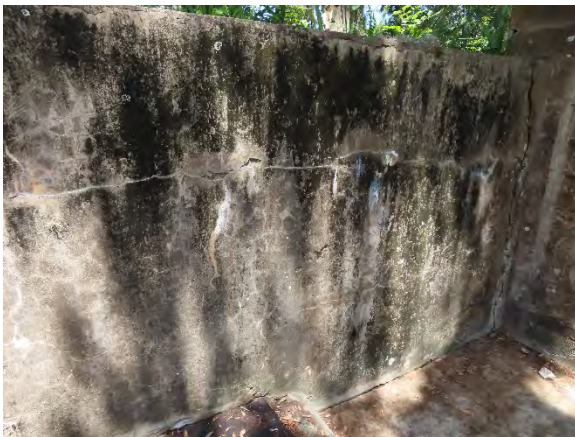
**FIGURE 66.** Darker organic growth on the parapet wall.

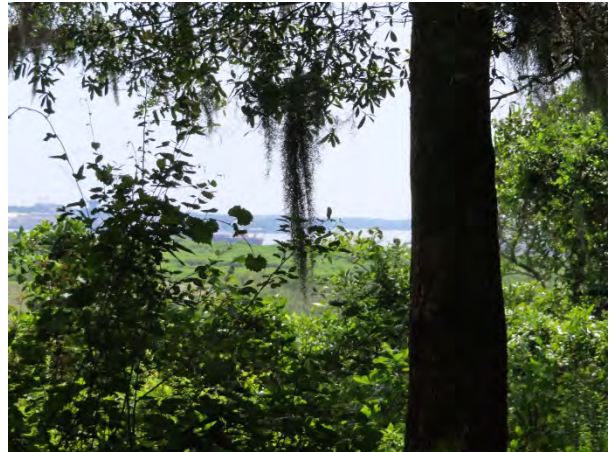
From the elevated position of the bluff north of the battery, long views are afforded to the St. Johns River beyond. These views are becoming increasingly obscured by woody growth associated with the top of the bluff and steep slopes below (Figure 67).

**FIGURE 67.** Generally expansive view from St. Johns Bluff north of the Spanish-American War Battery now filtered by trees and shrubs.

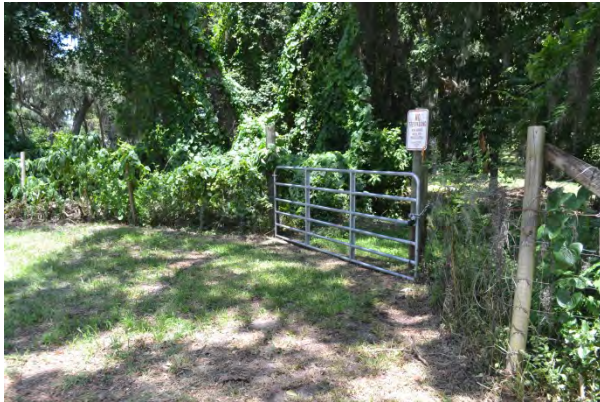
**Boundary fence and gate.** The property's southwestern boundary is marked by a wooden post and wire fence that extends to the adjacent residential properties (Figure 69). At the eastern end, the fence is 14 feet from the margin of Fort Caroline Road. The fence then jogs north, after which it follows a line that is 31 feet from the edge of the road. A tubular metal gate is in the section that lies further from the road. Wood posts supporting the fence measure 5 feet in height. Steel boxwire and strands of barbwire are nailed to the posts. The gate measures 11 feet 8-1/2 inches in length. It is supported by an 8-inch post at the left end; another 8-inch post at the right end is used to lock the gate with a metal chain. The gate is 4 feet 2 inches in height.

**FIGURE 69.** View of the entrance gate and post and wire fence marking the Spanish-American War Battery property boundary along Fort Caroline Road.

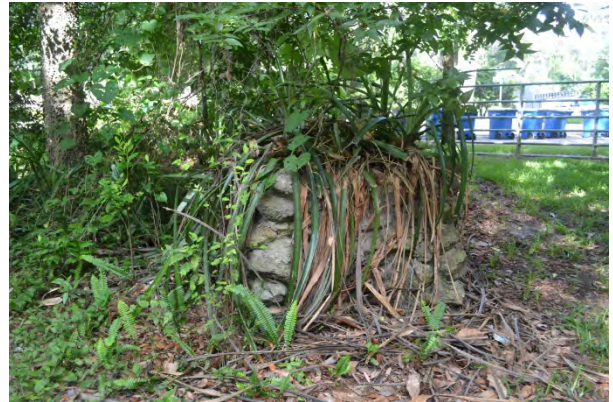
**Masonry columns (2).** Two masonry columns sit just inside the property boundary north of the fence along Fort Caroline Road. The columns are mortared rubble fieldstone and of marginal construction quality (Figure 70). The column to the east measures 2 feet in height and 3 feet by 3 feet 6 inches in plan. The column to the west measures 2 feet 6 inches in height and is 3 feet 6 inches square in plan. Yucca plants are growing within one of the columns.

**FIGURE 70.** One of the two masonry columns located near the property boundary along Fort Caroline Road.

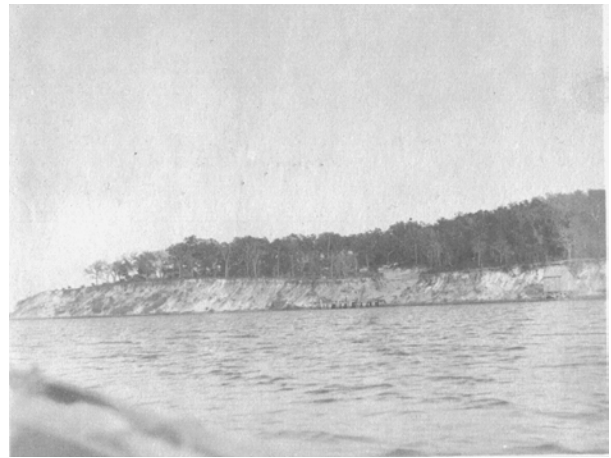
Two photographs looking toward St. Johns Bluff circa 1900 provide information about the character of the landscape around the time the guns were mounted at the Spanish-American War Battery. The photograph taken from farther away (Figure 77) shows the slope of the bluff generally denuded of woody vegetation with a dense stand of trees growing on top of the bluff. Although the tree species cannot be determined from the photograph, the stand appears relatively well-established and mature. Most of the trees are in leaf, but some are not, suggesting that the photograph was taken in winter and that there were both deciduous and evergreen trees present on the bluff. The second photograph, taken closer to the shoreline (Figure 78), similarly shows the slope of the bluff covered with low-growing woody vegetation and grasses. A stand of mature trees is visible atop the bluff, although many of the trees appear to have been cleared to the east (left) in the photograph, likely reflecting efforts to prepare the battery sites.

**FIGURE 77.** Circa 1900 photograph of St. Johns Bluff from the St. Johns River. The photograph shows a dock and a cut in the bank of the river near the center of the image where a rail line was established to convey construction materials to the top of the bluff for construction of the Spanish-American War Battery. To the right is a possible mine field terminal to the right. (Source: State Library & Archives of Florida)<sup>337</sup>

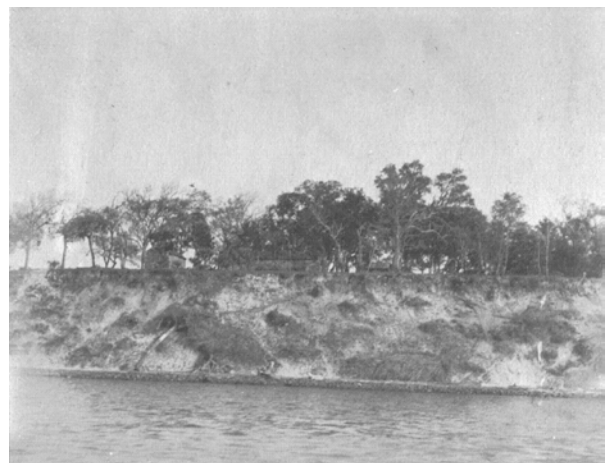
**FIGURE 78.** Circa 1900 photograph of St. Johns Bluff and the military reservation associated with the Spanish-American War Battery from the river. Buildings erected to support the project are visible, along with riprap placed along the river shoreline to protect against erosion. (Source: State Library & Archives of Florida)<sup>338</sup>

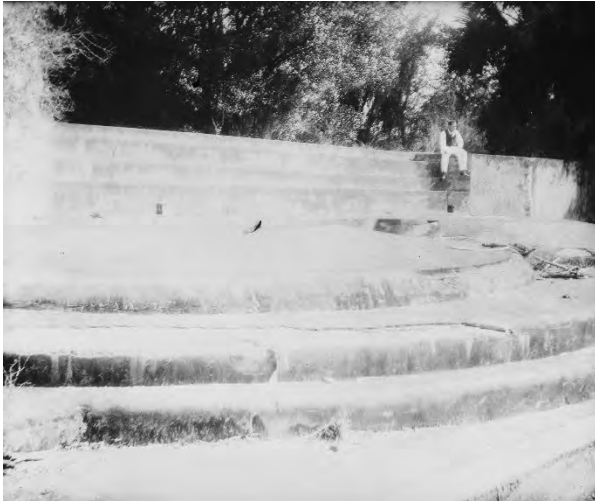
Little else is known about vegetation on the bluff at the time the battery was constructed. No additional information exists regarding the character or composition of vegetation during the early twentieth century prior to photographs taken as part of the 1934 HABS documentation effort. Although the landscape appears more open in 1934 than it is today in 2021, the photographs suggest the battery setting was generally wooded. Eastern red cedar and live oak trees can be identified in the photographs (Figure 79 and Figure 80).

**FIGURE 79.** View northwest toward the battery showing the wooded nature of the top of the bluff beyond, 1934. (Source: HABS)

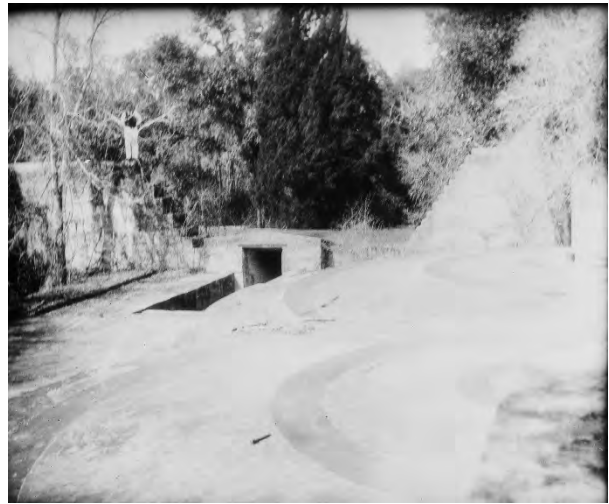
**FIGURE 80.** Photographic view of the Spanish-American War Battery in 1934 showing trees edging the structure. The evergreens visible are likely eastern red cedar trees. (Source: Library of Congress, 052286pu)

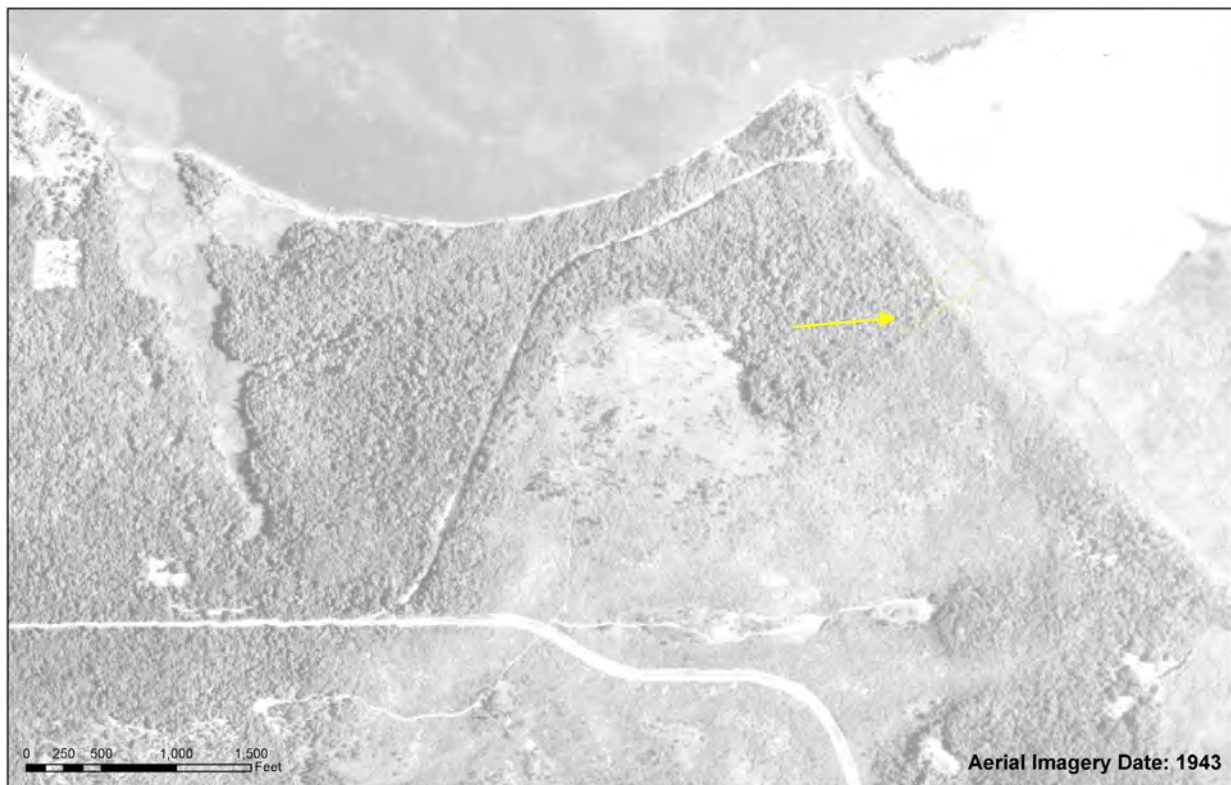
A 1943 aerial photograph taken just before the bluff was subdivided to establish the St. John Bluff Estates residential community indicates that the site was entirely wooded at the time (Figure 81). Another archival aerial photograph from 1960 shows much of the bluff remained wooded while several of the residential lots had been developed with dwellings set within small clearings (Figure 82).

**FIGURE 81.** Aerial photograph of St. Johns Bluff in 1943 indicating the dense woodland present on the bluff and the sites of the Spanish-American War Battery and other military features developed in 1898–1899. Yellow arrow shows location of the Spanish-American War Battery. (Source: National Park Service)

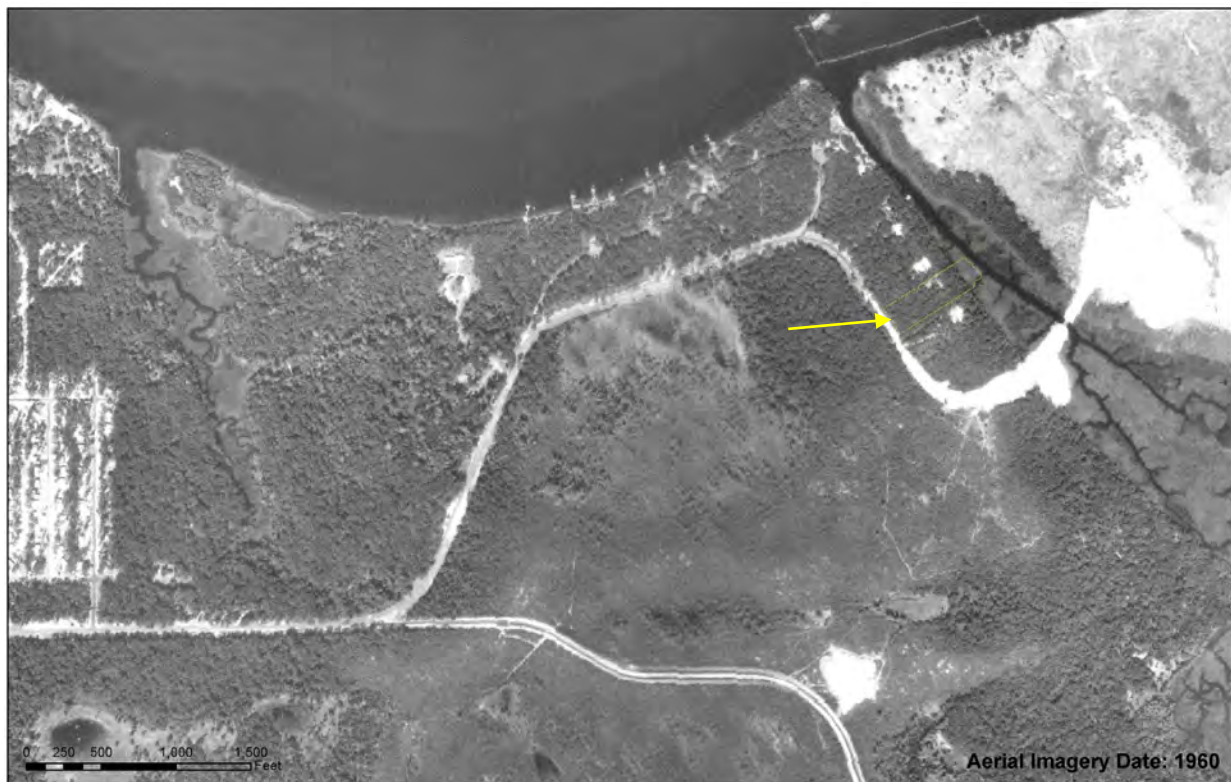
**FIGURE 82.** Aerial photograph of St. Johns Bluff in 1960 that indicates where several dwellings had been built within St. Johns Bluff Estates. Yellow arrow shows location of the Spanish-American War Battery. (Source: National Park Service)

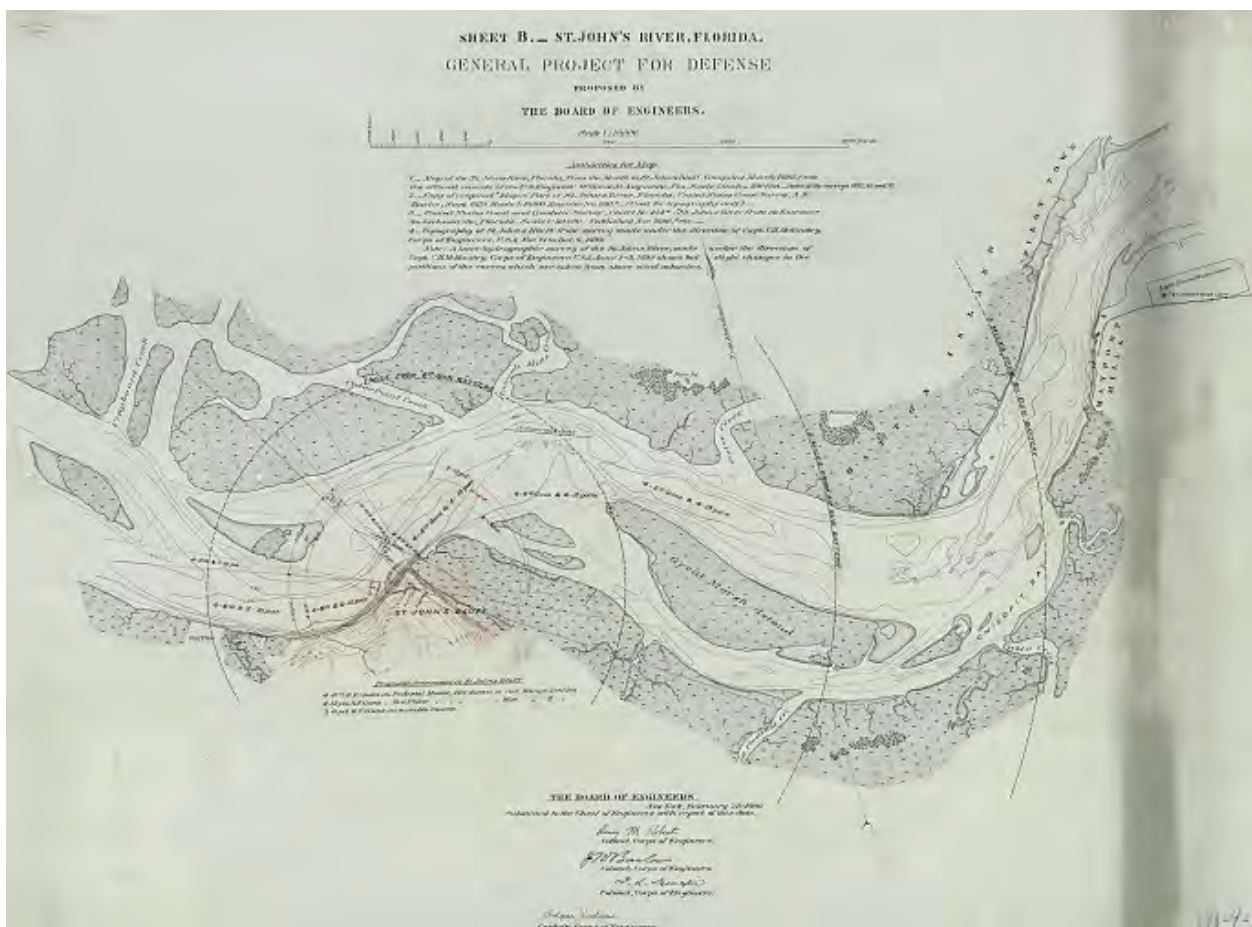
**FIGURE 85.** Map titled "General Project for Defense Proposed by the Board of Engineers," 1900. (Source: NARA RG 77, File Drawer 191, Sheet 9-3, February 28, 1900)

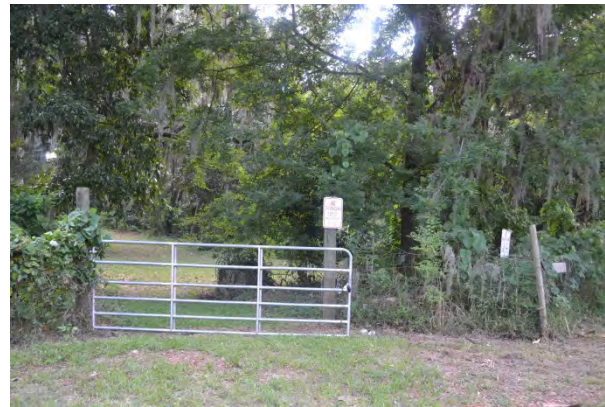
Although the date of origin of the columns is not currently known, they likely were built to support development of the parcel following subdivision of the bluff as St. Johns Estates in 1945. Similarly, although the dates of origin of the boundary fence and gate and signage are not known, they are contemporary additions to the property that likely date to the late-twentieth- or early-twentieth-first centuries (Figure 87).

**FIGURE 87.** View of the perimeter fence, gate, and signage along the southern boundary of the Spanish-American War Battery property, 2019.

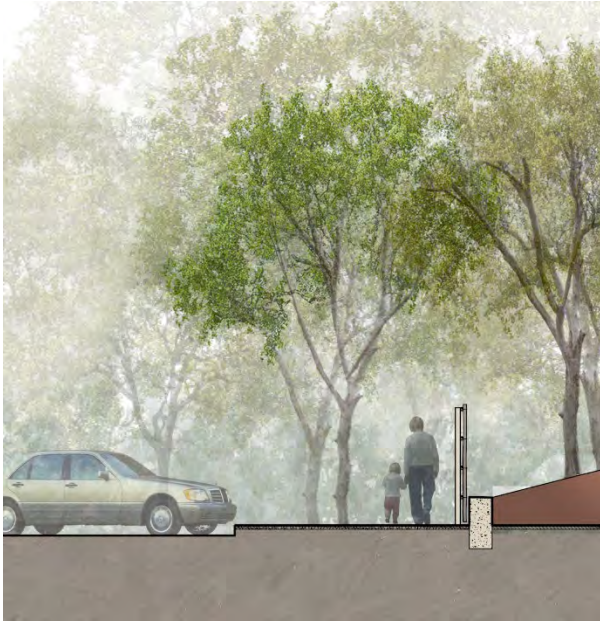
**FIGURE 89.** Parking area to be shady and set within a grove of trees. (Source: DIRT Studio)

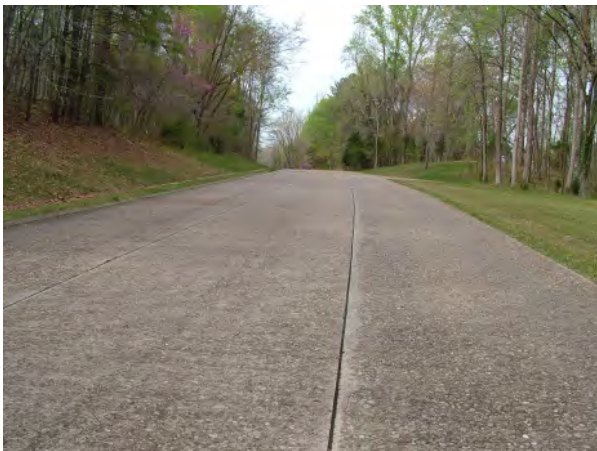
**FIGURE 90.** Road and parking surface to be warm colored concrete with exposed aggregate or similarly colored pervious paving. (Source: LSHLA)

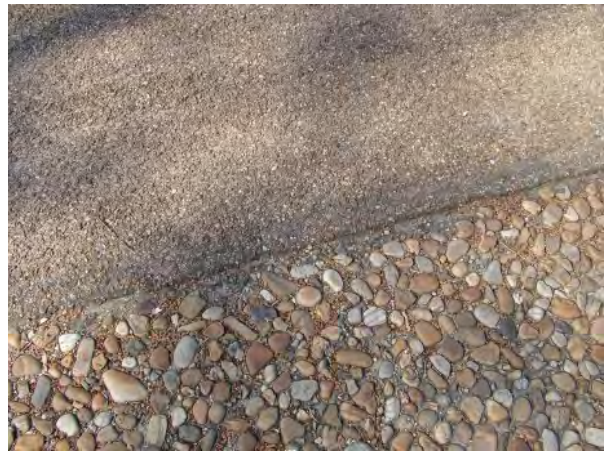
**FIGURE 91.** Detail of exposed aggregate road surfacing materials options. (Source: LSHLA)

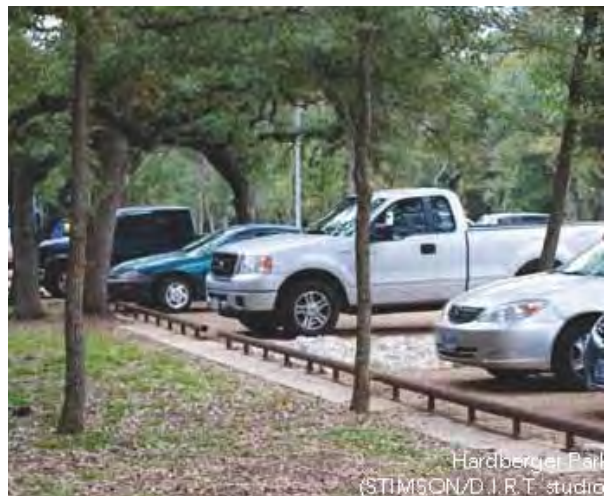
**FIGURE 92.** Parking wheelstops to convey a park-like but relatively informal character, such as wooden barriers. (Source: DIRT Studio)

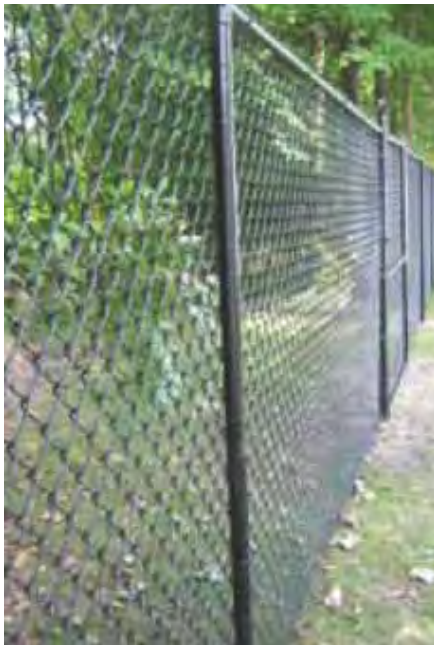
**FIGURE 93.** Property boundary fencing to be dark in color and metal to have little visual impact. (Source: LSHLA)

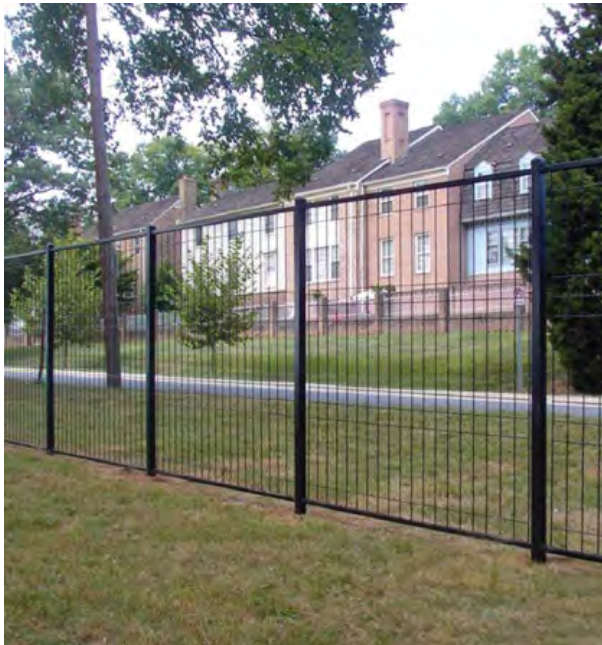
**FIGURE 94.** Property boundary fencing to be dark in color and metal to have little visual impact. (Source: Jerith Patriot Ornamental Wire Fence)

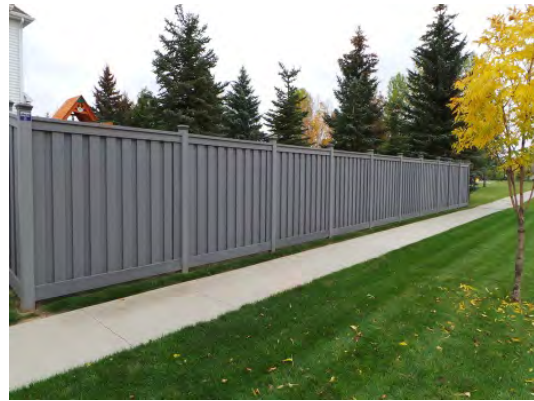
**FIGURE 95.** Dark colored privacy fencing to be used where adjacent residences are visible. A trellis with vines may be considered in addition to fencing and planting to create an effective screen. (Source: Dakota Fence)

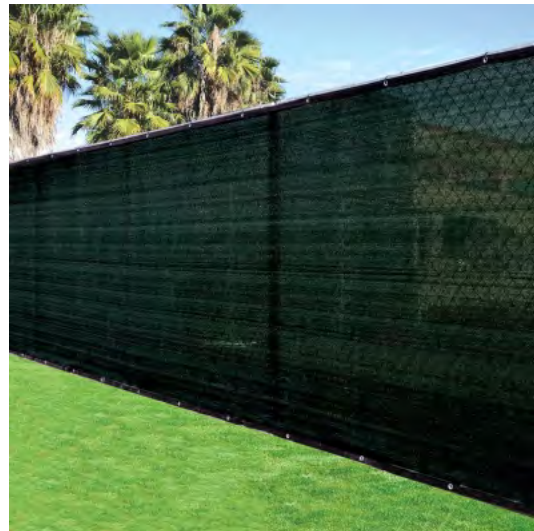
**FIGURE 96.** Dark colored privacy fencing to be used where adjacent residences are visible. A trellis with vines may be considered in addition to fencing and planting to create an effective screen. (Source: Riprin-70)
