# Spanish-American War Battery Cultural Landscape Report and Environmental Assessment Volume I: Cultural Landscape Report

**Spanish-American War Battery**

**Timucuan Ecological and Historic Preserve**

**Cultural Landscape Report and  
Environmental Assessment**

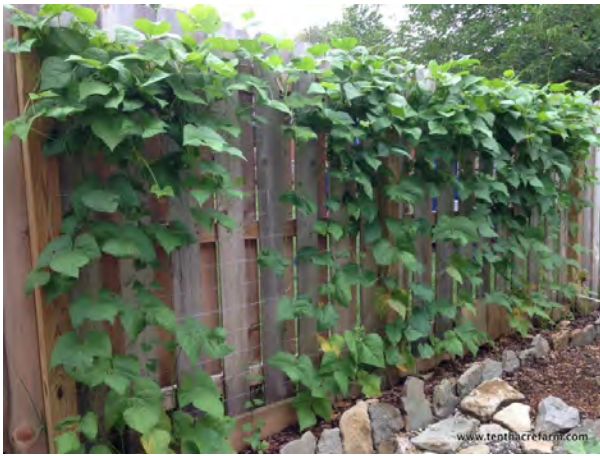
**FIGURE 97.** A trellis with vines may be considered in addition to fencing and planting to create an effective screen. (Source: Tenth Acre Farm)

The character and materials to be considered in the design of the proposed new access and interpretation features are illustrated below in Figure 89 through Figure 106.

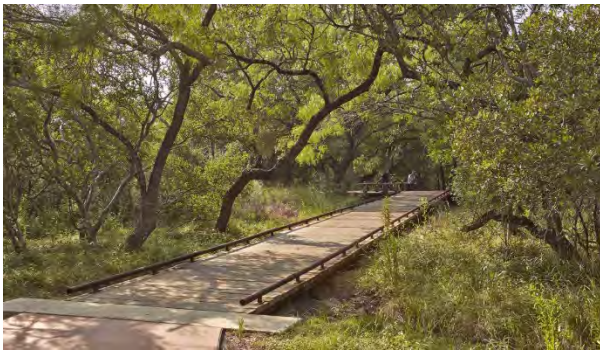
**FIGURE 98.** The elevated walk is proposed to be a durable wood such as lpe or a sustainable wood such as black locust that has a high slip resistance, is naturally rot resistant and does not become hot in the sun. (Source: DIRT Studio)

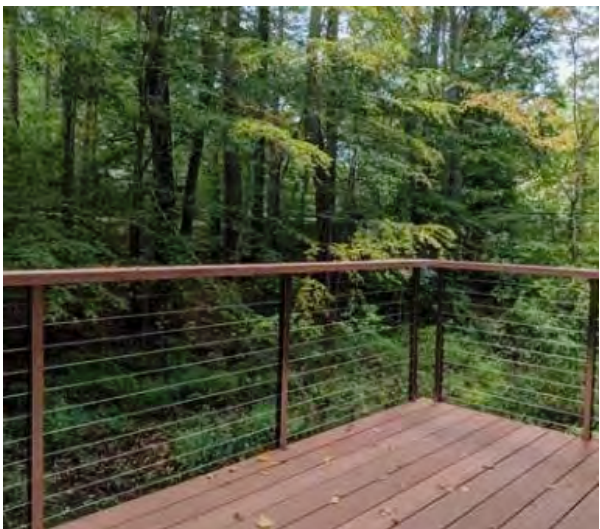
**FIGURE 99.** The elevated walk and platforms will be edged by barrier fencing composed either of wood or wood and metal cable. (Source: AGS stainless express rail cable)

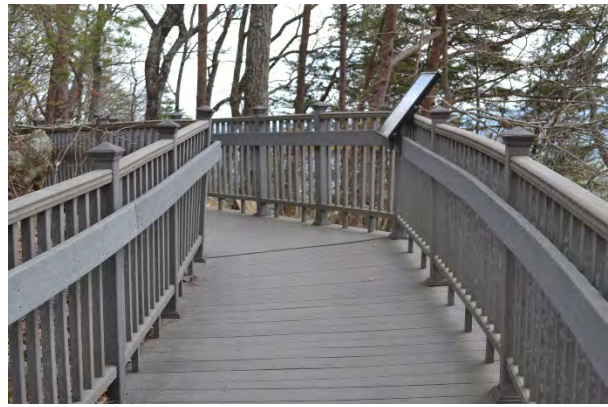
**FIGURE 100.** Signage will provide for orientation, wayfinding, and interpretation but will be kept minimal and unobtrusive. (Source: LSHLA)

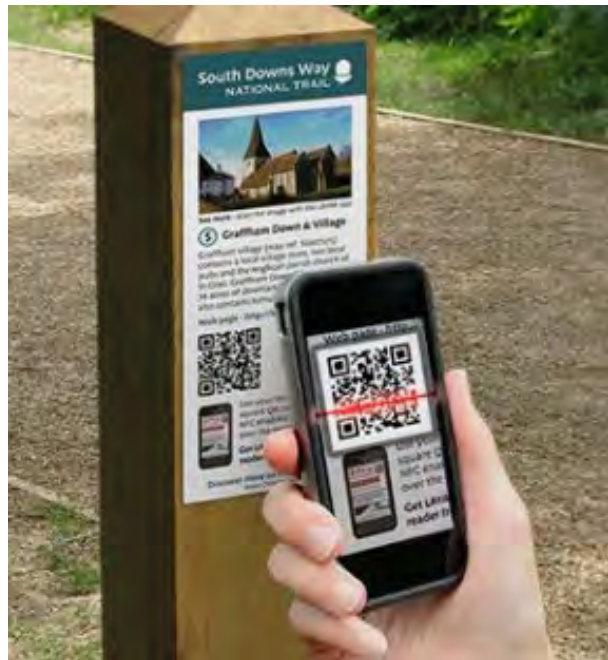
**FIGURE 101.** Provisions will be made for self-guided tours with features such as QR codes. (Source: Followthegiraffe.co.uk)

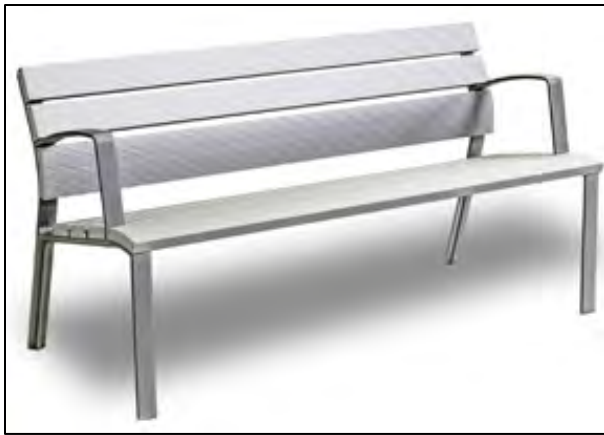
**FIGURE 102.** Site furnishings should include benches with backs that are simple and contemporary in design and character. (Source: SantaCole, NeoCombo-16)

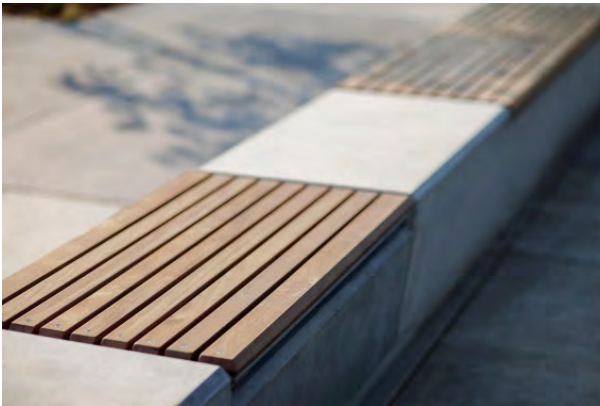
**FIGURE 103.** Benches without backs might also be provided in some locations that should also be simple and contemporary in design and character. (Source: Forms+Surfaces)

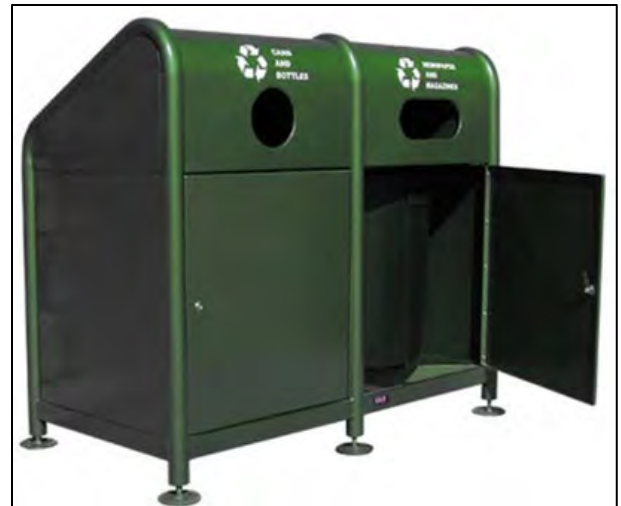
**FIGURE 105.** Recycling receptacles should also be provided. (Source: Park Warehouse, RC Series Enclosed Recycling Receptacle)

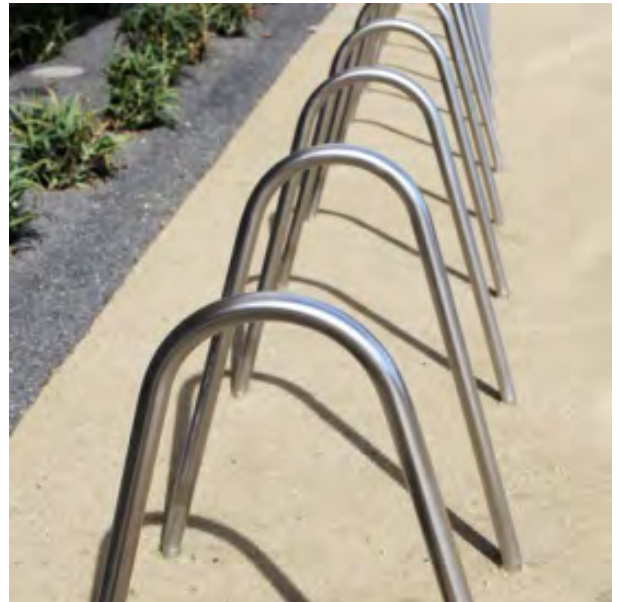
**FIGURE 106.** Bike racks will be provided for visitors in addition to parking. (Source: SF Bola)
