Historic Paint Finishes Study:

The original paint finishes of the Carter Mansion 1775-1780  
Elizabethton, Tennessee      Second Phase Study

The Stair Landing and above, The Second Floor: Passage 201, South Bedchamber 202, West  
Bedchamber 203

By:  
Matthew J. Mosca, Historic Paint Finishes Specialist  
Artifex, Ltd.  
2641 North Charles Street  
Baltimore, Maryland 21218

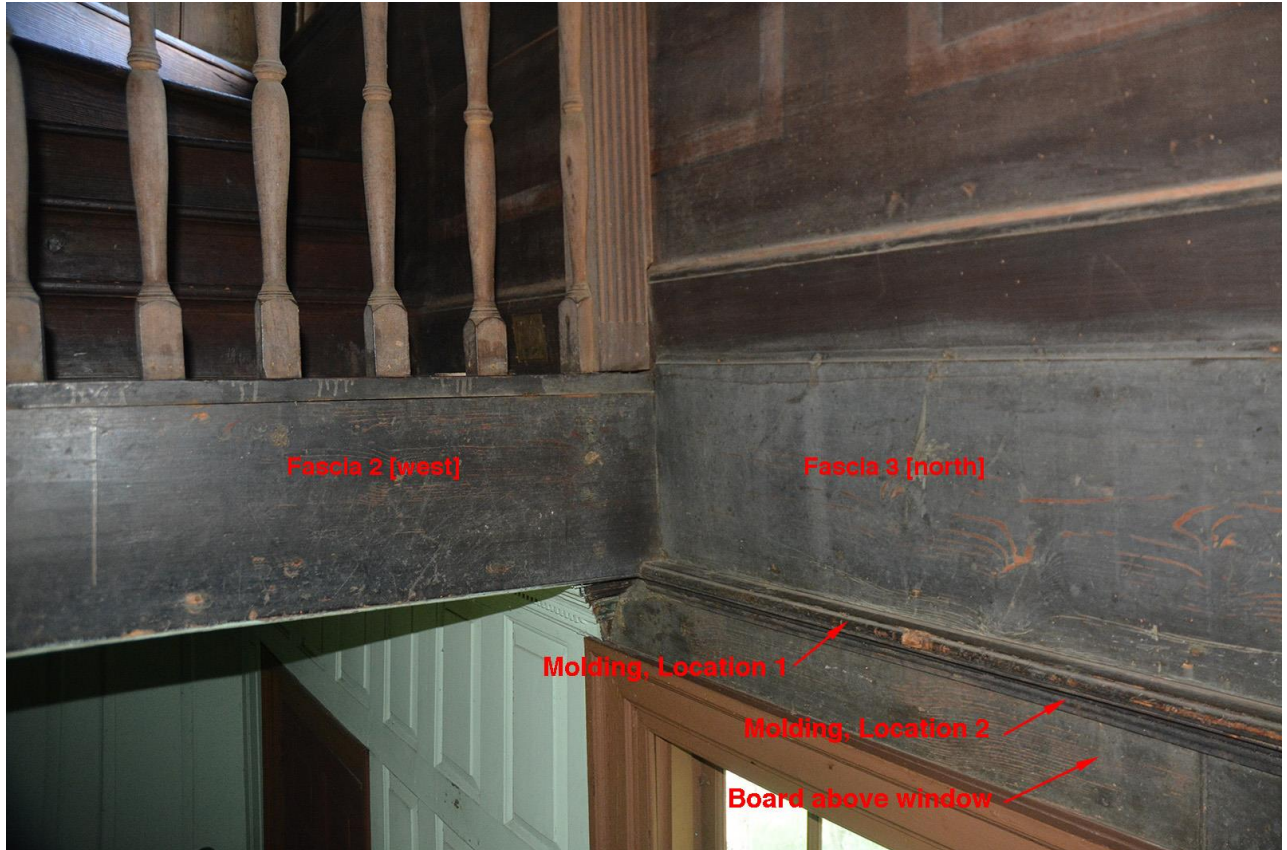
Many of the samples exhibited considerable discoloration, in particular fading of the Prussian Blue pigment [potassium ferric ferrocyanide]. This is the same pigment that was used for the walls of the Parlor, where the blue finish is still exposed. In the parlor, it is a deeper blue finish color.

The photomicrographs of the stair landing area fascia boards noted in the photograph above are very indicative of the very deteriorated condition of the paint layers. These paint layers are now of course, over two-hundred and forty years old.

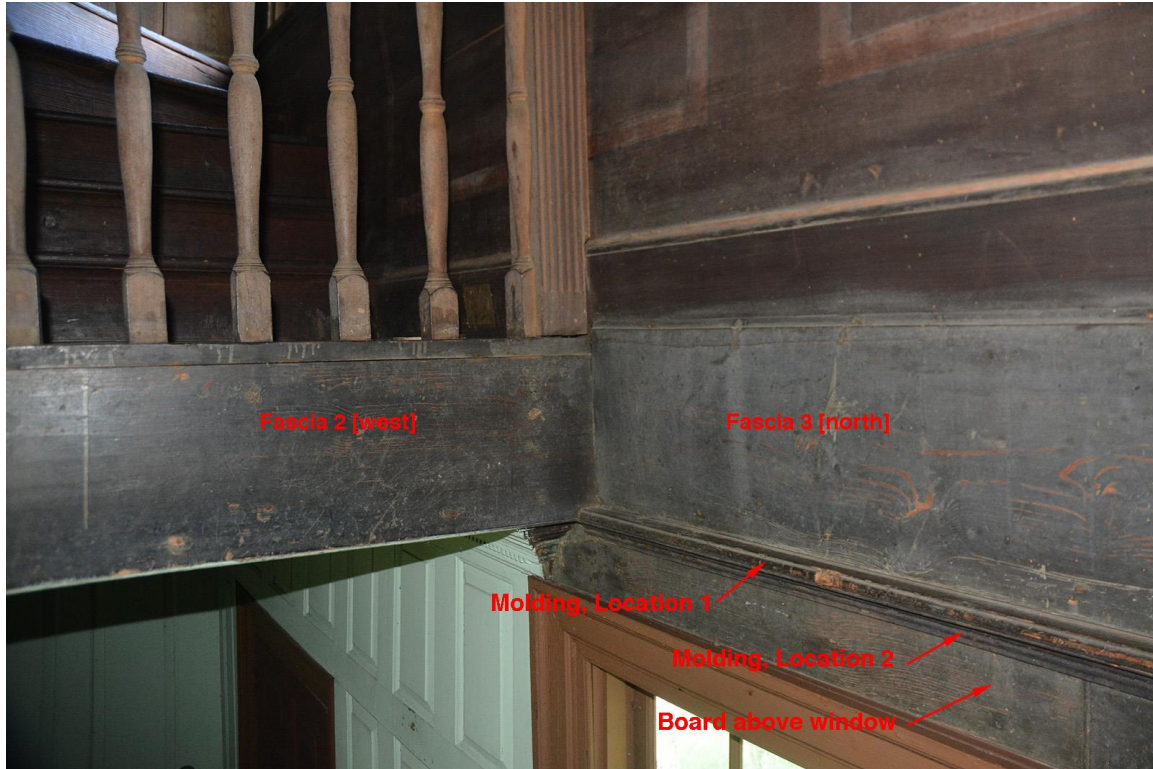
**Note:** The Molding separates the board above the window and the fascia board on the north wall of the stair landing.

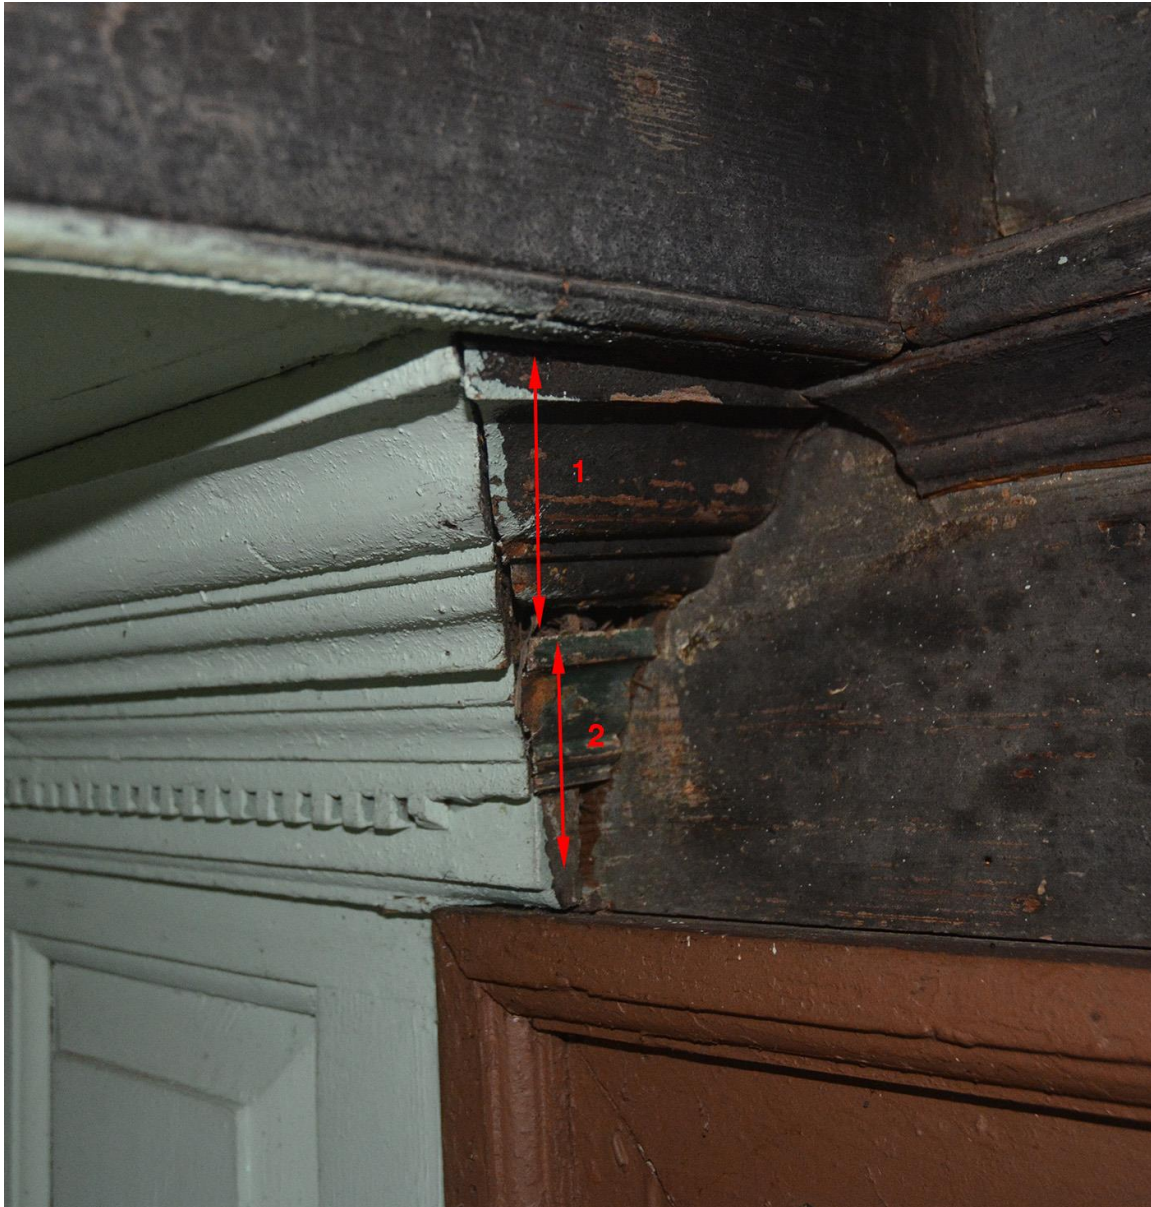
Stair Landing: Crown molding return  
Location of samples:

### Sample SL-9: Crown molding return, Location 1:

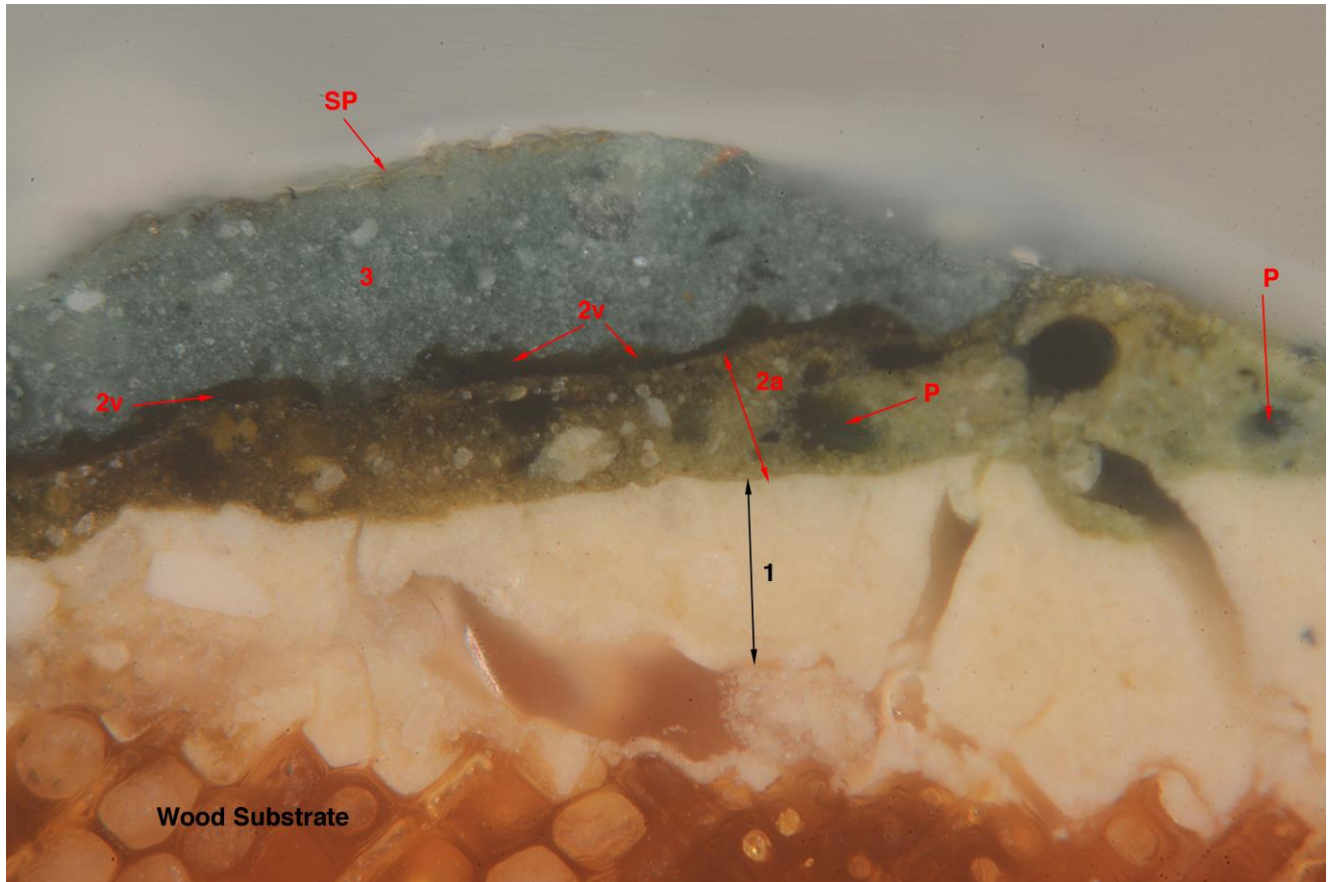
Note: The sample has been mounted in polymer resin cut and polished to 8000 micron grit polishing cloth. The wood substrate is seen at the base of the sample. The first finish is the lead white layer [1] that is clearly seen. The second finish posed a question: this appeared visually to be a paint layer with distilled cupric acetate [verdigris] mixed with lead white [2a], the pigments [P] looked green and the discoloration of the paint layer toward brown is also indicative of cupric acetate. As in the case of Sample: Crown molding return, Location 1, the paint is protected with a varnish coating [2v]. Polarized light microscopy was conducted on pigment particles from layer 2a [indicated: P] and proved that this paint layer was made with **Prussian blue pigment** and lead white. This is another indication of the extreme discoloration of materials at this site. The last layer, Layer 3, is the chromium oxide green paint from the 19<sup>th</sup> century.

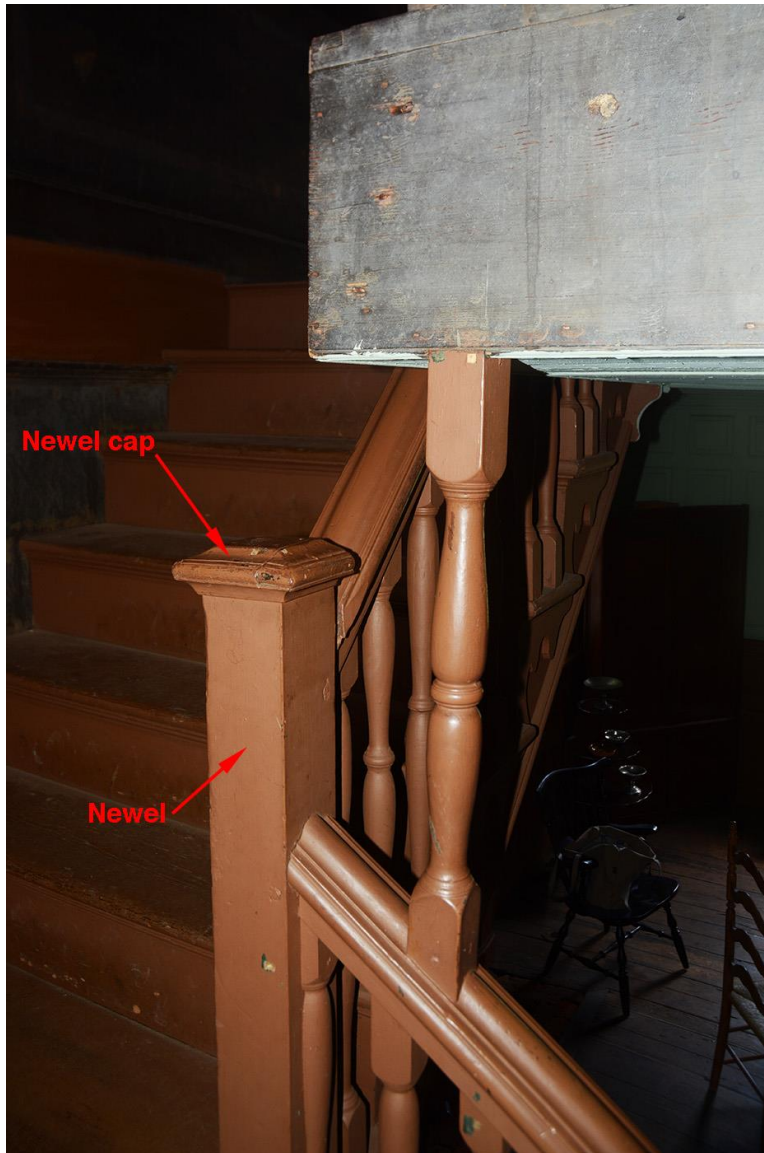
**Stair Landing, Newel:**

Newel and newel cap at the Stair Landing

**Note:** the surface of the stair newel was stripped during the restoration of 1972, however, the “staining” of the wood with the dark umber brown pigment is clearly seen.

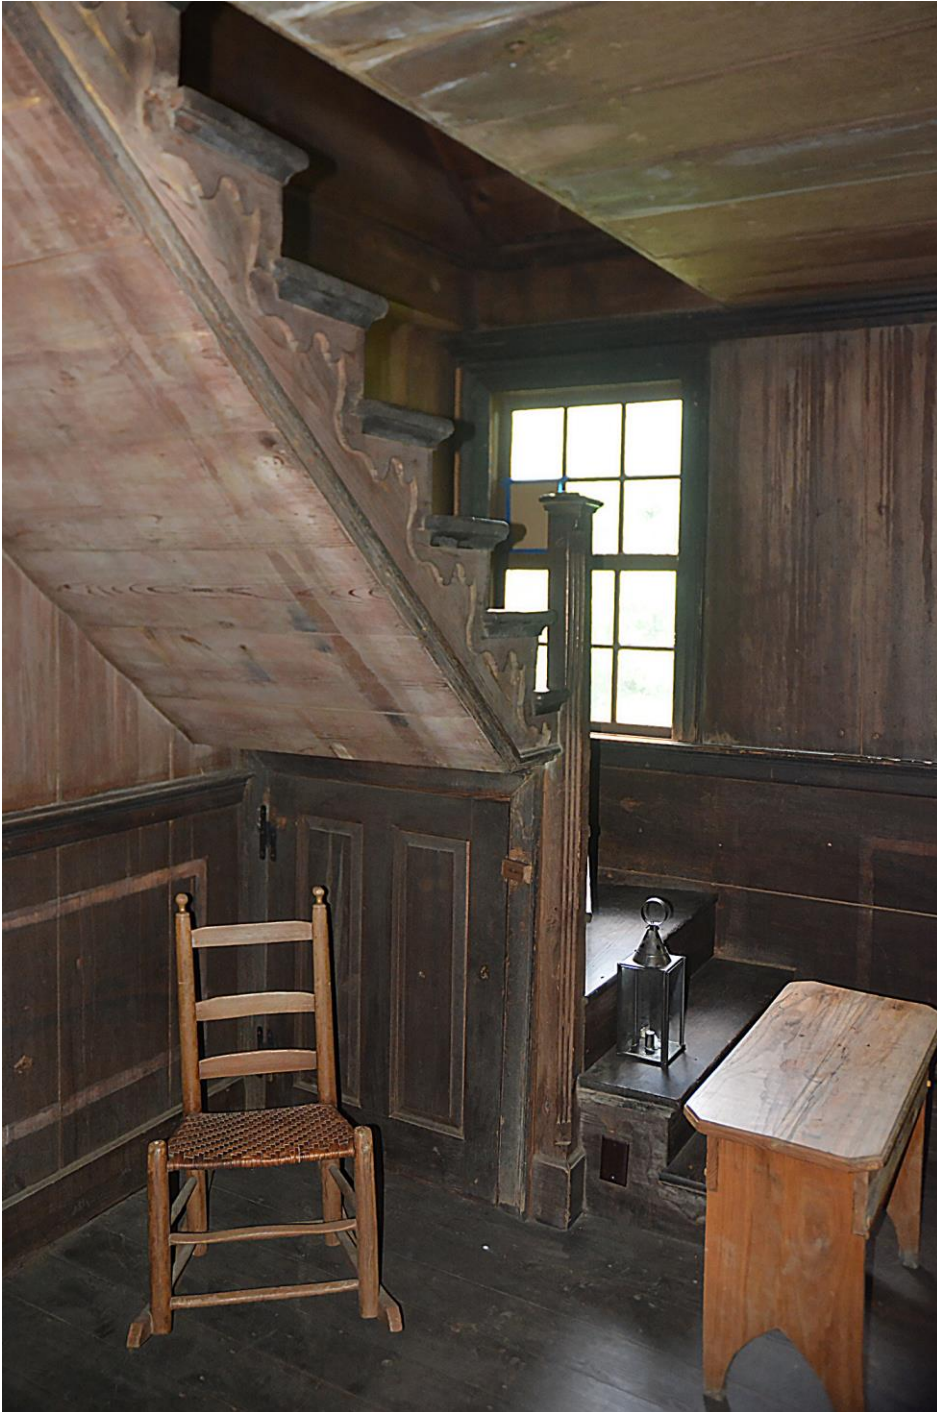
Note: The Second Floor Hall was finished in the same manner as the West Bedroom and the South Bedroom. Note the same panel trompe-l'oeil effect on the dado, carried out with the same colors, using a dark natural brown, a carbon black and white. The wall field and ceiling are nearly unrecognizable, but would have had the marbling effect carried out in white and pink. The best example of this is found in the West Bedroom.

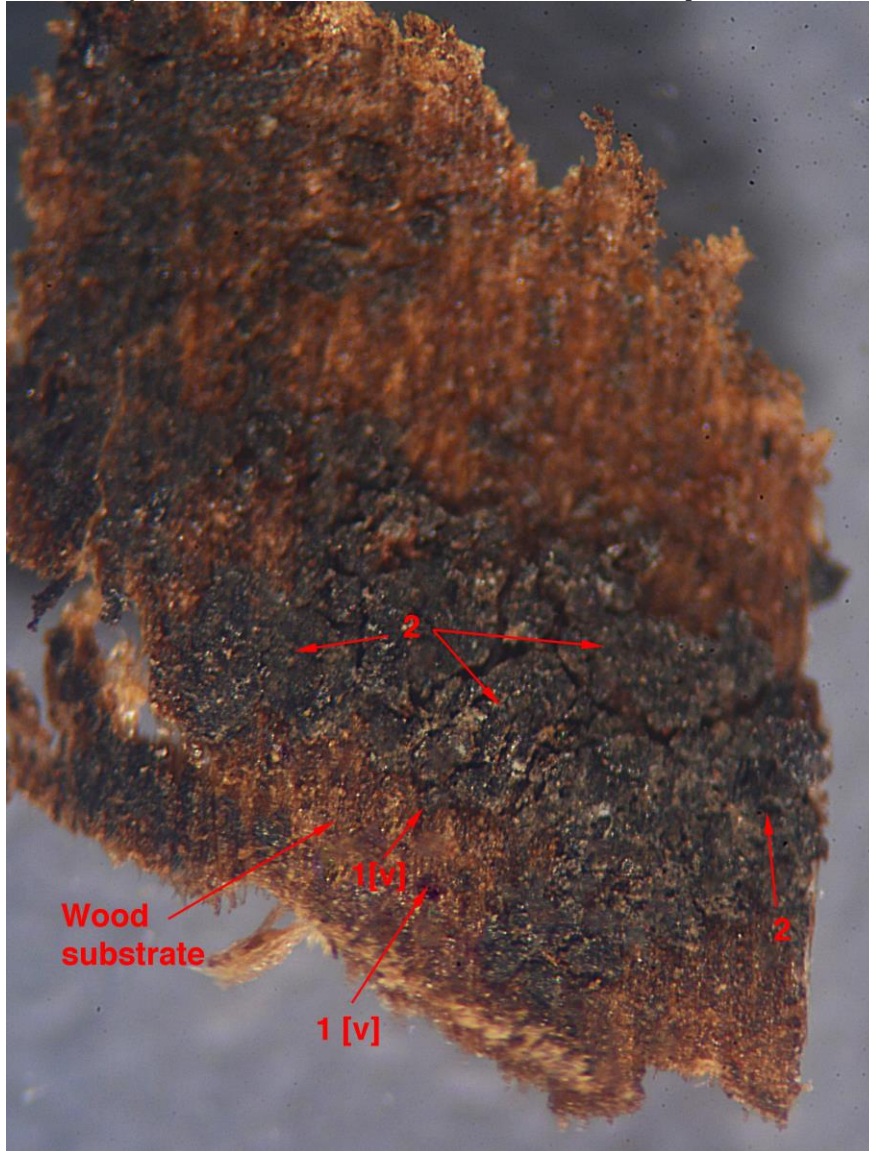
Note: The view of this sample is looking down onto the finish surface. The wood substrate is clearly seen and indicated. Note that the first finish appears to be a dark varnish (1[v]). The thickness of this natural resin coating strongly suggests that this was a finish that was exposed. This surface is coated with a black finish [2].

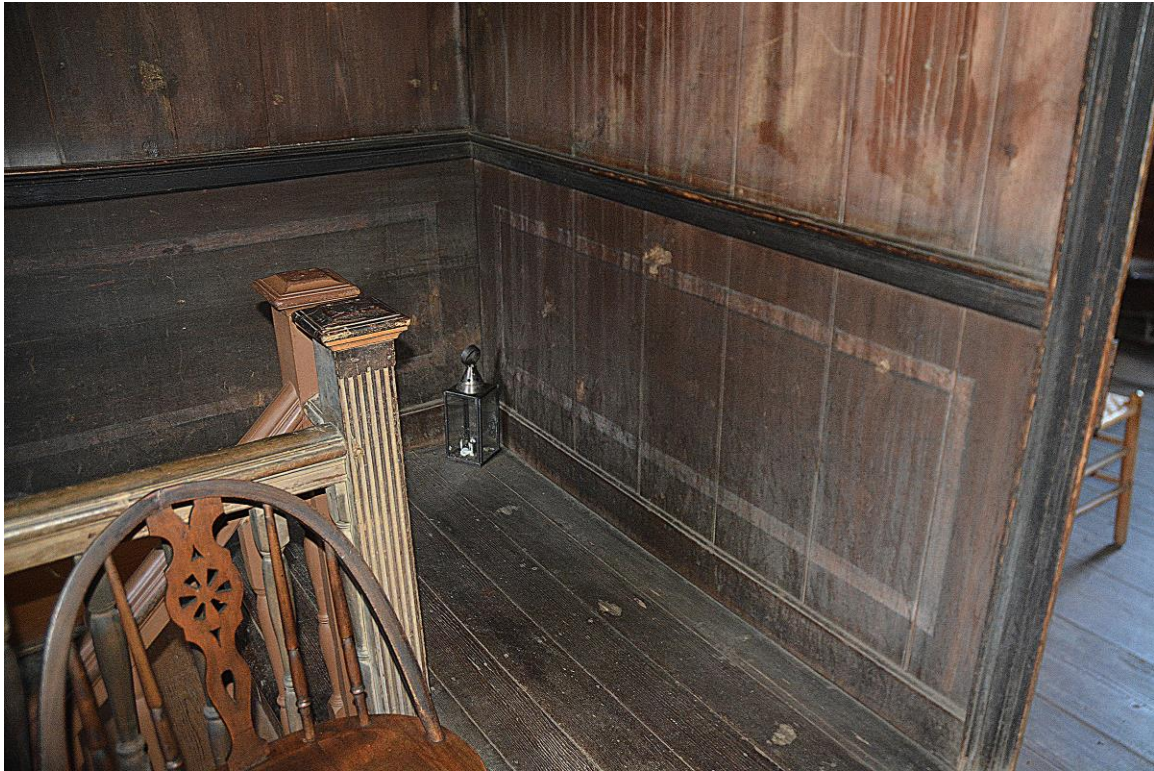
Note: The Dado of the Second Floor Hall shows the same trompe-l'oeil panel design as seen in the South Bedroom and the West Bedroom. As in the rooms, this surface is the original from the eighteenth century.

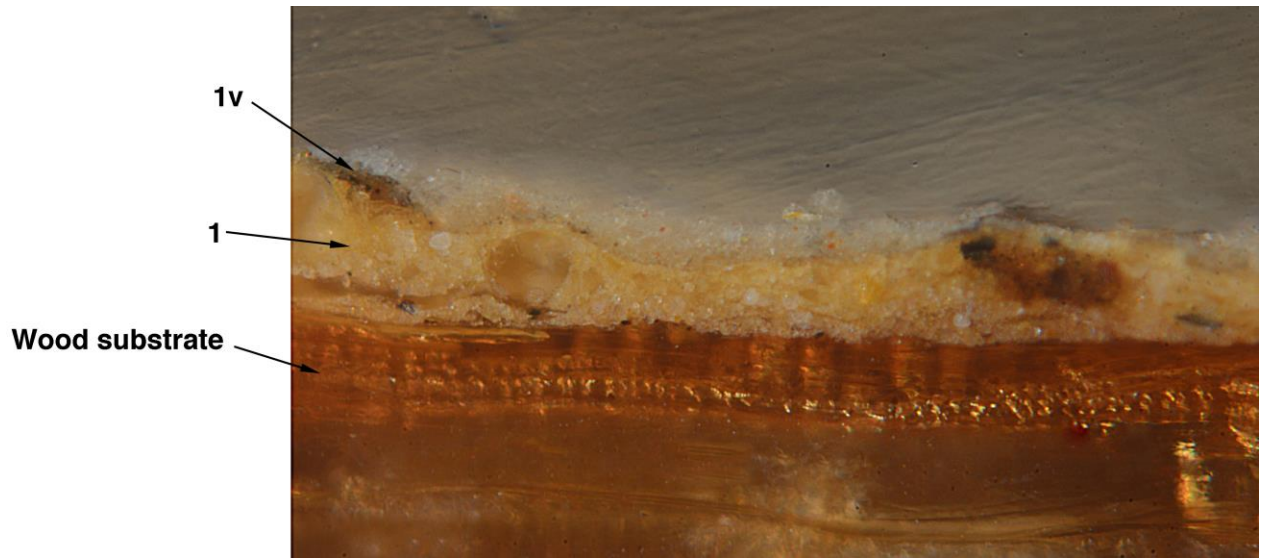
**Sample: 201-9: Stair newel flutes**

Note: The sample has been mounted in polymer resin, cut and polished to 8000 micron grit polishing cloth for additional examination. The wood substrate is clearly seen at the base of the sample. The first finish [1] is clearly seen, and appears to be made with a yellow ochre and lead white. Fragments of the darkened natural resin varnish are also visible [1v].

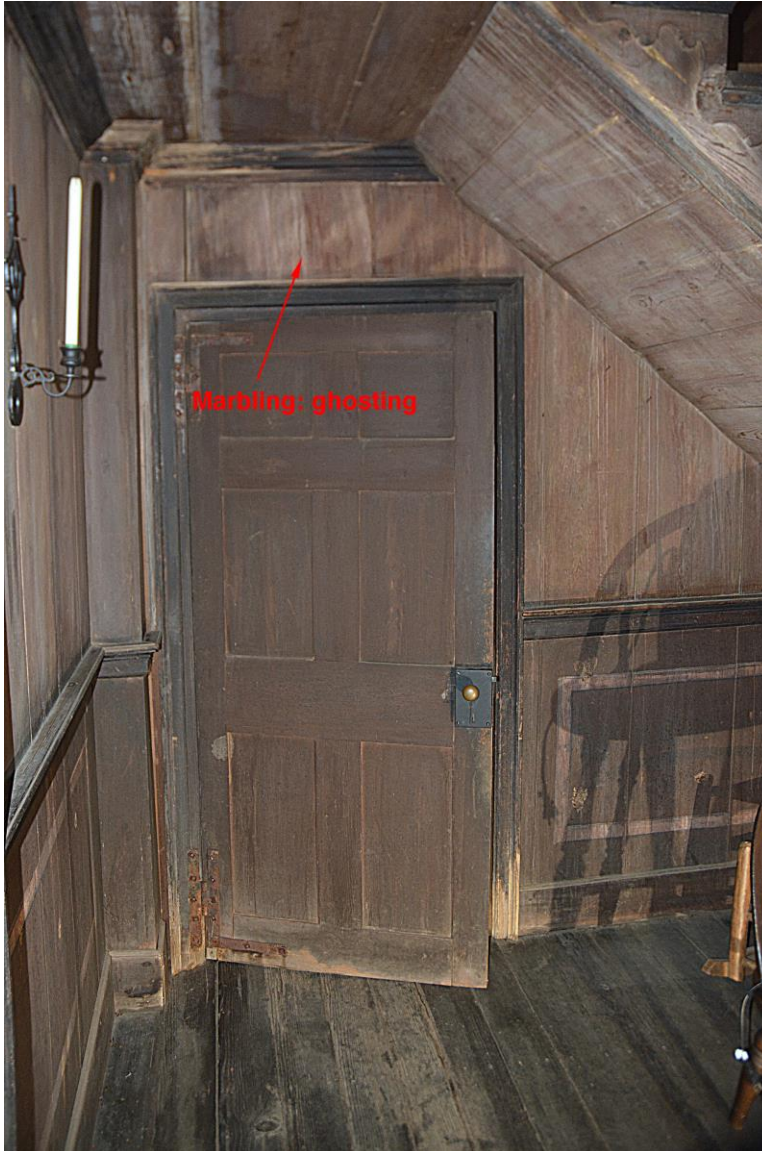
Note: the paint removal process disrupted the original finishes, however, the ghost marks of the early marbling is still visible, and indicated above the door to the West bedroom.

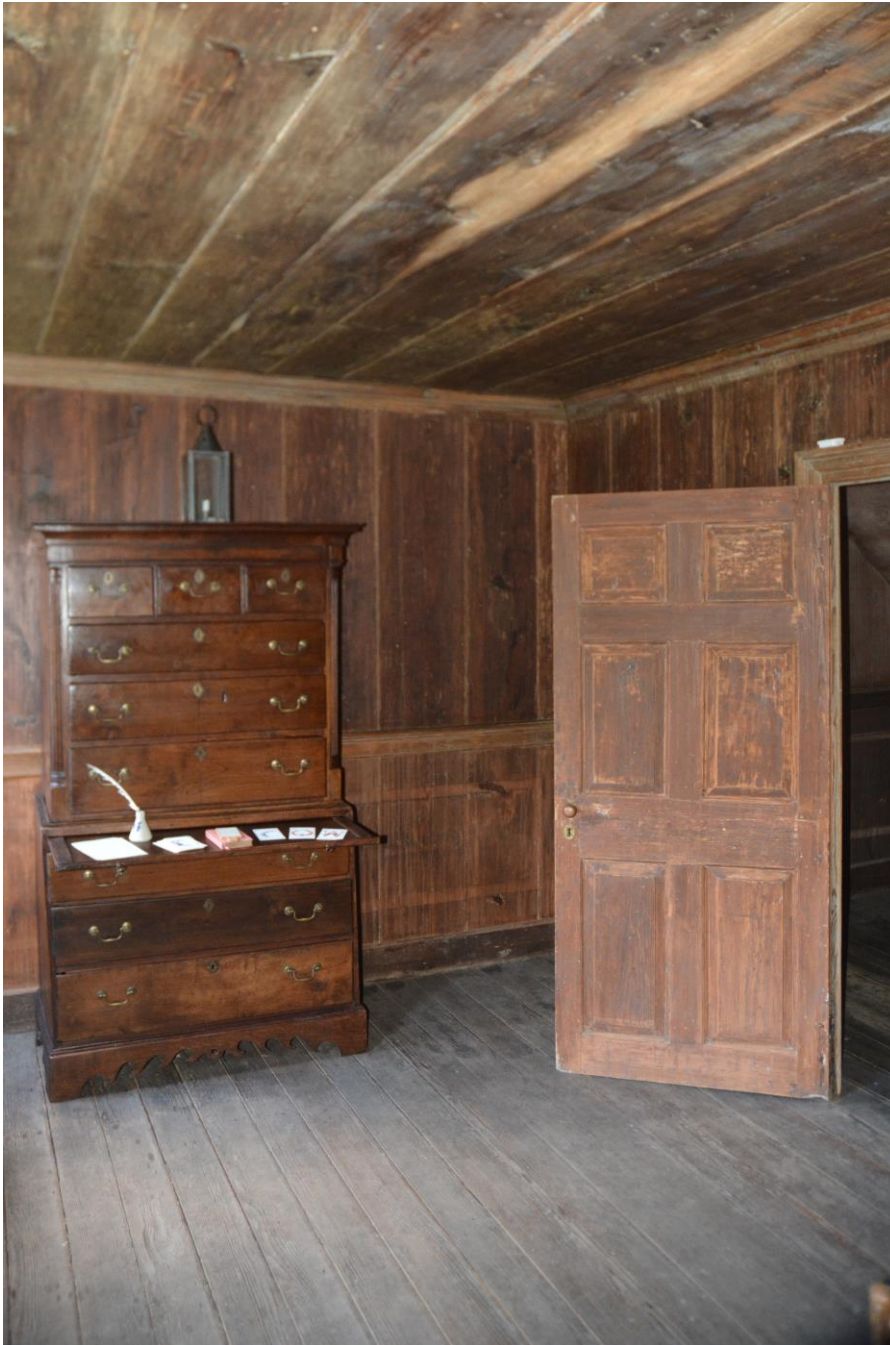
restoration was done, this room was subject to paint removal. It was possible to disclose the trompe-l'oeil panel painting on the dado, but the other surfaces appear to have been over-cleaned, as can be seen in the site photograph to the left. Despite this it has been possible to extract paint samples that indicate what the earliest finish was.

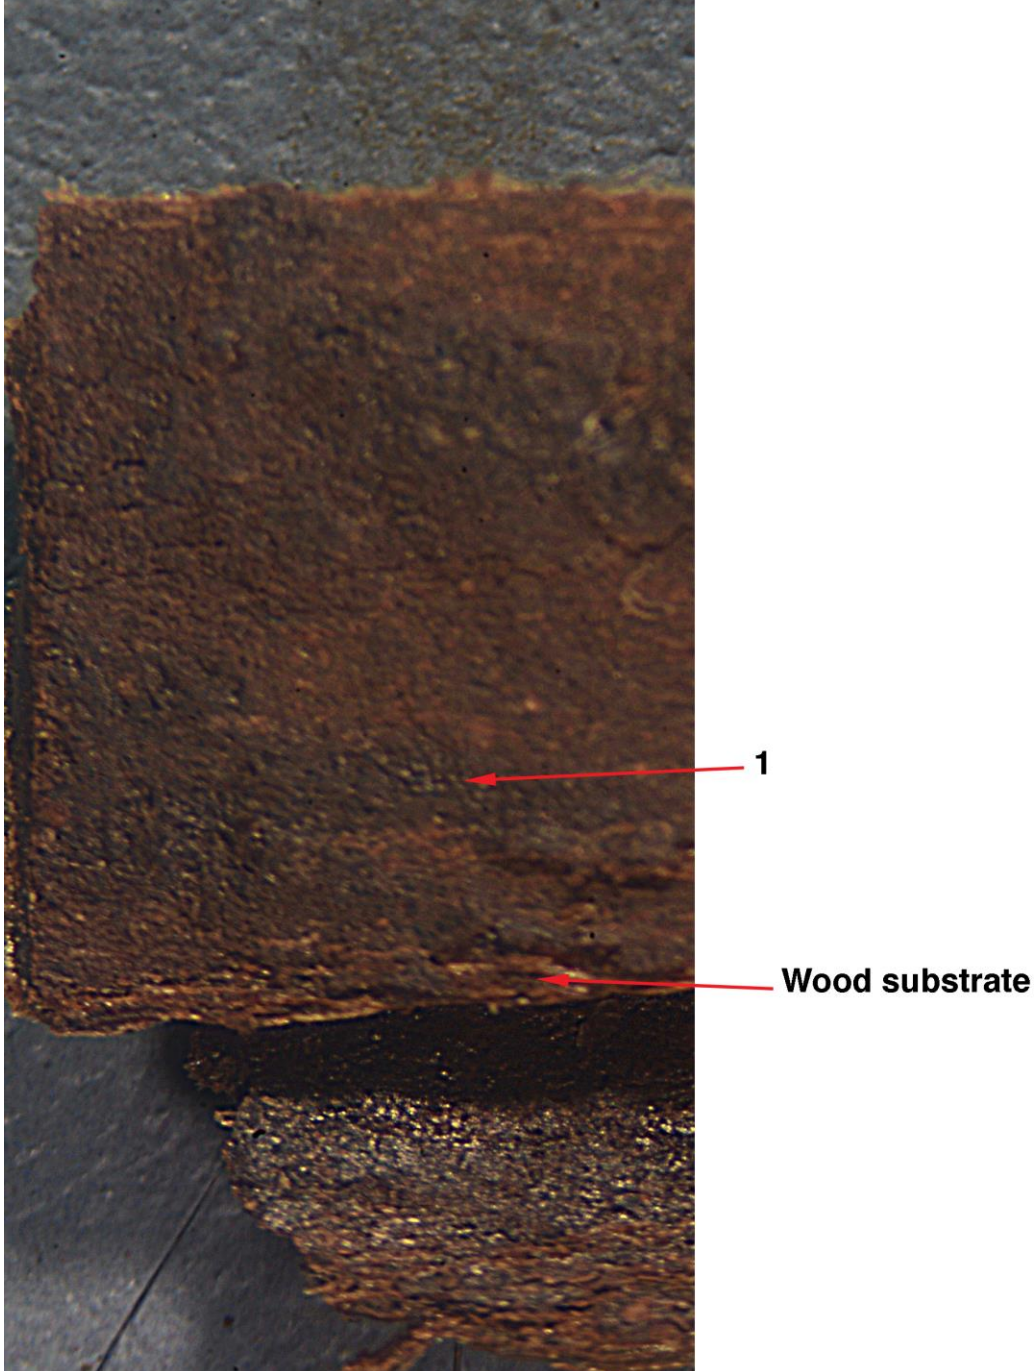
Note: The view of this sample is looking down onto the finish surface. The surface shows the original dark brown ochre [1] as retained on the sample: later finishes were removed in 1972 and this action disrupted the original brown finish as well.

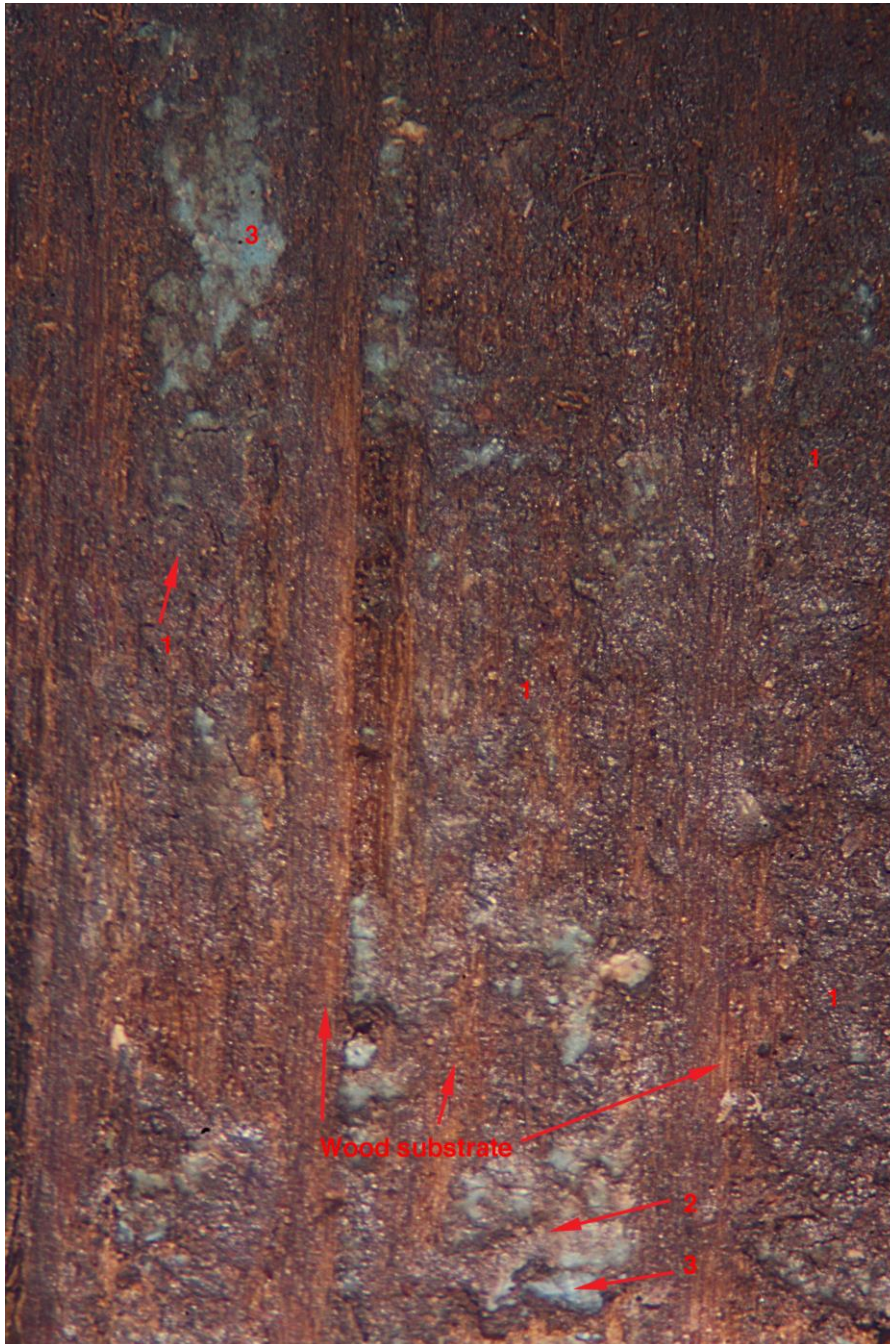
Note: The view of the sample is looking down onto the finish surface. This surface was subject to paint removal during the restoration of 1972. Despite that, the original finish was retained at least partially, which was the intention. The wood substrate is clearly seen and noted. The dark brown finish [1] is the first finish. This is the same brown pigment that was used on the dado as the ground. The second finish, which appears gray is actually an example of the Prussian blue color [2, Prussian blue pigment with lead white]. The third finish is the brighter Prussian blue color that is also seen as the third finish on **Sample 202-2: Crown Molding South wall,**

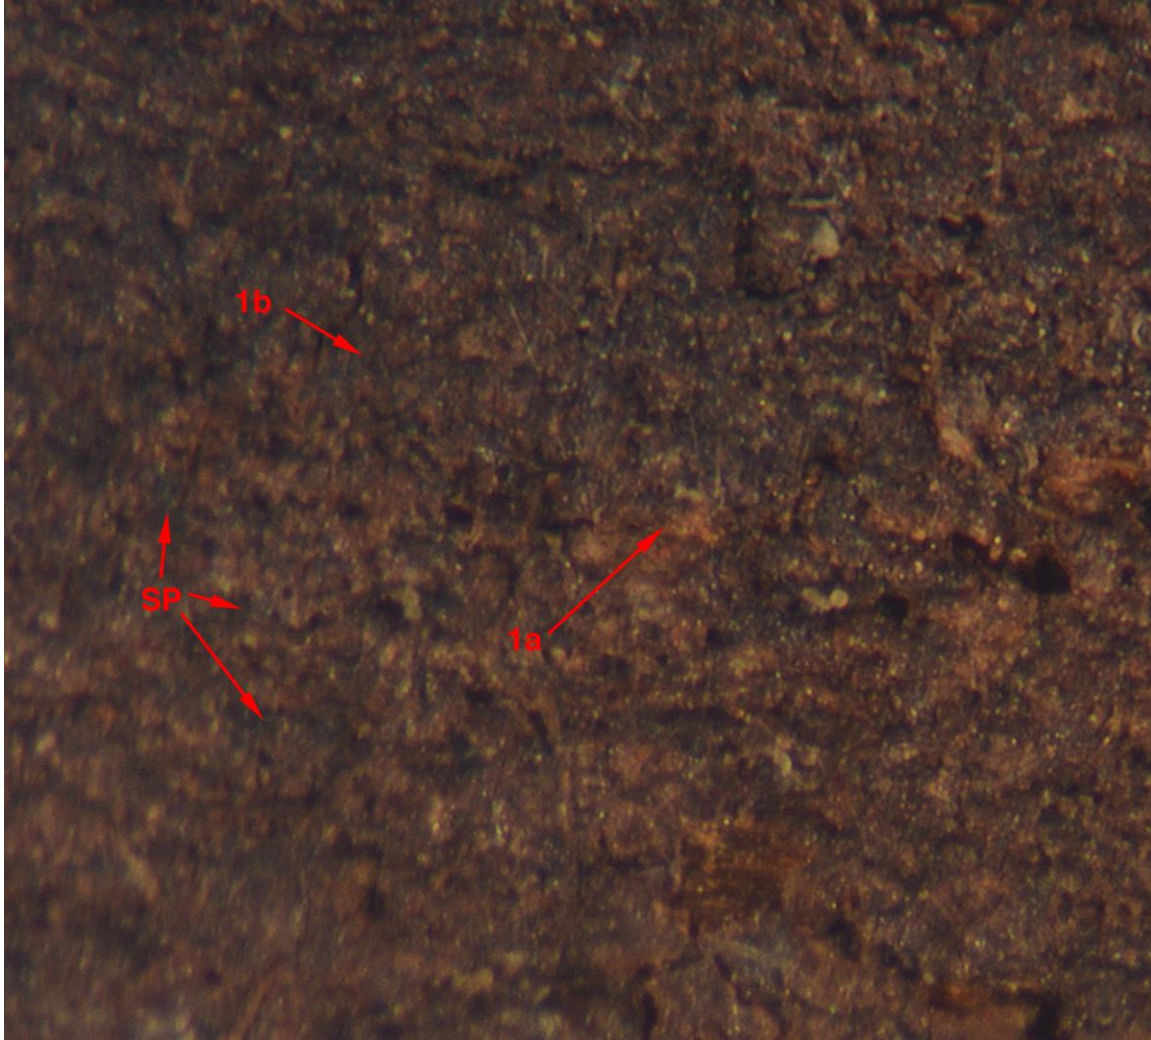
Note: The view of the sample is looking down onto the finish surface. This is a detail view of the surface of the **Sample 202-11: Baseboard fascia**. The first layer is a natural brown ochre [1a], slightly lighter than the dark brown finish [1b]. The layer of accumulated surface particulate is clearly visible also [SP].

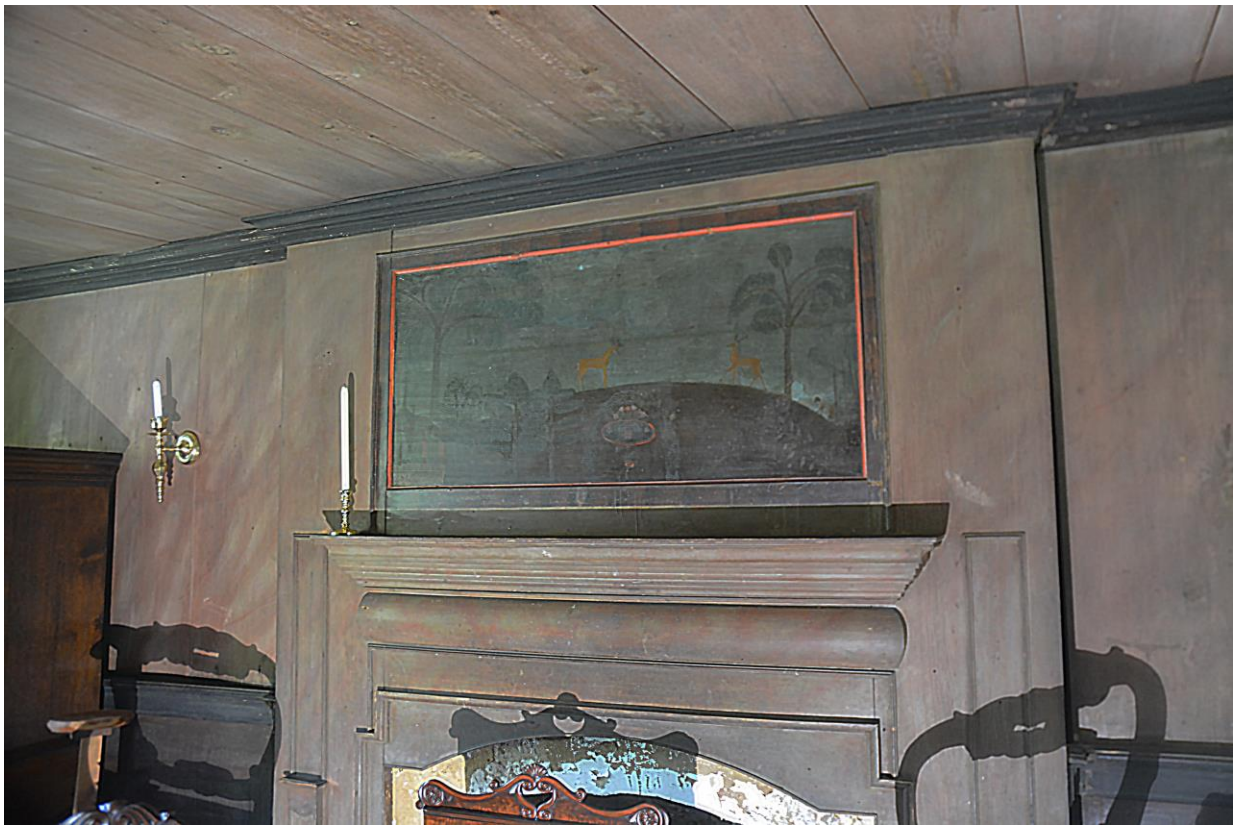
Above is the mantel and overmantel painting with its landscape painting. The painted marble effect of the walls and mantel are clearly seen. Note that the ceiling also shows some variation that indicates the marbled effect carried out on the ceiling as well: an unusual conceit.

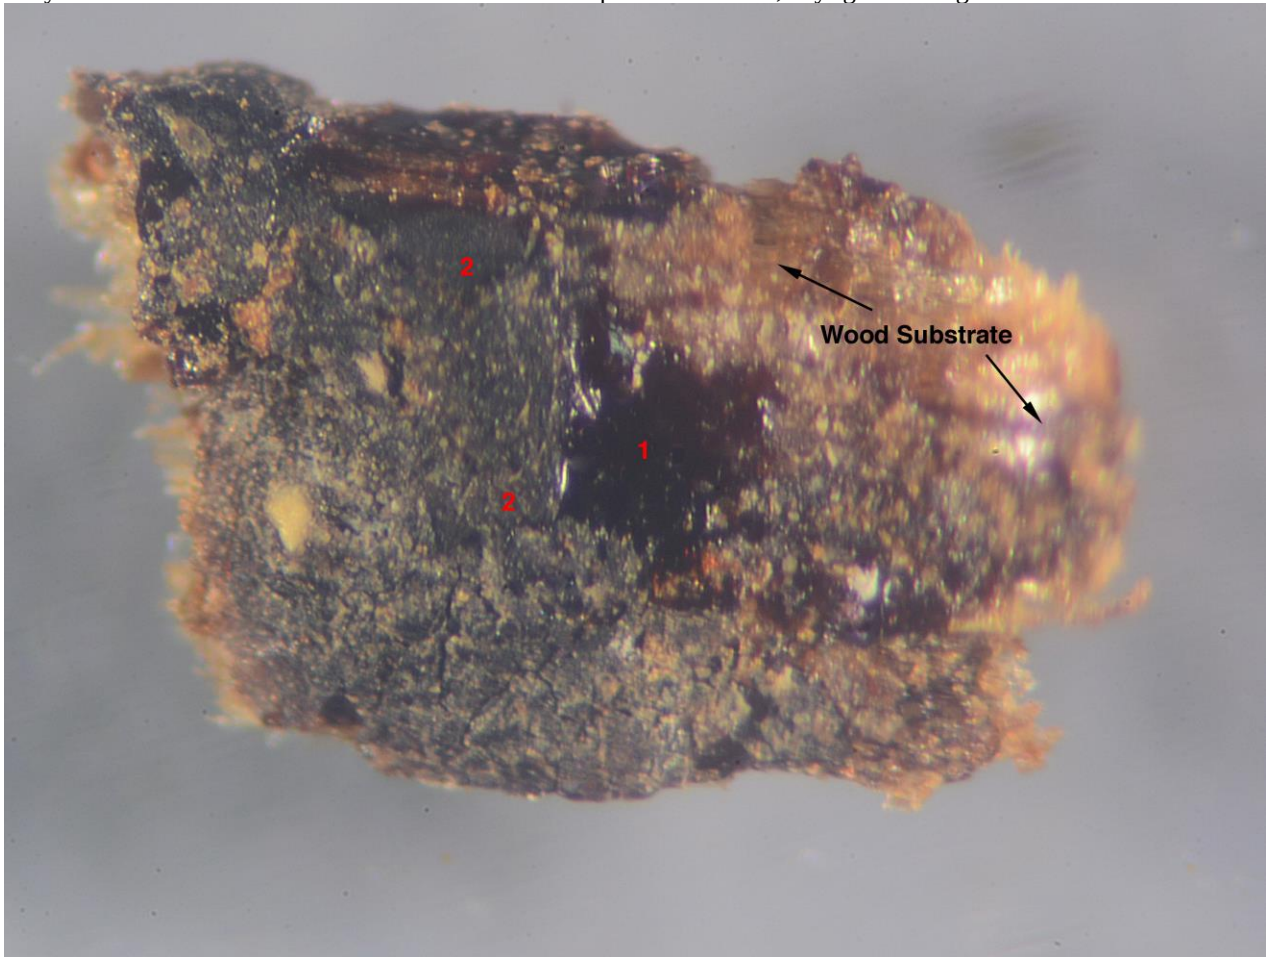
Note: The view of the sample is looking down onto the finish surface of the sample. This sample is particularly informative. The sample is extremely minute. The wood substrate is clearly seen and noted. The first finish is the brown varnish coating, which retains the gloss level [1]. The black opaque paint layer [2] was applied over the glossy brown coating; the black finish [2] is still exposed.
