# COMPLETION REPORT

## CHRISTIANSTED NATIONAL HISTORIC SITE

Steeple Building Fence and  
Fort Christianvaern Wingwall  
Repairs, 1992

U.S. NATIONAL PARK SERVICE  
SOUTHEAST REGIONAL OFFICE  
HISTORIC ARCHITECTURE DIVISION  
75 SPRING STREET, SW  
ATLANTA, GEORGIA 30303

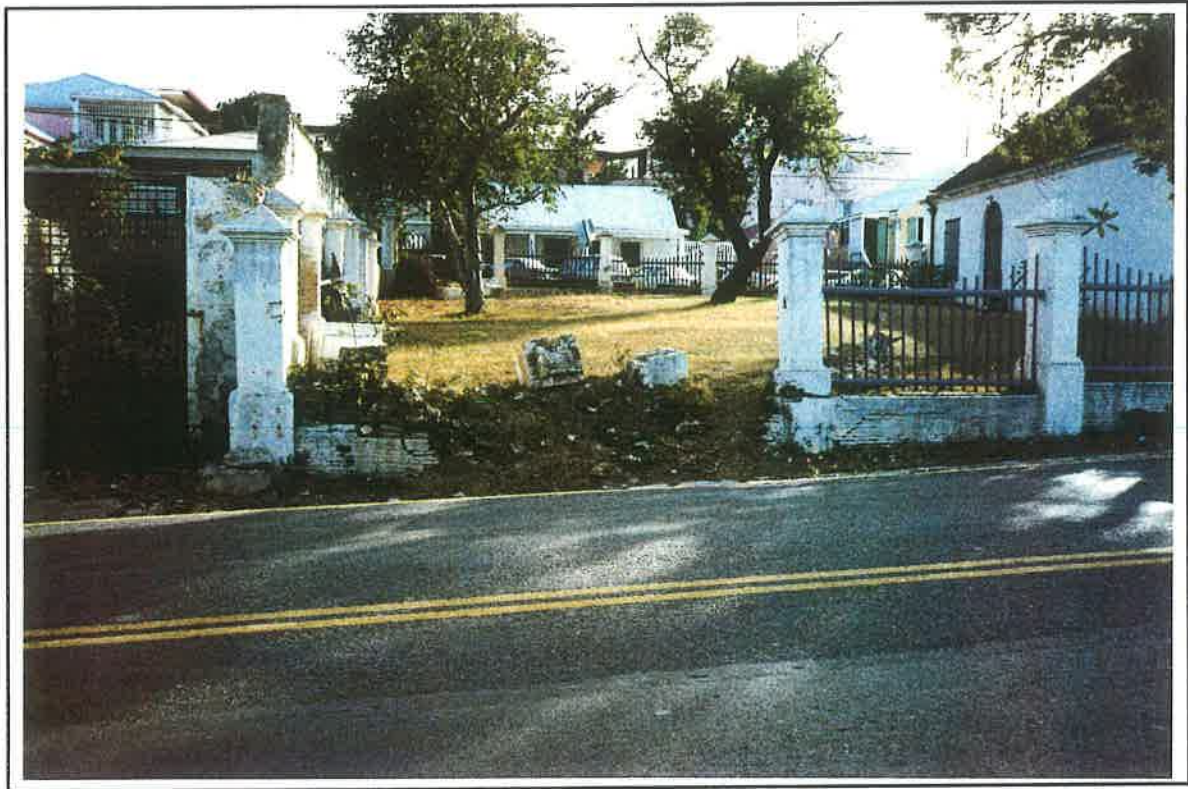
Steeple Building Fence showing Hurricane Hugo damage

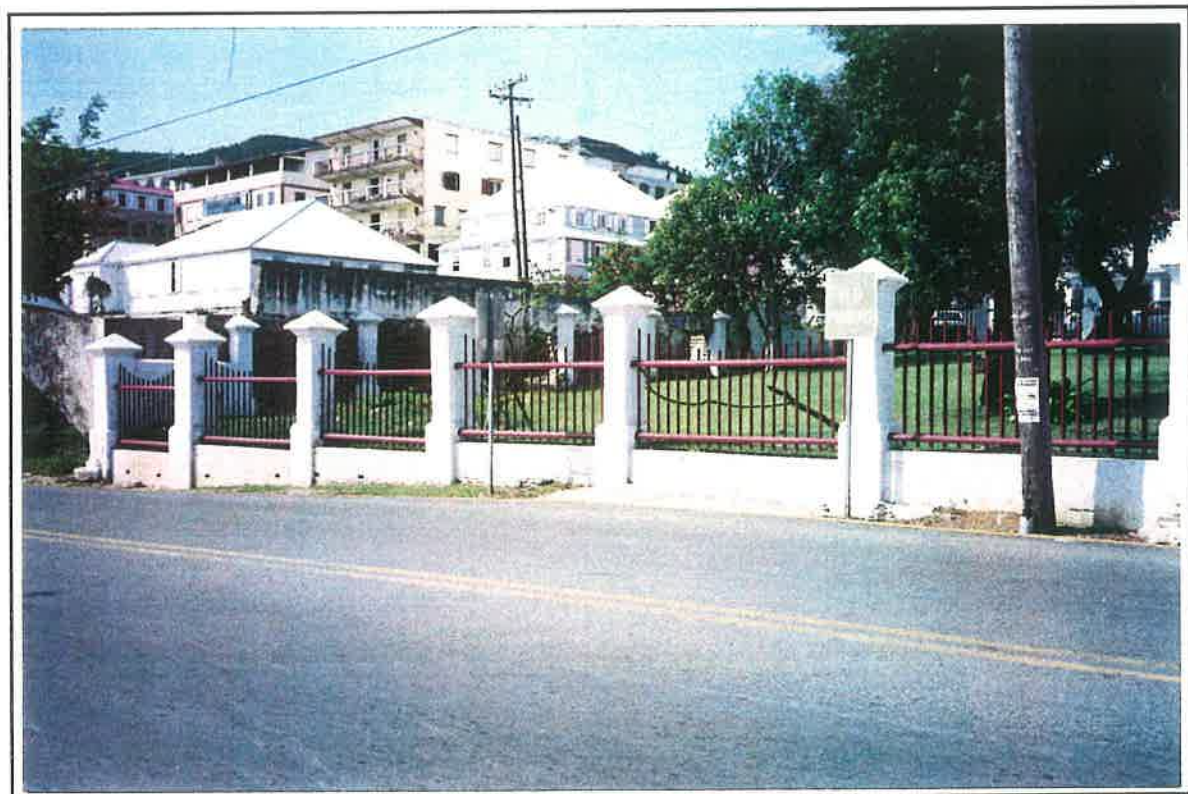
Steeple Building Fence following repairs by Field Services Unit

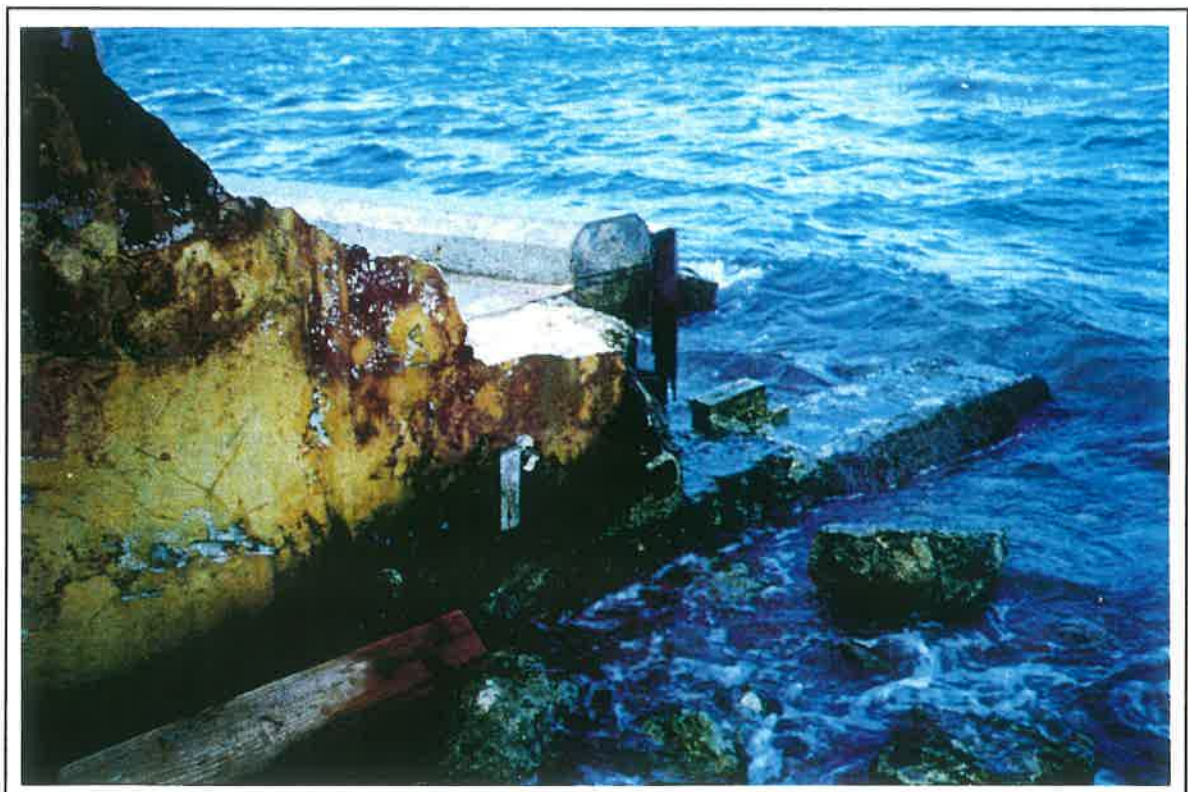
Concrete footing was repaired and reused for wingwall extension

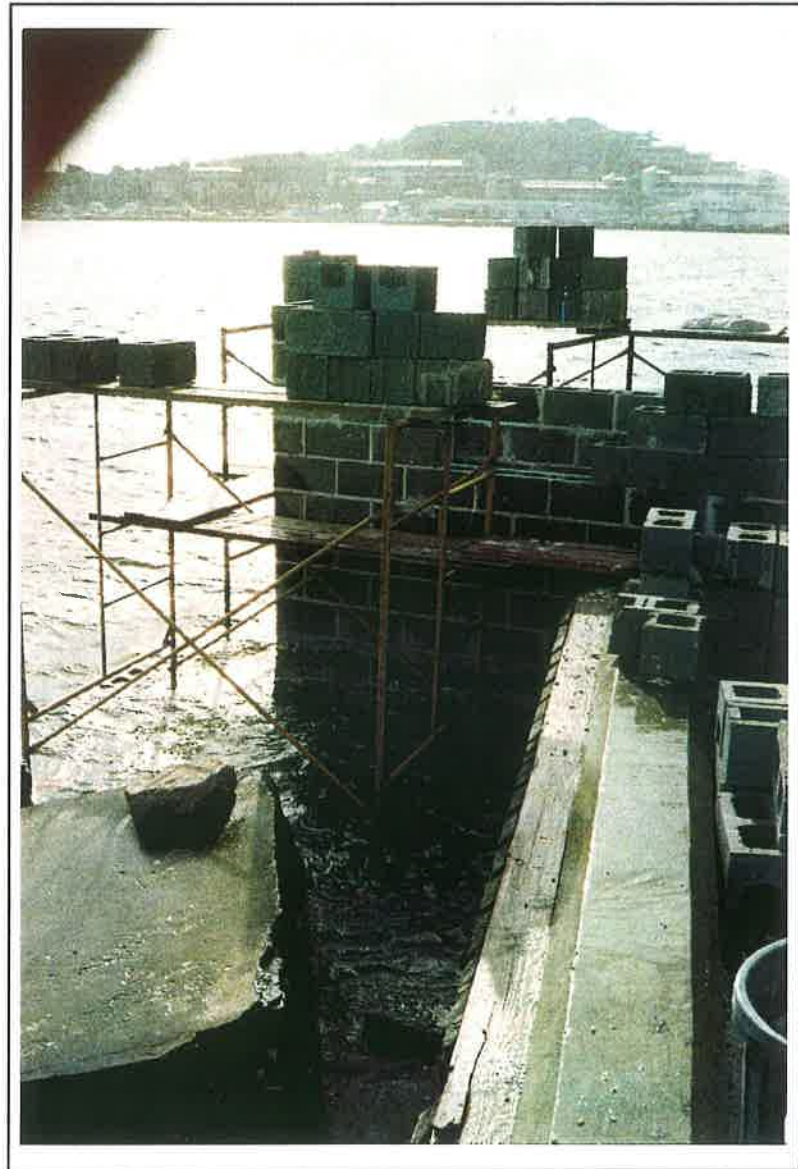
Scaffold was erected in the water in order to rebuild the wall

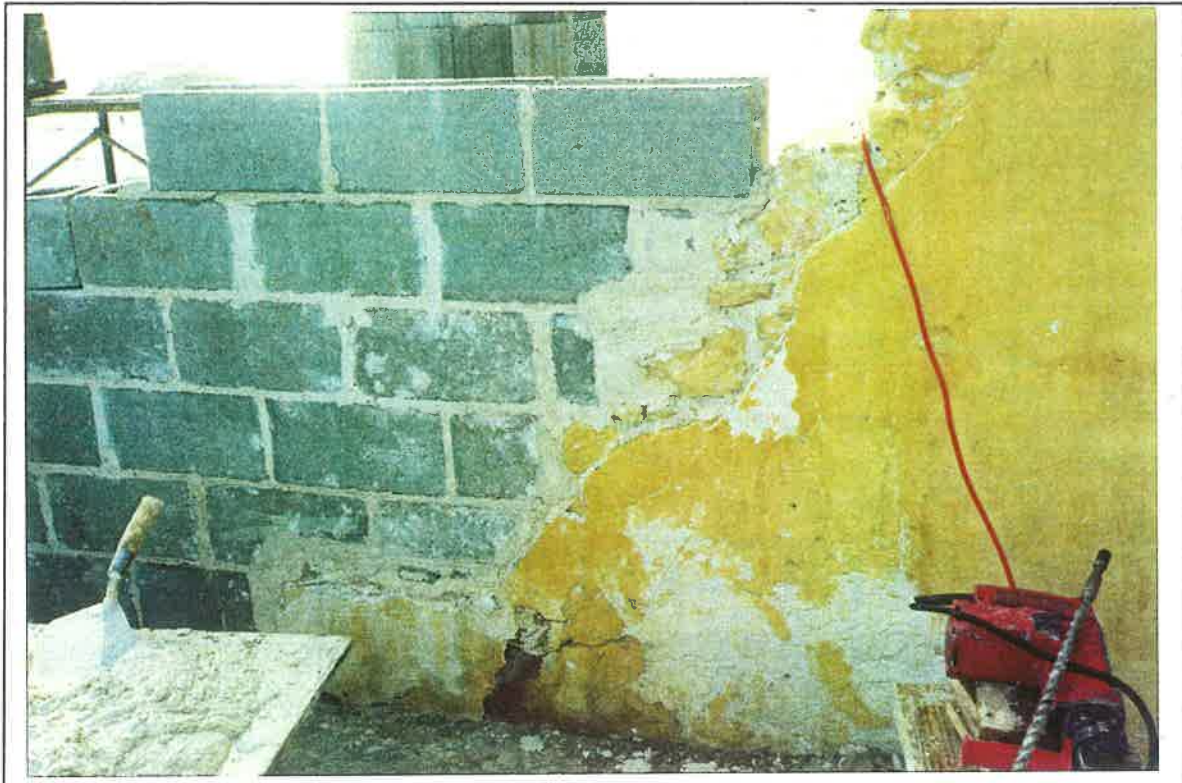
Concrete block was attached to the existing stone work with 3/4 inch galvanized rods anchored horizontally at 16 inch intervals

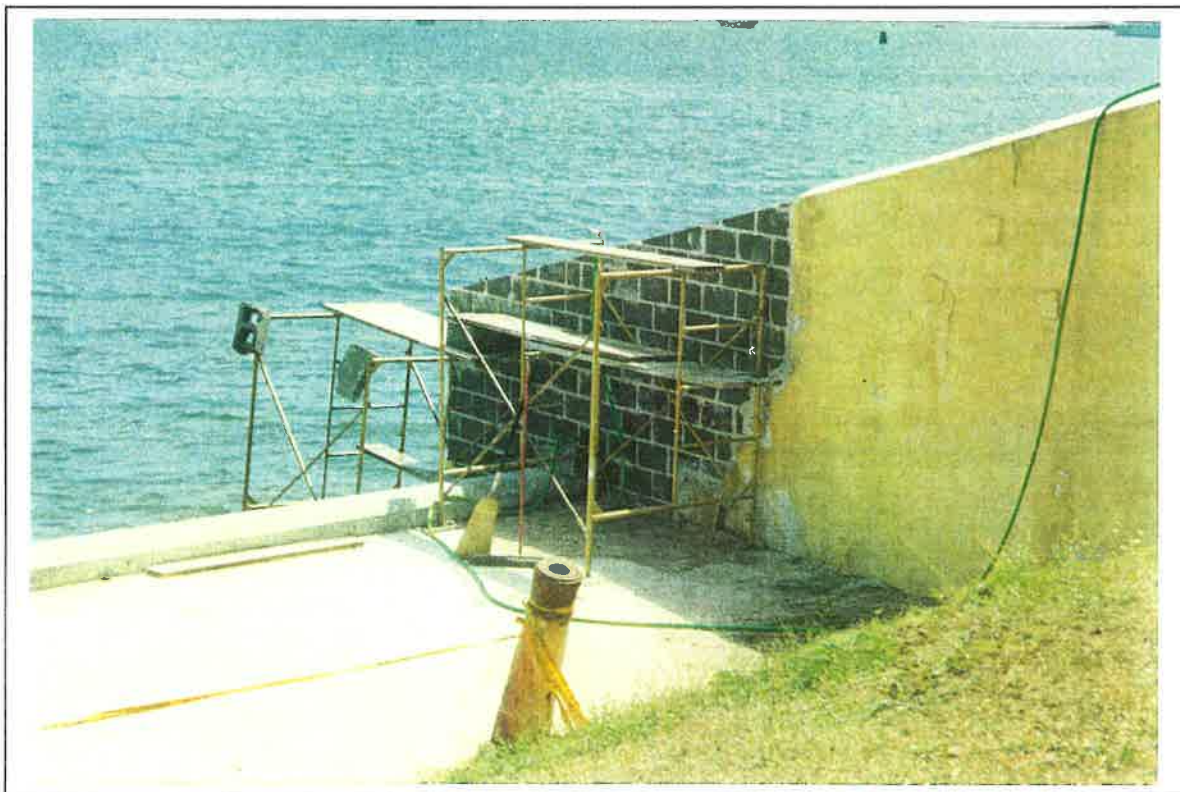
The finished wall prior to stucco application
