# **Initial Investigation into Microplastic Pollution in Lake McDonald, Glacier National Park**

**Brandon Barnes, Fisheries Technician Intern**

**Chris Downs, Aquatic and Physical Science Programs Manager**

**August, 2021**

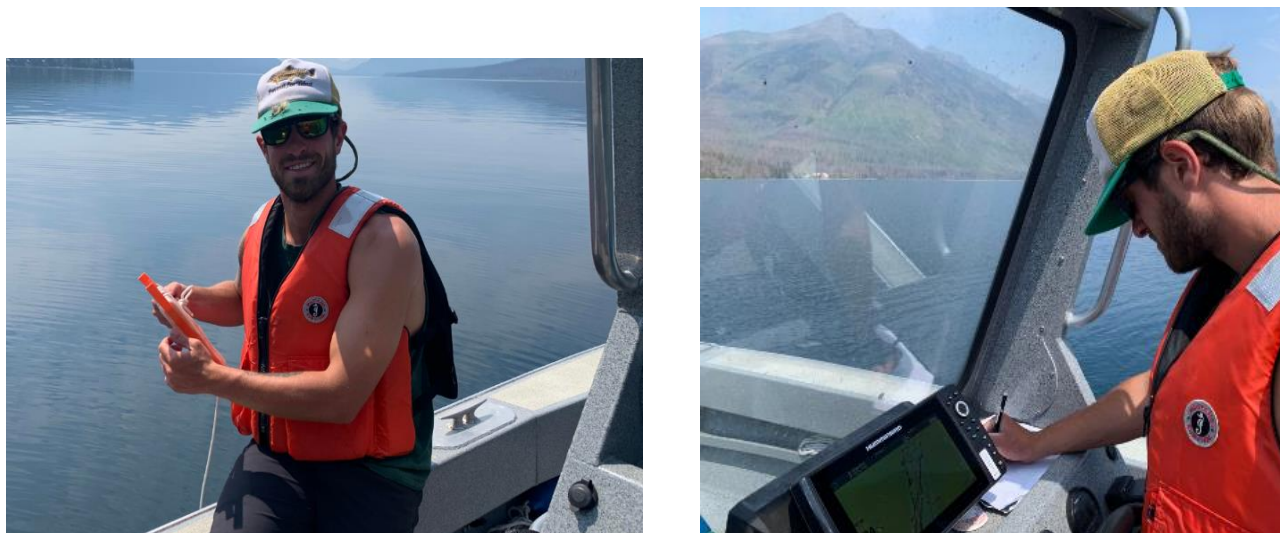
Figure 2. Deploying the plankton net and recording sample coordinates.

We used a 64 micron plankton net on a 20m rope to collect samples. Our sampling method involved recording the coordinates of each given point, dropping the net to the depth of 20 meters and retrieving it slowly allowing the net to capture plankton, debris and microplastics in the 1.41 m<sup>3</sup> of water sampled during each vertical tow (Figures 2 and 3). We remained careful not to create a pressure wave at the net entrance during the retrieval process that could interfere with sample collection.

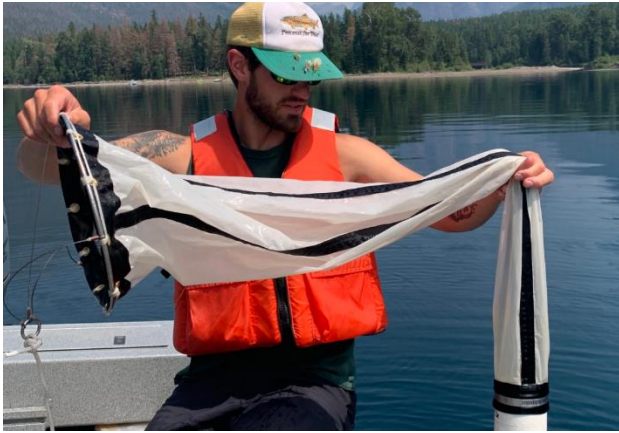
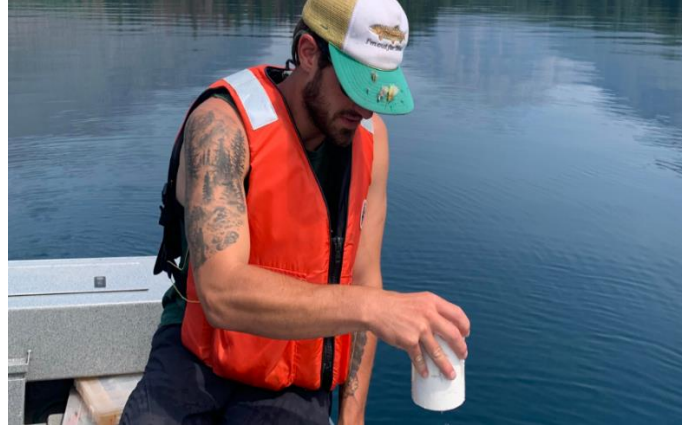
Figure 3. Retrieving the plankton net and decanting off much of the water to concentrate the sample.

Most of the water was decanted off and the remaining samples were poured into a 45 ml vial. Each sample was stored separately. At the office, each sample was poured through a white coffee filter and allowed to dry overnight on a shelf in an area of low use (to reduce the likelihood of contamination). Suspected microplastics were defined as particles <5mm in diameter or length (Driscoll et al. 2021) that appeared as colored threads or particles under the microscope. We used a 10X dissecting scope to sort through the samples and identify suspected microplastics (Figure 4). When a suspected microplastic was encountered, we use the "hot needle test" (Marine and Environmental Research Institute) to determine if the particle in question was likely plastic. Plastic reacts to a hot needle by curling and melting under the scope.

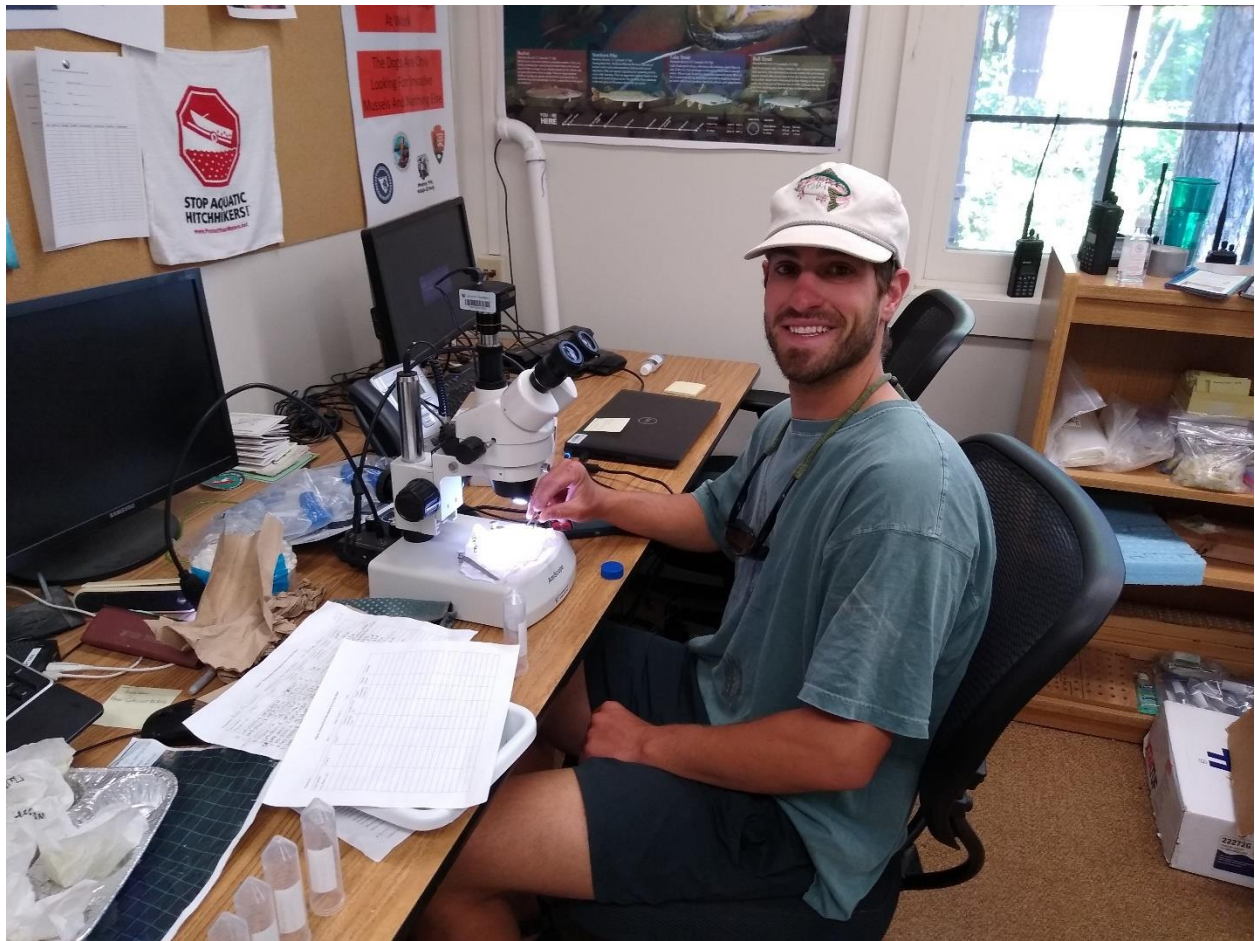
Figure 4. Sorting through each dried sample looking for microplastics.
