National Park Service  
Cultural Landscapes Inventory

2014

Peaks of Otter Lodge  
Blue Ridge Parkway

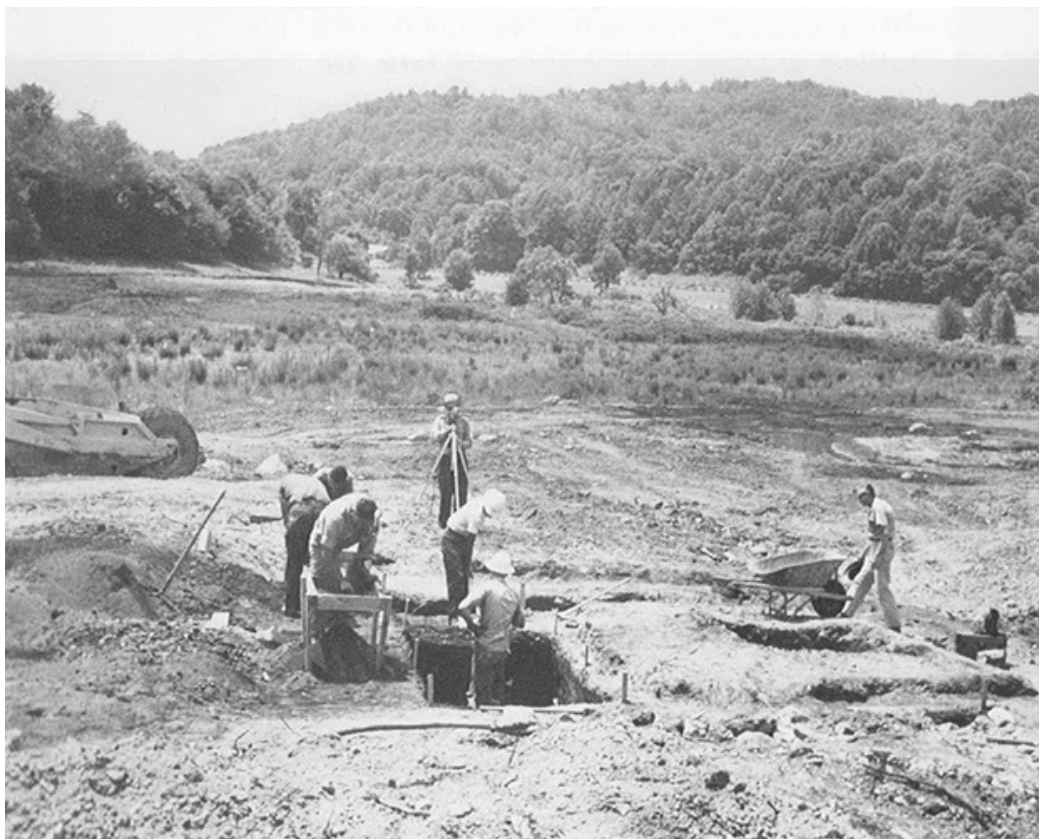
*FIGURE 7. An undated photo of the archeological investigation at the site of Abbott Lake (2012 Peaks of Otter Cultural Landscape Report).*

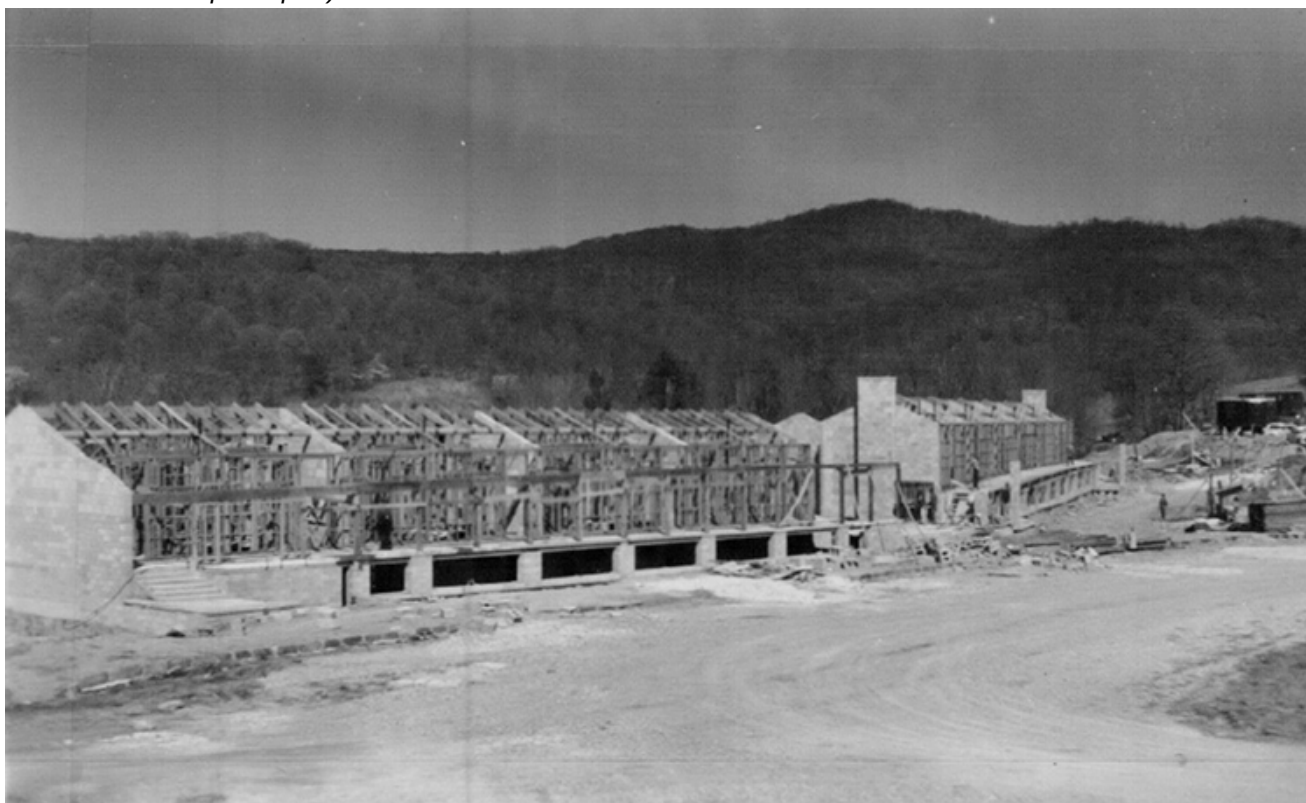
*FIGURE 8. The Peaks of Otter Lodge under construction in 1963 (2012 Peaks of Otter Cultural Landscape Report).*

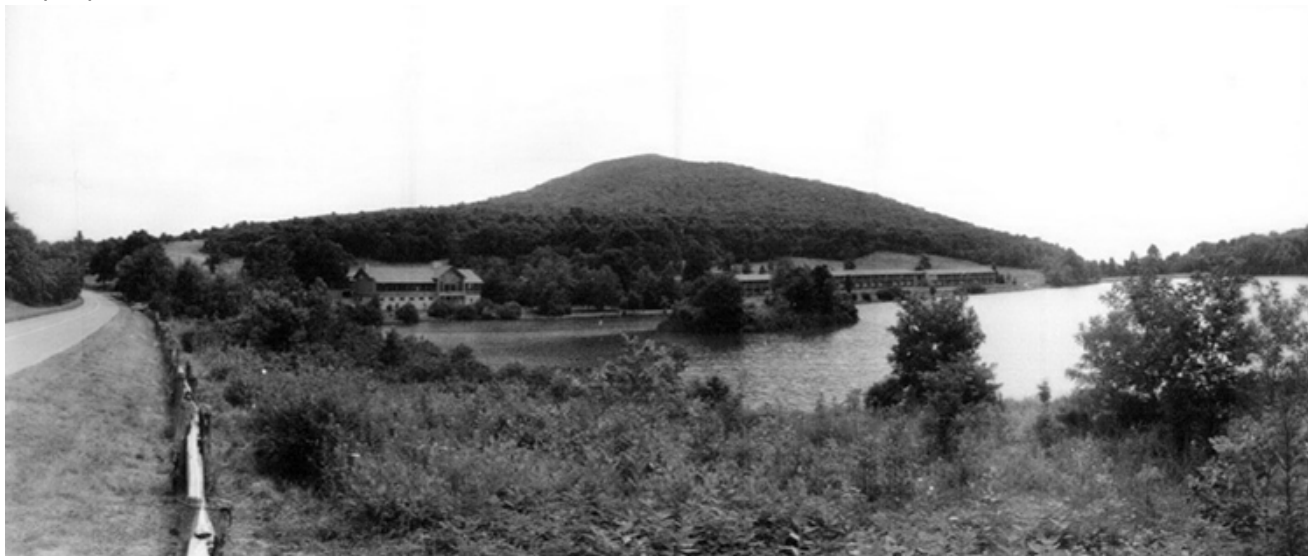
*FIGURE 9. A 1974 view of Abbott Lake with the Peaks of Otter Lodge in the background (2012 Peaks of Otter Cultural Landscape Report).*
