National Park Service  
Cultural Landscapes Inventory

2013

Humpback Gap and Trail  
Blue Ridge Parkway

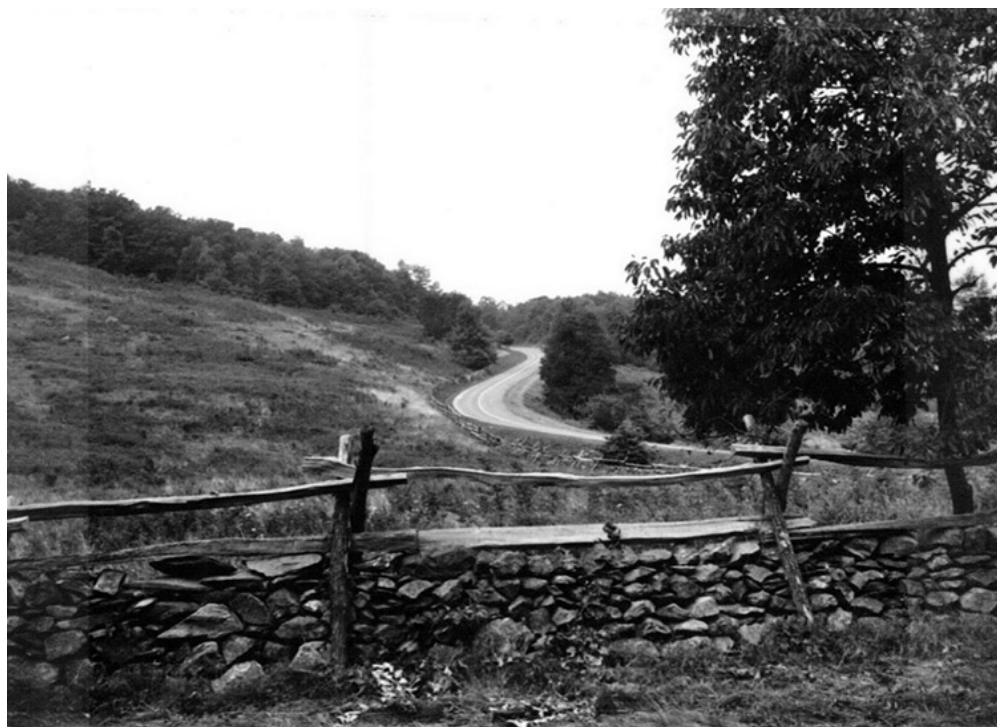
*FIGURE 13. The Blue Ridge Parkway from the Humpback Gap parking access road, 1973 (2012 Humpback Rocks Cultural Landscape Report).*

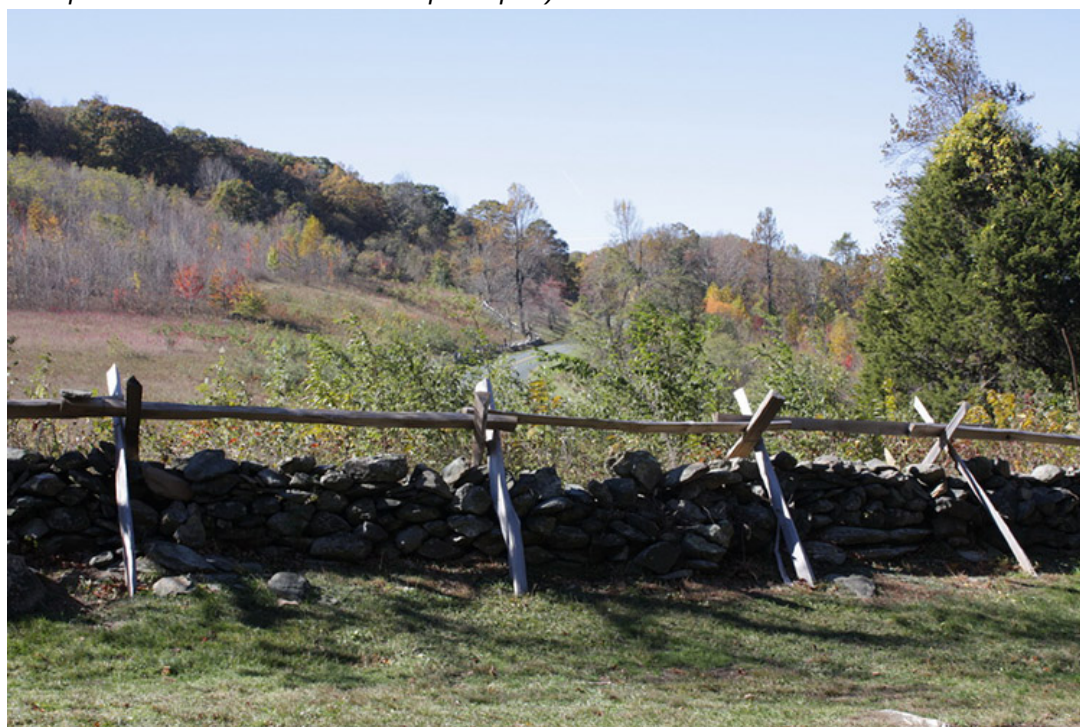
*FIGURE 14. The Blue Ridge Parkway from the Humpback Gap parking access road, 2010 (2012 Humpback Rocks Cultural Landscape Report).*

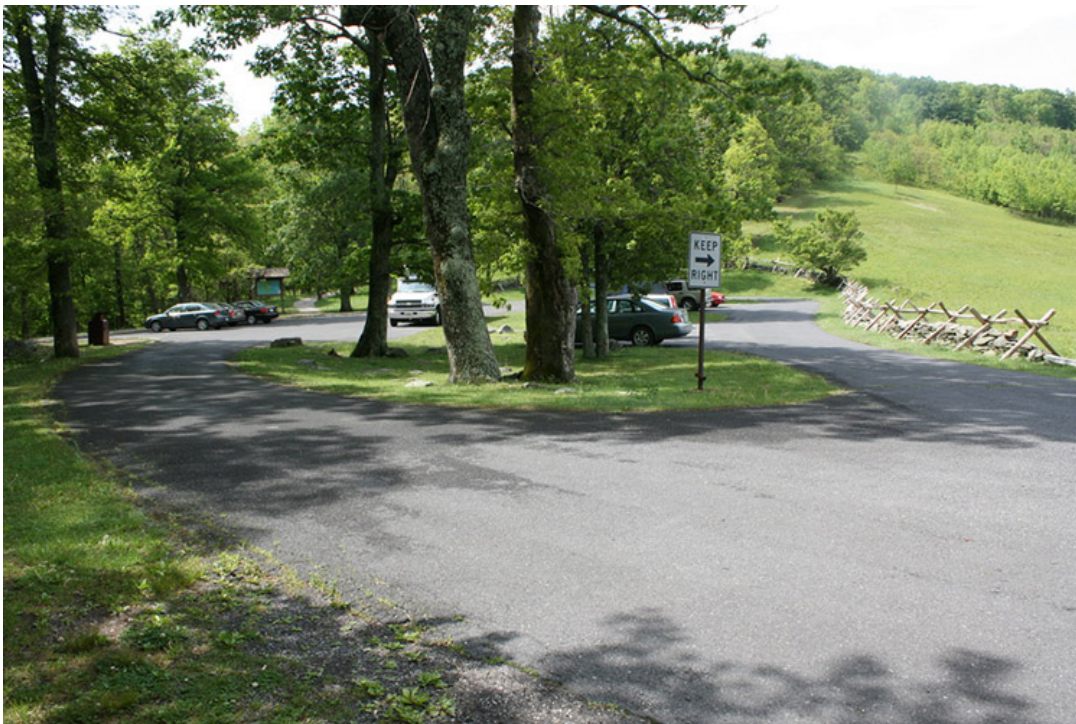
*FIGURE 17. The Humpback Gap parking area loop road and parking bays (2012 Humpback Rocks Cultural Landscape Report).*

The access road and parking area asphalt is cracked and uneven.

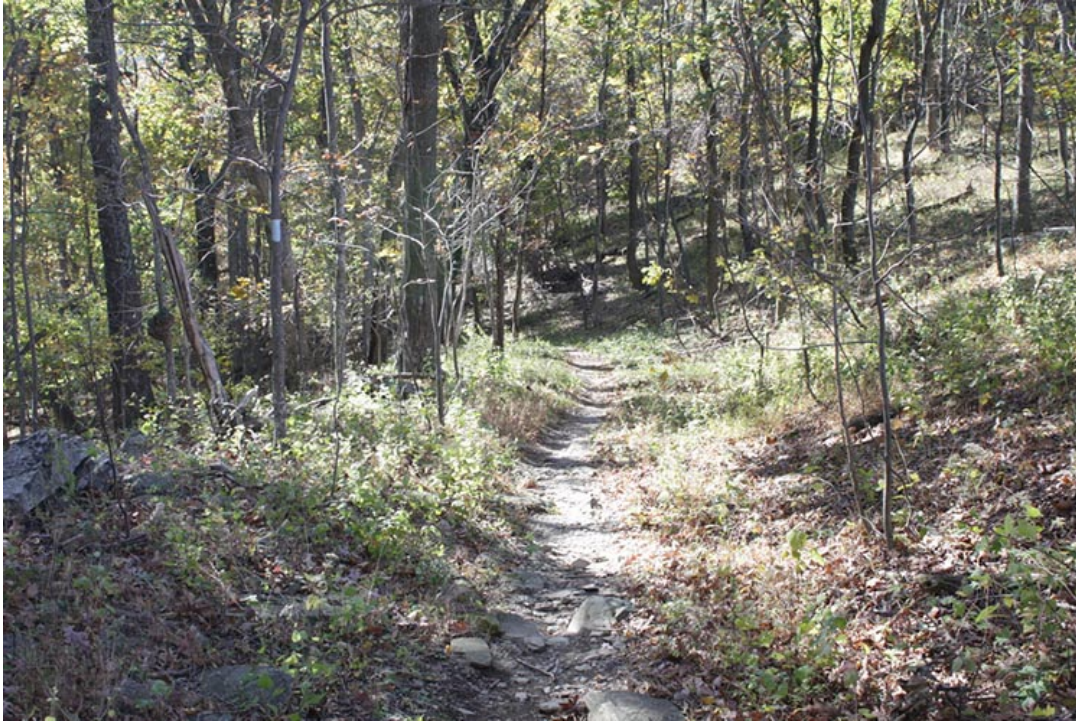
*FIGURE 20. The Appalachian Trail connector trail (2012 Humpback Rocks Cultural Landscape Report).*

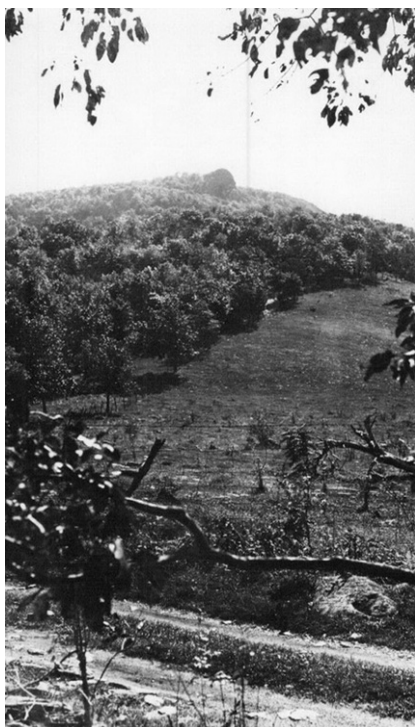
*FIGURE 21. View of Humpback Rocks with a dirt road in the foreground (possibly the Howardsville Turnpike) (2012 Humpback Rocks Cultural Landscape Report).*

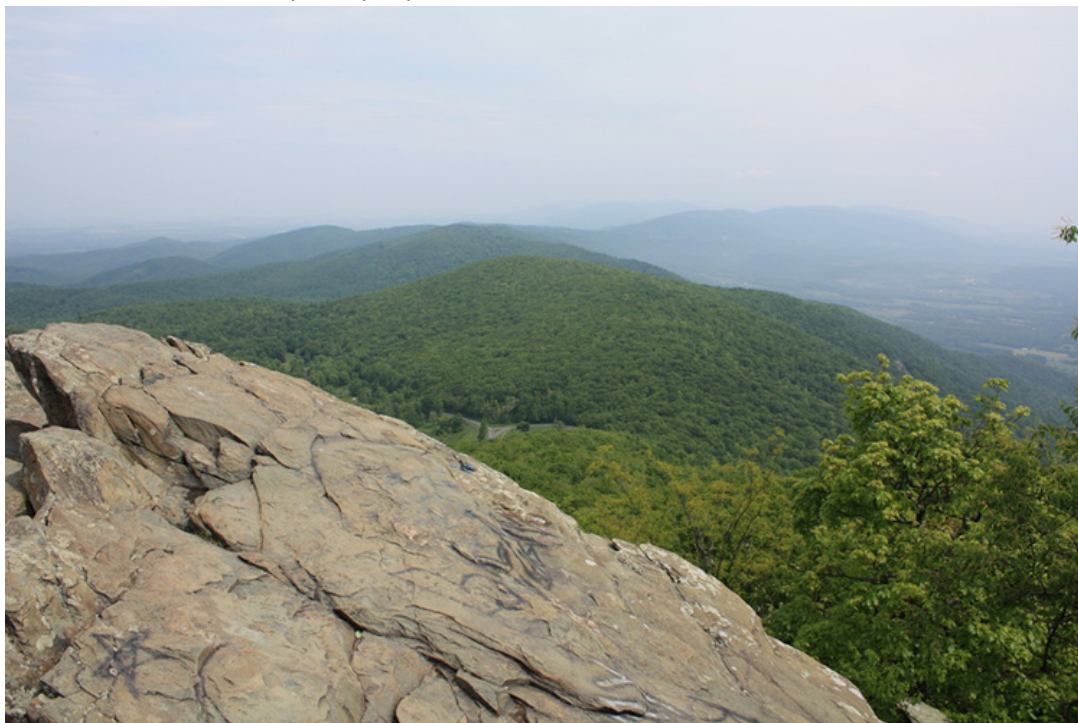
*FIGURE 24. View north of the parking area and the parkway from Humpback Rocks (2012 Humpback Rocks Cultural Landscape Report).*

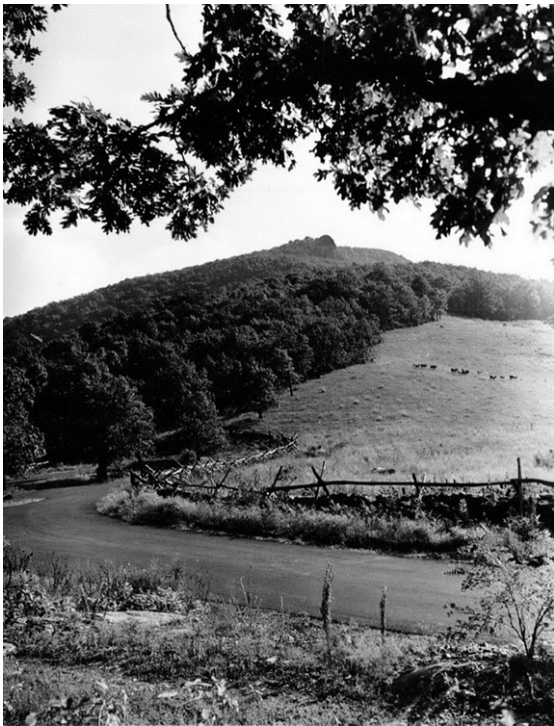
*FIGURE 25. Humpback Rocks and Humpback Gap parking access road, 1953 (2012 Humpback Rocks Cultural Landscape Report).*

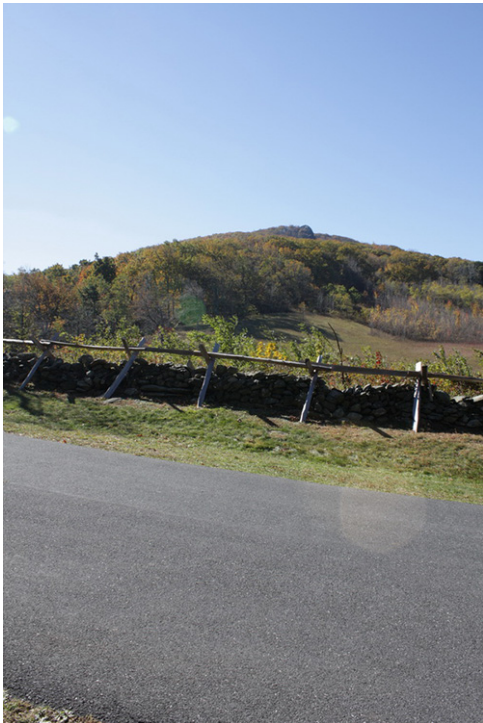
*FIGURE 26. Humpback Rocks and Humpback Gap parking access road, 2010 (2012 Humpback Rocks Cultural Landscape Report).*

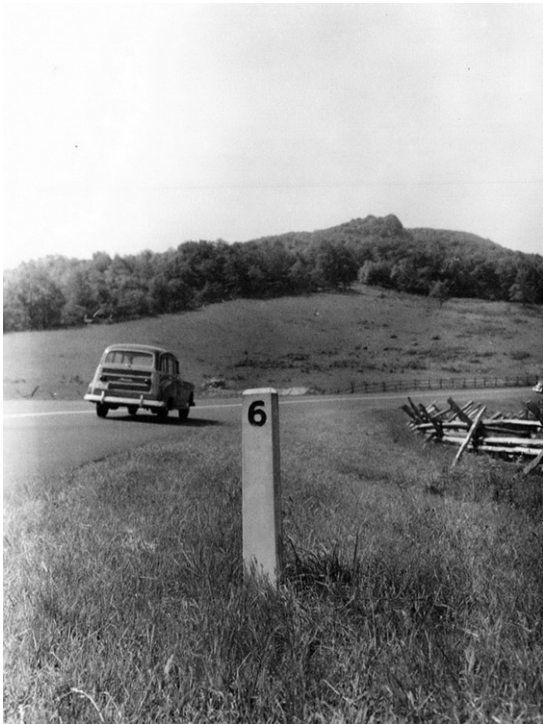
*FIGURE 27. View of Humpback Rocks with marker for milepost 6 along the Blue Ridge parkway, 1953 (2012 Humpback Rocks Cultural Landscape Report).*

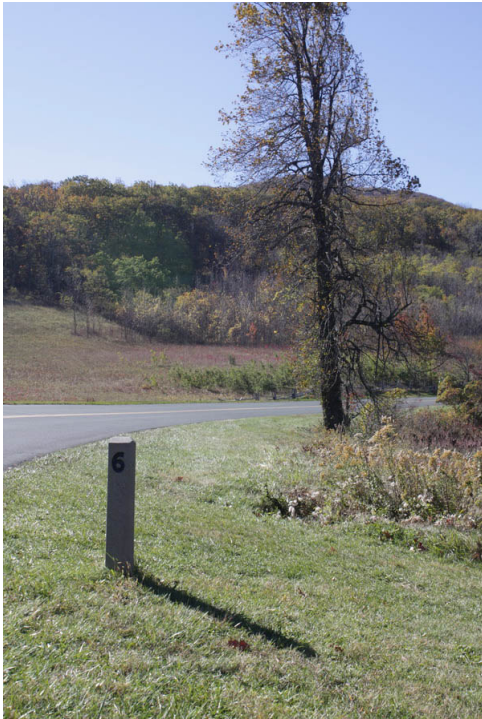
*FIGURE 28. View of Humpback Rocks with marker for milepost 6 along the Blue Ridge parkway, 2010 (2012 Humpback Rocks Cultural Landscape Report).*

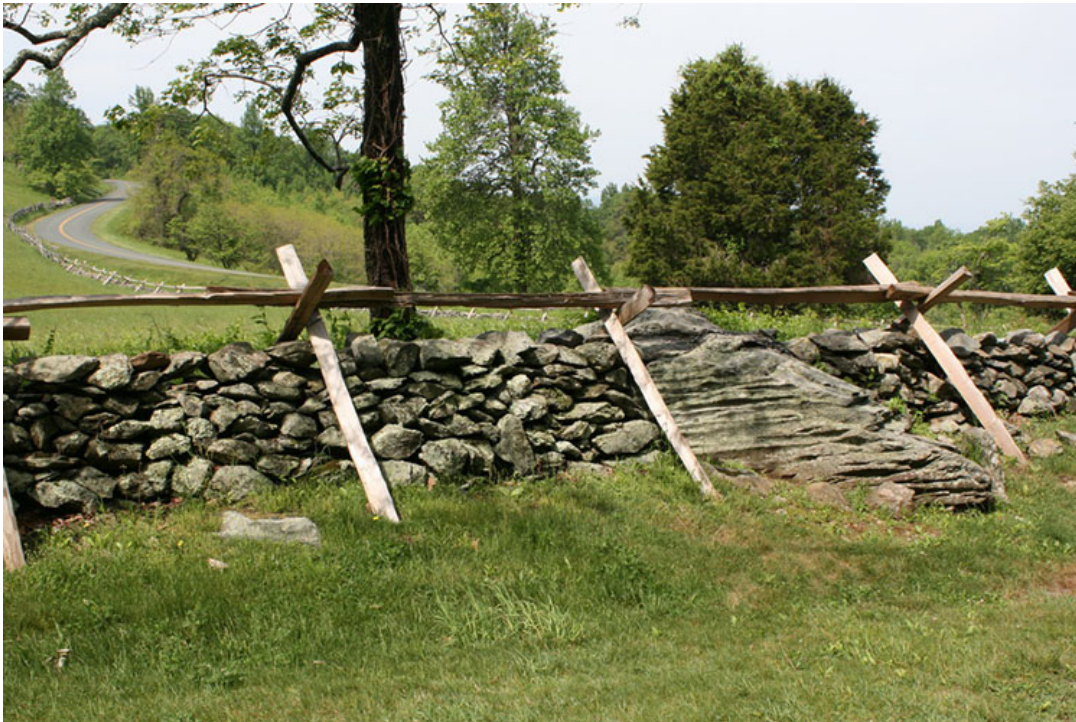
**Fences and Gates.** The fences that appear to survive from the period of significance in the Humpback Gap and Trail component landscape include the stake and rider fencing associated with the fieldstone wall around the meadow below Humpback Rocks, the remnant fieldstone hog wall along the slope up to Humpback Rocks, and the metal gate limiting access to the Howardsville Turnpike. These fences and gates contribute to the significance of the historic landscape, although it is likely that many of the individual wooden components have been replaced over time due to their tendency to deteriorate in the humid climate. The park appears to have attempted to replace these materials in kind as possible.

*FIGURE 29. A rock outcrop set within the stone and rider fence along the Humpback Gap parking area road (2012 Humpback Rocks Cultural Landscape Report).*

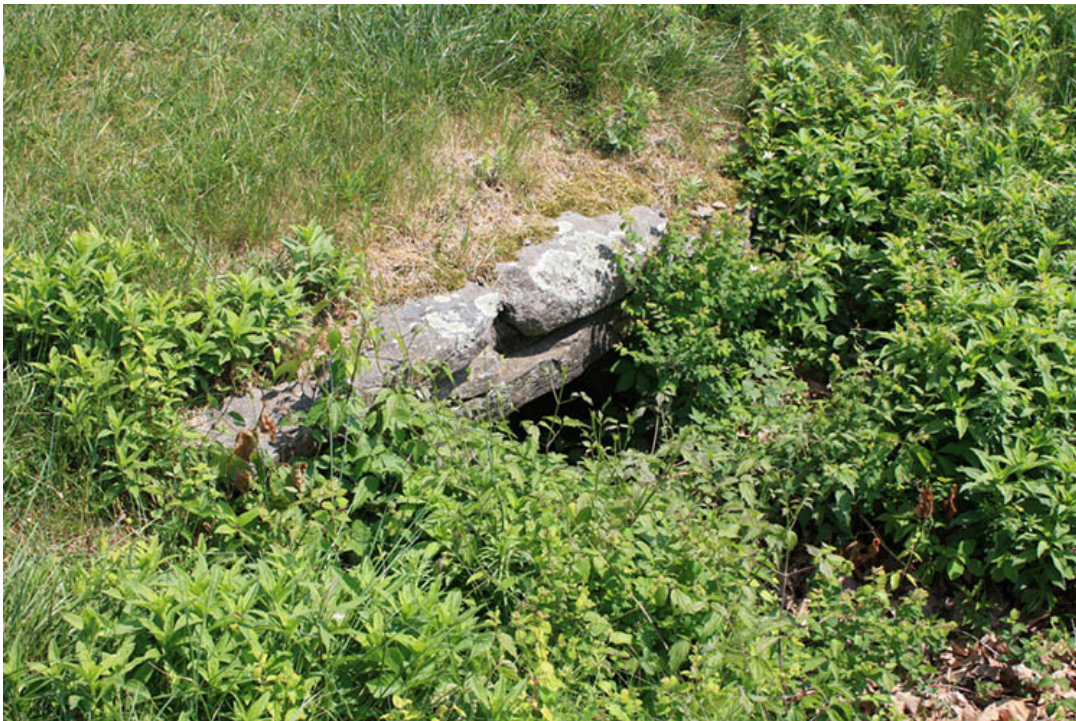
*FIGURE 30. A stone-faced headwall associated with a culvert conveying stormwater under the parkway (2012 Humpback Rocks Cultural Landscape Report).*

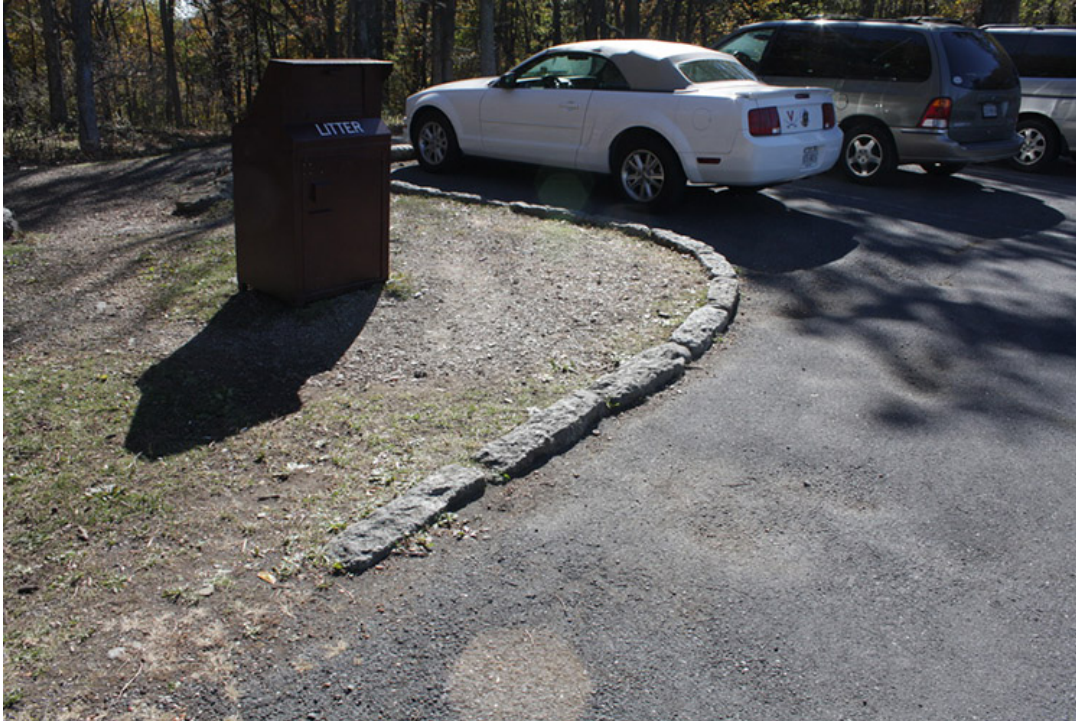
*FIGURE 31. Stone curbing edges the parking area and tapers to meet the asphalt; bear proof trash receptacle post-dates the period of significance (2012 Humpback Rocks Cultural Landscape Report).*

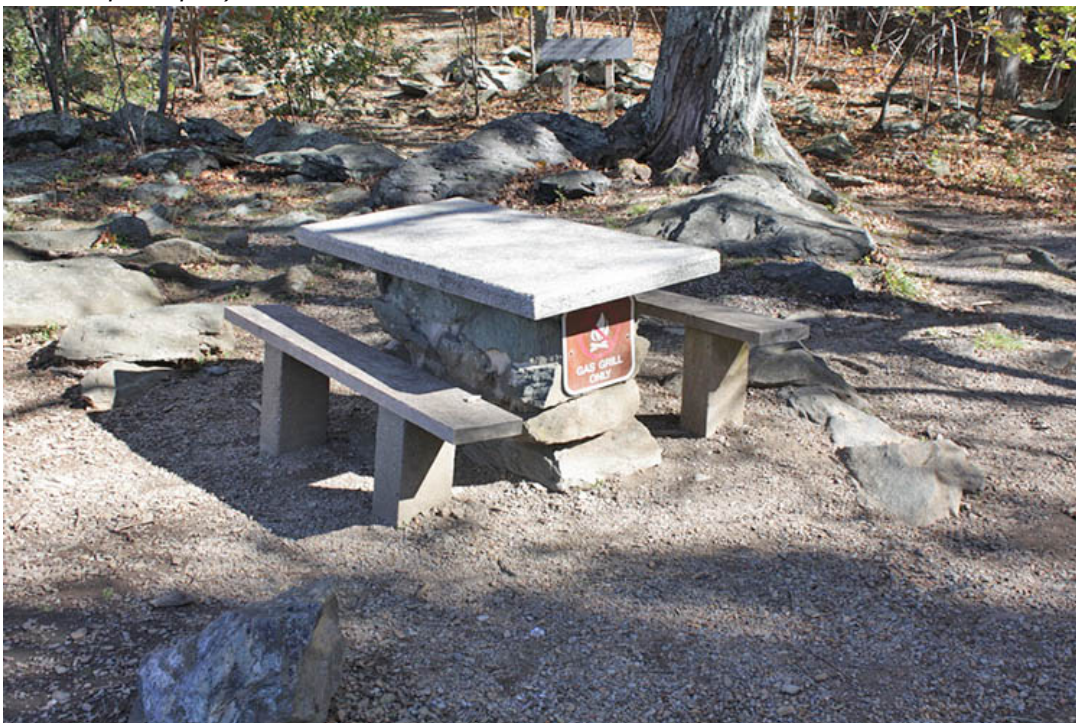
*FIGURE 32. The picnic table at Humpback Gap parking area (2012 Humpback Rocks Cultural Landscape Report).*

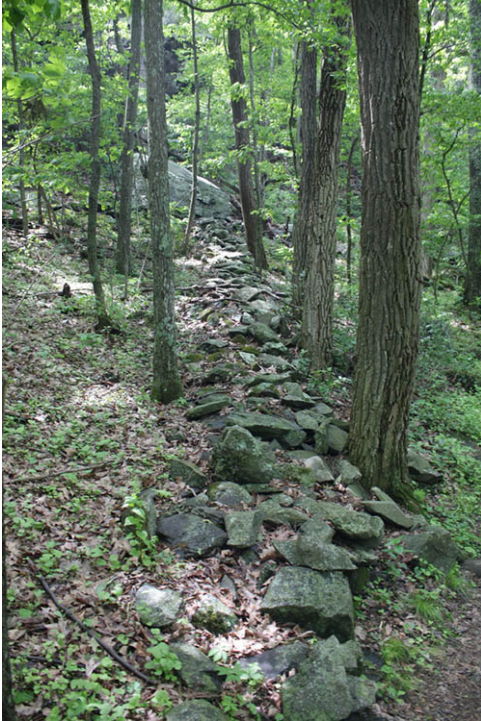
*FIGURE 33. A remnant hog-wall along the Humpback Rocks Trail (2012 Humpback Rocks Cultural Landscape Report).*

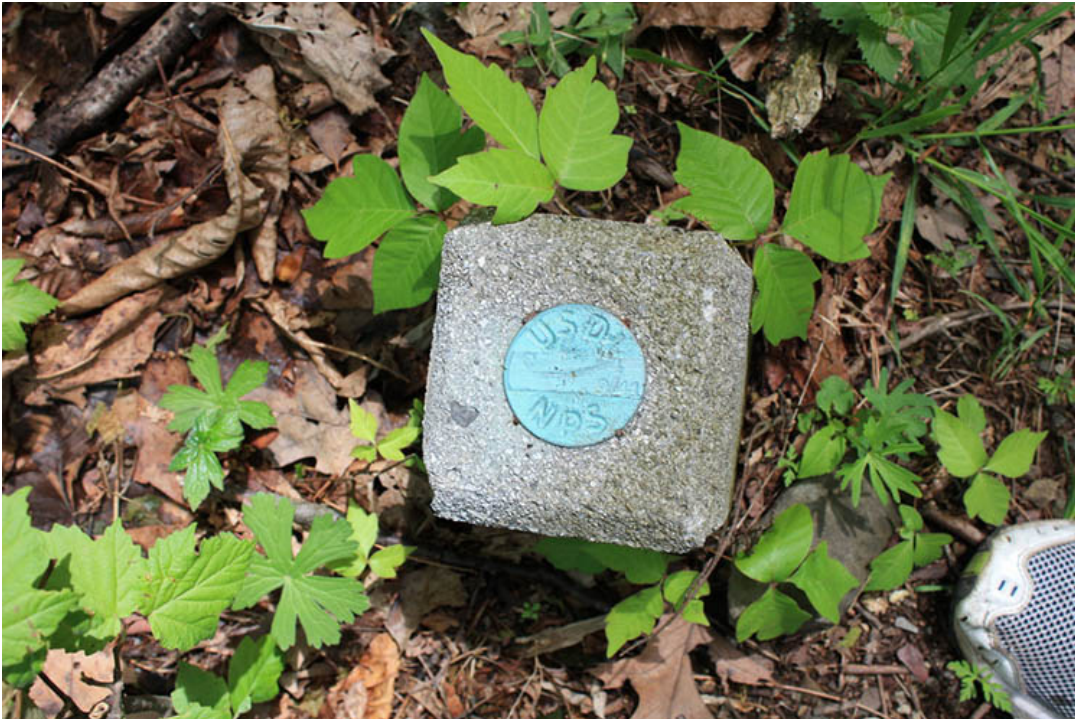
*FIGURE 34. A concrete boundary marker dated September 1941 near the start of the Humpback Rocks Trail (2012 Humpback Rocks Cultural Landscape Report).*
