National Park Service  
Cultural Landscapes Inventory

Humpback Rocks Mountain Farm  
Blue Ridge Parkway

## Cultural Landscape Summary & Site Plan

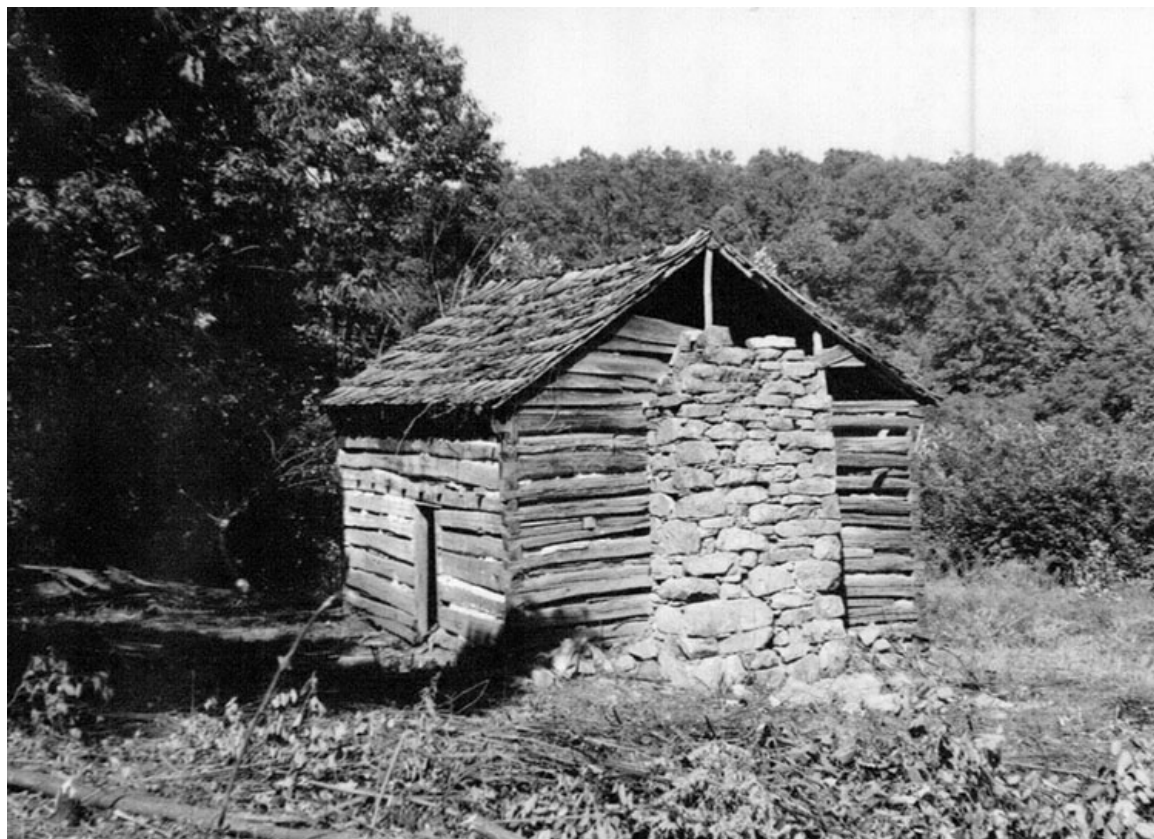
*FIGURE 6. An undated photo of the William Ramsey house at its original location (2012 Humpback Rocks Cultural Landscape Report).*

In 1950, an inventory of the Ramsey Cabin conducted by the National Park Service indicated that the house featured four rooms on two floors, with a vertical board sheathed north wing containing a kitchen. A porch elevated on 'log stilts' extended wider than the front of the house. The dwelling stood on a stone foundation containing a cellar. Vandals had stripped the house of its staircase and some flooring. (Speer and Haskell 1999, 175) The description also suggested that the cabin contained a hall-chamber or two room plan on the first floor, with additions dating to the early twentieth century. The two-room plan with added frame wing resembled the house at the Johnson Farm at Peaks of Otter and

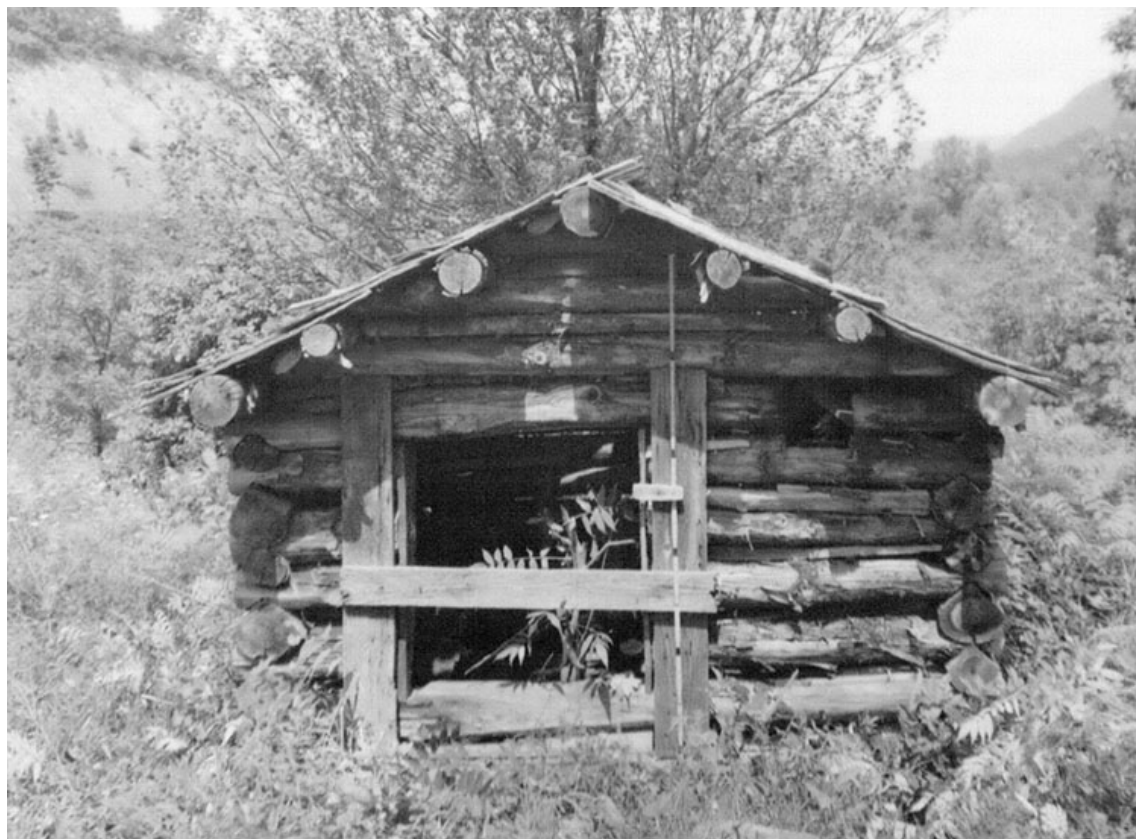
*FIGURE 9. The chicken house at the John C. Clark Farm in 1952 before relocation to Humpback Rocks (2012 Humpback Rocks Cultural Landscape Report).*

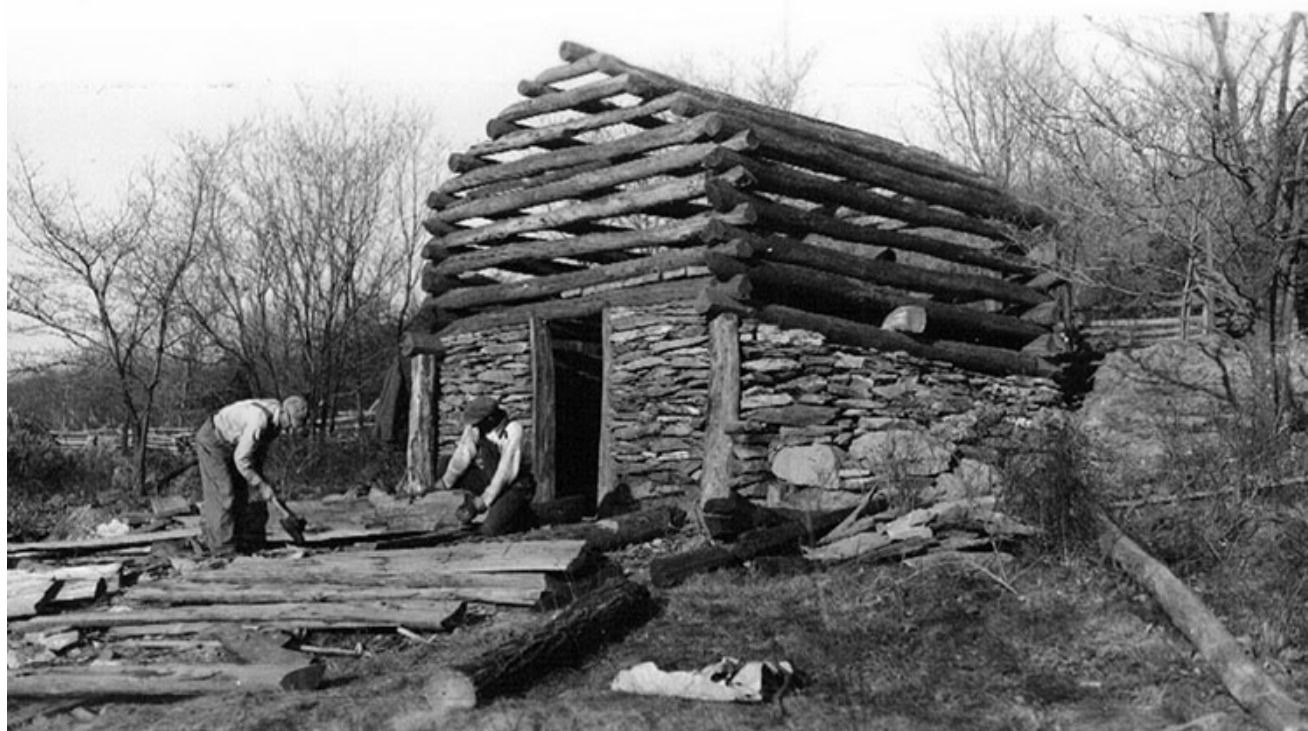
*FIGURE 10. Rehabilitation of the root cellar at Humpback Rocks in 1953 (2012 Humpback Rocks Cultural Landscape Report).*

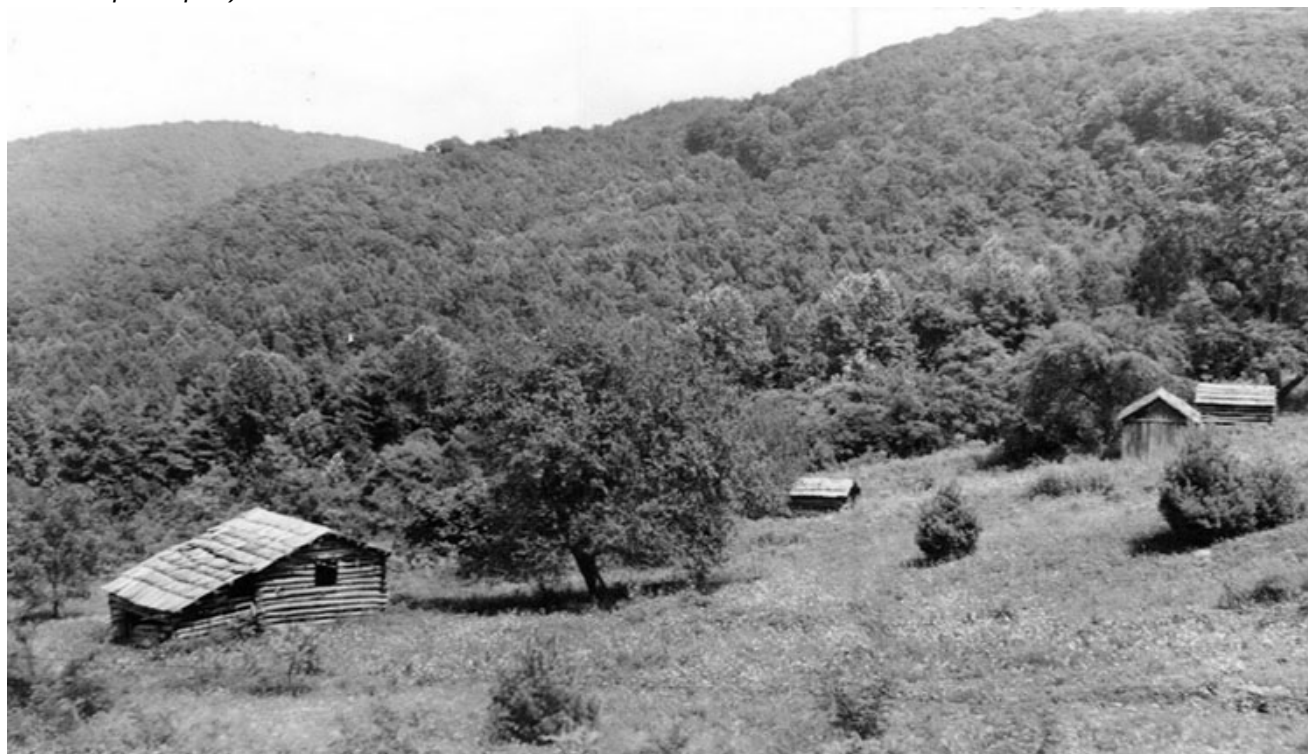
*FIGURE 11. A view of the John C. Clark farm in 1952, before the moving of farm structures (2012 Humpback Rocks Cultural Landscape Report).*

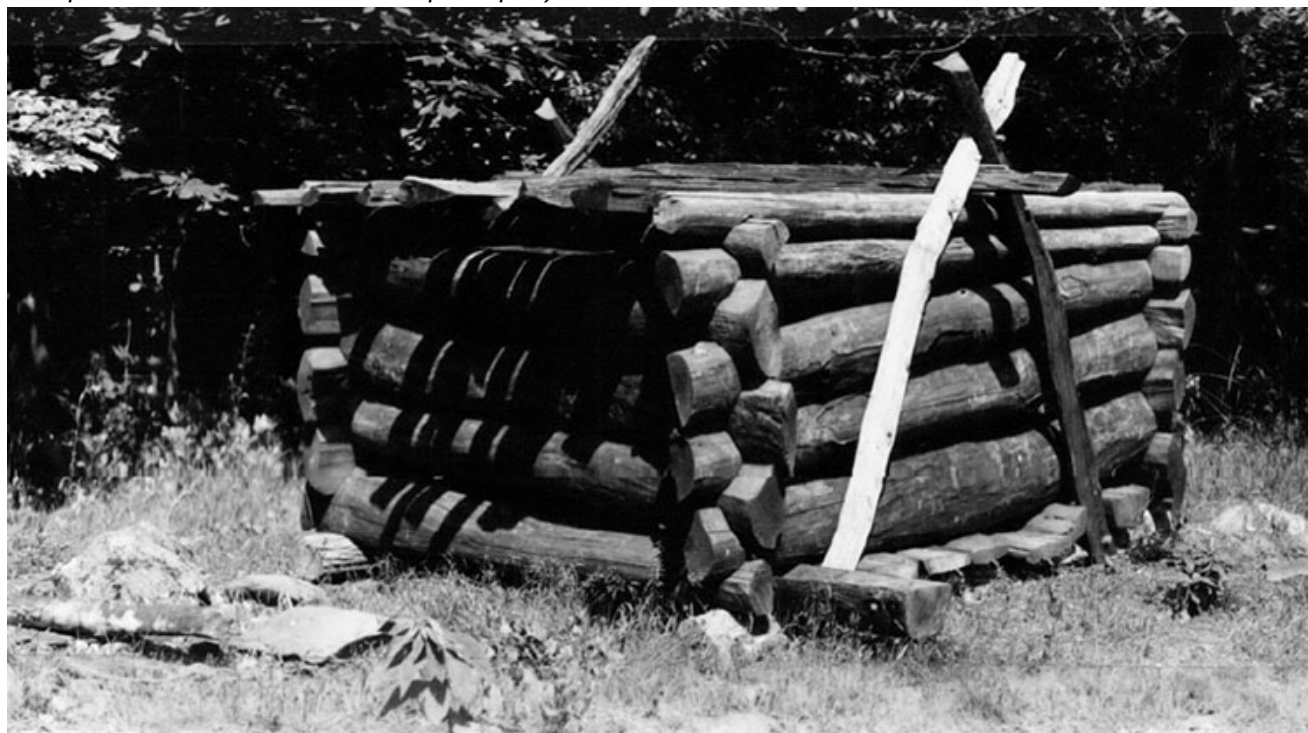
*FIGURE 14. The newly constructed reproduction pig pen at Humpback Rocks in 1953 (2012 Humpback Rocks Cultural Landscape Report).*

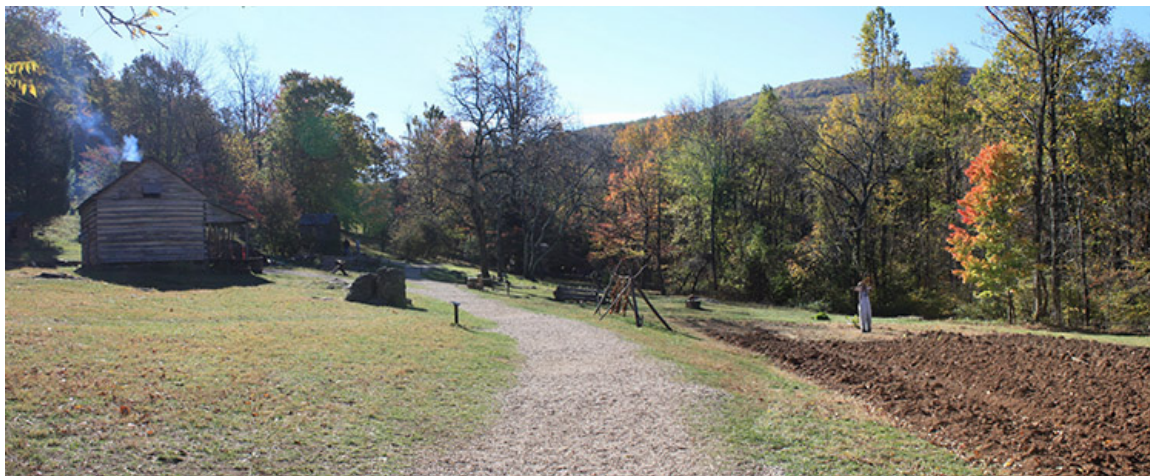
*FIGURE 23. A view of the Mountain Farm exhibit including the log cabin, agricultural field, and trail (2012 Humpback Rocks Cultural Landscape Report).*

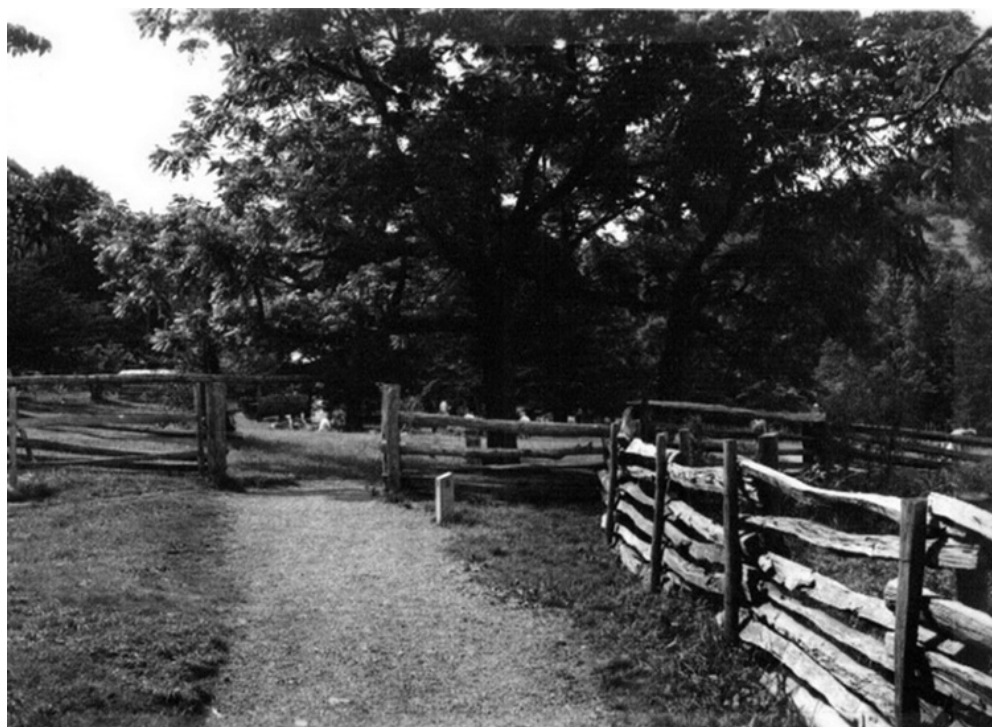
*FIGURE 25. Walk to Mountain Farm exhibit, 1973 (2012 Humpback Rocks Cultural Landscape Report).*

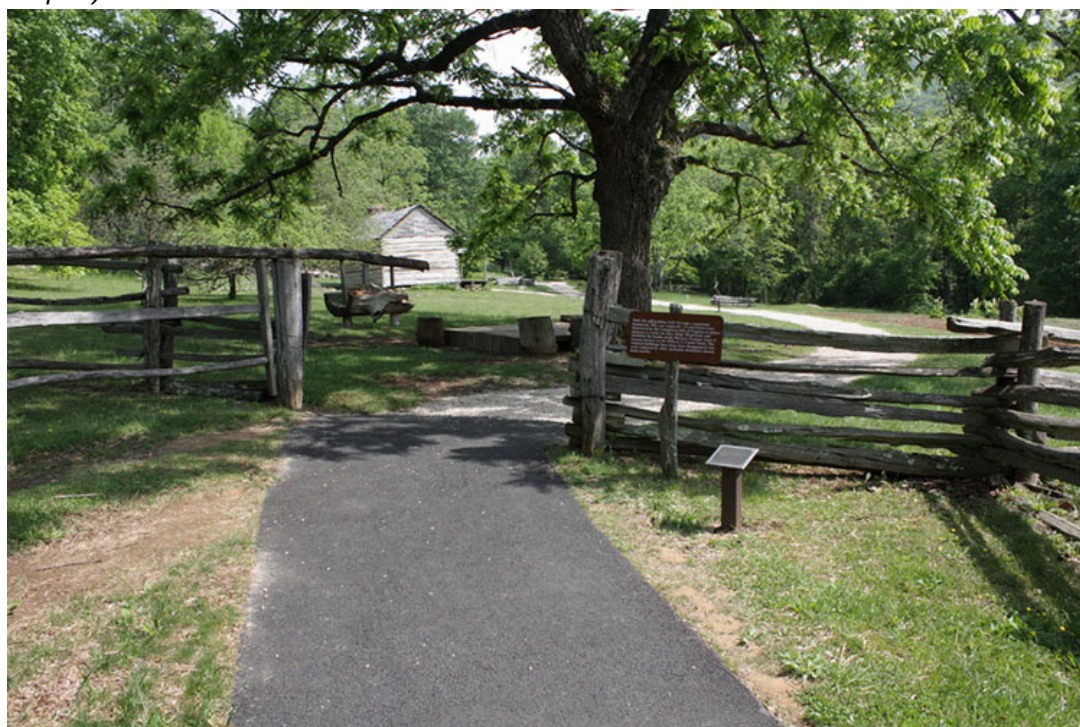
*FIGURE 26. Walk to Mountain Farm exhibit, 2010 (2012 Humpback Rocks Cultural Landscape Report).*

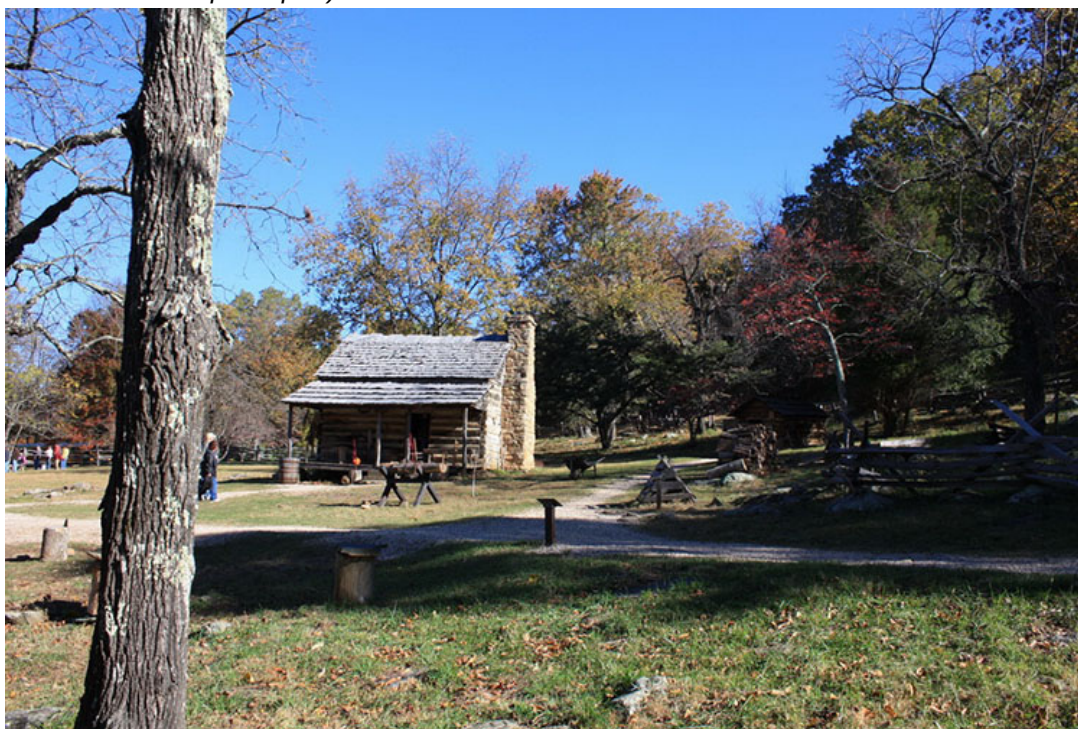
*FIGURE 28. Log cabin at the Mountain Farm exhibit, 2010 (2012 Humpback Rocks Cultural Landscape Report).*

The interior features a plank floor, exposed hewn pole joists, and a loft space accessed by a ladder. The building is generally in good condition as a result of ongoing cyclical maintenance by parkway facilities staff.

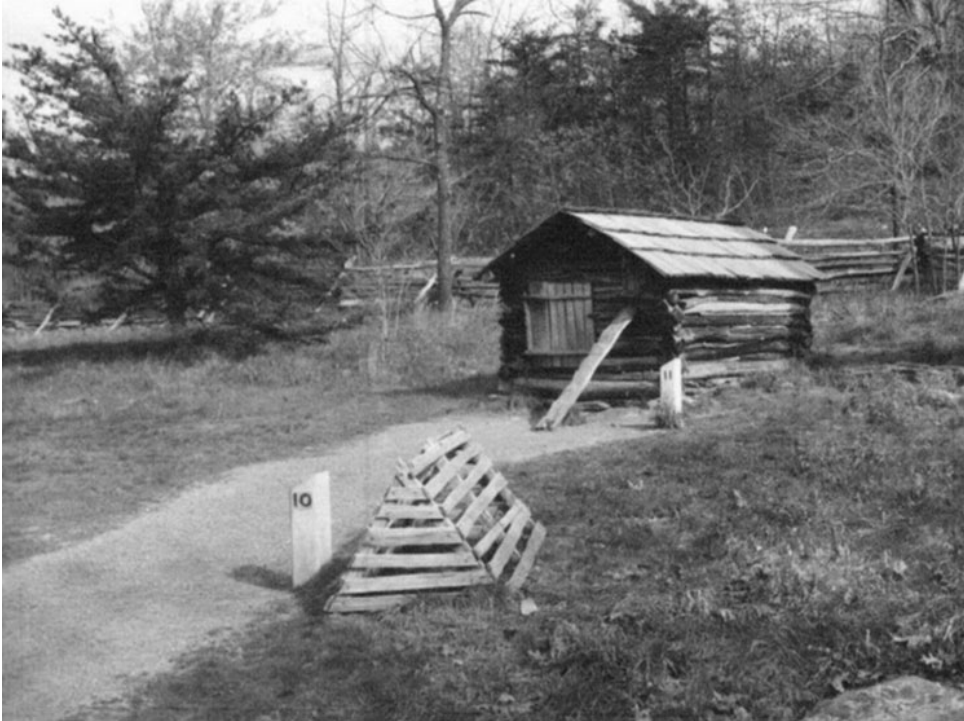
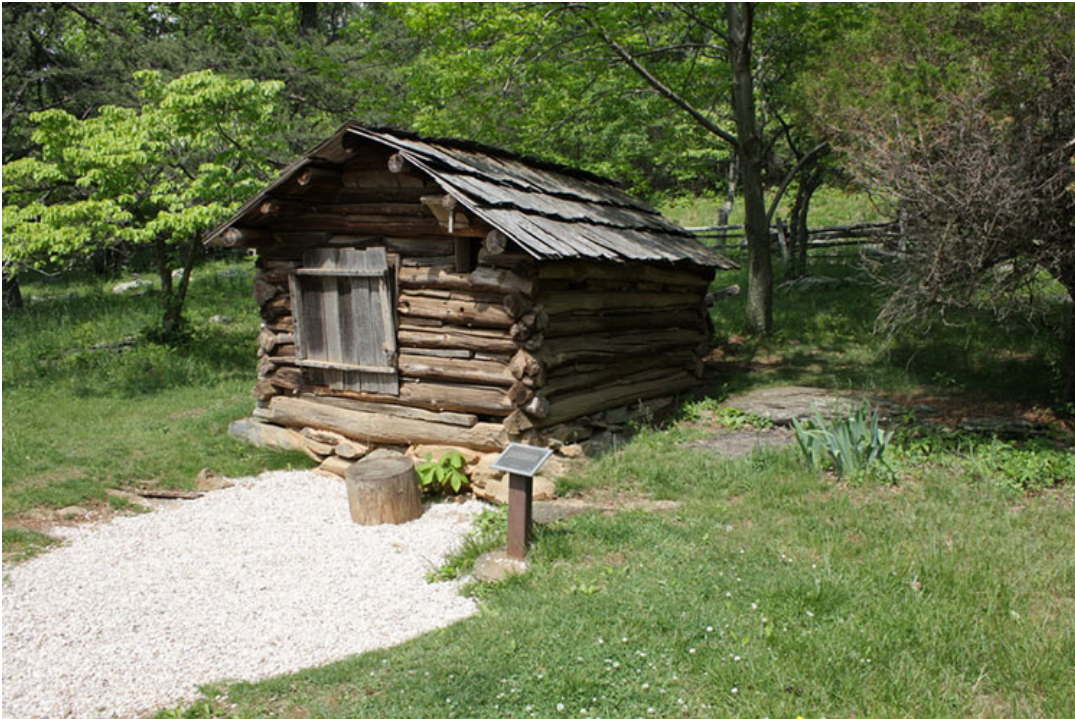
*FIGURE 29. The chicken house at the Mountain Farm exhibit, 1971 (2012 Humpback Rocks Cultural Landscape Report).*

*FIGURE 30. The chicken house at the Mountain Farm exhibit, 2010 (2012 Humpback Rocks Cultural Landscape Report).*

Mountain Farm chicken house. (LCS ID005130). The Mountain Farm chicken house is approximately 8 by 10 feet in size. It is a rectangular log pen structure with round logs set with V-shaped notches at the corners. The walls are chinked with split wood poles held in place by locust wedges intended to prevent access by predators. The roof is composed of log purlins supported on log gable ends and covered with wood shakes. The structure stands on a low limestone rubble foundation.

There are two doors set within the front facade. The larger door is set low and off-center, hung by wooden pintles, and contains pegged jambs. The smaller door hangs on leather hinges. It is set more than 4 feet above the ground and was accessed by a chicken ladder, now missing. It is generally in good condition.

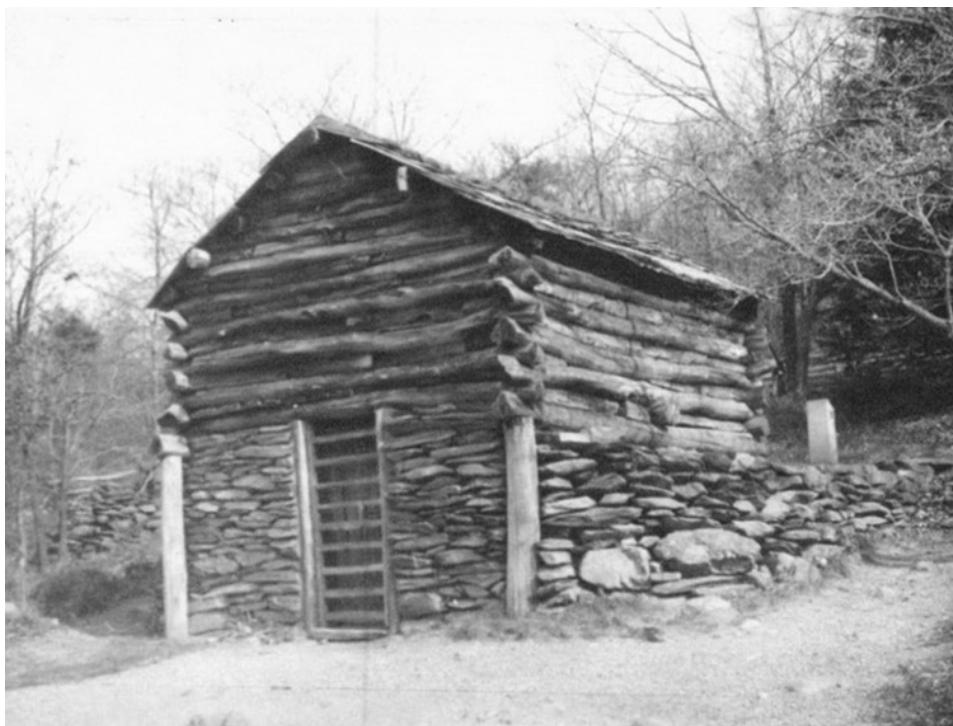
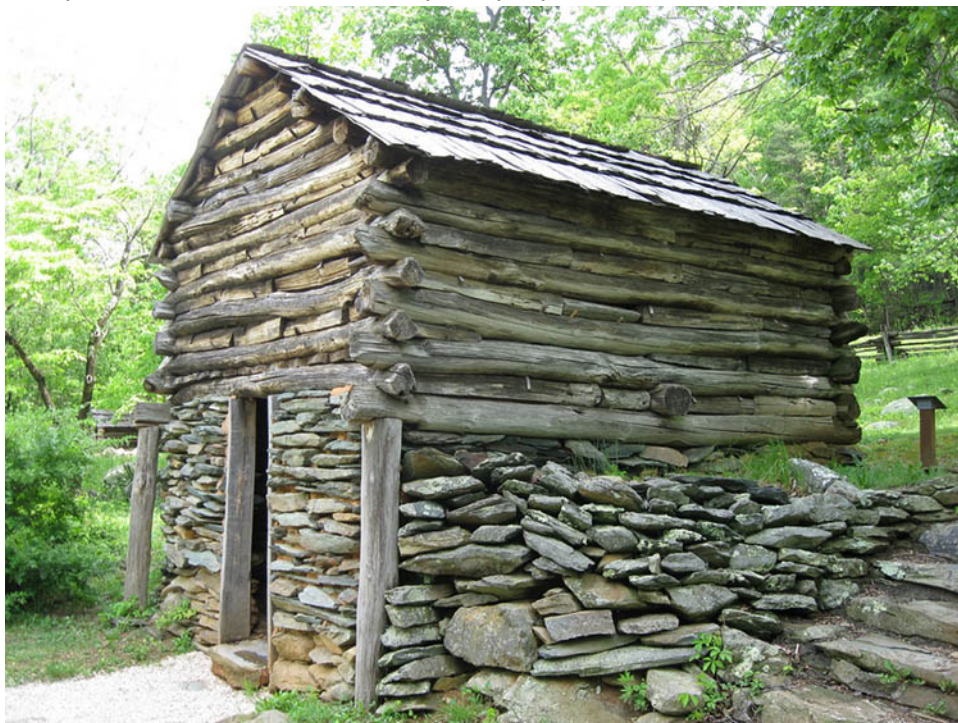
*FIGURE 31. The meat house and root cellar at the Mountain Farm exhibit, 1971 (2012 Humpback Rocks Cultural Landscape Report).*

*FIGURE 32. The meat house and root cellar at the Mountain Farm exhibit, 2010 (2012 Humpback Rocks Cultural Landscape Report).*

Mountain Farm meat house and root cellar. The building, also originally a part of the John C. Clark farm, was relocated to the site in 1952-1953 as part of the establishment of the exhibit. The relocated meat house, originally thought to have been constructed in 1881, was set on a more elevated foundation to adapt to the steeper grade of the Mountain Farm location. One observable difference is a stick-made summer door designed to provide ventilation shown in the post-restoration photos but not visible in the original photographs. It may have been added by the restorers in the 1950s based on local experience or observation of other nearby buildings (Speer and Haskell 1999, 178).

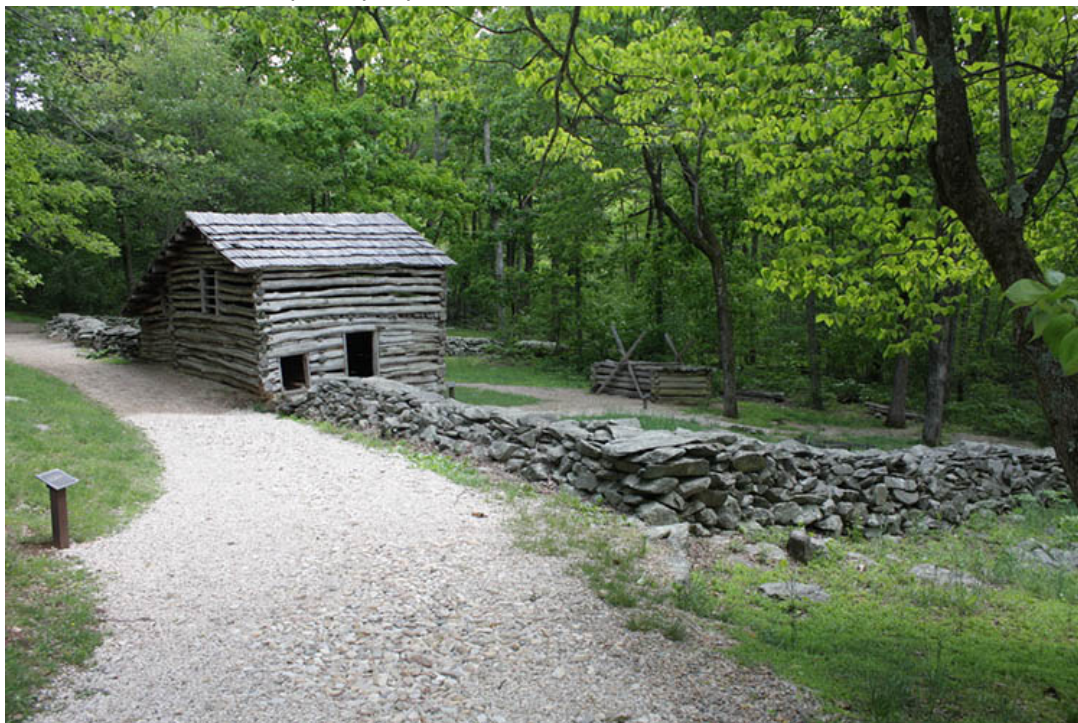
*FIGURE 34. The barn and stone fence at the Mountain Farm exhibit, 2010 (2012 Humpback Rocks Cultural Landscape Report).*

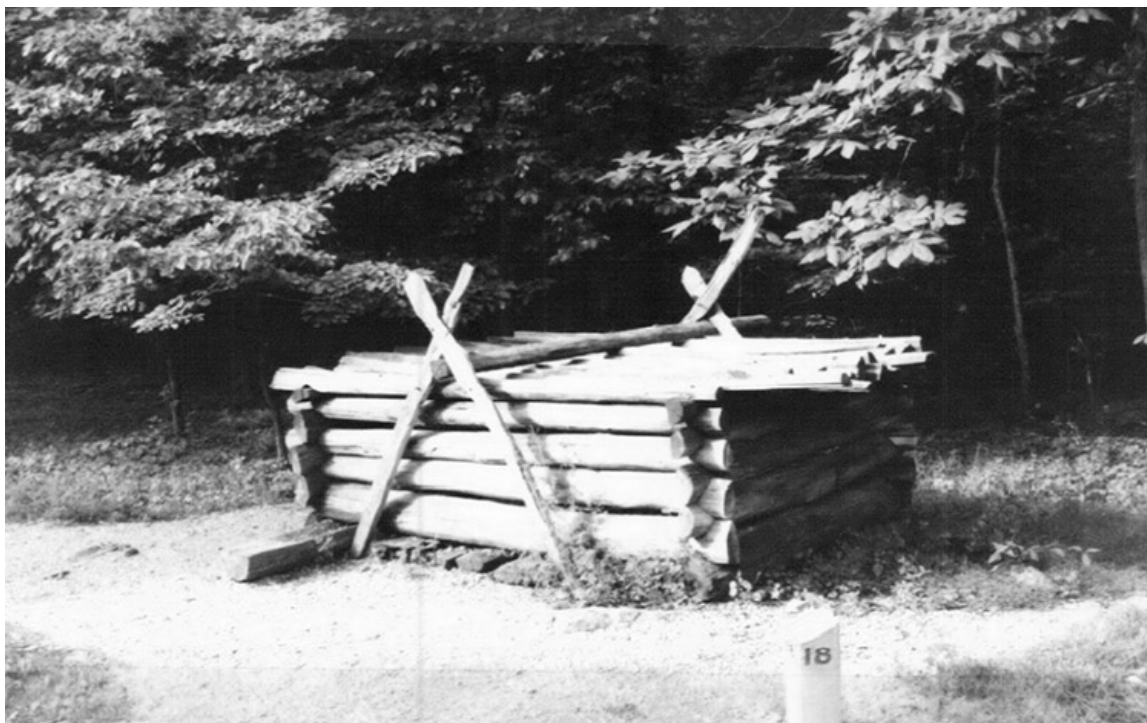
*FIGURE 35. The pig pen at the Mountain Farm exhibit, 1975 (2012 Humpback Rocks Cultural Landscape Report).*

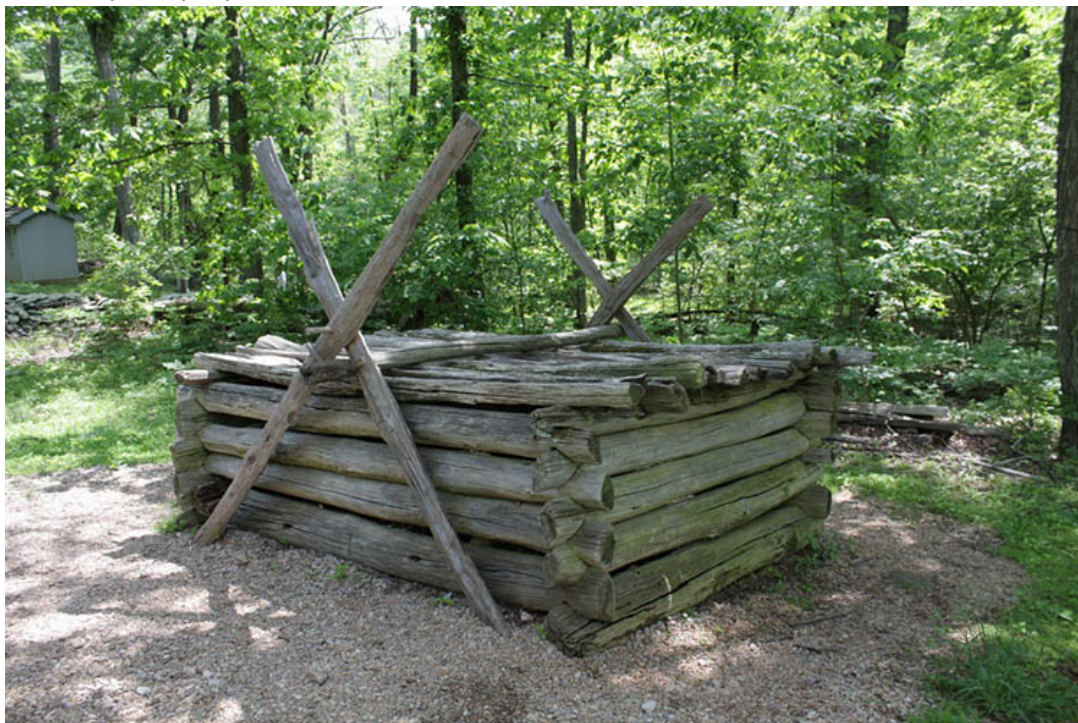
*FIGURE 36. The pig pen at the Mountain Farm exhibit, 2010 (2012 Humpback Rocks Cultural Landscape Report).*

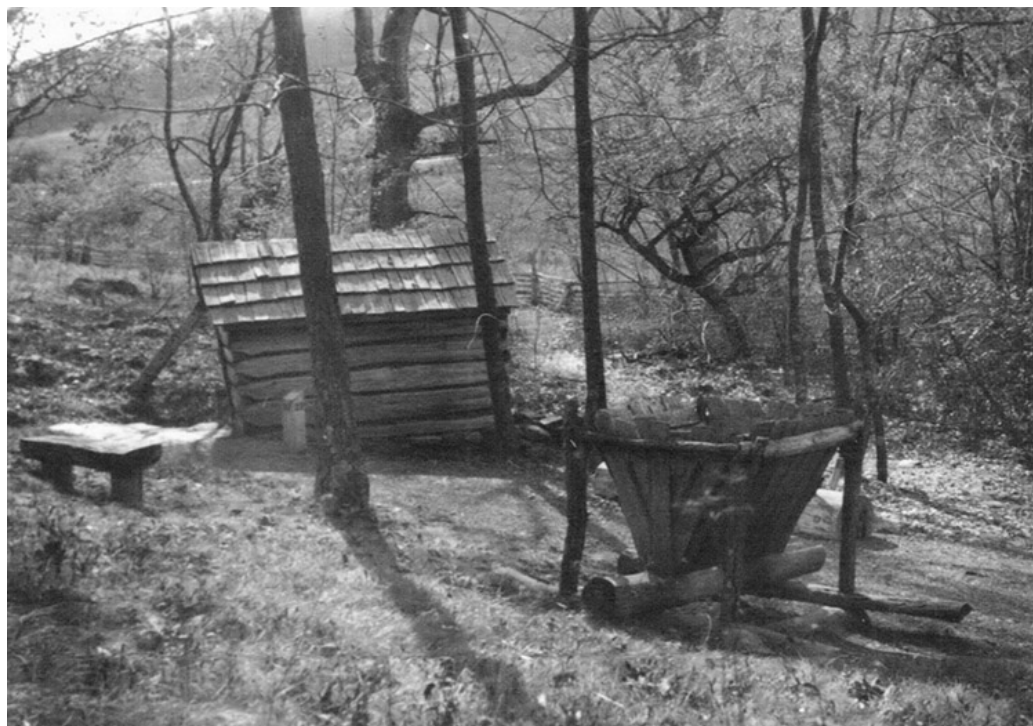
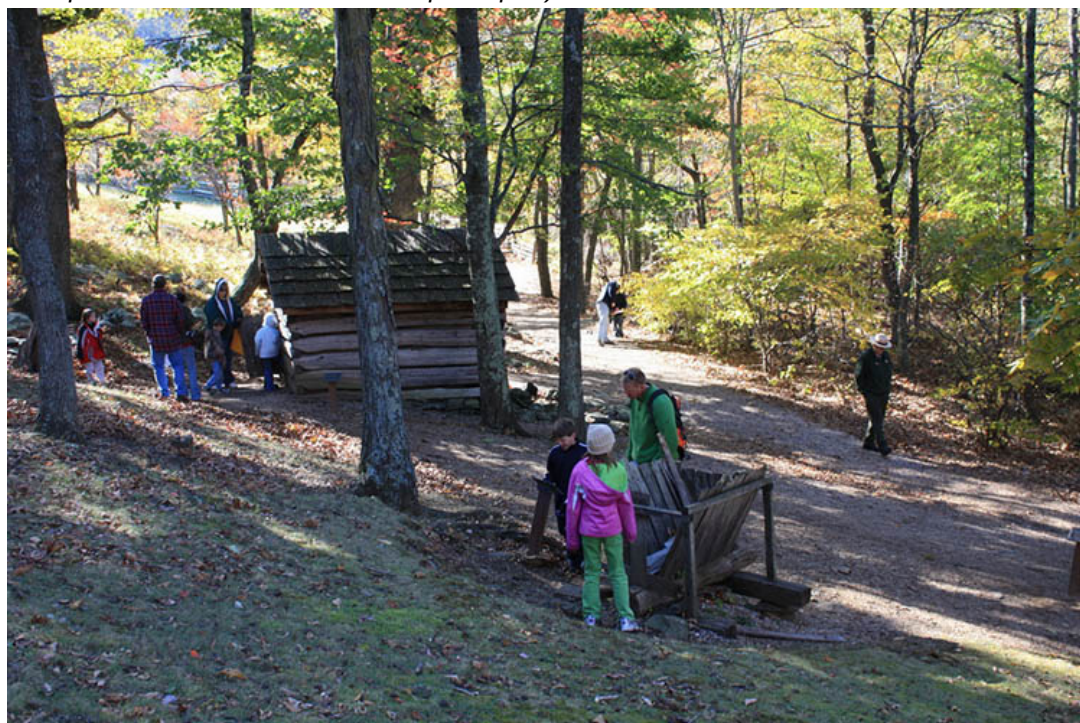
FIGURE 37. The spring house and the ash hopper at the Mountain Farm exhibit, 1971 (2012 Humpback Rocks Cultural Landscape Report).

FIGURE 38. The spring house and the ash hopper at the Mountain Farm exhibit, 2010 (2012 Humpback Rocks Cultural Landscape Report).

Mountain Farm spring house. The spring house was relocated to this site in 1952–1953 from Cash Hollow near milepost 29 of the Blue Ridge Parkway as part of the exhibit, and was sited above a naturally-occurring spring that likely supported Carter family use of the property during the late nineteenth and early twentieth centuries. It was in good condition and required only a new roof when it was relocated. Otherwise the spring house was likely modified to fit the existing spring site. The stone flooring and spring surround and the outflow configuration appear to be site-specific responses to the hydrologic properties of the spring. Like the cellar, it was designed to interpret food storage and preservation methods.

Mountain Farm spring house. (LCS ID005126). The Mountain Farm spring house is located near the southern end of the exhibit complex. The one-story rectangular frame structure is approximately 8-1/2 by 10 feet in size and constructed of squared hewn logs set with V notching at the corners and a wooden board gabled roof covered with shakes. The gables are filled with conventional framing. The foundation is composed of coursed limestone rubble. A low, 3 1/2 foot high door set on wooden hinges provides access to the interior from the center of the east gable end. Water from a free-flowing spring is channeled through pipes to a cooling trough set along the centerline of the building interior. The door provides access to the trough, which is edged by a flagstone floor. The water exits the rear of the building into a small rock pile where it is culverted beneath the path or infiltrates the ground. Oak boards line the interior walls, and in some locations wooden shakes are nailed to the logs to cover the spaces between. (Gibson Worsham, "Humpback Rocks Farm, Nelson County, Virginia" (Christiansburg, Virginia: National Park Service, 1999), 170–171.)

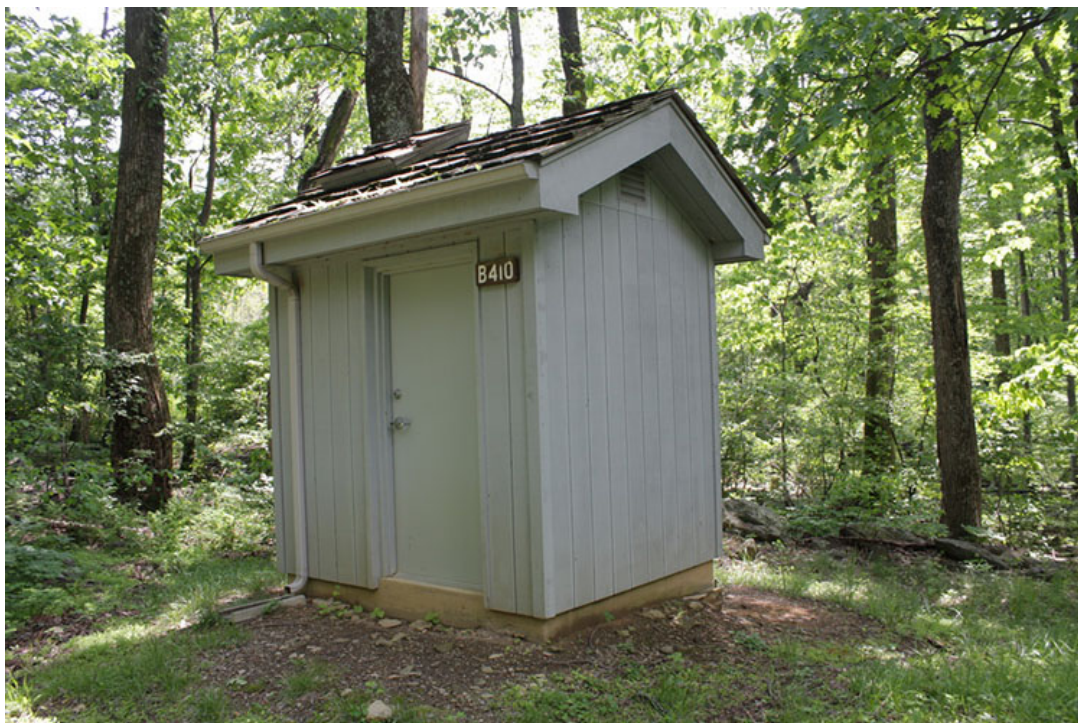
*FIGURE 39. The contemporary pump house structure (2012 Humpback Rocks Cultural Landscape Report).*

Pump house at the Mountain Farm. The pump house is an 8 foot 5 inch by 7 foot single-story frame structure with a gable roof clad with asphalt shingles. The roof has deep overhangs on all sides. The structure has vertical board siding and a concrete foundation. Vents are located at the top of the walls in the gable ends. The roof includes gutters and downspouts. A single door is recessed within the center of the long dimension of the principle facade, which faces east. A routed wood sign identifies the building number as B410. A utility meter is attached to the rear facade. The well supplies potable water to drinking fountains and the visitor center, is 65 feet deep, and can produce 60 gallons of water per minute.

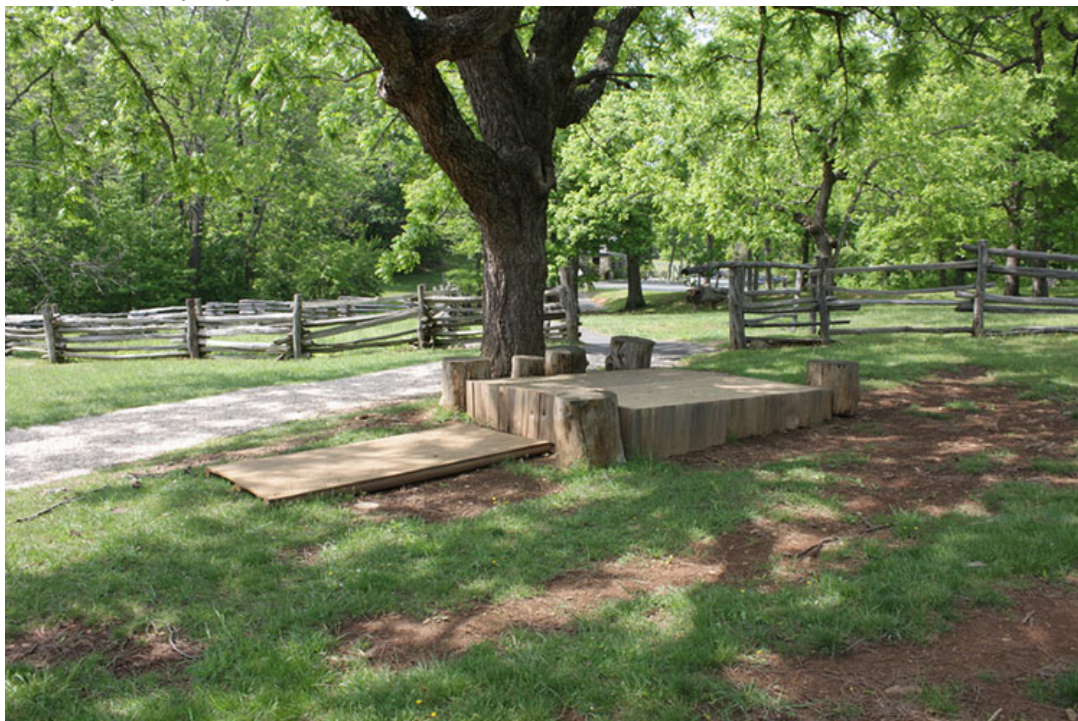
*FIGURE 40. The contemporary wooden performance stage (2012 Humpback Rocks Cultural Landscape Report).*

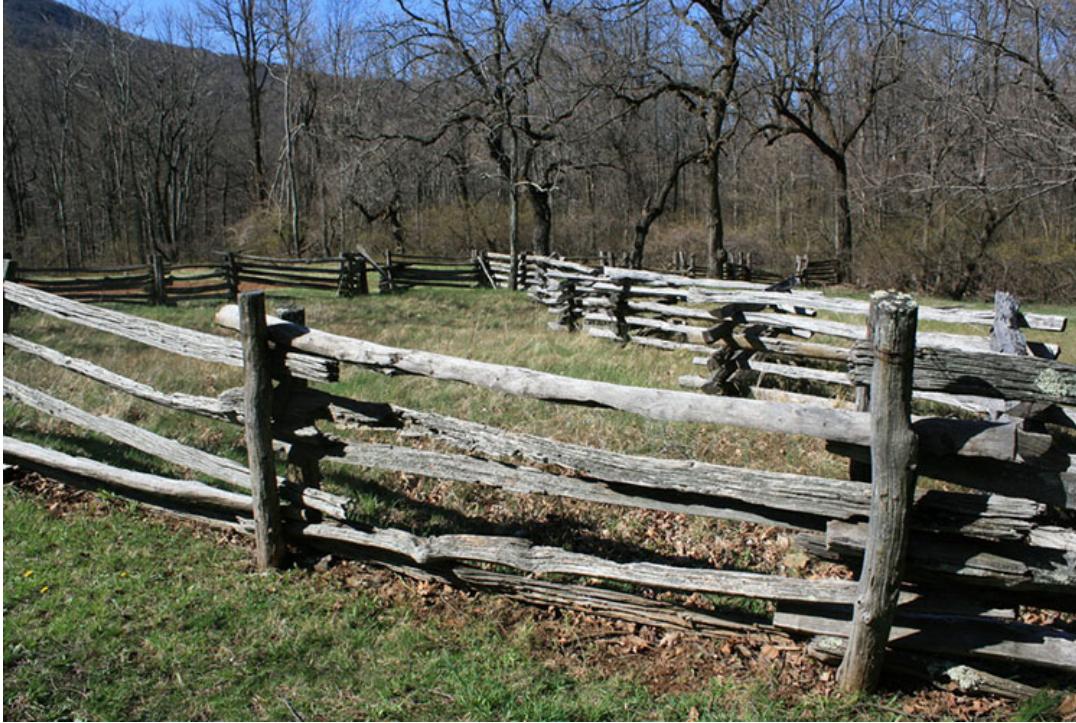
*FIGURE 41. Five rail post-and-rail fencing edges a small pasture near the Mountain Farm (2012 Humpback Rocks Cultural Landscape Report).*

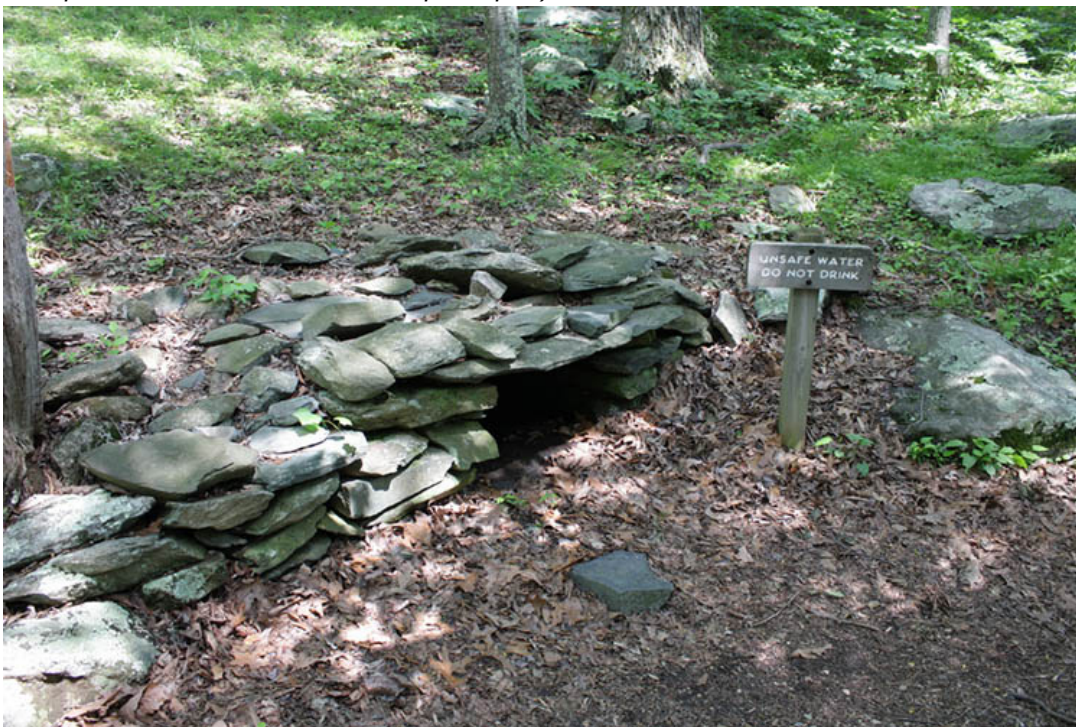
*FIGURE 42. The spring located in the Mountain Farm exhibit is marked by stacked stone and a wooden sign (2012 Humpback Rocks Cultural Landscape Report).*

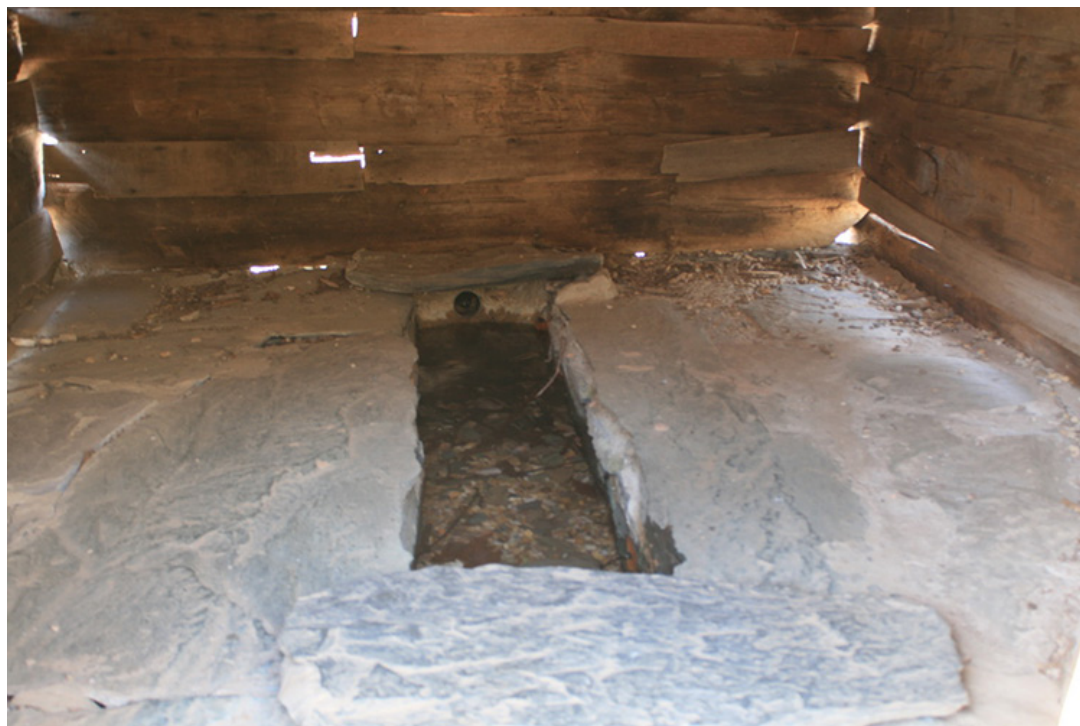
*FIGURE 43. A stone-lined pool captures water in the interior of the spring house (2012 Humpback Rocks Cultural Landscape Report).*

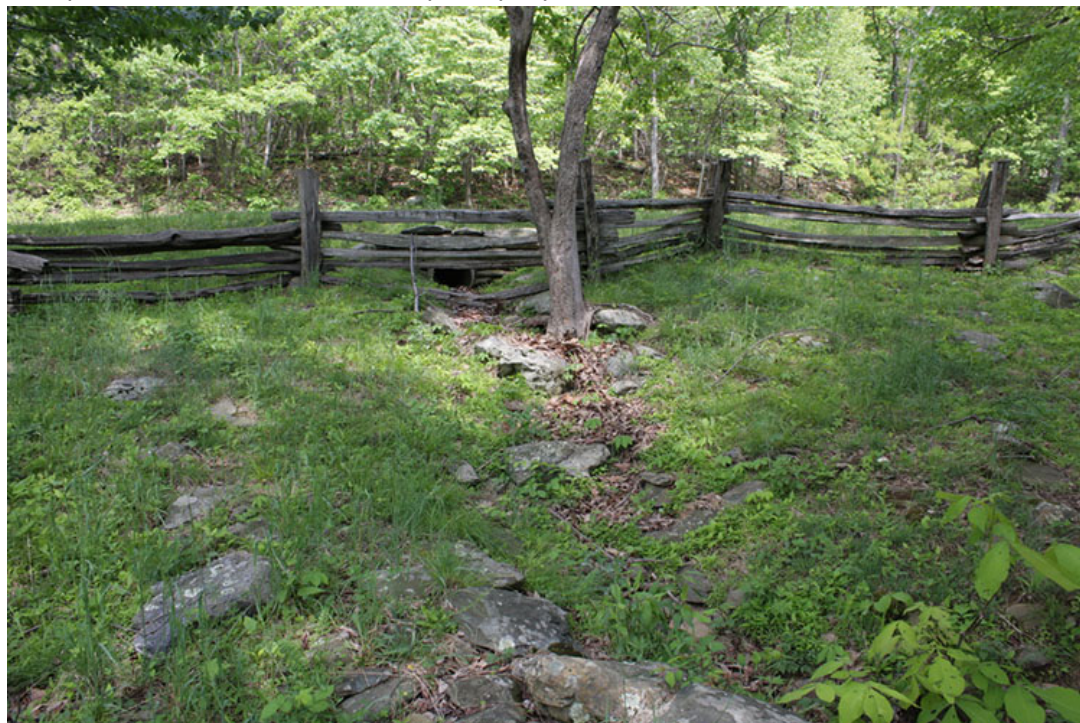
*FIGURE 44. Drainage flows from a culvert beneath the parkway into the Mountain Farm (2012 Humpback Rocks Cultural Landscape Report).*

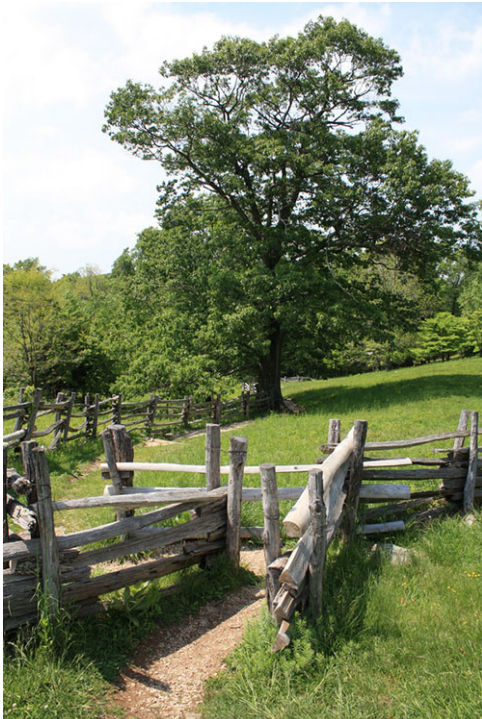
*FIGURE 46. At the south end of the Mountain Farm Character Area visitors enter through the "kissing gate;" large red oak in mid-ground (2012 Humpback Rocks Cultural Landscape Report).*

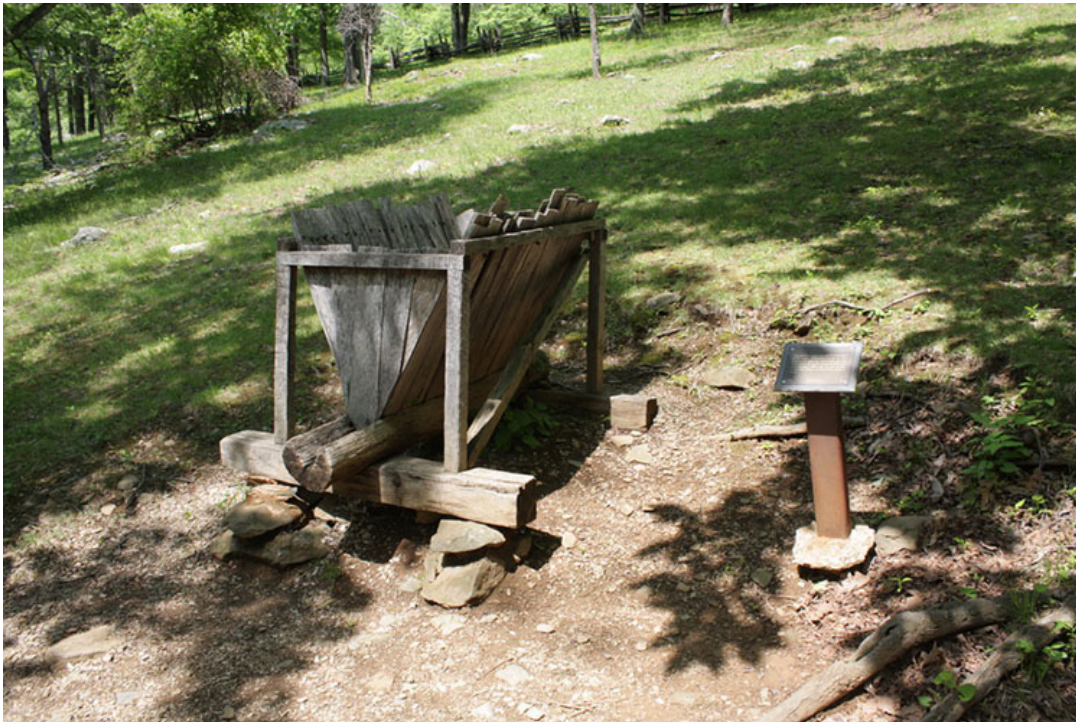
*FIGURE 47. The ash hopper used to interpret the production of lye used for soap (2012 Humpback Rocks Cultural Landscape Report).*
