National Park Service  
Cultural Landscapes Inventory

Humpback Rocks Mountain Farm  
Blue Ridge Parkway

## Cultural Landscape Summary & Site Plan

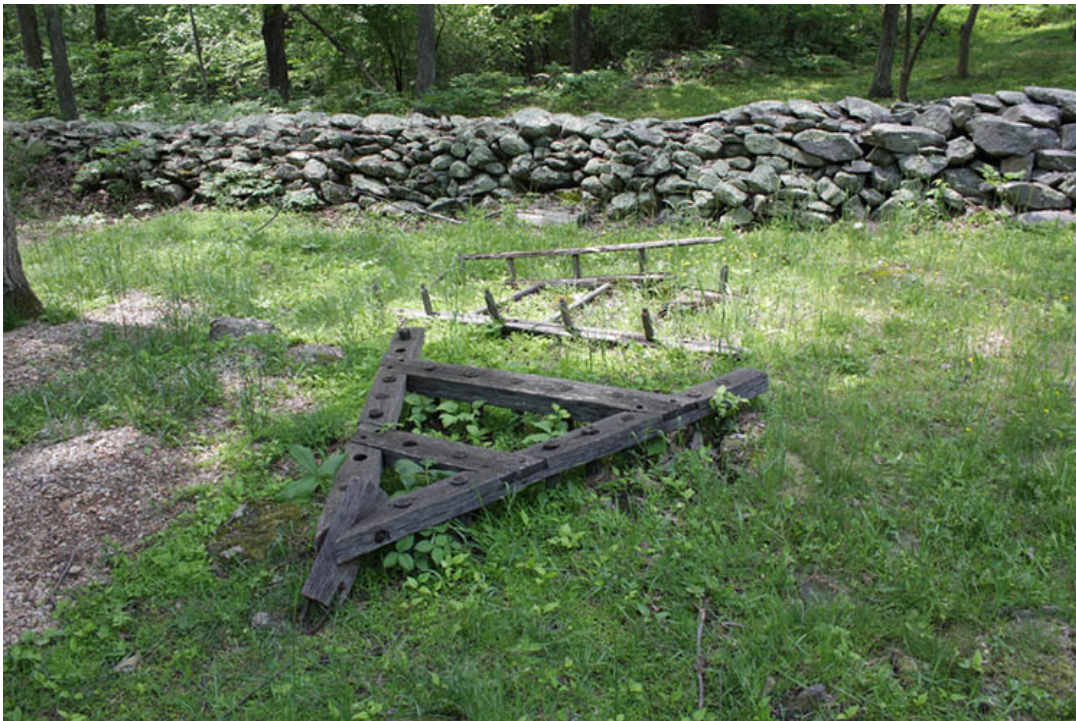
*FIGURE 48. A wooden plow near the log barn illustrates the types of equipment used to break the ground (2012 Humpback Rocks Cultural Landscape Report).*
