National Park Service  
Cultural Landscapes Inventory

2014

Rocky Knob Campground  
Blue Ridge Parkway

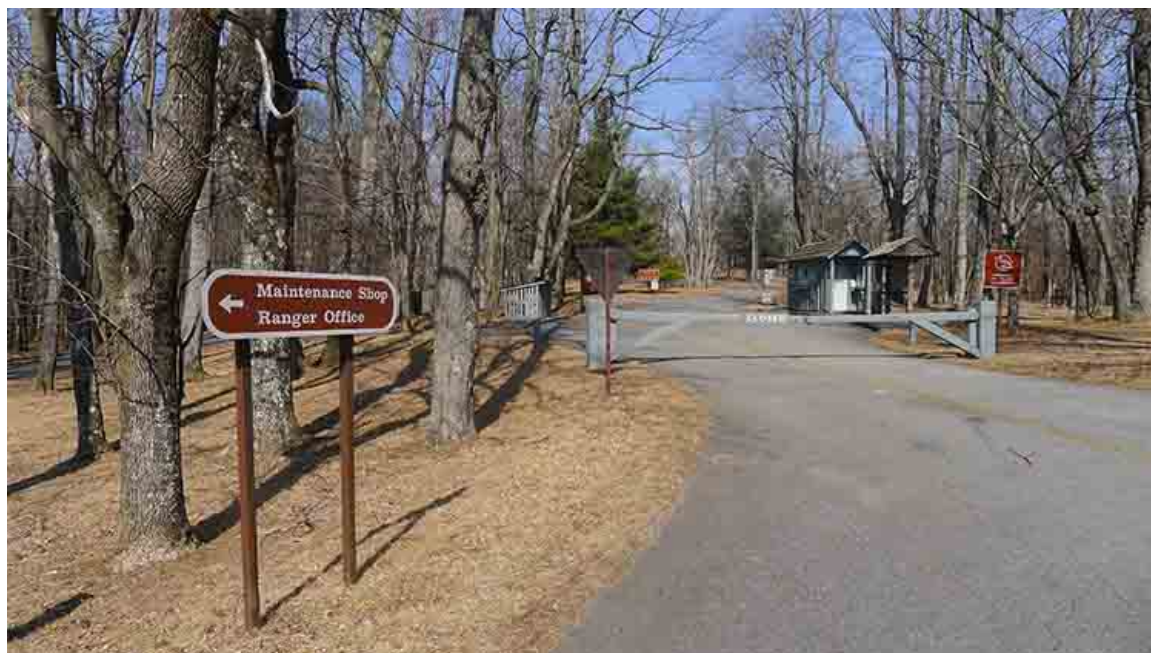
*Figure 6. Campground entrance (2014 Rocky Knob Recreation Area CLR, p. 202)*

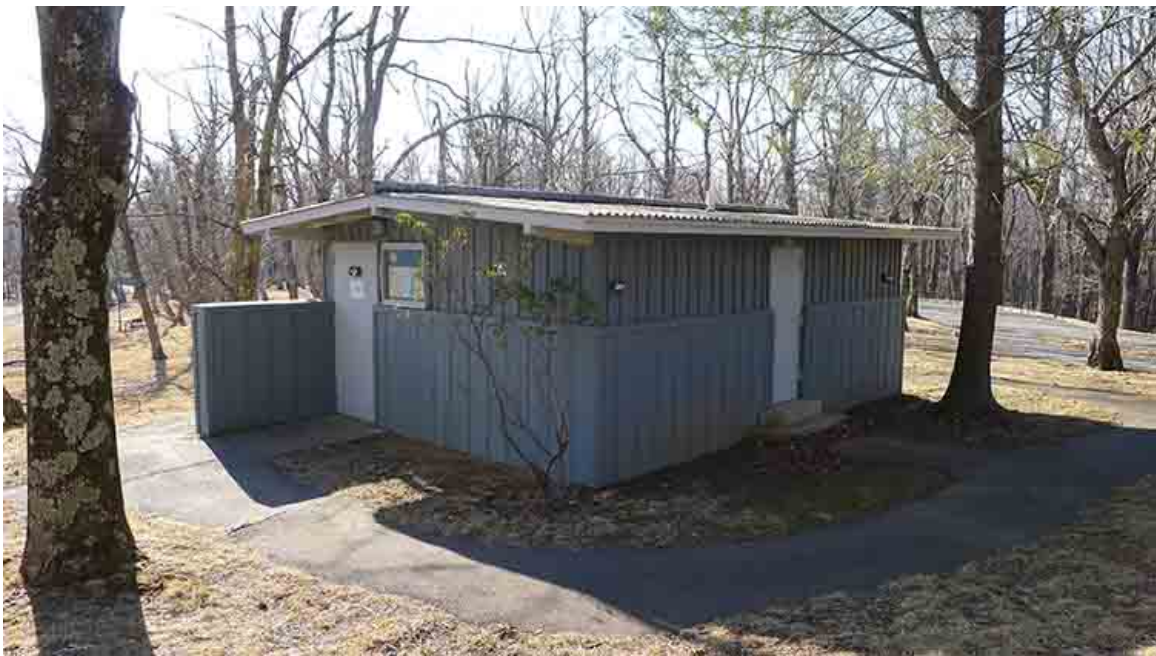
**Existing Conditions:** Some alterations have occurred to the comfort stations Post-Mission 66. For example, NPS staff altered the exterior materials by adding a thin wood veneer over the original concrete block walls, as well as painting over the stained board and batten upper portion of the exterior. The architectural style and craftsmanship of these buildings remain intact. The buildings retain their original doors, roofs and ridge caps. The buildings are significant contributing resources to Rocky Knob Recreation Area. The buildings retain a moderate to high degree of integrity, as their exterior modifications are reversible.

*Figure 7. Comfort Station #450 (2014 Rocky Knob Recreation Area CLR, p. 120)*

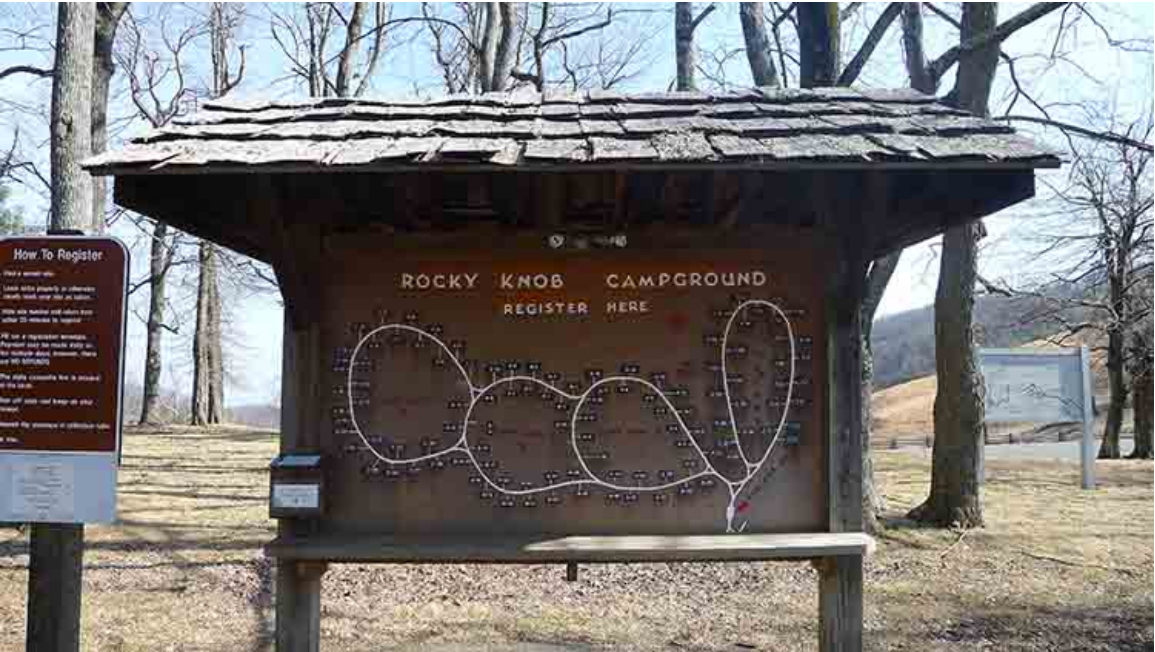
The registration sign has undergone slight alterations. NPS staff added lighting to both sides of the sign Post-Mission 66. In addition, a metal box replaced a wooden registration box that previously existed on the right side of the sign. The replacement box is located on the left side of the registration sign and is painted a shade of brown that blends with the wooden sign. The hand-split shakes on the roof remain a predominant element and the sign retains its original font and map. The feature is in good condition.

Figure 8. Campground registration sign (2014 Rocky Knob Recreation Area CLR, p. 199)

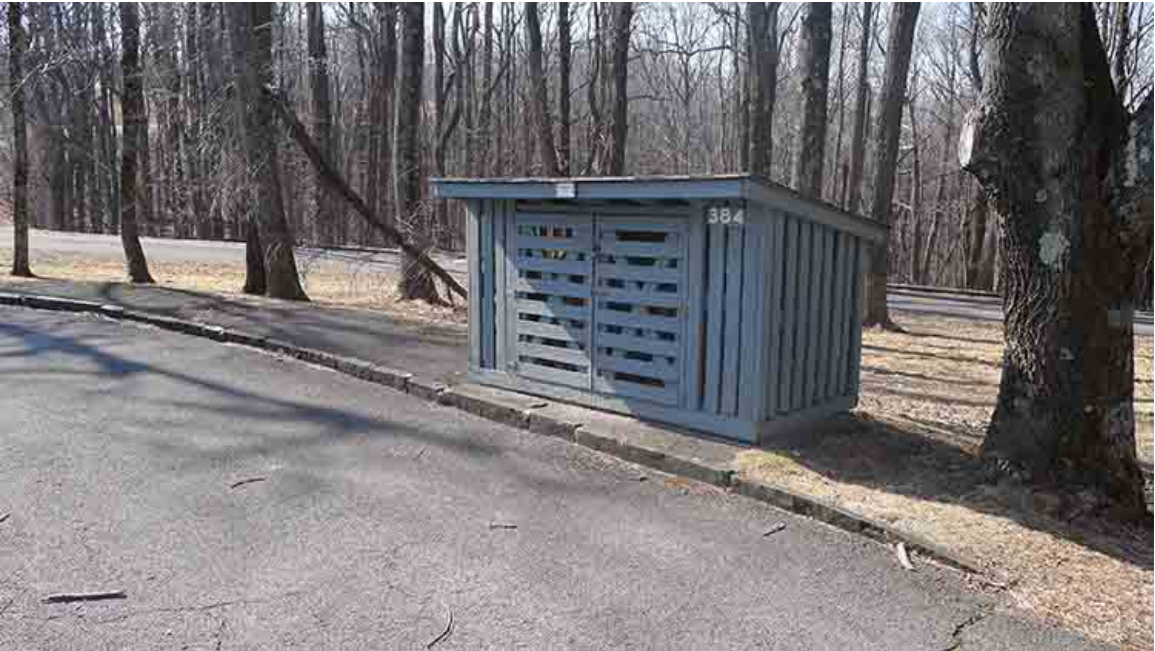
NPS staff replaced the original firewood crib sometime Post-Mission 66. Historical photographs confirm that the materials, form, and size of the present crib are similar to the original. The design, however, differs as wooden legs elevated the original slightly above the ground. In addition, the front of the original crib was open while the current one has locked doors. Accordingly, this variation in design alters the feeling of the firewood crib, as a sign on the front of the original crib suggests a time when visitors respected the honor system.

Figure 9. Firewood crib (2014 Rocky Knob Recreation Area CLR, p. 200)

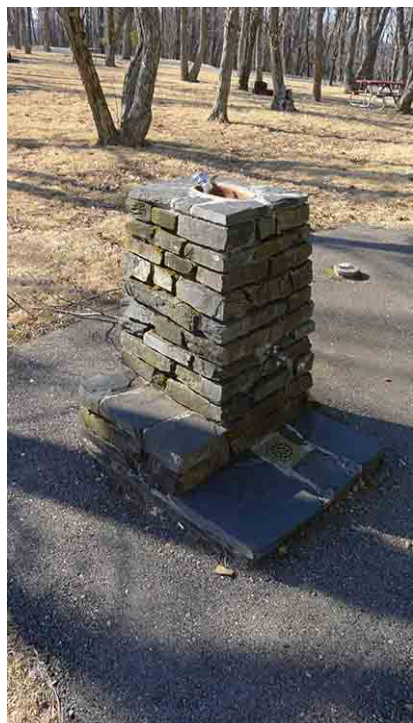
Seven drinking fountains exist in the Campground today. Three fountains are original stone Parkway drinking fountains that date to Mission 66. Four fountains are Post-Mission 66 replacements. Five additional Mission 66 stone fountains no longer exist. The Mission 66 fountains retain their original materials and rustic craftsmanship of stacked native stone set on mortared stone bases, hence are considered contributing. The Post-Mission 66 replacements, however, differ greatly in material and craftsmanship, hence are considered noncontributing.

Figure 10. Stone drinking fountain (2014 Rocky Knob Recreation Area CLR, p. 147)

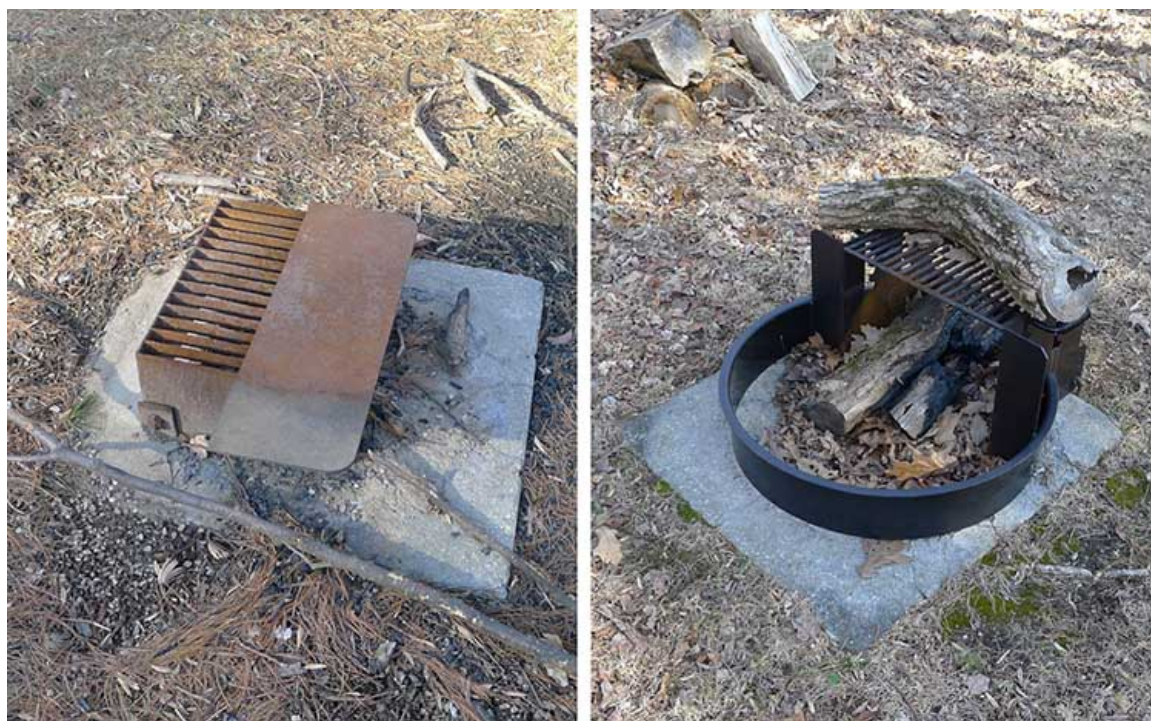
Presently, several different grill configurations exist around the campsites. Post-Mission 66, NPS staff replaced some of the original grills with ones ordered from contemporary catalogs. In some instances, original concrete bases are deteriorating or absent. Replacement grills are circular-shaped and only slightly larger than the original square-shaped ones.

Figure 11. Grill types: Mission 66 grill on left, post-Mission 66 grill on right (2014 Rocky Knob Recreation Area CLR, p. 126)

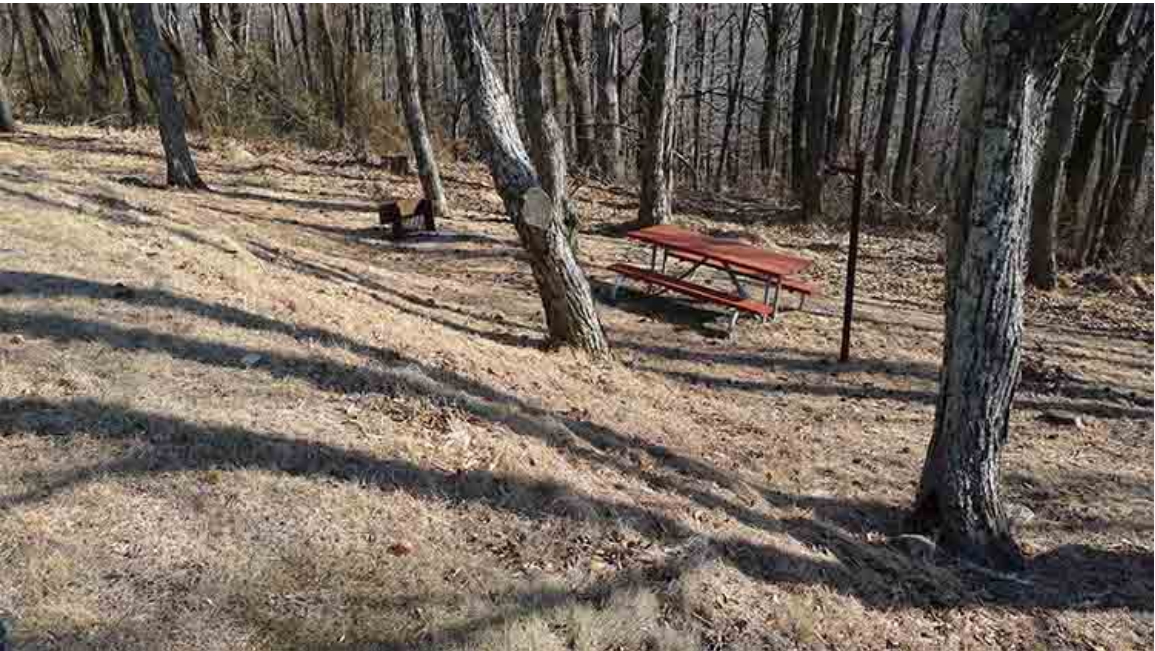
Figure 12. Typical campsite (2014 Rocky Knob Recreation Area CLR, p. 125)
