National Park Service  
Cultural Landscapes Inventory

2014

Rocky Knob Gas Station  
Blue Ridge Parkway

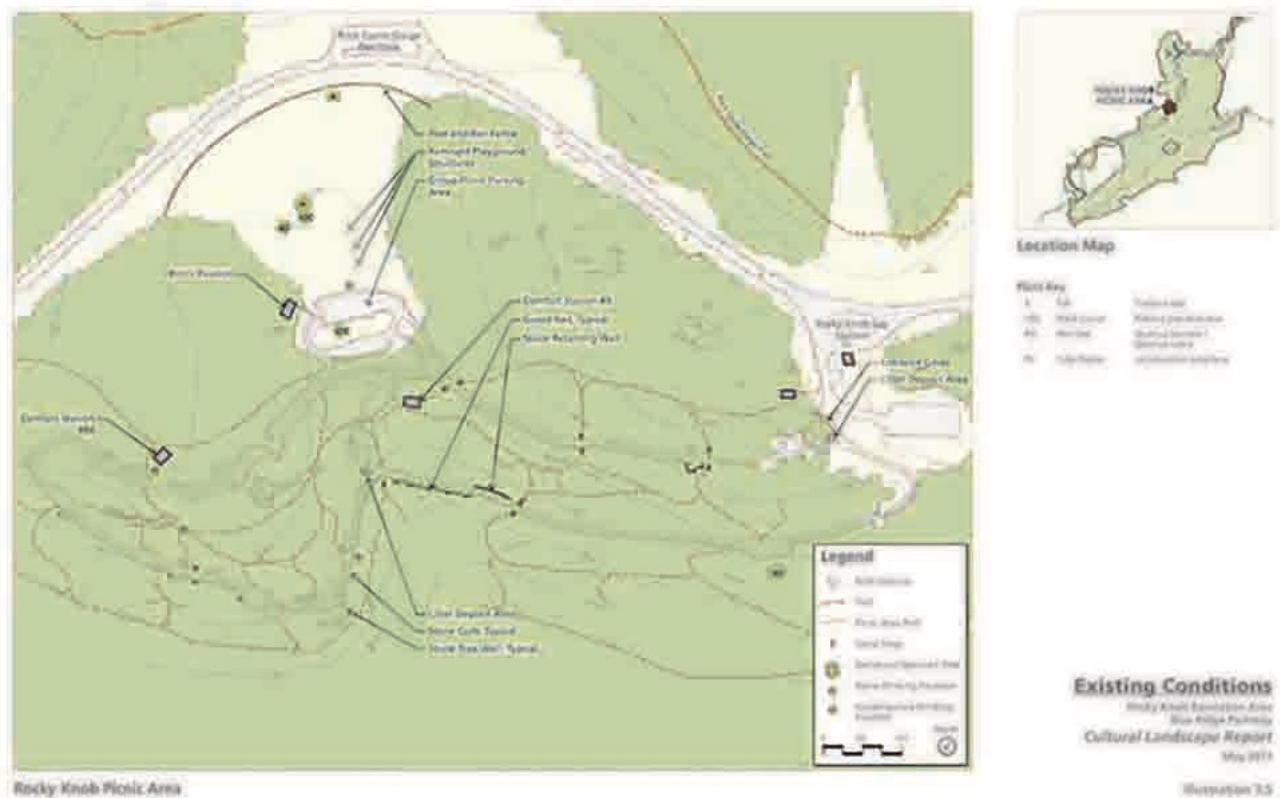
Figure 2 A. Picnic Area component landscape site plan. (2014 Rocky Knob Recreation Area Cultural Landscape Report, p.97)

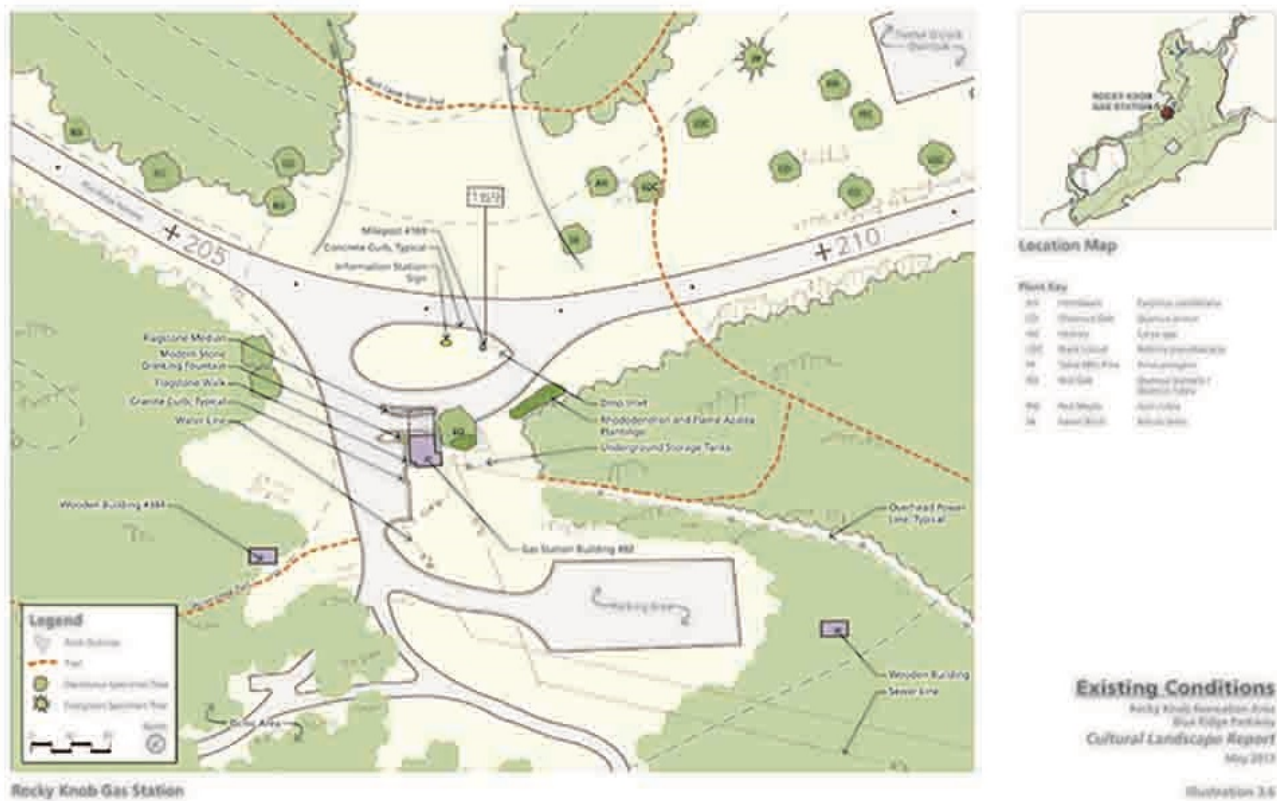
Figure 2 B. Gas Station component landscape site plan. (2014 Rocky Knob Recreation Area Cultural Landscape Report, p.98)

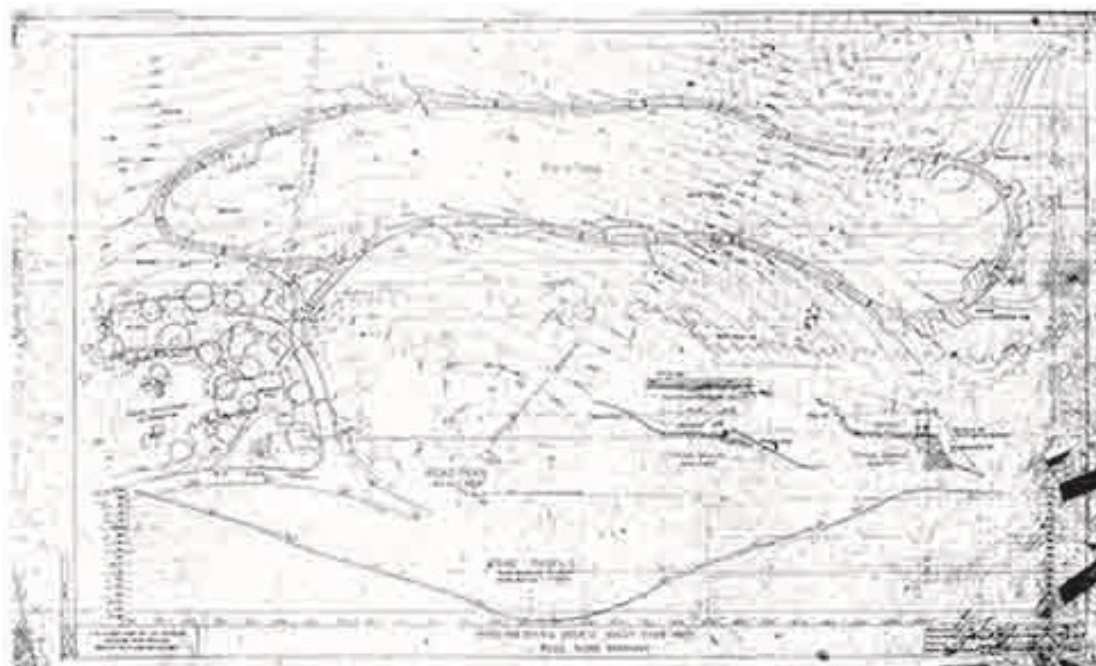
1937 - Road No. 2 Picnic Area Plan, Profile, and Sections

*Figure 4. Road No. 2 Picnic Area Plan, Profile, and Sections, 1937 (2014 Rocky Knob Recreation Area Cultural Landscape Report, p.51)*

Historic Conditions: Construction was underway on the Picnic Area by 1937. The 1937 plans show two loops set back from the Parkway in a protective cove. The first loop functioned as a picnic area with a variety of parking slip configurations to accommodate a wide range of group sizes. The second loop acted as the campground, with separate areas for tent and trailer camping, comprising sixteen campsites. By 1941, overcrowding had become a problem and Parkway staff developed plans to provide “group size” facilities to all of the recreation areas. Workers constructed a new vehicular turnaround and group parking area along with an area for active recreational activities, such as playing fields and a playground, in the large open field near the intersection of the picnic and camping loops.

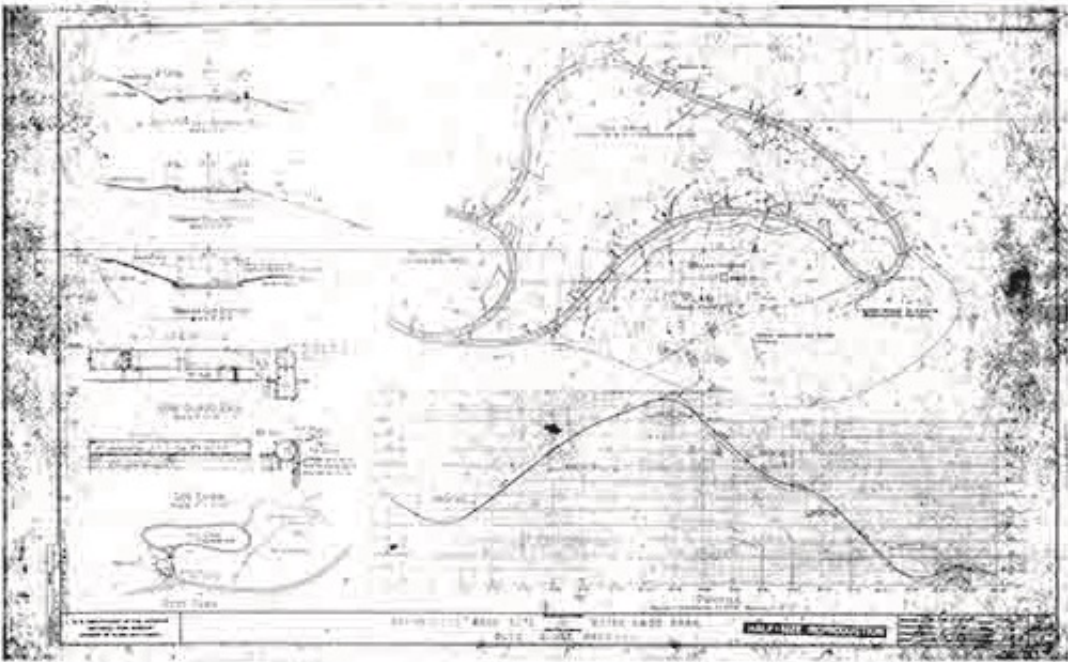
1938 - Campground Area No. 1 Sections, Plans, and Profile

Figure 5. Campground Area No. 1 Sections, Plans, and Profile, 1938. (2014 Rocky Knob Recreation Area Cultural Landscape Report, p.55)

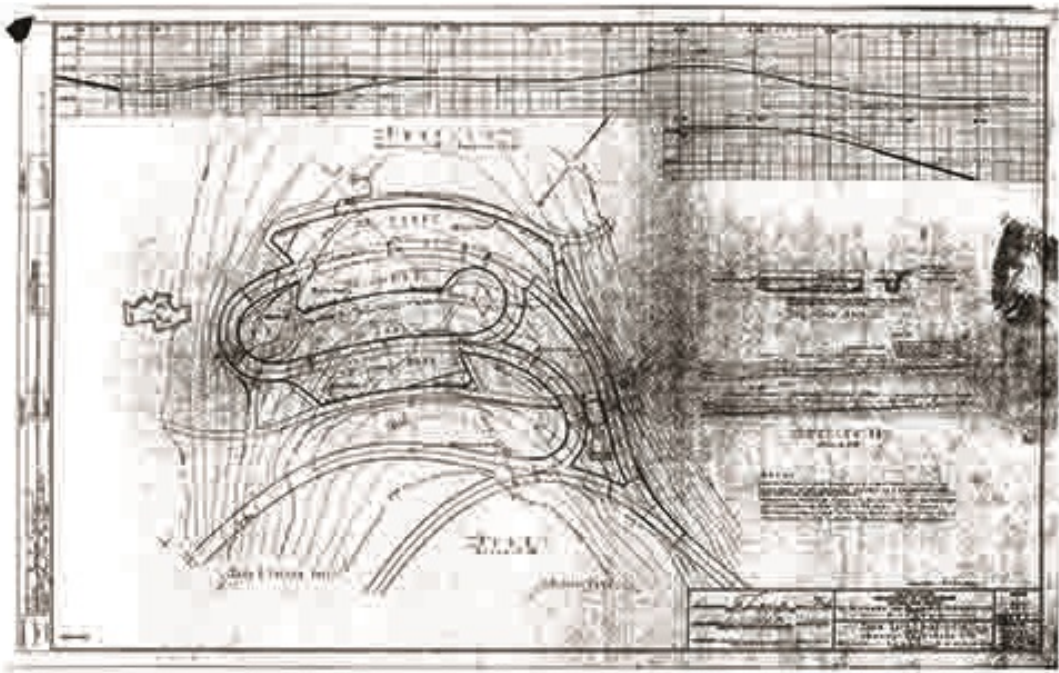
1940 - Cabin Area and Play Field - Camp and Trailer Area Profile, Plan, Sections, and Detail

Figure 6. Cabin Area and Play Field – Camp and Trailer Area Profile, Plan, Sections, and Detail, 1940. (2014 Rocky Knob Recreation Area Cultural Landscape Report, p.57)

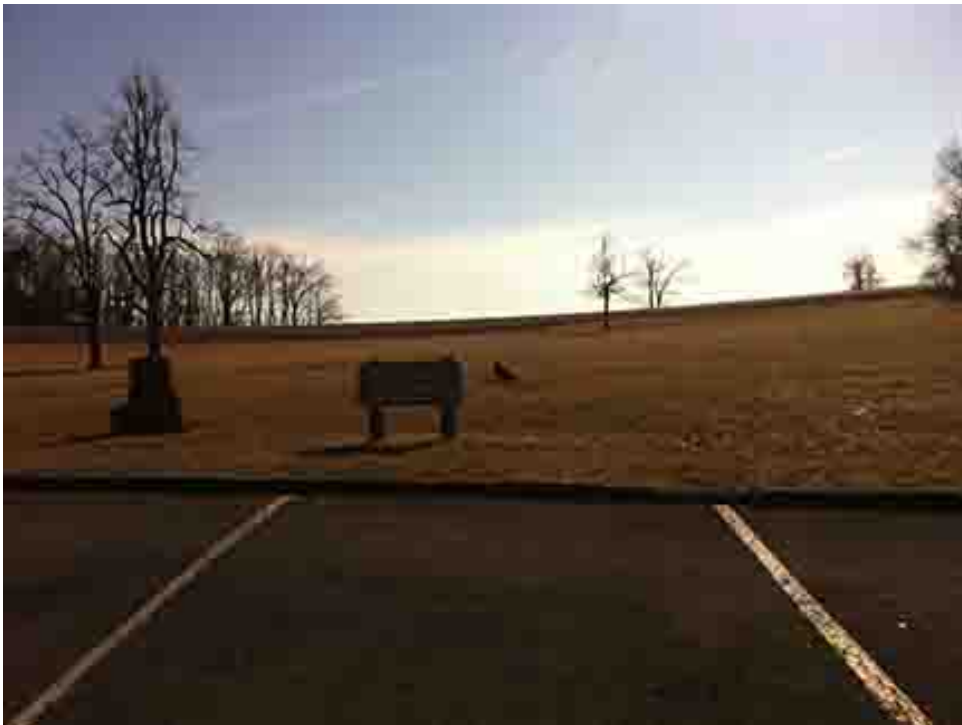
Overall, the vegetation in the Picnic Area is in good condition, with a few of the specimen trees showing signs of decline.

*Figure 8. Specimen trees in the lawn and view of the Parkway from picnic parking area (2014 Rocky Knob Recreation Area Cultural Landscape Report, p.141)*

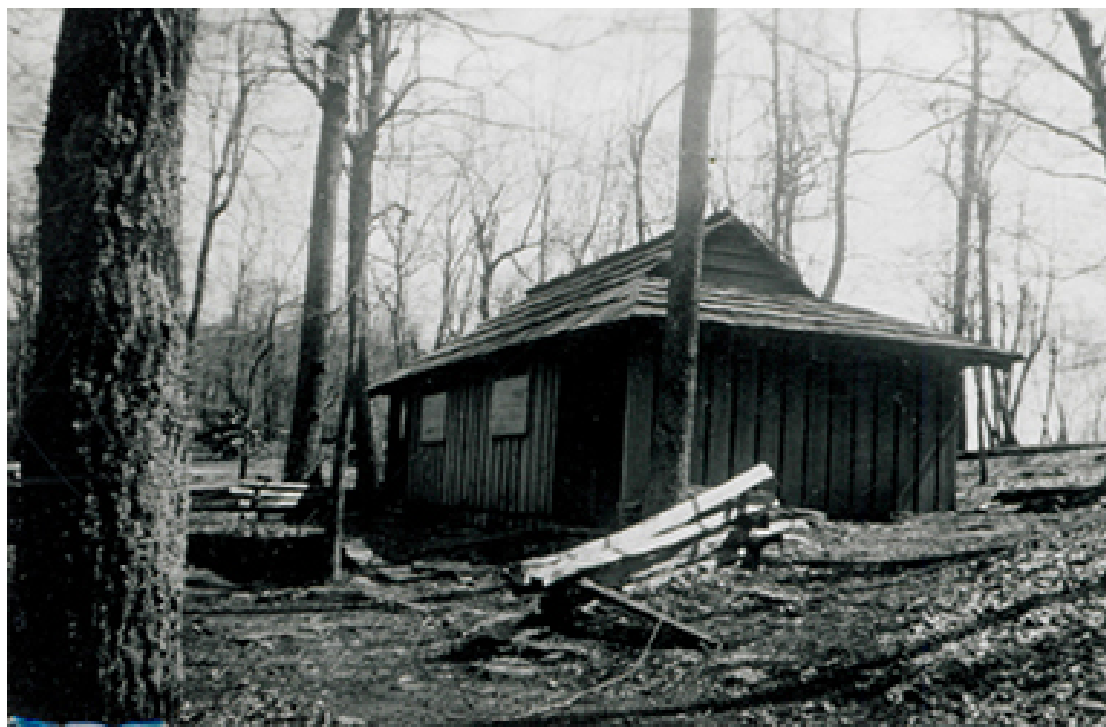
Comfort Station #9- Constructed by the ERA in 1941 for a total cost of \$2,600, this building was one of the first comfort stations built along the Parkway. The regional, rustic aesthetic of early Parkway design character is evident in the materials, massing, and rooflines of this building. The materials used to construct this building include a stone foundation, vertical board siding, and paned wood frame windows.

*Figure 9. Comfort Station #9, 1952 (2014 Rocky Knob Recreation Area Cultural Landscape Report, p.141)*

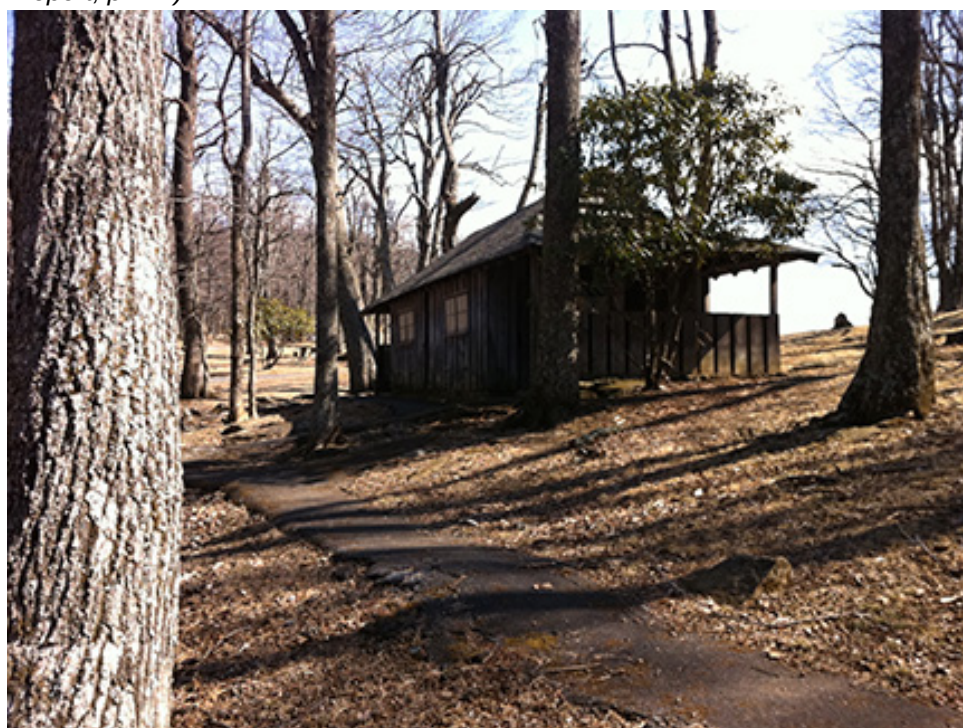
**Comfort Station #9**— The NPS replaced the original wood shake shingle roof with a Post-Mission 66 asphalt shingle roof and opened up the enclosed breezeways that lead to the restroom doors on either side of the building. Despite these Post-Mission 66 alterations, the building is in good condition and is an excellent example of early parkway construction based on vernacular architectural forms.

*Figure 10. Comfort Station #9, 2011 (2014 Rocky Knob Recreation Area Cultural Landscape Report, p.141)*

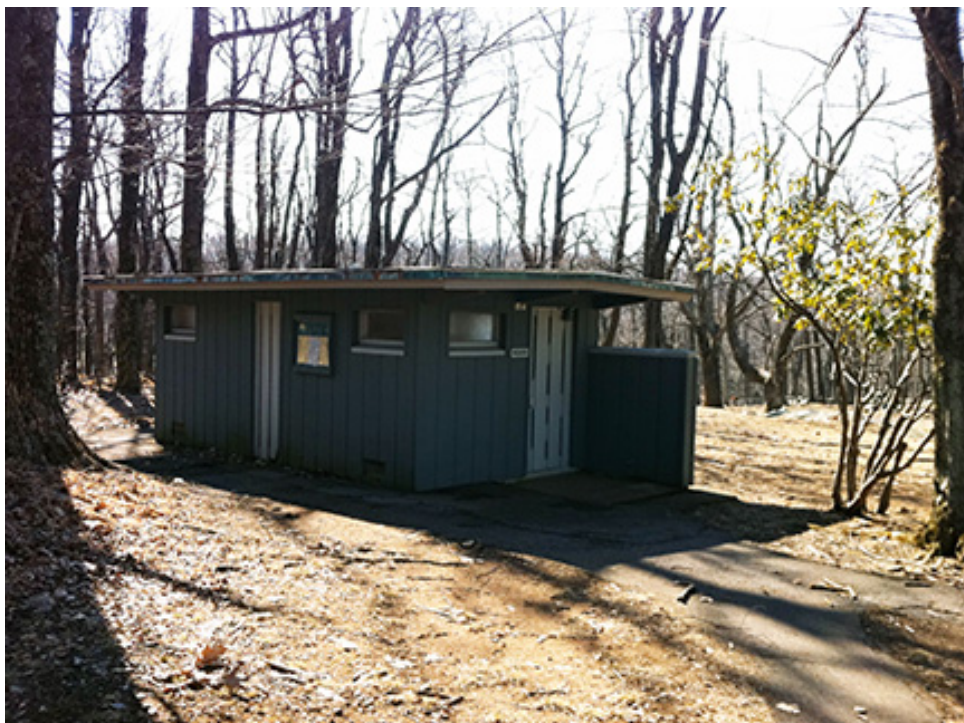
**Comfort Station #84**— This building retains its original doors and windows and the only exterior alteration is the addition of a thin layer of painted wood veneer applied to the exterior block walls. The building is in good condition. Rocky Knob Recreation Area contains no other comfort stations of this design. This type of comfort station is an important intermediate step in the evolution of comfort station design throughout the Parkway, acting as a bridge between the early rustic type and the later type found in the Rocky Knob Campground and elsewhere along the Parkway. A network of asphalt

*Figure 11. Comfort Station #84, 2011 (2014 Rocky Knob Recreation Area Cultural Landscape Report, p.142)*

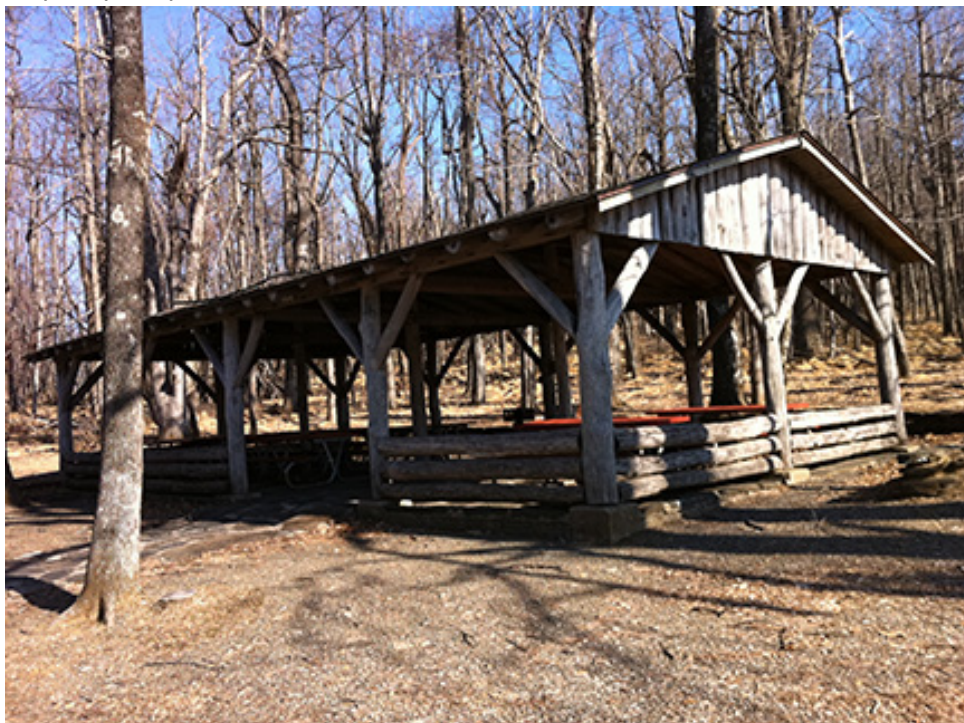
Picnic Pavilion #964- The pavilion is in good condition. The retaining wall is in fair condition due to the damaged grills and some failed mortar joints. The mortared stone walkway leading to the pavilion is also in fair condition, due to failing mortar. An identical pavilion occurs at the Smart View Picnic Area, further south along the Parkway, suggesting that this pavilion structure was a Parkway standard at the time of its construction.

*Figure 12. Picnic Pavilion, 2011 (2014 Rocky Knob Recreation Area Cultural Landscape Report, p.143)*

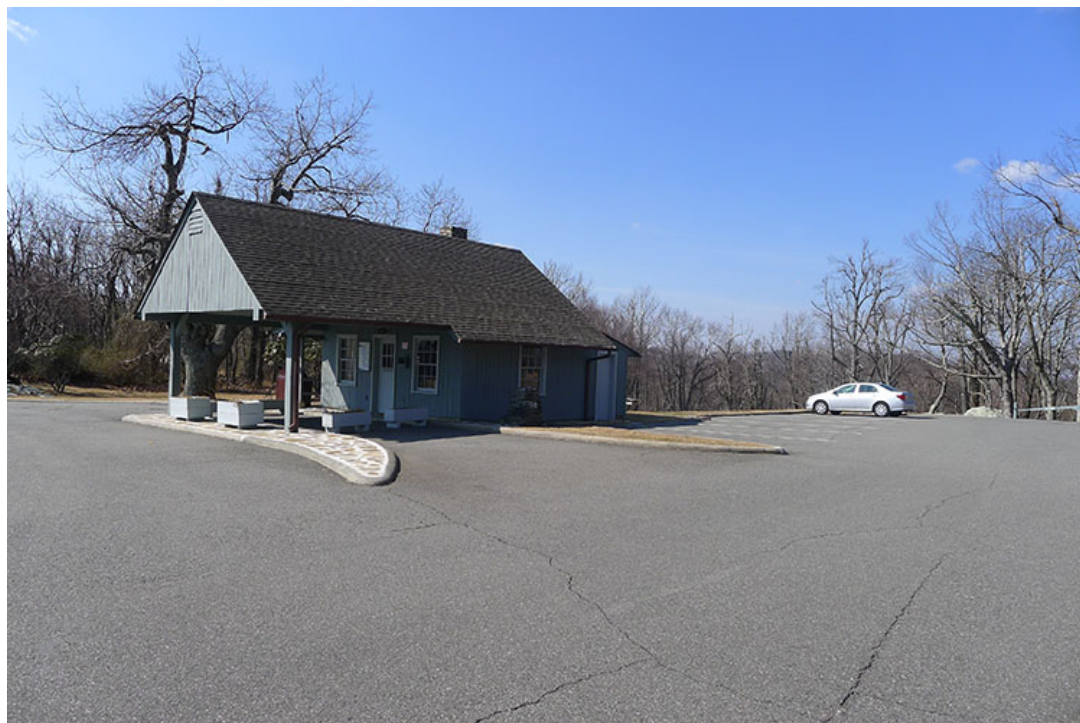
Gas Station Building #82- Asphalt shingles replaced the original cement roof shingles. An original stone chimney remains. The front façade features a central original door, with two original double hung six-over-six windows located on either side. The two identical gas pumps were both removed. NPS staff recently reset the flagstone walkways and they appear to be in good condition. The NPS altered and expanded the perimeter of the gas pump median in 1973 and it is no longer symmetrical in plan. Also, a flagstone path has been added to connect the parking area to the building entrance. Additionally, the small parking area located on the northeast side of the station was expanded at some point prior to 1966, resulting in the loss of an original planting bed in the process. These alterations are all visible in historic photos. The interior of the building contains many of its original features, including the service desk, restroom fixtures, wall treatments and concrete floor covered in linoleum designed to look like mortared slate. The building is good condition and the best example in Rocky Knob of post-war Parkway architecture that employed the use of Post-Mission 66 materials and construction techniques, while still being based on vernacular forms.

Figure 13. Rocky Knob Gas Station, 2011 (2014 Rocky Knob Recreation Area Cultural Landscape Report, p.155)

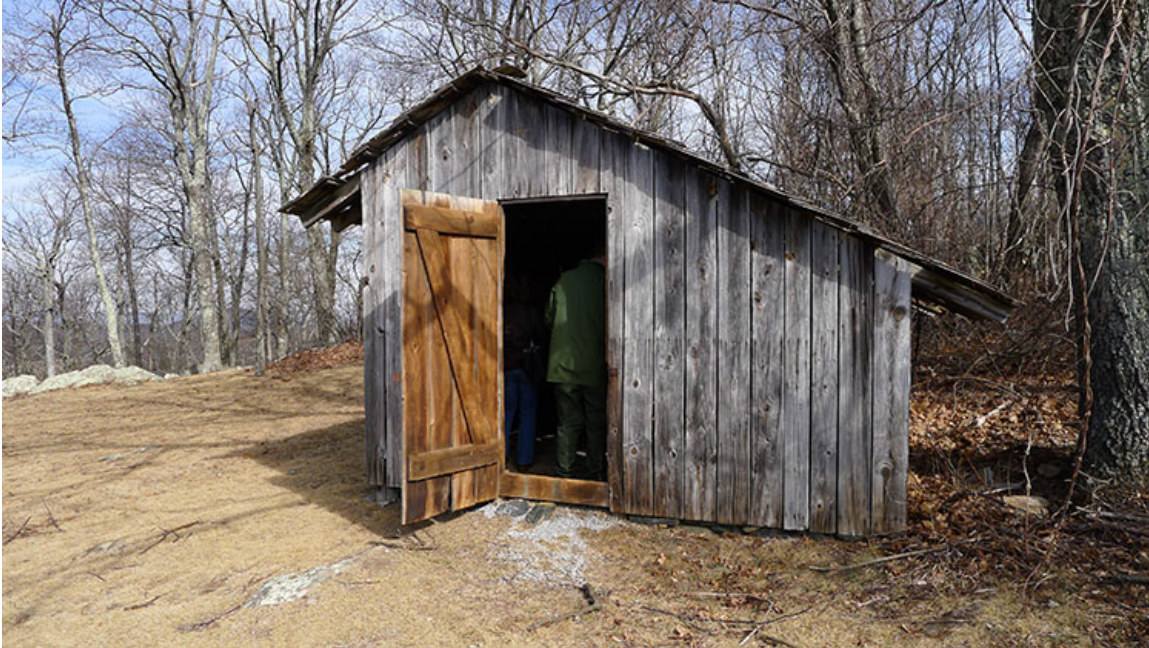
Wooden Buildings—The NPS currently uses both of the buildings for storage. Both are in poor condition. The building located near the parking area contains an original painted wood sign from the earliest days of the Parkway. Similar signs appear in historic photographs taken in the 1930s within Rocky Knob Recreation Area.

*Figure 15. Wooden Building, 2011 (2014 Rocky Knob Recreation Area Cultural Landscape Report, p.156)*

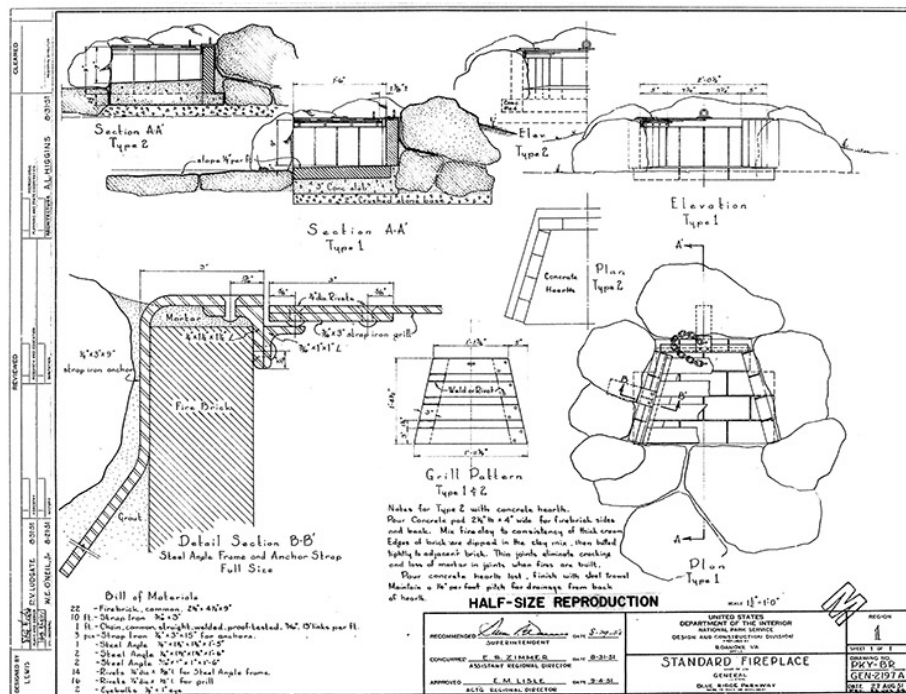
**Grills-** Original drawings for these grills show the method of construction. The grills consist of a small concrete slab set on a crushed stone base, surrounded by native boulders to give the appearance that the fireplace was carved out of the surrounding natural rock outcrops. Builders lined the concrete base with fireproof bricks coated in a special fire clay to eliminate cracking and failed mortar caused by multiple fires. The bricks also provided a rigid base upon which a trapezoidal metal grill surface could rest evenly. Doughton Park contains examples of similar, u-shaped stone grills, making them an early Parkway standard.

Figure 16. Plans for Parkway standard fireplace or grill, 1951 (2014 Rocky Knob Recreation Area Cultural Landscape Report, p.145)

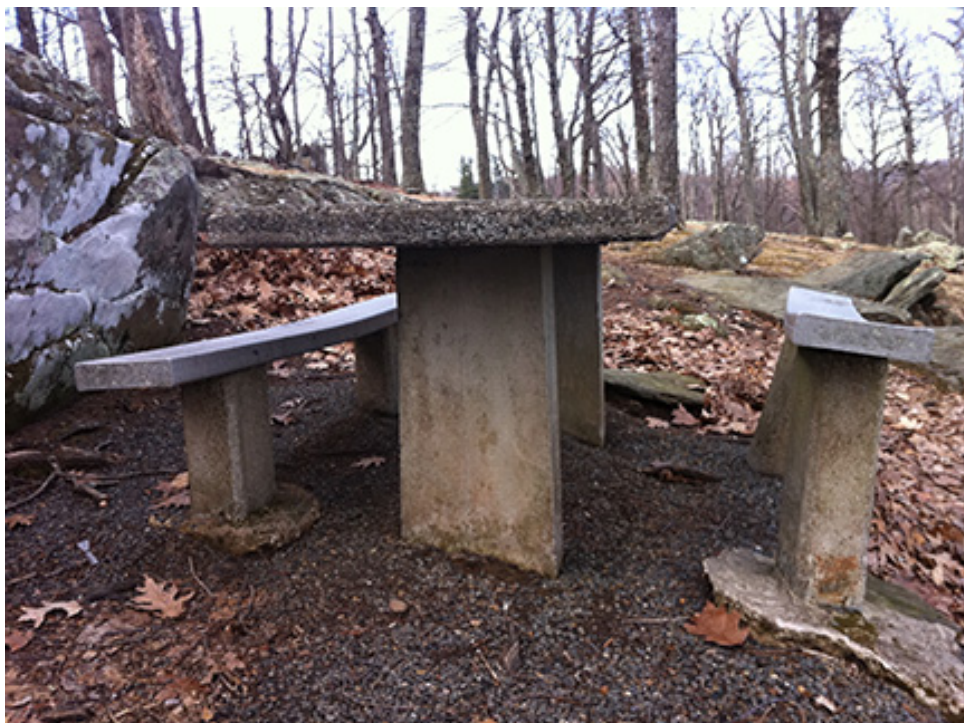
**Picnic Tables**- Except for the six aluminum and wood picnic tables associated with the Picnic Pavilion, all of the picnic tables that remain at the site are constructed of concrete with either recycled plastic or wooden seats. Only one table was documented that still retains wooden seats, both of which had deteriorated severely. Recycled plastic bench seats are much more common, and while the material is sustainable, it does not work well in this application. The distance spanned by the seats is simply too great and as a result the plastic seats sag dramatically in the middle. In addition to sagging, the recycled plastic boards are not as thick as the original wooden boards were, altering the proportions of the original design. The tables vary in condition from fair to poor. The concrete tabletops are broken in some cases and the concrete seat supports have often settled or suffered from erosion at their bases. These tables are not original to the Picnic Area as historic photographs show wooden tables located here. The current tables are likely 1950s or 1960s replacements, as they are identical to picnic tables found in Julian Price Memorial Park built during that period.

*Figure 18. Picnic table with sagging seat slats and exposed footings (2014 Rocky Knob Recreation Area Cultural Landscape Report, p.146)*

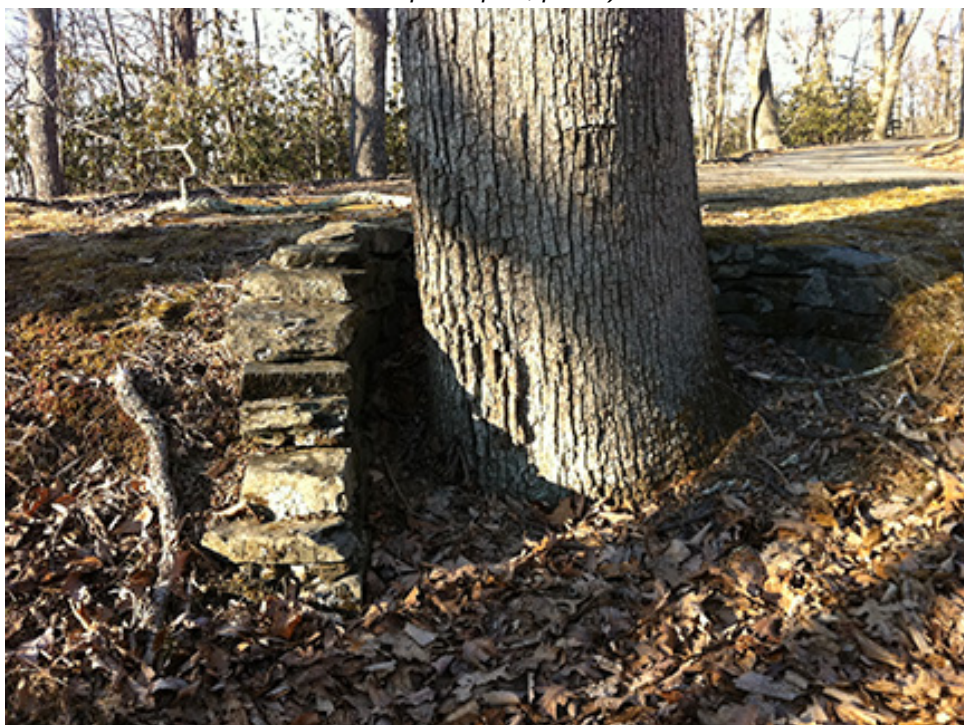
**Stone Tree Wells**- Two of the three tree wells still contain specimen trees of considerable size that are likely the original trees dating to the late 1930s. The third well no longer surrounds a tree and instead functions as a small retaining wall. All three of the tree wells are in good condition.

*Figure 19. Stone tree well in the Picnic Area (2014 Rocky Knob Recreation Area Cultural Landscape Report, p.146)*

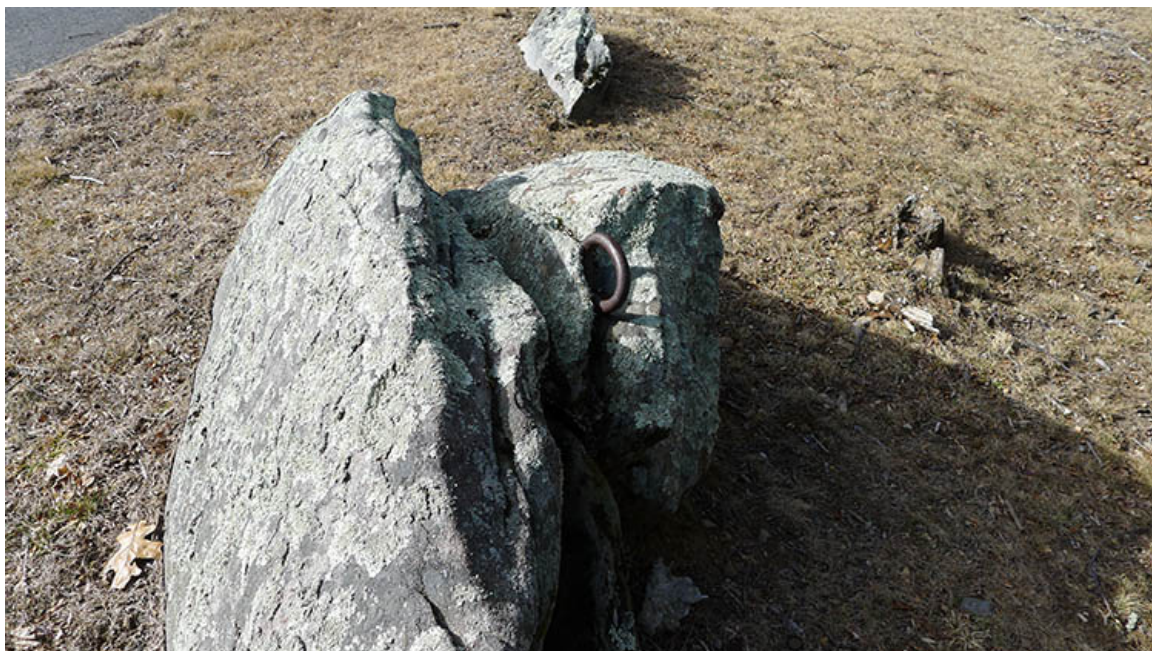
**Entrance Gates-** The original Picnic Area gate likely consisted of a simple chain strung through two eyebolts. Research failed to uncover a photograph of the original gate; though a construction plan for the Picnic Area dated 1937 (Illustration 2.10), clearly shows the location of the gate between the two rock outcrops.

*Figure 22. Remnant eyebolts embedded into rock outcrops at the Picnic Area entrance (2014 Rocky Knob Recreation Area Cultural Landscape Report, p.148)*

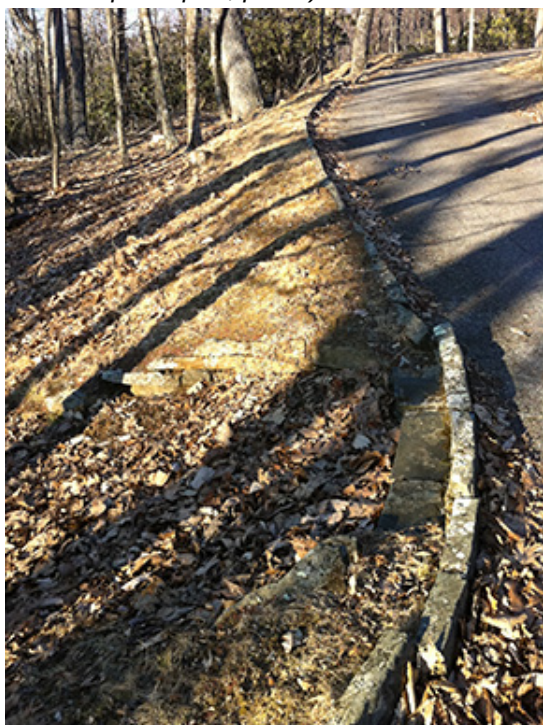
**Stone Curb-** The condition of the stone curb in the Picnic Area varies from good to poor, with some sections needing to be reset.

*Figure 27. Stone curb in Picnic Area, 2011 (2014 Rocky Knob Recreation Area Cultural Landscape Report, p.150)*
