National Park Service  
Cultural Landscapes Inventory

2014

Rocky Knob Maintenance Area  
Blue Ridge Parkway

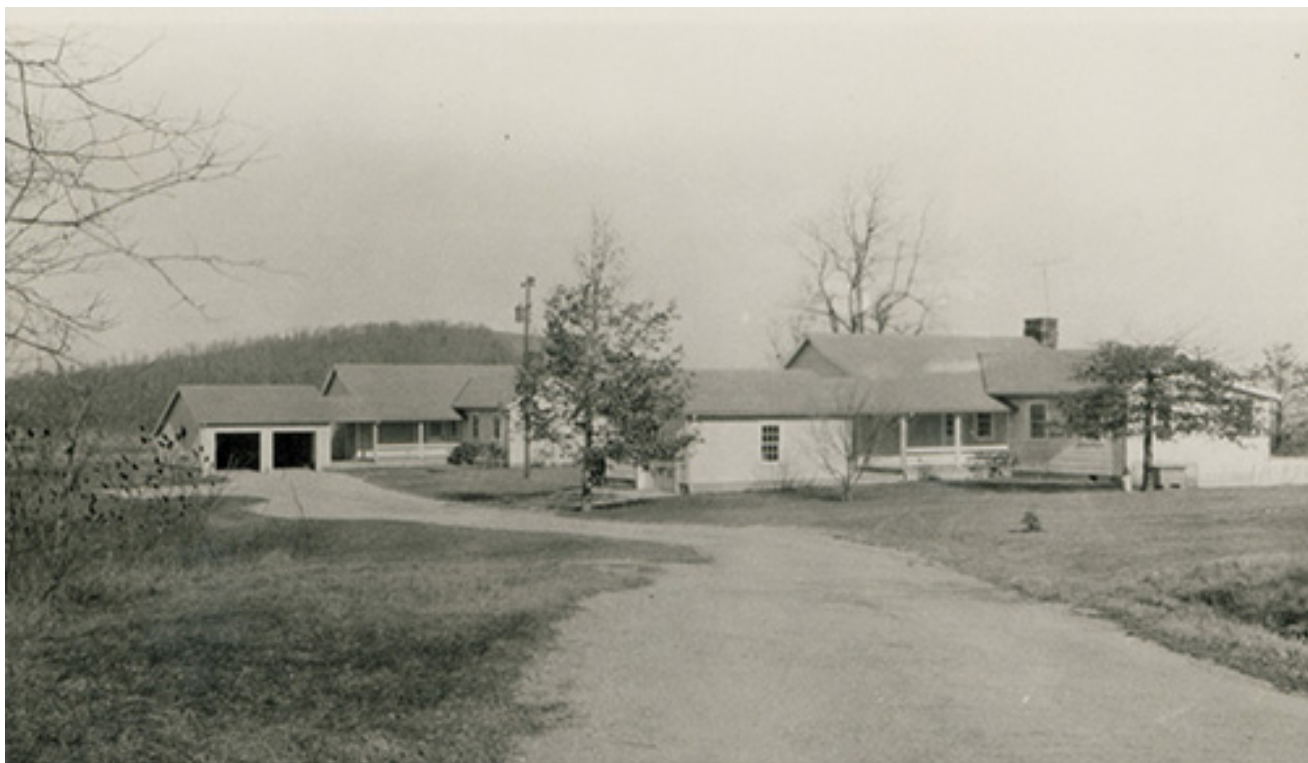
*Figure 4. Employee Residences after extensive alterations 1952 (2014 Rocky Knob Recreation Area CLR, p. 63)*

**Employee Residence #7 and #8**– NPS remodeled and expanded both residences in 1950, and as a result, the buildings lost much of their original character. Each is faced with Post-Mission 66 vinyl siding and retains an original battered stone chimney. The NPS replaced each building's original wood shake roof with asbestos shingles in the 1950s and then later replaced the asbestos shingles with asphalt shingles. The current windows are Post-Mission 66 replacements and retain the general appearance of the original six-over-six double-hung sash windows. Each home features a garage addition attached to the house with a breezeway, added during the Resumption of Construction era. Residence #8 features a two-car garage, while Residence #7 has a single car garage. Post-Mission 66, the NPS added a wooden deck to the eastern elevation of each residence. The NPS has significantly altered the exterior appearance of each residence, but both are in good condition.

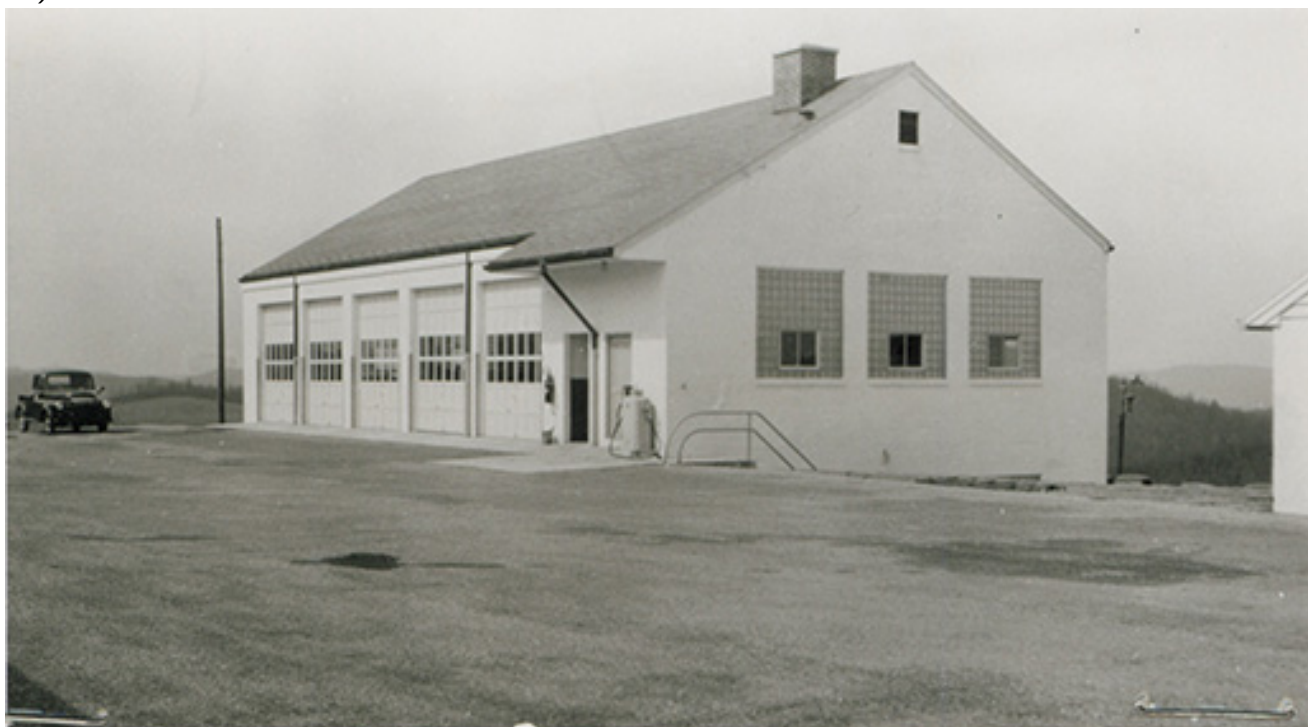
*Figure 5a. Upper (top) level of Building #86 after construction. (2014 Rocky Knob Recreation Area CLR, p. 74)*

**Shops and Heavy Equipment Building #86**– The Shops and Heavy Equipment Building continues to serve its intended function. The upper level contains the auto repair shop, oil room, locker room and storage room. The lower story contains the fire equipment room, the boiler room and storage for heavy equipment. The shop is now sided with the same T1-11 plywood veneer that the NPS used to cover the exterior walls of all the other buildings in the maintenance compound. The NPS replaced the original cement asbestos shingle roof with asphalt shingles. The garage doors are Post-Mission 66 replacements and only one of the entrance doors appears to be original. The ground level of the northern façade also contains five garage bays with replacement garage doors. Two original entry doors and a single window constructed of semi-transparent glass block are located on the eastern end of the building. The building also retains portions of the original copper gutter system. The building is in good condition.

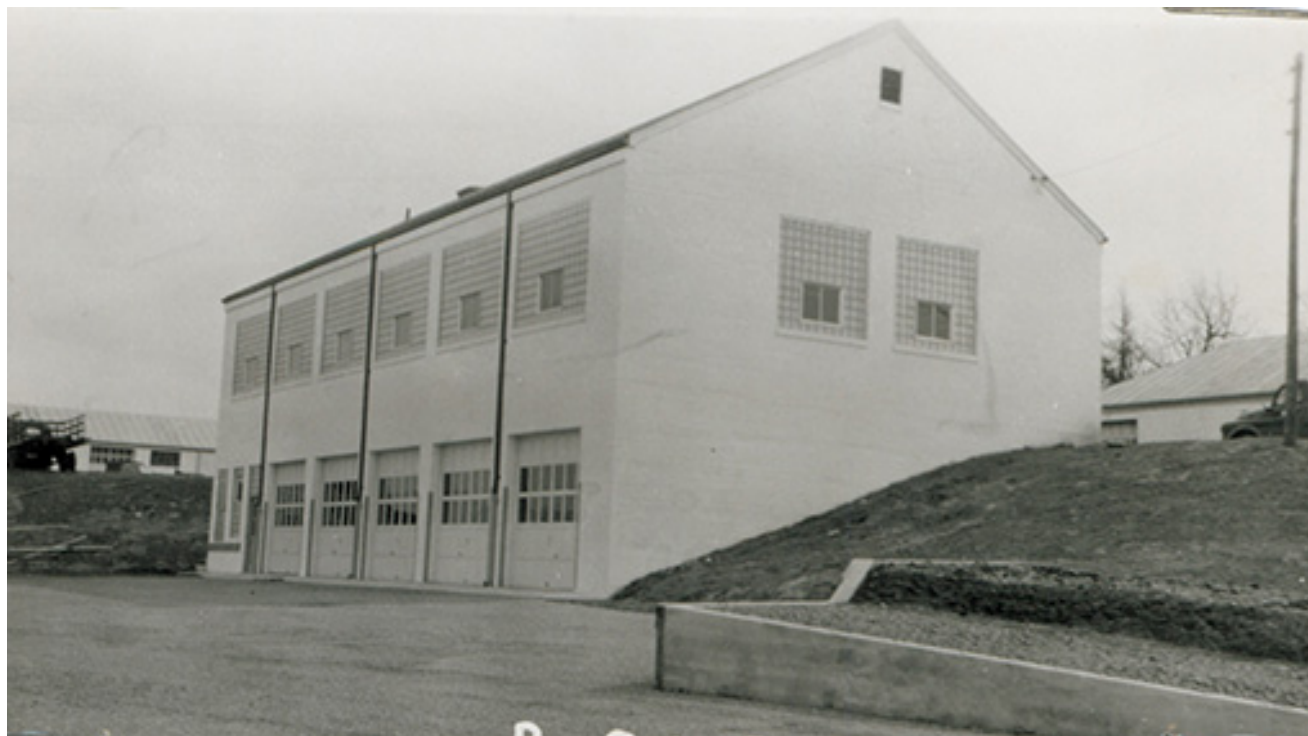
*Figure 5b. Lower (bottom) level of Building #86 after construction. (2014 Rocky Knob Recreation Area CLR, p. 74)*

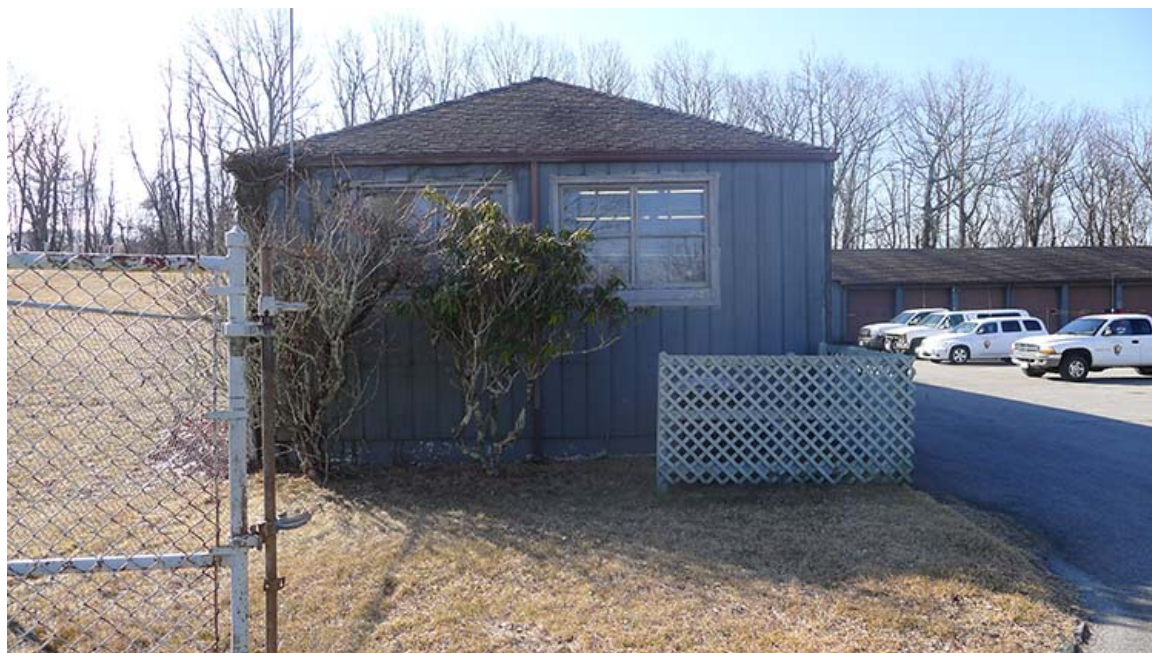
The maintenance compound is located in a large cleared area surrounded by woodland. Vegetation is sparse, consisting primarily of mown turf interspersed with the occasional specimen tree. True to the utilitarian programming of the area, very little ornamental plantings exist in the Maintenance Area. A few ornamental rhododendron plantings exist near the Office and Tool Storage Building. Based on historic photographs of this area, these plantings appear to be original. No landscape plans for the Maintenance Area could be located. These remnant plantings are in poor condition.

*Figure 6. Ornamental plantings in the Maintenance Area 2011 (2014 Rocky Knob Recreation Area CLR, p. 128)*

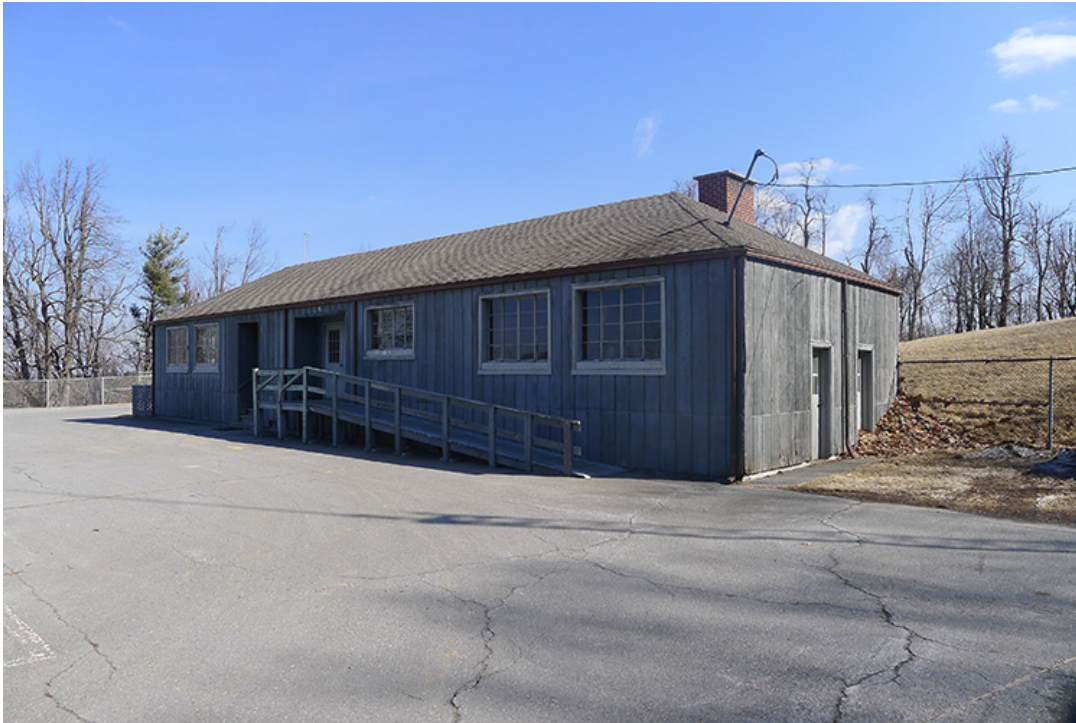
*Figure 7. Office and Tool Storage Building #4 with contemporary wooden ramp, 2011 (2014 Rocky Knob Recreation Area CLR, p. 202)*

**Office and Tool Storage Building #4**– The NPS completed some renovations to the building post Mission-66. Today the original windows remain, but NPS replaced the original garage door with a set of double doors Post-Mission 66. The NPS also added a wooden ramp to provide access to these double doors. The rear and side façades still retain their original windows and doors, but as with the other two previously described buildings in the Maintenance Area, Post-Mission 66 plywood siding

and an asphalt shingle roof currently cover this entire building. The building is in good condition overall, but is plagued with deteriorating windows.

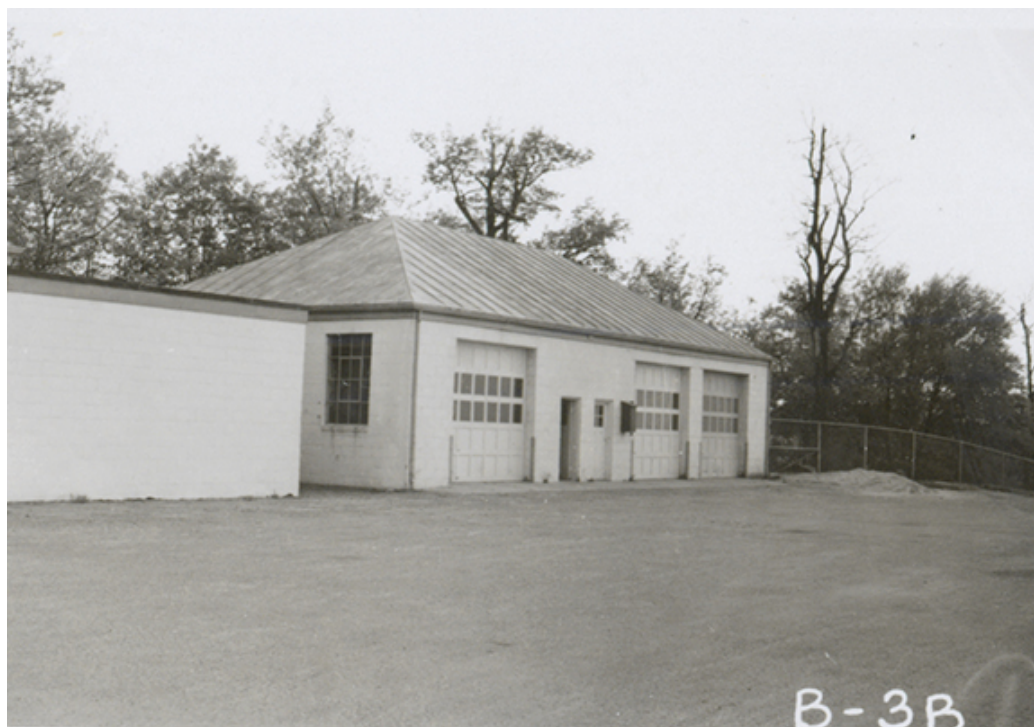
*Figure 8. Carpenter and Paint Shop Building #3, c. 1952 (2014 Rocky Knob Recreation Area CLR, p. 132)*

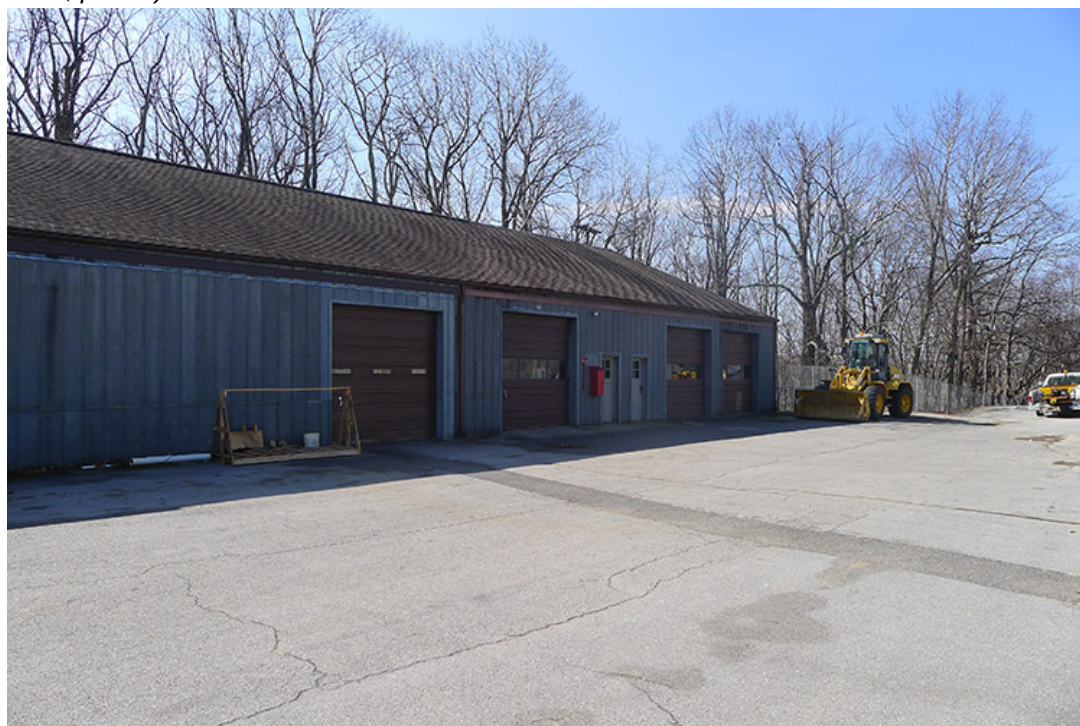
**Carpenter and Paint Shop Building #3**– In 2000, the NPS carried out additional renovations to the building. The NPS removed a flat roof section of the additional storage area and constructed an A-Line roof in its place, giving the appearance of single unified façade across the Warehouse and Equipment Storage Building and the Carpenter and Paint Shop. As with most of the other buildings in the maintenance compound, plywood siding, Post-Mission 66 garage doors and a replacement asphalt shingle roof cover this building. The south and west façades feature three large sixteen light, metal-clad windows. The center four panes of each window can be opened and function as awning windows. These windows are original. The building retains its original entrance doors as well as the original exterior fire safety kit; although the latter is no longer in its original location. The building is in good condition, with a few exceptions, most notably the windows, which contain cracked glazing.

*Figure 9. Carpenter and Paint Shop Building #3, 2011 (2014 Rocky Knob Recreation Area CLR, p. 12)*

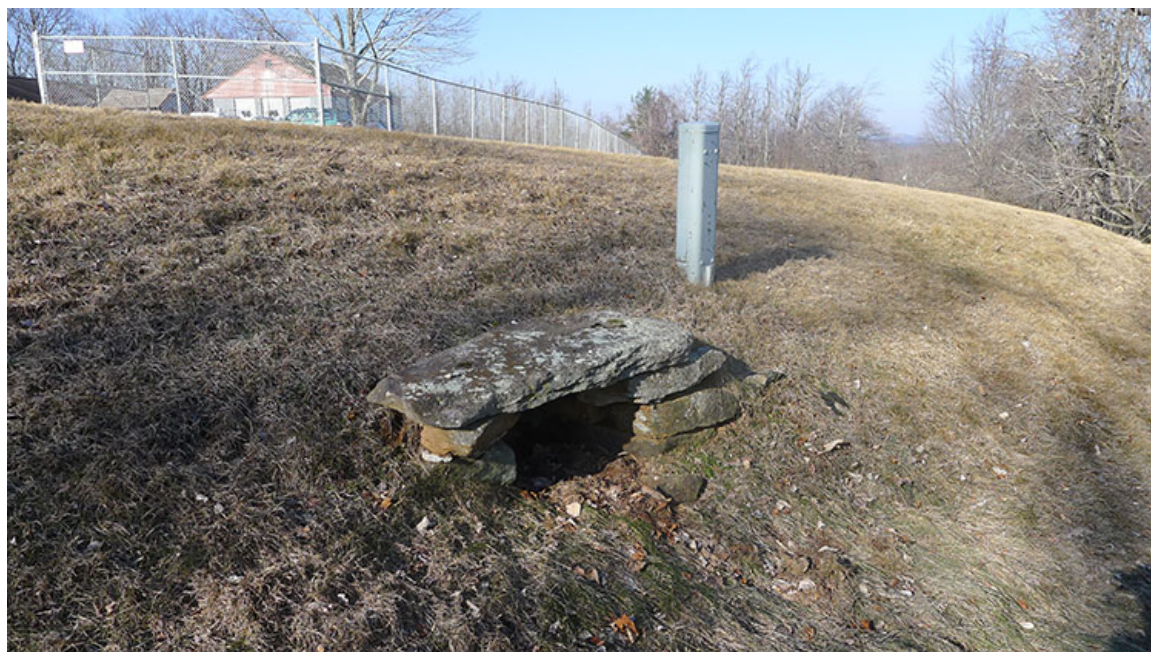
**Drainage Structures–** The intended function of the stone headwalls to convey storm water is unchanged and they are good condition.

*Figure 12. Stone drainage structure, 2011 (2014 Rocky Knob Recreation Area CLR, p. 137)*

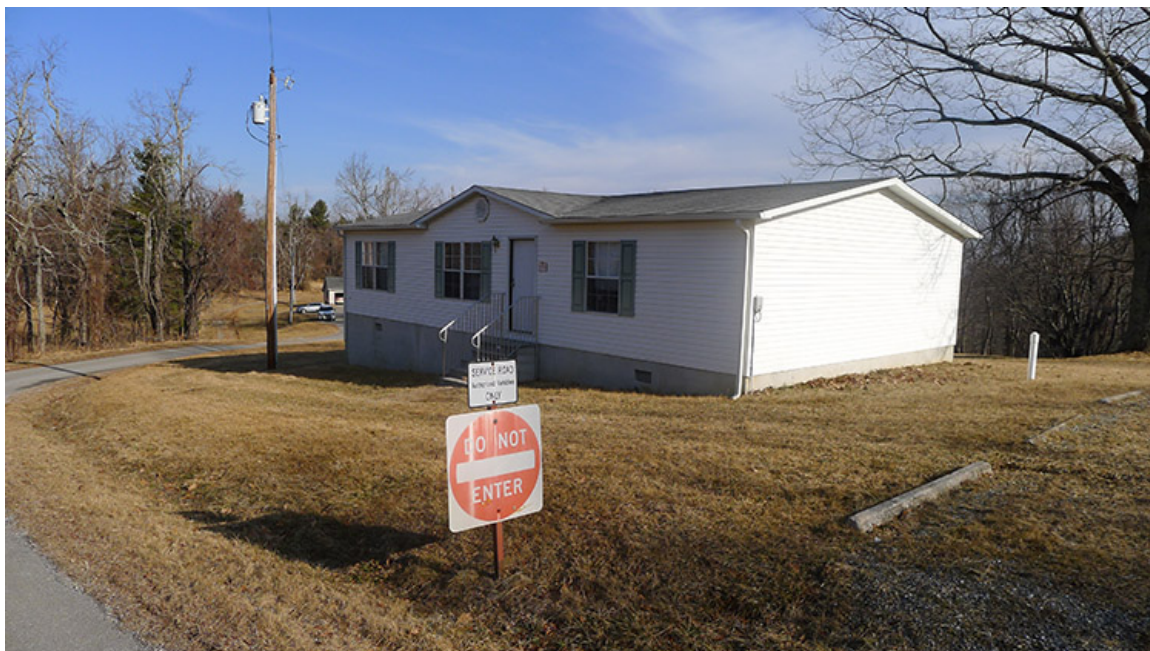
**Signage–** A standard brown and white reflective metal sign is located near the gated entrance to the Maintenance Area. This sign directs visitors to the District Office and Maintenance Area. A faded metal “Do Not Enter” sign is located along the entrance road, directly in front of one of the District Office Trailers. Additionally, most buildings located within the maintenance compound have a small sign that denotes the official Parkway building number. The NPS has replaced many of the original wood signs with Post-Mission 66 recycled plastic versions. The signs are in good condition.

*Figure 13. Regulatory sign, 2011 (2014 Rocky Knob Recreation Area CLR, p. 137)*

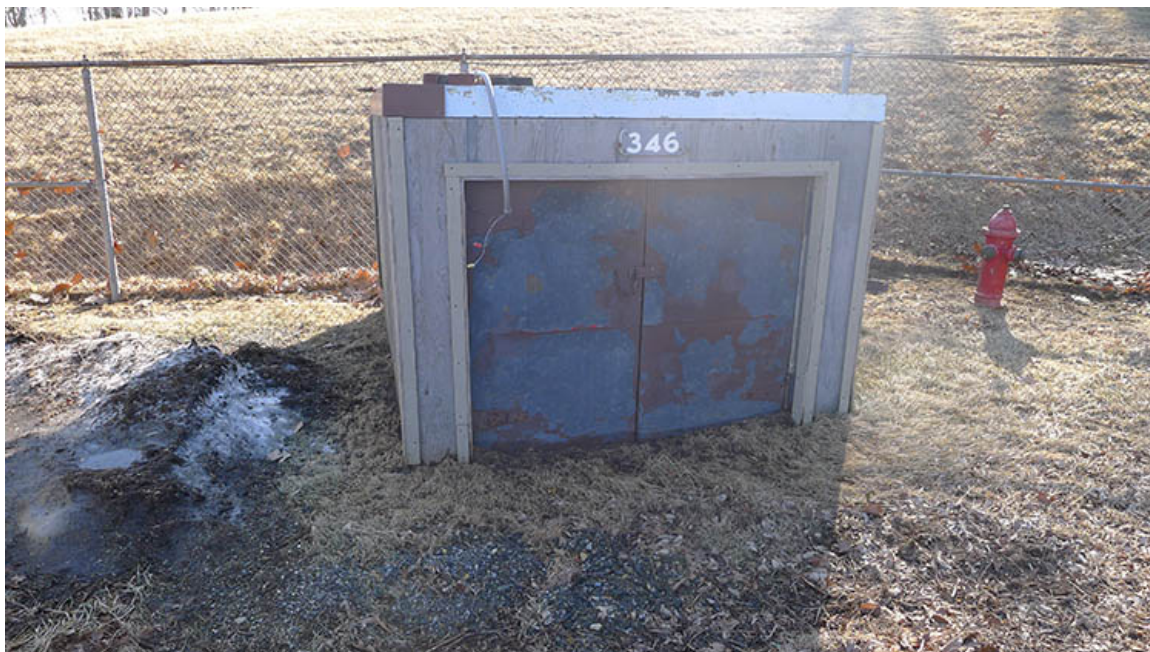
*Figure 14. Building number designation sign, 2011 (2014 Rocky Knob Recreation Area CLR, p. 137)*

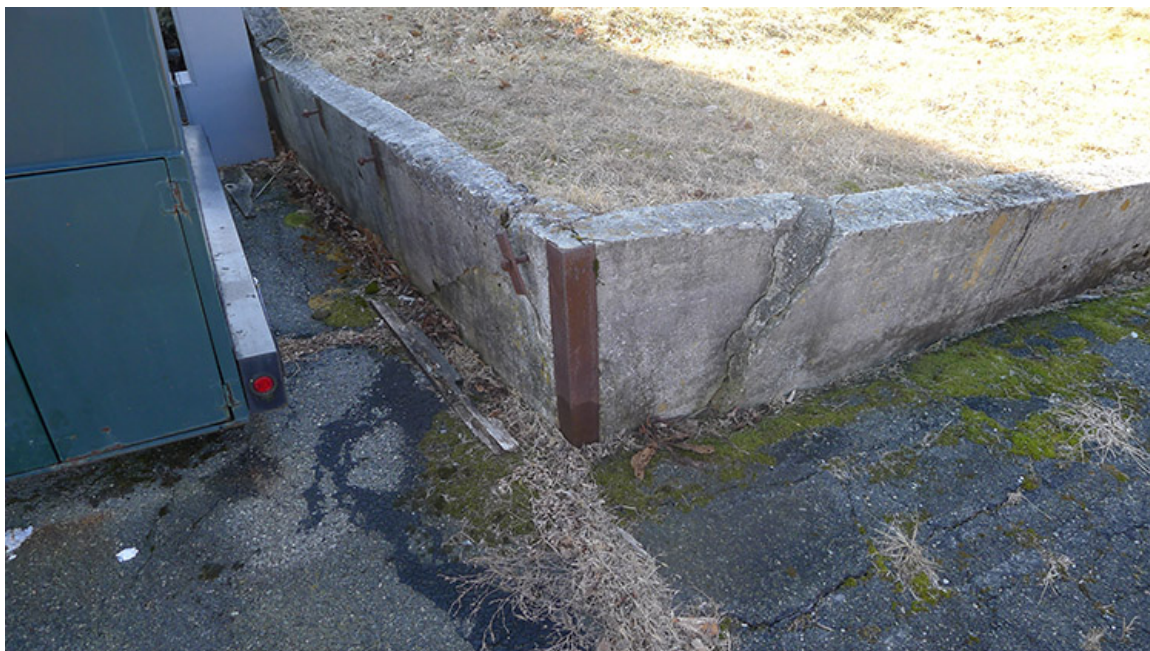
**Concrete Retaining Wall–** The wall is in poor condition and is in need of repair, but few changes in materials, craftsmanship, and design are evident.

*Figure 15. Concrete retaining wall, 2011 (2014 Rocky Knob Recreation Area CLR, p. 138)*

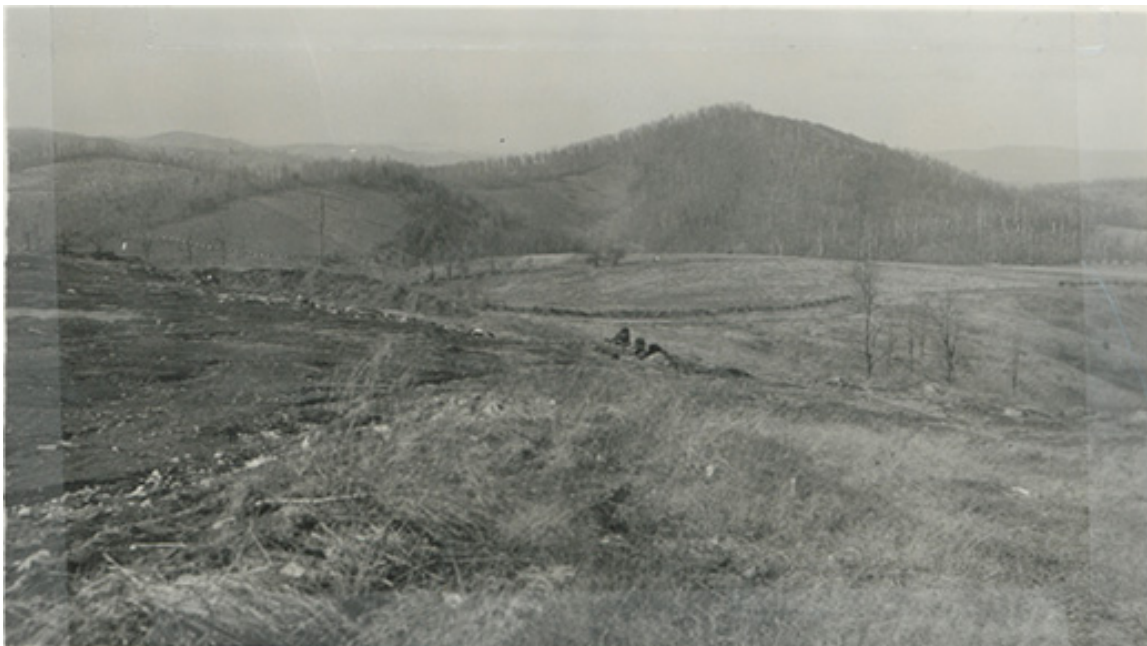
*Figure 16. Maintenance Area landscape prior to construction (2014 Rocky Knob Recreation Area CLR, p.62)*
