National Park Service  
Cultural Landscapes Inventory

2014

Rocky Knob Section 1S  
Blue Ridge Parkway

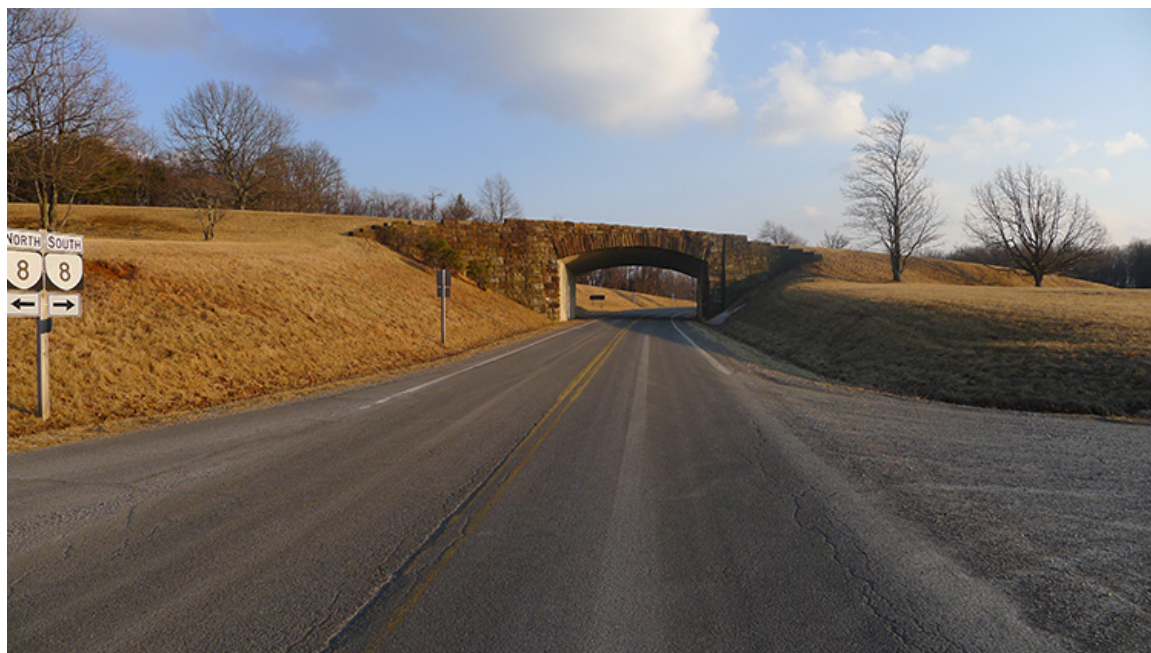
Existing Conditions: The arched bridge at the Tuggle Gap Grade is in good condition. A historic photo of the bridge under construction shows that the bridge has changed little since its construction in the 1950s.

*Figure 18. Grade-separated interchange at Tuggle Gap, 2011 (2014 Rocky Knob Recreation Area CLR, p. 159)*

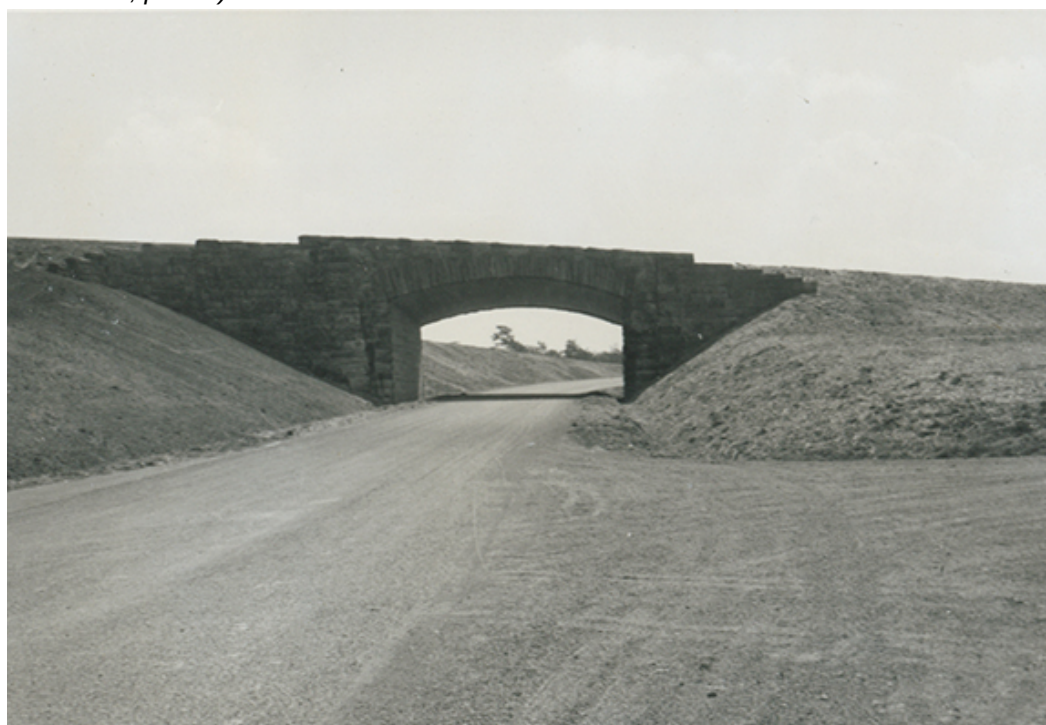
Historic Conditions: An impressive arched bridge is located at the Tuggle Gap Grade Separated Interchange along Parkway Section 1-S. This single span bridge is a good example of a stone-faced Parkway bridge constructed over a state route. Built by NPS in 1955, this bridge is constructed of poured reinforced concrete faced in masonry stone. It features a stepped stone parapet wall.

*Figure 19. Grade-separated interchange at Tuggle Gap, c.1954 (2014 Rocky Knob Recreation Area CLR, p. 159)*

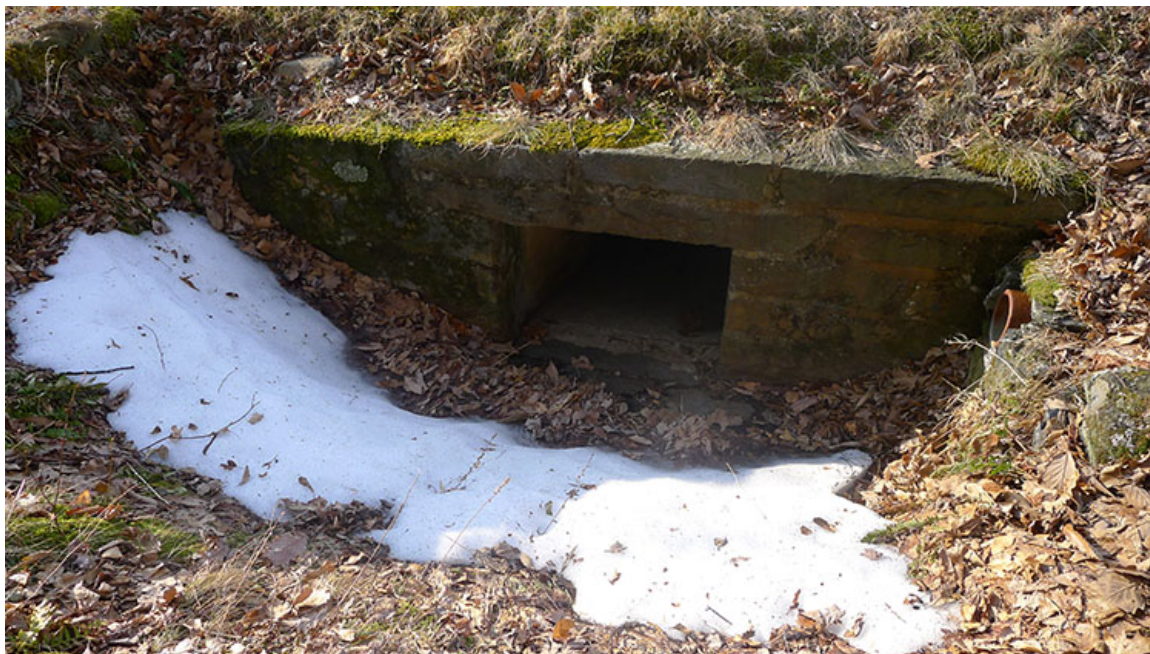
*Figure 21. Typical stone headwall along Parkway Section 1-S, 2011 (2014 Rocky Knob Recreation Area CLR, p. 159)*

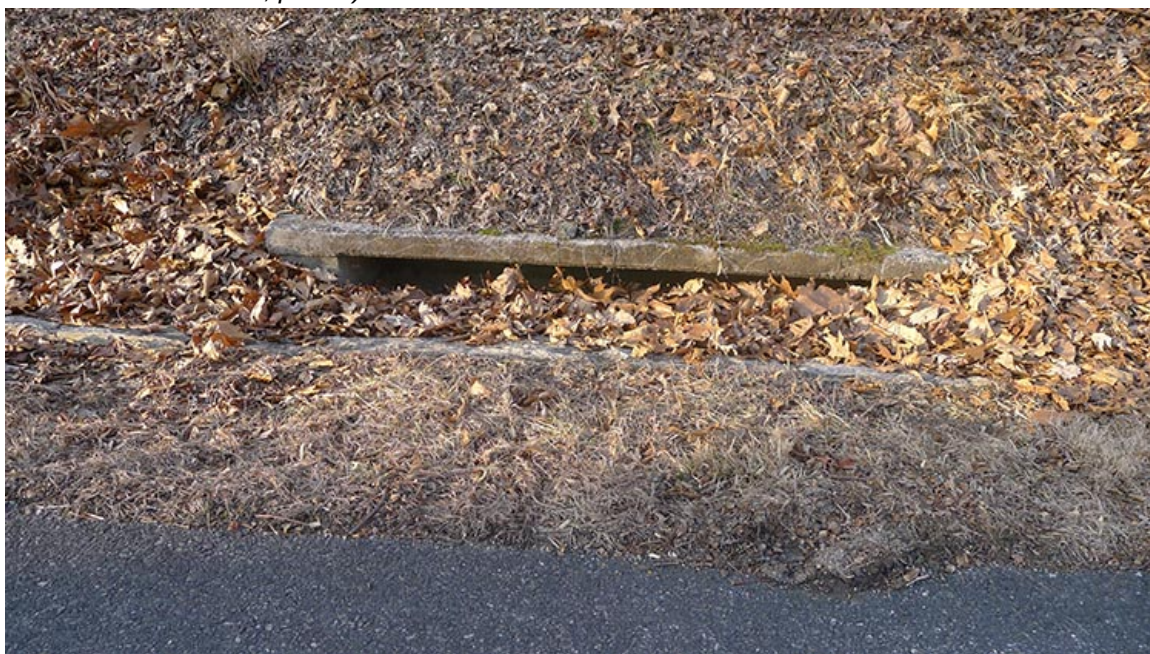
Drainage Structures- All of these original drainage structures appear on the PLUMs, are functional and appear to be in good condition.

*Figure 22. Concrete drop inlet along Parkway Section 1-S, 2011 (2014 Rocky Knob Recreation Area CLR, p. 159)*

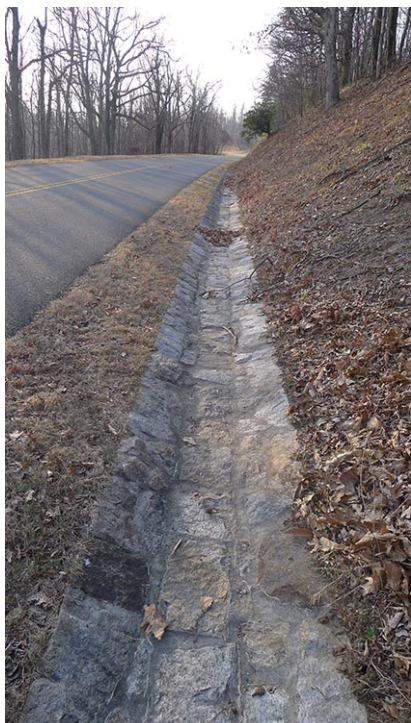
Stone Gutters- The overall condition of the gutter system is fair due to encroaching vegetation in the mortar joints of some sections of gutter. However, the NPS appears to have maintained some sections better than others over the years, and there is evidence that some sections were reset recently.

Figure 23. Stone gutter along Parkway Section 1-S, 2011 (2014 Rocky Knob Recreation Area CLR, p. 160)

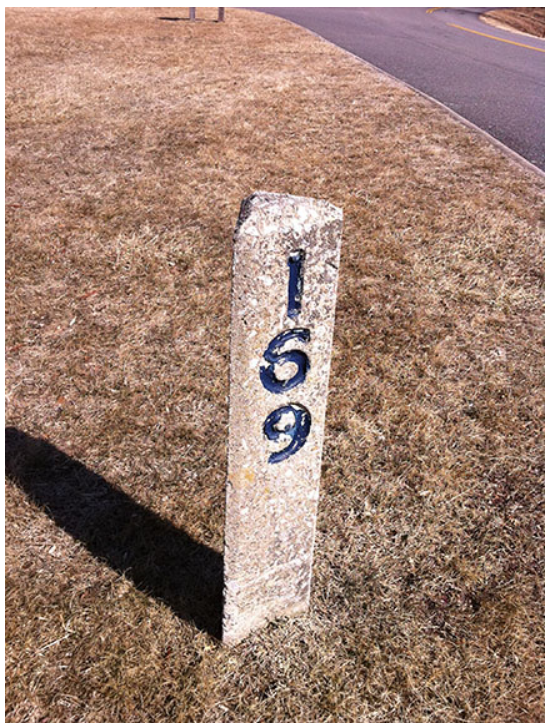
Signage- The concrete mile markers are in good condition. This Parkway standard style is still used today. The Parkway entrance sign at the Tuggle Gap Grade-Separated Interchange is in good condition.

Figure 25. Concrete mile marker along Parkway Section 1-S, 2011 (2014 Rocky Knob Recreation Area CLR, p. 161)

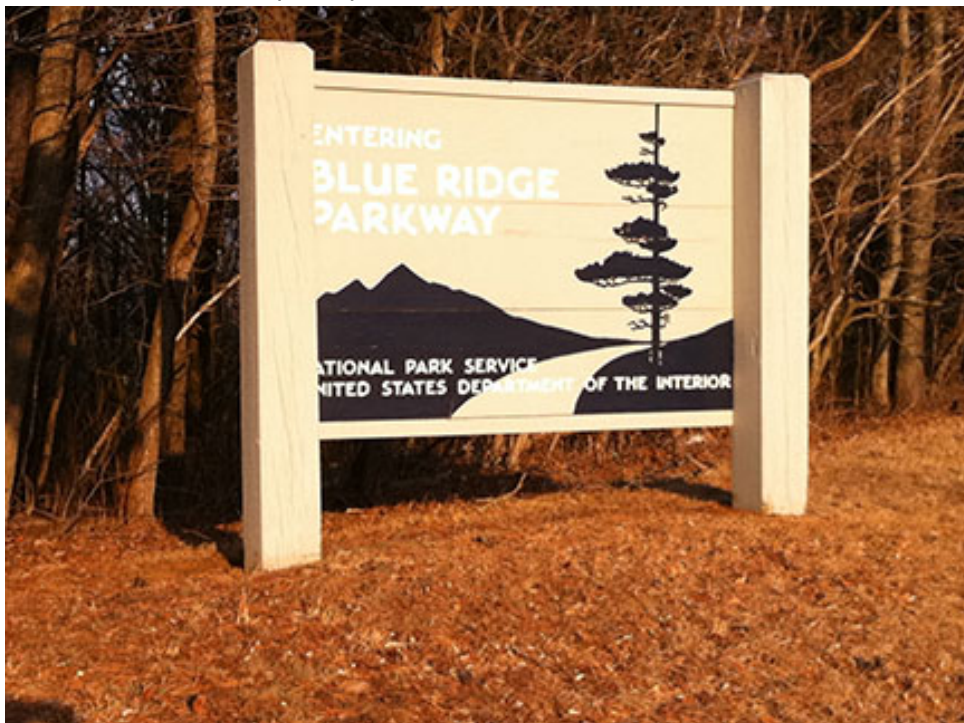
Figure 26. Parkway entrance sign (2014 Rocky Knob Recreation Area CLR, p. 161)

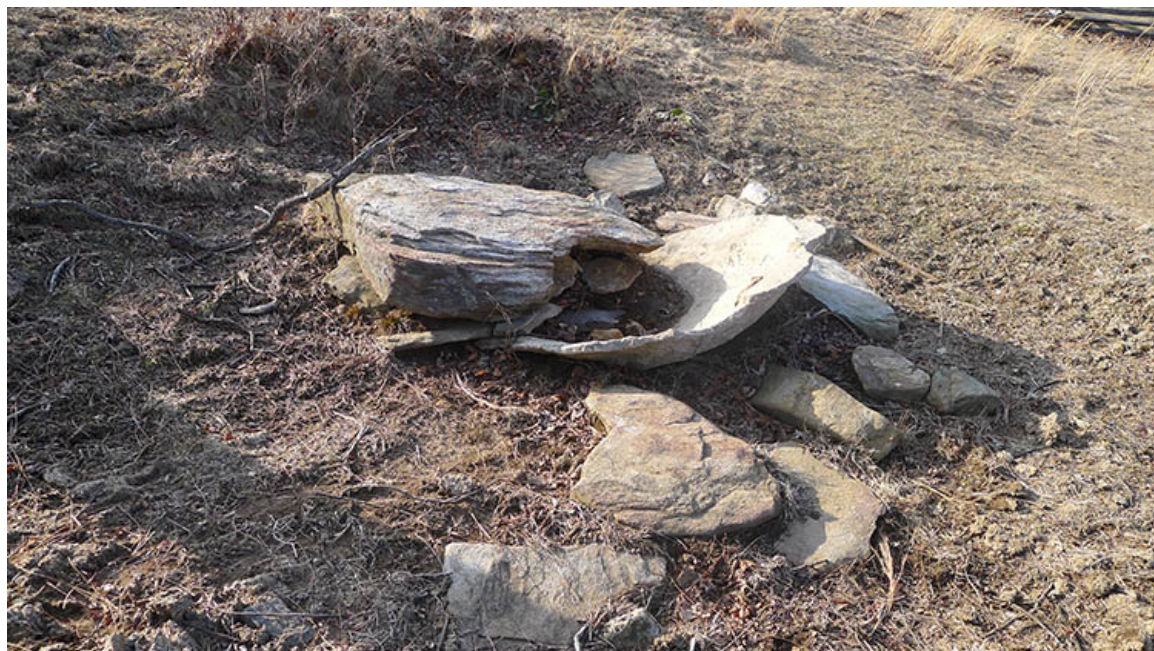
Spring Outlet Wall- The structure collapsed and only portions of the stone and mortar remain in the landscape today, leaving this resource in poor condition.

*Figure 29. Collapsed spring outlet wall along Parkway Section 1-S near mile 169.6 (2014 Rocky Knob Recreation Area CLR, p. 162)*

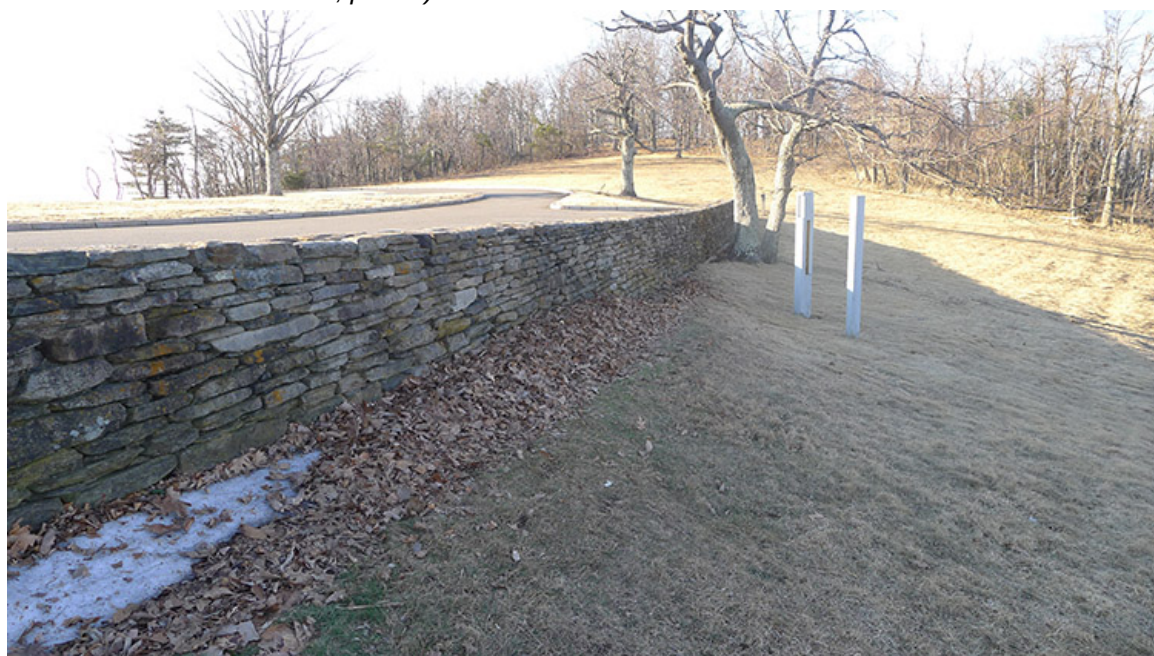
Stone Retaining Wall- This feature is in good condition, as is the rest of the wall, although there are some areas where stones are missing and recent mortar repairs are obvious.

*Figure 30. Stone retaining wall at The Saddle Overlook, 2011 (2014 Rocky Knob Recreation Area CLR, p. 166)*

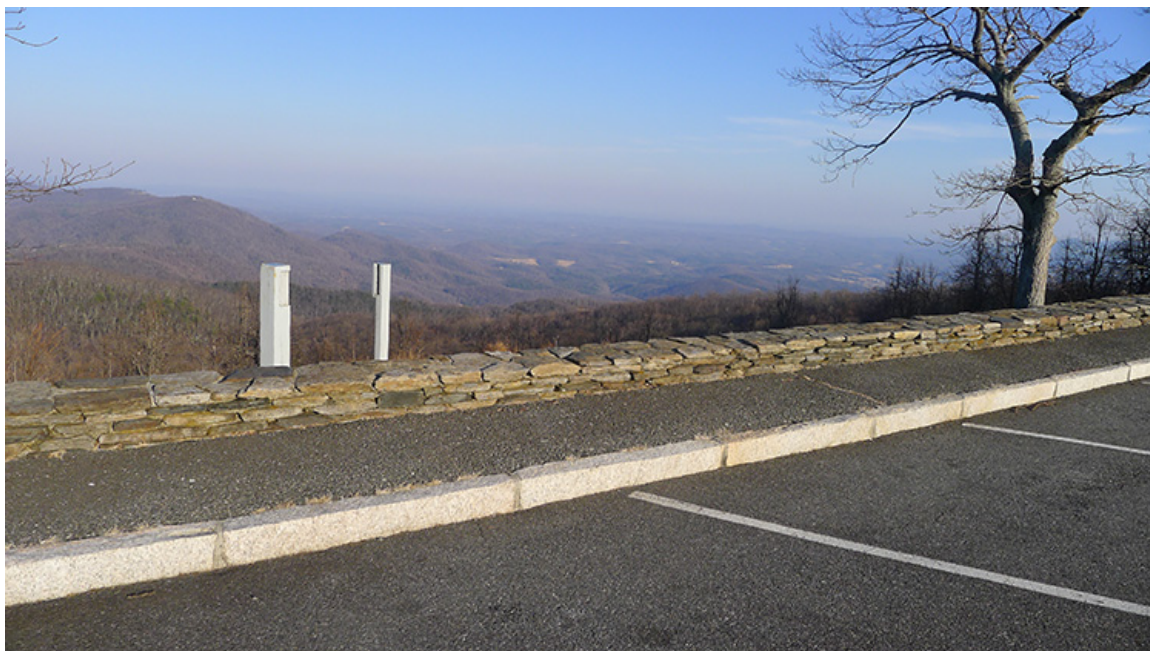
Stone Curbs- Split face granite curb exists around the perimeter of the parking area at the Saddle Overlook. The same type of curbing surrounds the center median. The type of granite used contains a considerable amount of quartz, which gives each section of curbing a distinct pinkish hue. Granite was not the original curbing material at this location. Examples of the pink granite curbing type exist at the Rock Castle Gorge Overlook and the parking area adjacent to the Gas Station. All curbs at this location are in good condition and feature the characteristic gradual transition into grade at the starting point of each section, which is common design detail present throughout the Parkway.

Figure 35. Pink granite curbing at The Saddle Overlook, 2011 (2014 Rocky Knob Recreation Area CLR, p. 166)

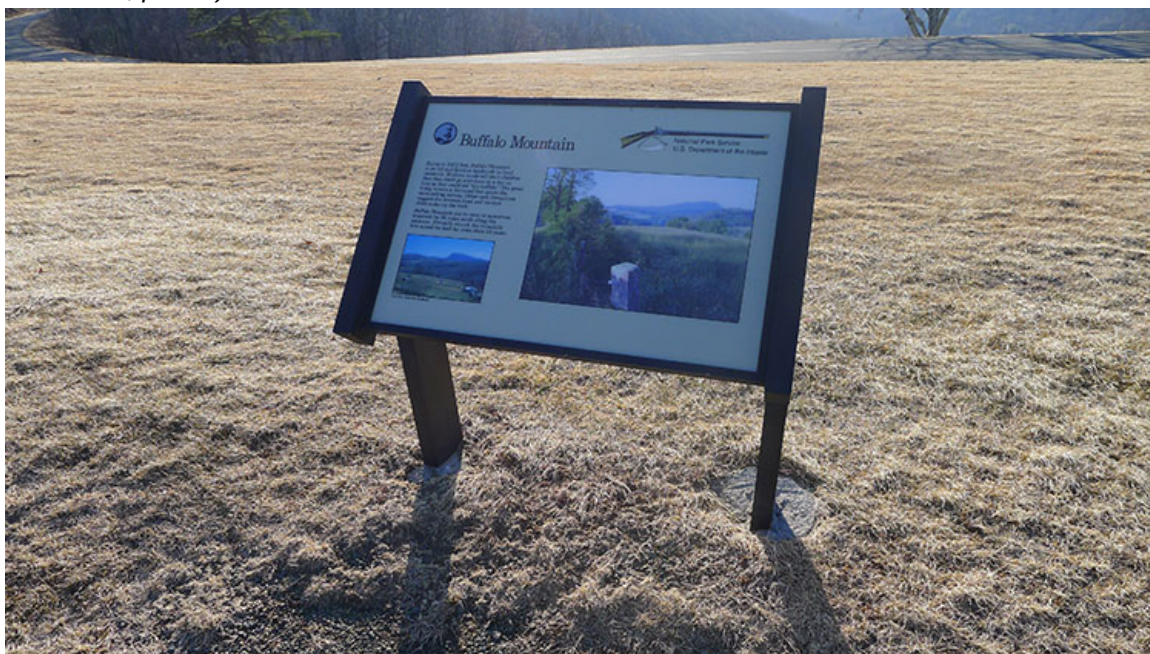
Signage- Two interpretive signs are located at the Saddle Overlook. The first sign is located on the edge of the western parking area. This sign focuses on the history of Buffalo Mountain, which is visible in the distance from this location. This sign is constructed of metal posts that hold a vandal-proof integrated graphic board, which is consistent with the new interpretive signs found along the Parkway. The second sign was the traditional gunboard style sign. Over time, the NPS replaced many of the original wooden signboards with Post-Mission 66 signboards made from either recycled plastic or foam. At the time of this report, the Saddle gunboard sign was missing and only the mounting posts were visible. Through research, a recent photograph of this particular sign was discovered that shows a badly deteriorated replacement foam sign at this location. This damaged foam sign was likely in the process of being replaced at the time fieldwork was conducted by the project team.

Figure 36. Post-Mission 66 interpretive sign at The Saddle Overlook, 2011 (2014 Rocky Knob Recreation Area CLR, p. 167)

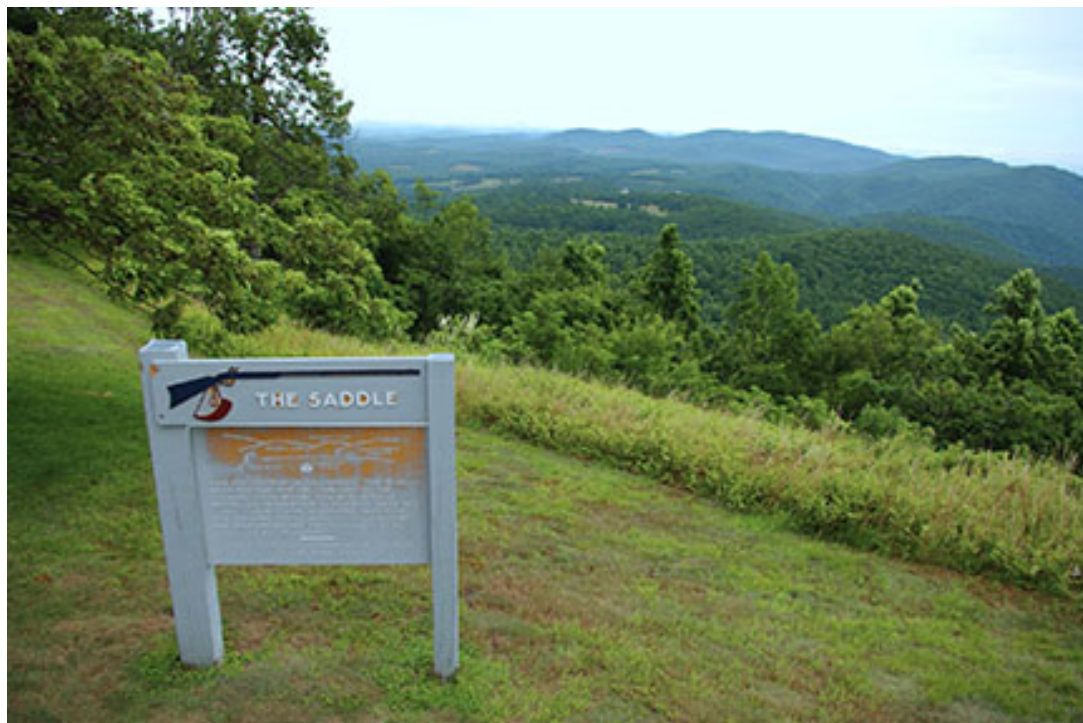
| Year | Event | Annotation |
|---|---|---|
| CE 2000 | Altered | Early 2000s. Parkway staff replaced the gunboard sign at The Saddle Overlook with a pressed foam sign. |

*Figure 37. Foam gunboard sign at The Saddle Overlook, 2010 (2014 Rocky Knob Recreation Area CLR, p. 167)*

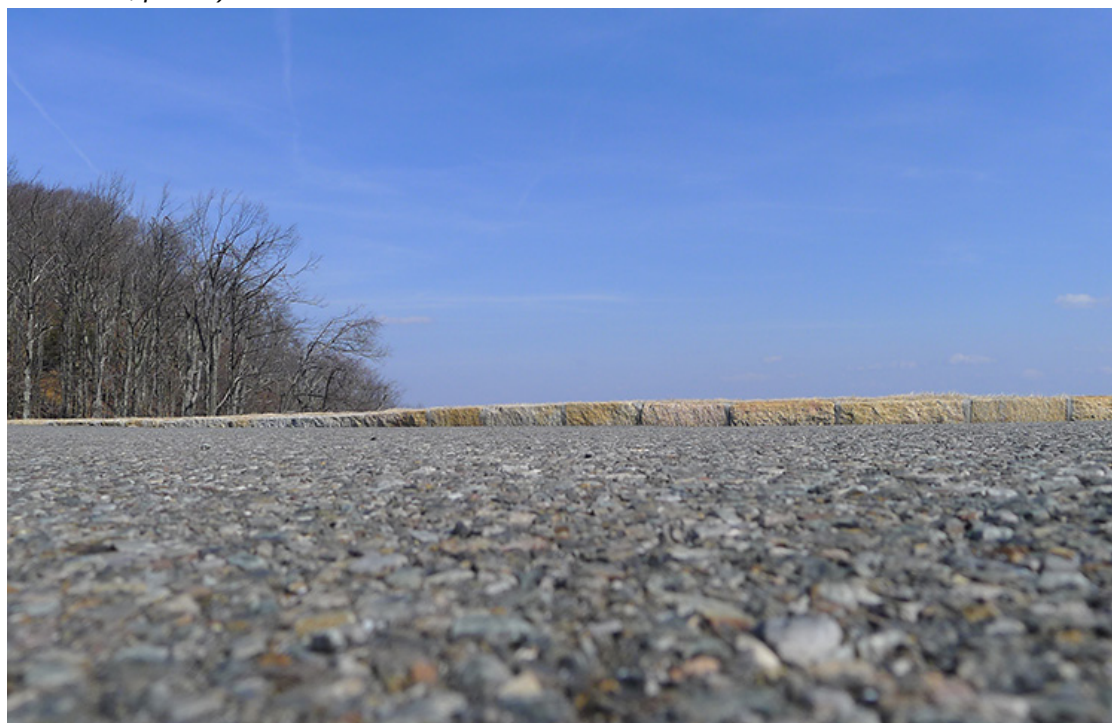
*Figure 38. Stone curb transition into grade at Rock Castle Gorge Overlook, 2011 (2014 Rocky Knob Recreation Area CLR, p. 172)*

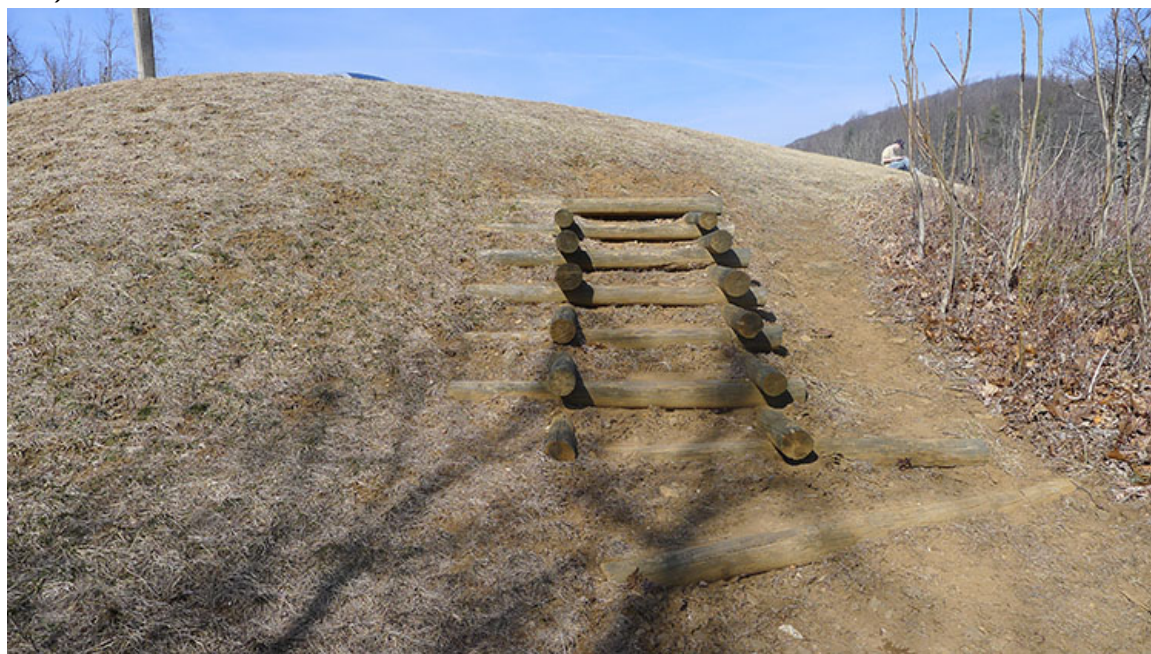
Wooden Steps- A set of Post-Mission 66 wooden trail steps is located at the western end of the parking bay. These steps provide access to the Rock Castle Gorge Trail from the parking area. The stairs are in fair condition; however, the adjacent turf is compacted and eroding away due to heavy foot traffic.

*Figure 40. Wooden trail steps at Rock Castle Gorge Overlook, 2011 (2014 Rocky Knob Recreation Area CLR, p. 172)*

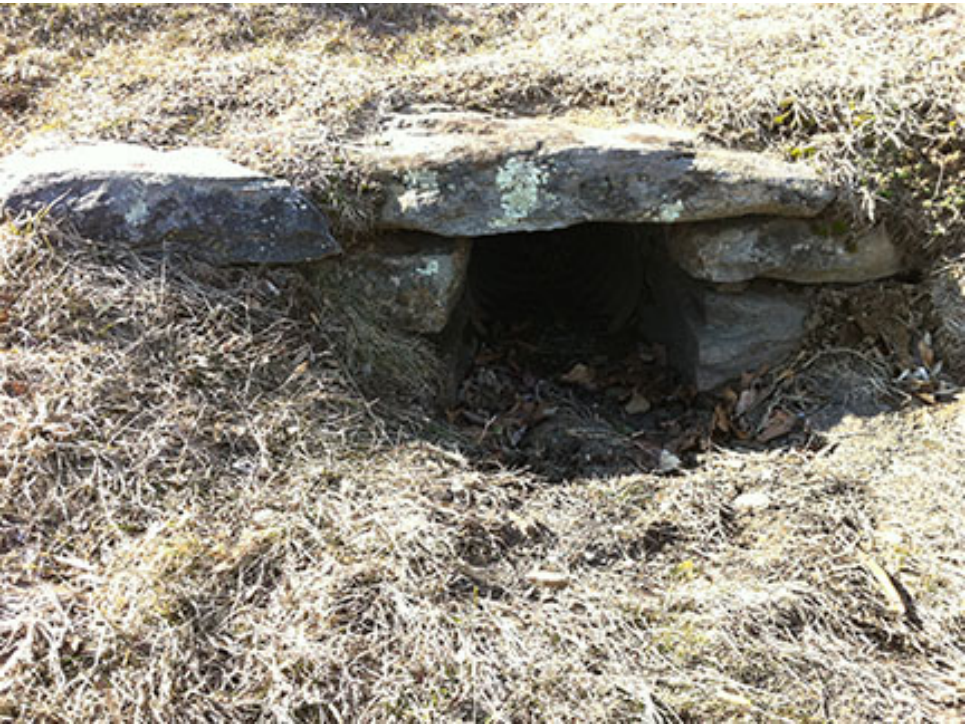
Stone Headwall- This headwall is in good condition.

Figure 41. Stone headwall at Twelve O'clock Overlook, 2011 (2014 Rocky Knob Recreation Area CLR, p. 176)
