# Coastal Topography Change at Padre Island National Seashore, Texas

## *2017–2021 Data Summary*

Natural Resource Data Series NPS/GULN/NRDS—2022/1347

Jeff Bracewell and Jane Carlson

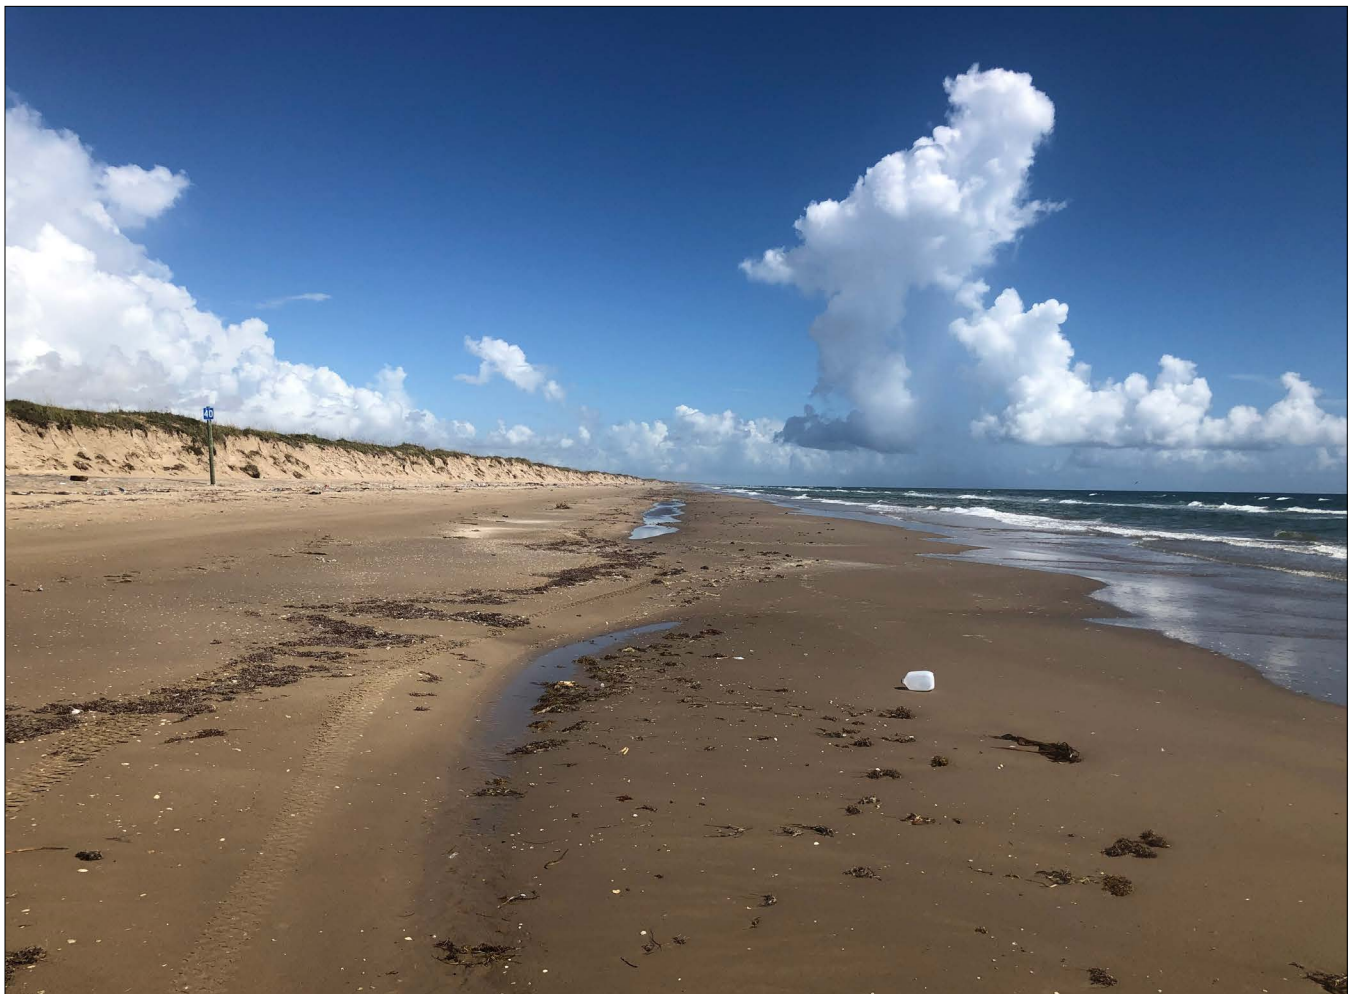
**ON THE COVER**

Photo taken in August 2020 near mile marker 40, after Hurricane Hanna. It shows sloped beach and eroded foreshore dune margin. NPS photo / GULN staff.

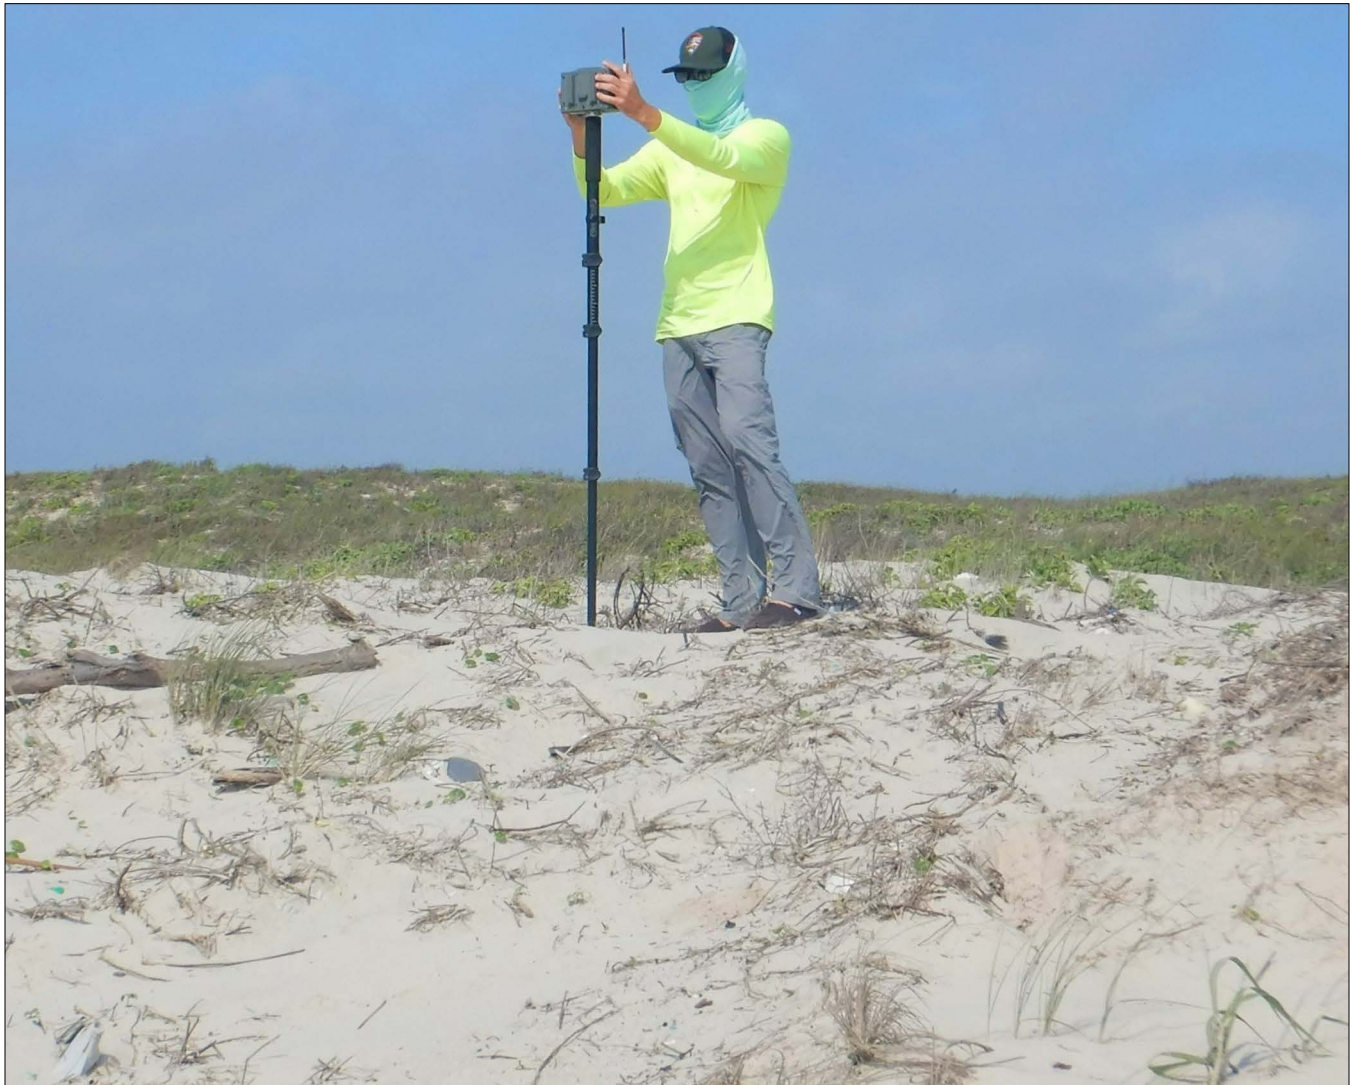
**Figure 2.** Field crew measuring the topo point at transect 105 in Padre Island National Seashore. NPS photo / GULN staff.

park resource management decisions and other GULN vital signs monitoring projects (Figure 1). To collect monitoring data, a crew member records elevation using precision GPS equipment at the topographic inflections in the beach and primary dune complex along the transect (Figure 2).

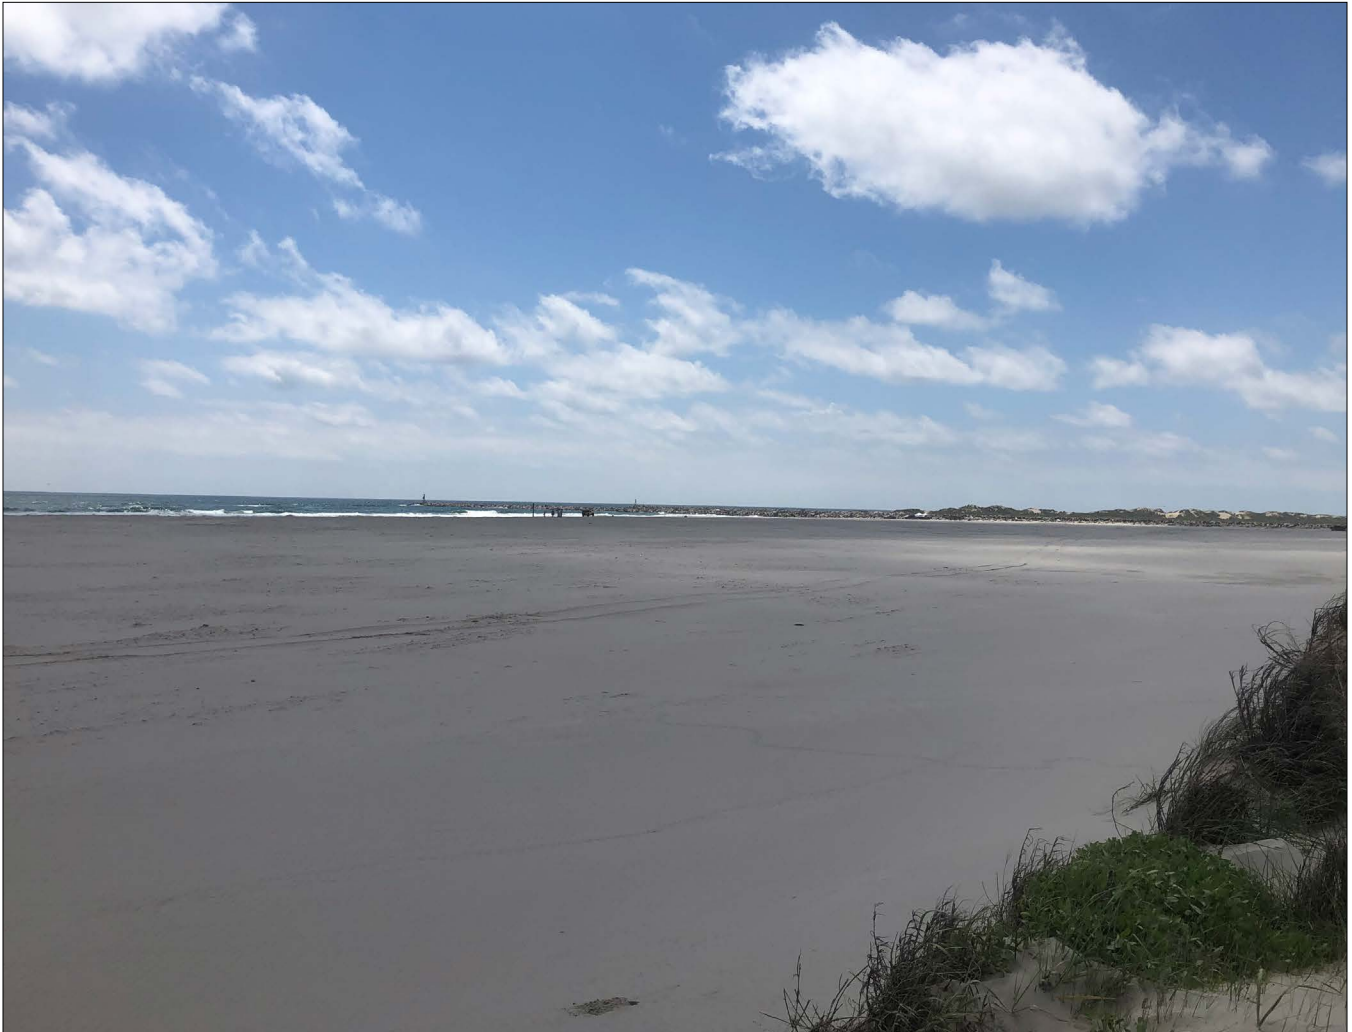
**Figure 4.** Photo taken May 7, 2021 near Port Mansfield Channel, facing south. This section of the park experienced the highest shoreline advance following the recent placement of dredged material.

Recent dredging at the Mansfield Channel, the southern boundary of the park, nourished a 1-kilometer (0.62-mile) stretch of beach at Mile Marker 60. In late 2019, a hopper dredge transported material from Mansfield Channel to a nearshore disposal site north of the north jetty. A larger

project, started in October 2020 and completed in early 2021, placed 970,000 cubic yards (741,618 cubic meters) of material dredged from the channel on the adjacent northern beach (Figure 4). No maintenance dredging had occurred on the channel since 2011 (USACE 2014).
