# DendroArchaeology NADEF – 2015

Gary Macadaeg  
Meghan Ladolcetta  
Jeffrey Benjamin  
Bill Flynt  
*introducing,  
Paul Krusic*

# Introduction

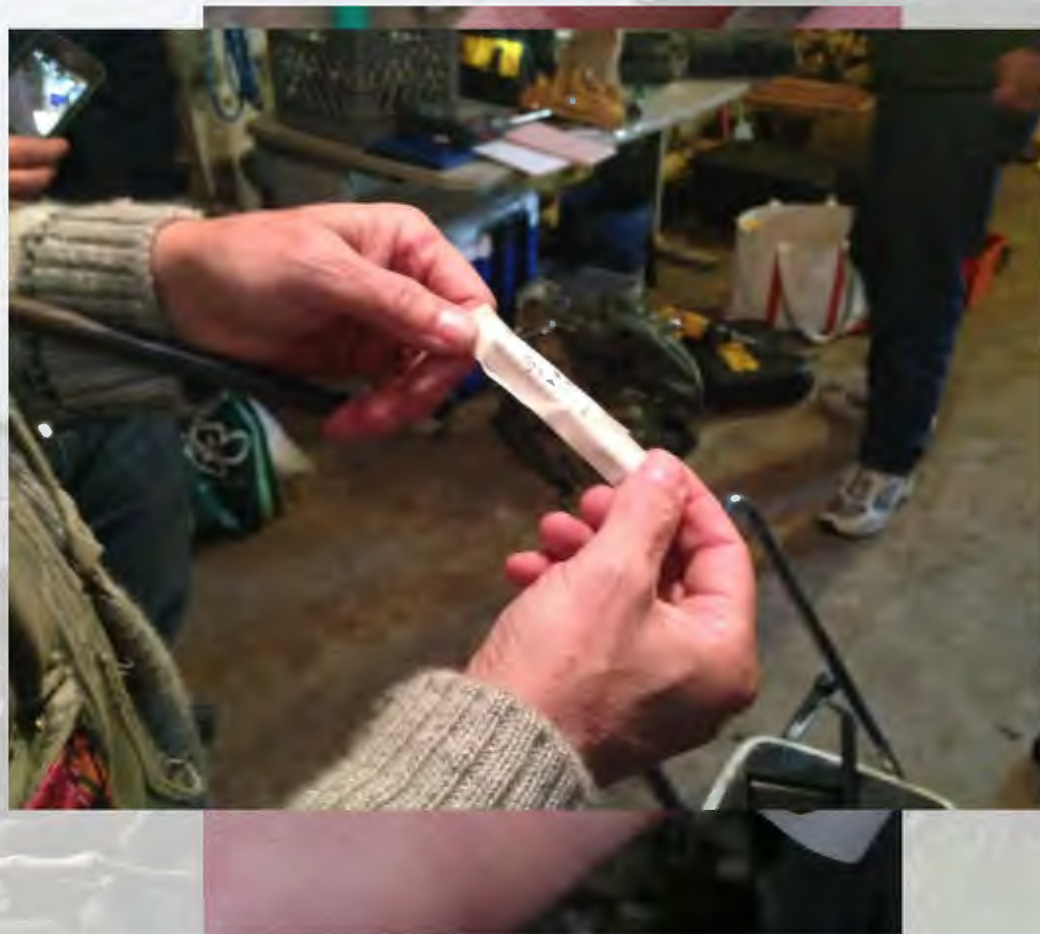
# Coring

Electric drills with  
two custom bits

Numbered, noted, stored

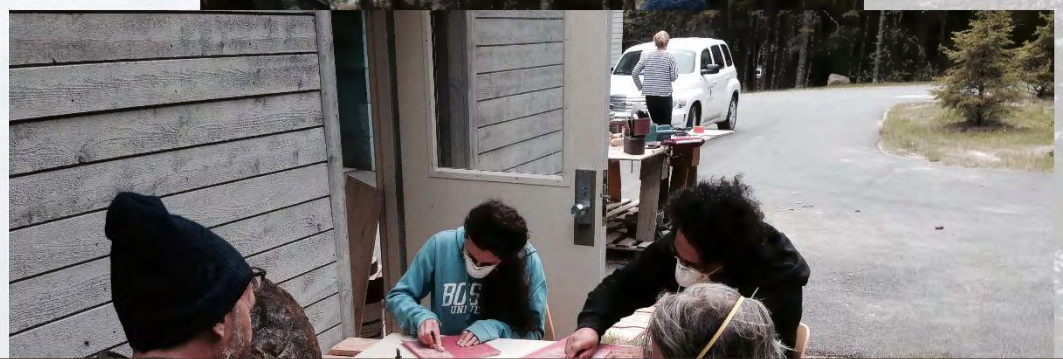
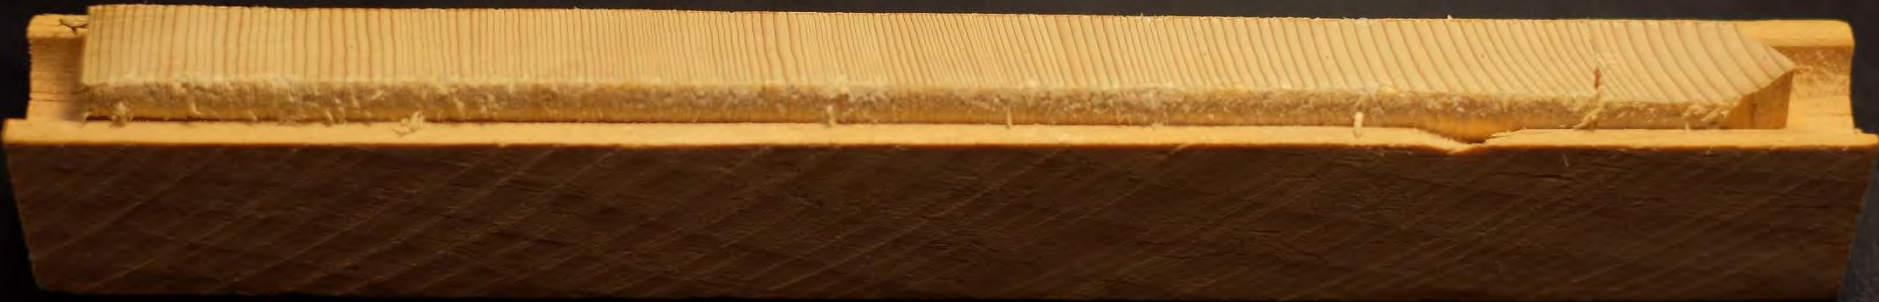
# Preparation

Glue to core mounts

Progressive sanding

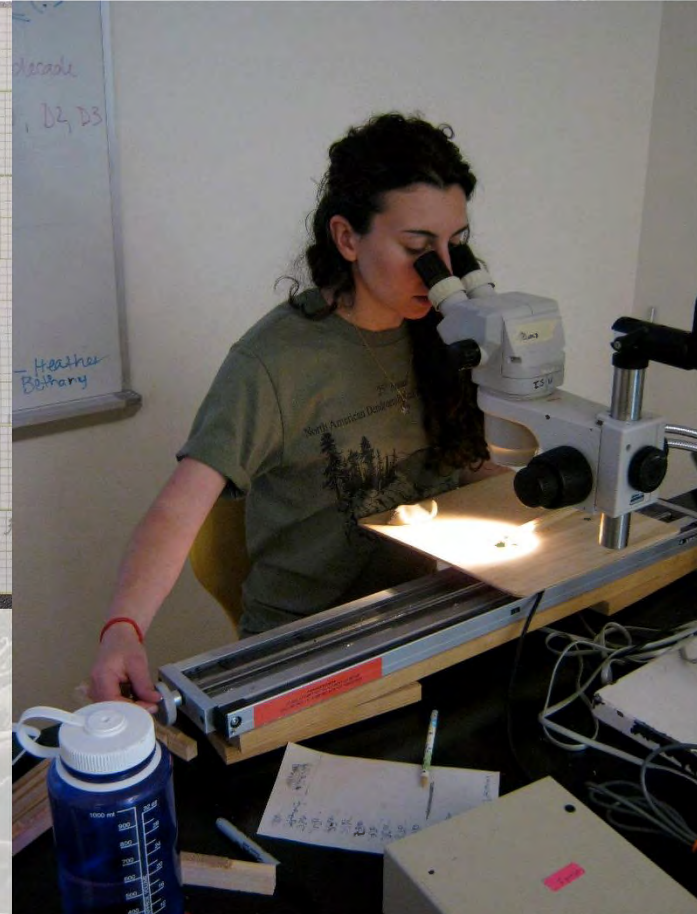
# Measurement

Skeleton Plotting

Measuring

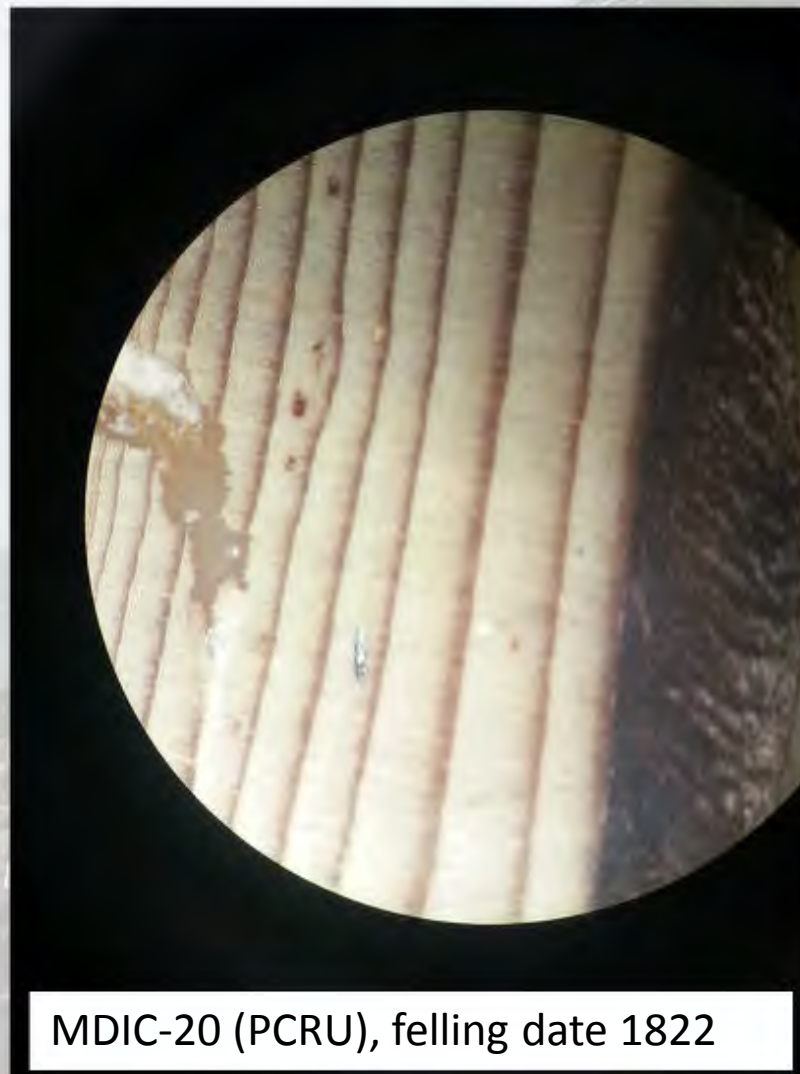
MDIC-20 (PCRU), felling date 1822

- The Rice House
  - 1837-1840
- The Dowling-Meyers House
  - 1839-1842
- The Carroll House
  - Phase I: 1819-1822
  - Phase II: 1836-1841
