# Cleetwood Cove Trail and Marina Rehabilitation Revegetation Project

## *2021 Annual Report*

Carolyn S. Wyler, Scott E. Heisler, and Jennifer S. Hooke

April 2022

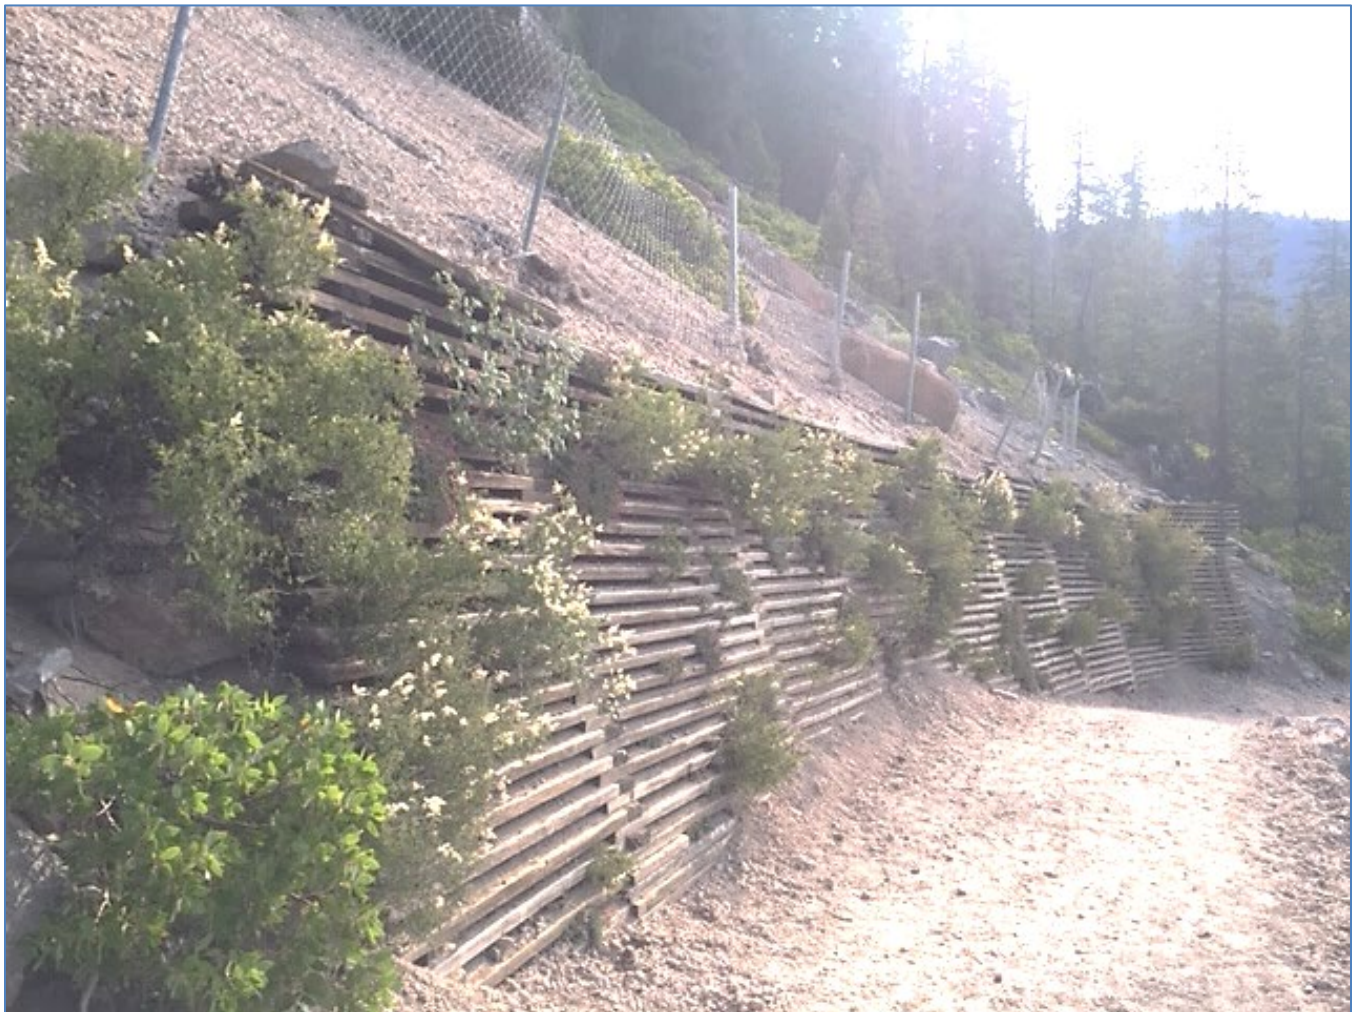
**ON THE COVER**

Cribbing retaining wall in need of repair along the Cleetwood Cove trail.  
Photo by Carrie Wyler.

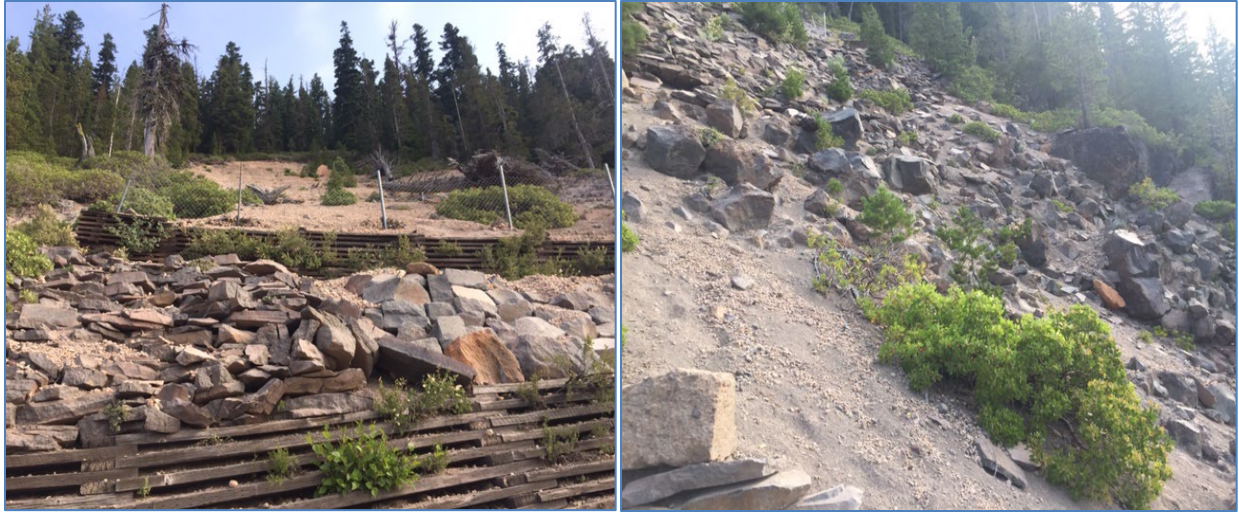
**Figure 2.** Deteriorated cribbing and rock retaining wall (left); unstable, rocky pumice soils (right) on the Cleetwood Cove trail. Photos by Carrie Wyler.

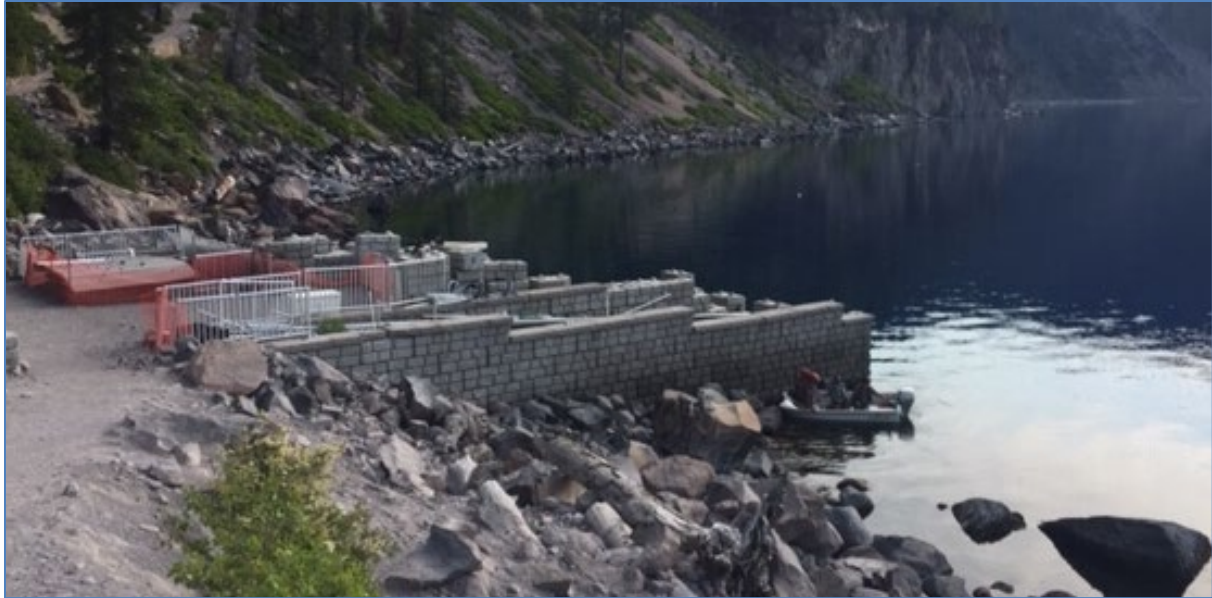
**Figure 4.** View of Crater Lake's shoreline with failed dock and bulkhead. Photo by Carrie Wyler.

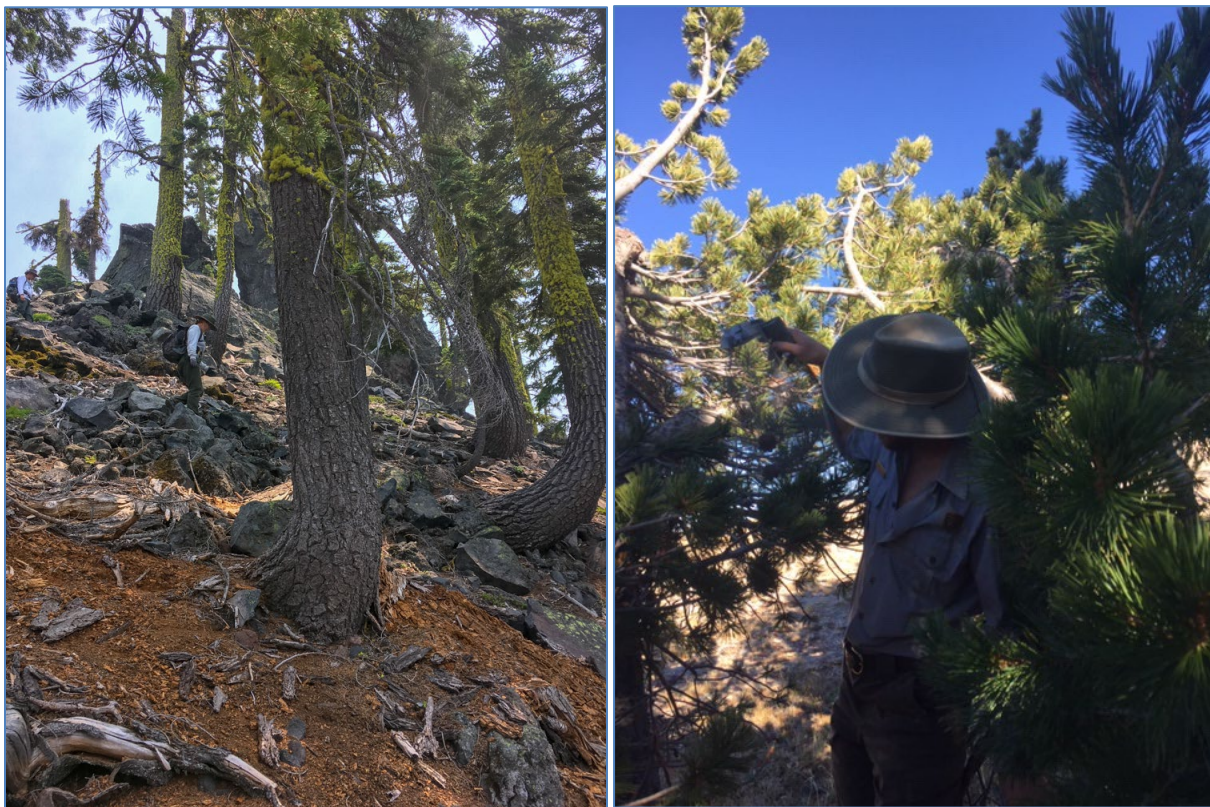
**Figure 5.** Surveying for whitebark pine on steep caldera slopes (left). Determining the age class of a whitebark pine (right). NPS photos.

The survey was conducted by traversing along slopes adjacent to the trail and marking the location of all encountered whitebark pine using a high-accuracy GNSS receiver (Leica GG04 Plus; Figure 5). The Federal Highway Administration's Cleetwood Cove Rock Scaling construction plans (70%

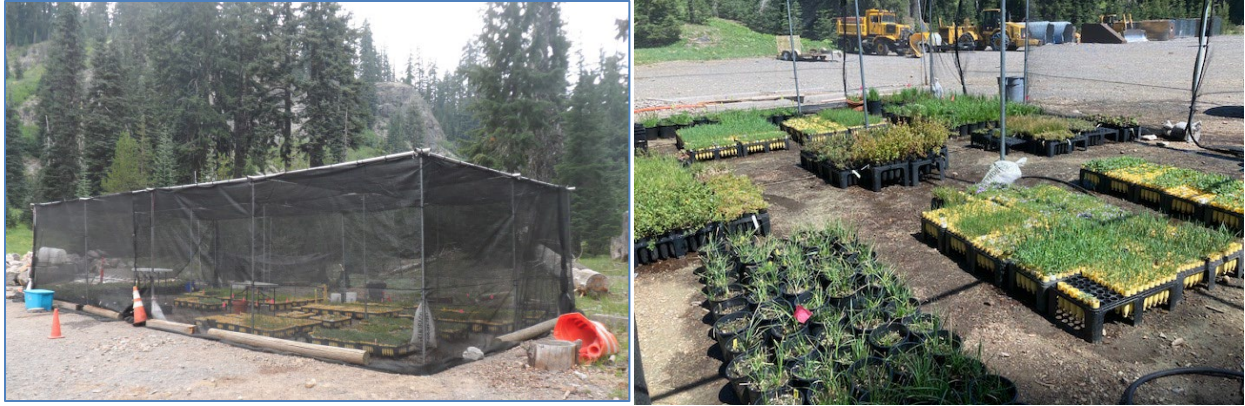
**Figure 6.** Shadehouse structure used to house plants for this and other Park projects. Photos by Carrie Wyler.

An initial round of plant propagation for this project was conducted at CRLA in the fall of 2020. These plants were cared for at CRLA’s native plant nursery at the Park’s Ball Diamond (Figure 6) during the 2021 growing season. In addition to the plants grown at CRLA, a shipment of plants grown for the project at the DGRC was retrieved from Cottage Grove, OR in September 2021. These plants were examined for quality and cared for by the Botany staff during the 2021 growing season. Excess growth was manually trimmed with scissors or hedge clippers as needed. Any reproductive structures were removed to promote root development and prevent excess evapotranspiration, and dead growth was removed to discourage fungal growth. Undesired plant volunteers originating from the DGRC in the planting tubes (e.g., mosses, liverworts, and weeds) were removed to minimize the risk of introducing non-native plant species to the Park.

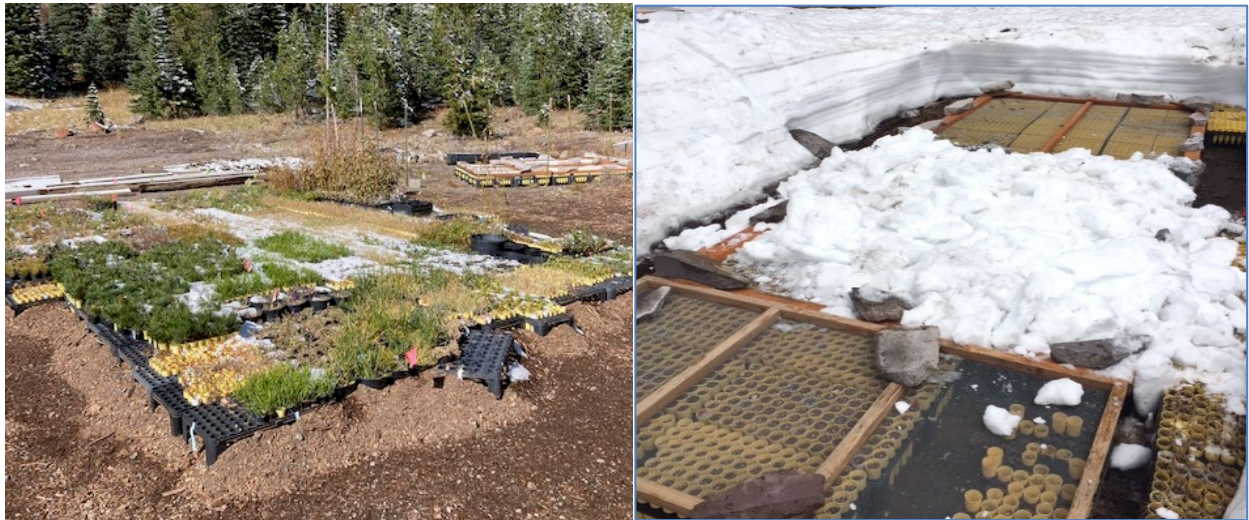
**Figure 7.** Plants being prepared for overwintering (left). Overwintered plants covered in snow (right). Photos by Carrie Wyler.

Due to the delay in project implementation, all plants are being held over the winter at the Ball Diamond native plant nursery. When ambient temperature dropped below freezing the containers were consolidated and mulch was stacked around the bases of herbaceous plants to prevent root freezing (Figure 7). These plants will need further care in the summer of 2022 including watering, fertilization, transplanting into larger containers, and inspection for invasive plant species.

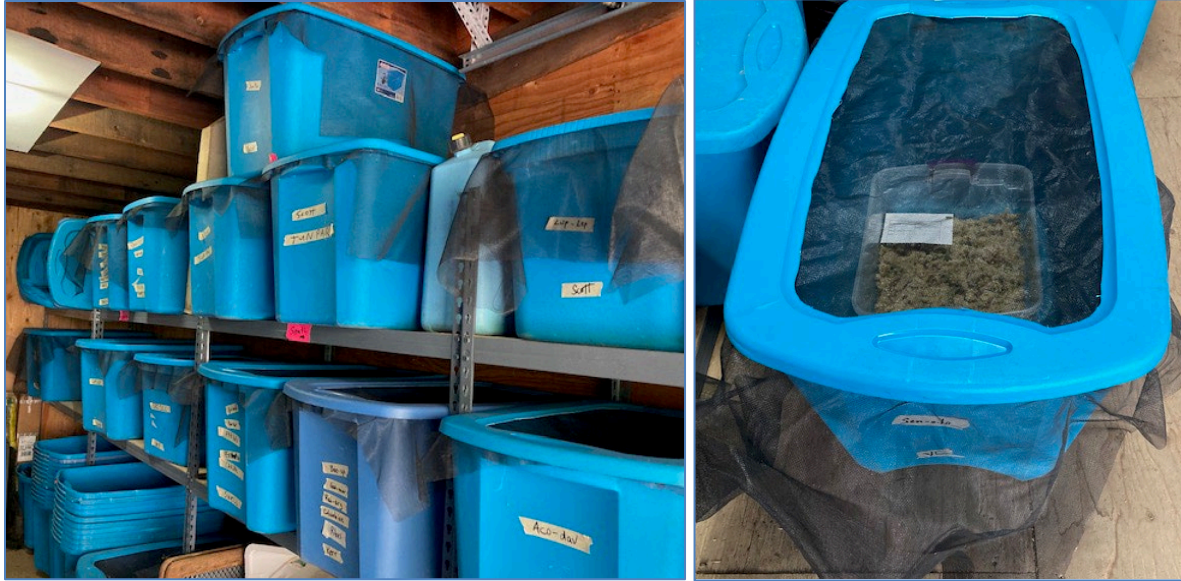
**Figure 10.** Seed drying facility in the Stall 2 garage. Photos by Carrie Wyler.

Individual accessions of seed were collected from five plant species during the 2021 field season (Table 3). Collected seed was dried at the seed drying facilities in the Stall Two garage at Park headquarters (Figure 10). Some seed collected during 2021 was sent to the DGRC to be cleaned and stored until needed. Seed collected as mixes and seed from certain easy-to-clean species was cleaned in-house by Botany program staff.
