# Status of Climate and Water Resources at Chiricahua National Monument, Coronado National Memorial, and Fort Bowie National Historic Site

*Water Year 2019*

Natural Resource Report NPS/SODN/NRR—2022/2378

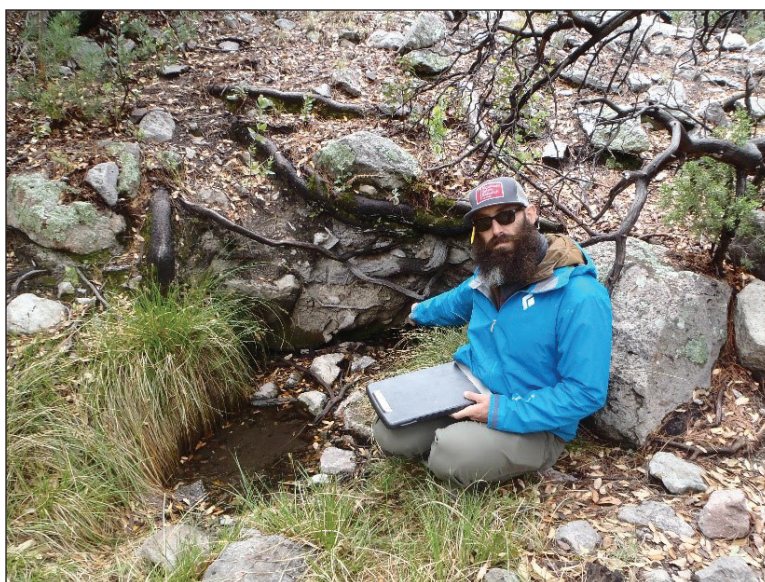
Figure 4-1. Garfield Spring, sampling location 1, orifice A, Chiricahua National Monument, April 2019.

**Water quality**—. In 2019, core water quality (Table 4-2) and water chemistry (Table 4-3) were measured at orifice A (sampling location 1).

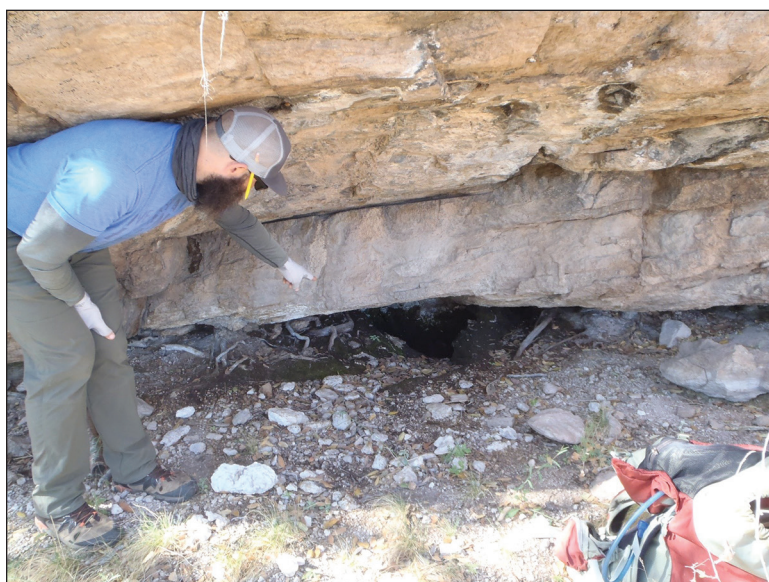
Figure 4-3. Newton Cave Seep, sampling location 1, orifice A, Chiricahua National Monument, April 2019.

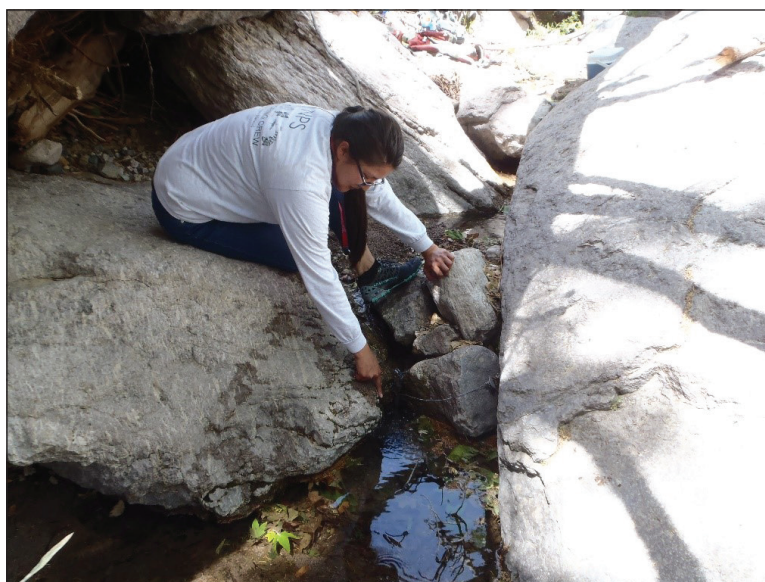
Figure 4-5. Shake Spring, sampling location 1, a pool below orifice A, Chiricahua National Monument, May 2019.

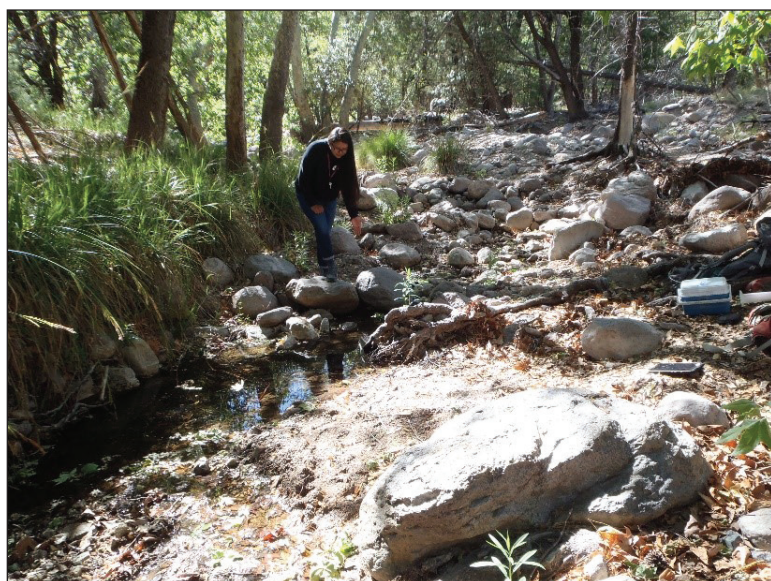
Figure 4-7. Silver Spur Spring, sampling location 1, orifice A, Chiricahua National Monument, May 2019.

**Water quality**—. In 2019, core water quality (Table 4-6) and water chemistry (Table 4-7) were measured at the first pool downstream of the orifice.

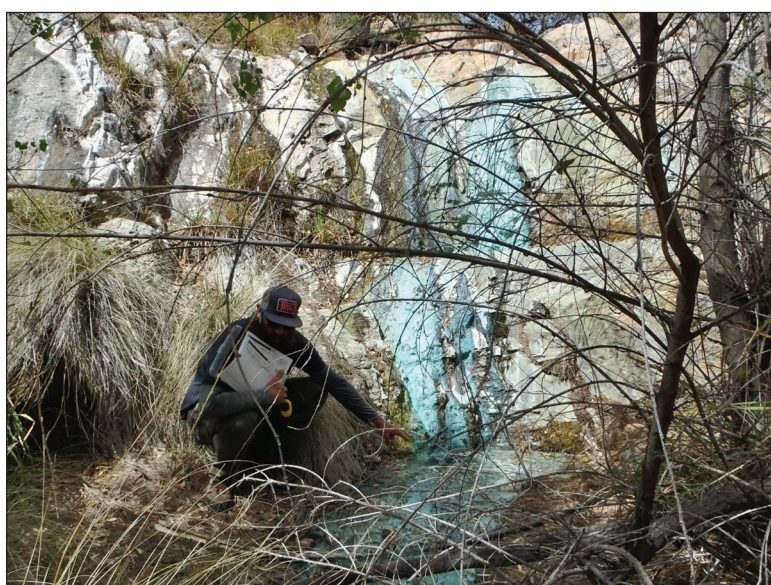
Figure 4-9. Blue Waterfall #2, sampling location 2, Coronado National Memorial, April 2019.

**Site characterization**—. Blue Waterfall #2 is a rheocrene spring in the bottom of a small drainage (Figure 4-9). When characterized in WY2017, the spring emerged as a small pool below an undeveloped earthen wall, then flowed as a small, shallow spring-brook with several large pour-offs. The substrate was a mix of gravel, bedrock, and significant detritus. The spring emerged directly below an abandoned mine, which likely causes the distinct turquoise coloration of the substrate.

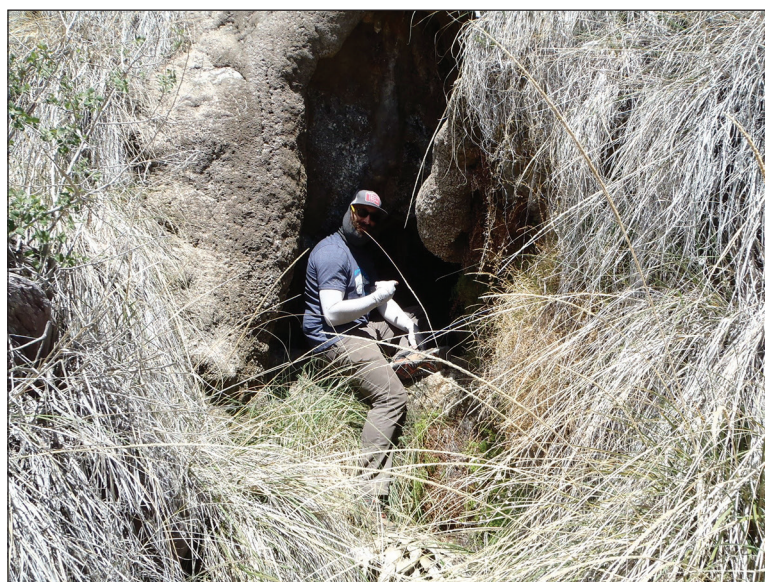
**Figure 4-11. Fern Grotto, sampling location 2, orifice B, Coronado National Memorial, April 2019.**

**Site condition**—. Disturbance surveys estimated a mean of 1.8 (slightly disturbed) for anthropogenic and 1.38 (undisturbed) for natural disturbance. Median values for both disturbance categories were 1 (undisturbed). There were high levels of disturbance from historic human use and flow modification. Trash found on site indicated slight disturbance from contemporary use. The crew

noted drying as a slight natural disturbance, as orifice A was smaller than on previous visits, and orifice B was dry. Tracks and trampling showed only slight disturbance by wildlife.

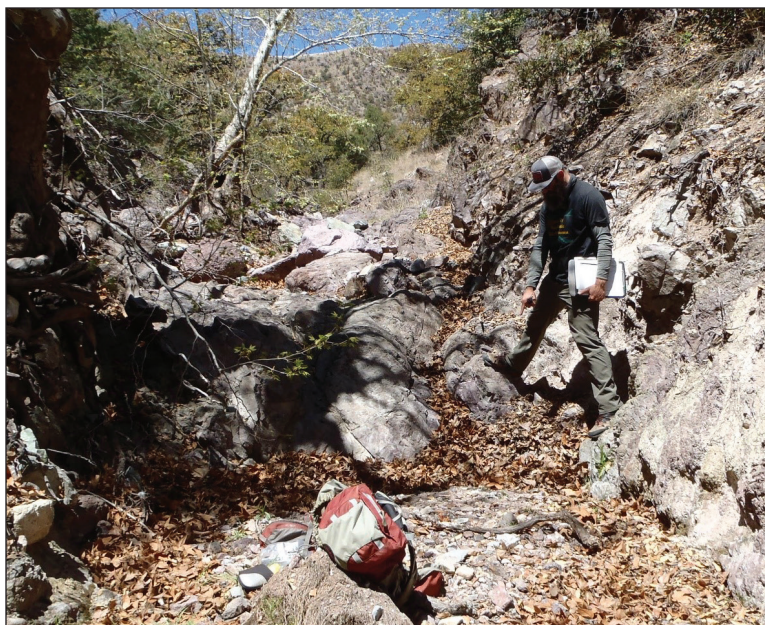
Figure 4-12. Sparkes Spring, sampling location 1, Coronado National Memorial, April 2019.

**Water quality**—. In 2019, core water quality (Table 4-12) was measured at the stagnant pool underneath litter at orifice A (sampling location 1) and at the first clear pool downstream of the orifice (sampling location 2). Water chemistry was measured only at the orifice A pool due to the close proximity of the two sampling locations (Table 4-13).

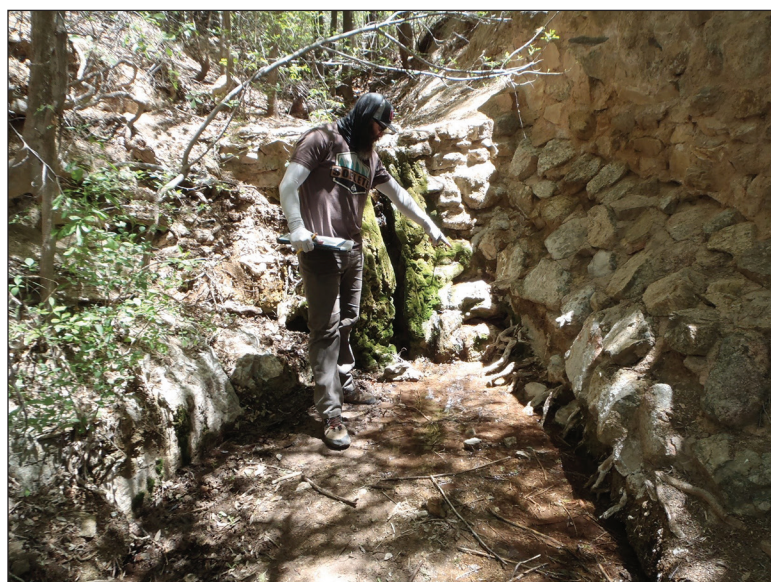
Figure 4-14. Apache Spring, sampling location 1, orifice A, Fort Bowie National Historic Site, April 2019.

**Water quality**—. In 2019, core water quality (Table 4-14) and water chemistry (Table 4-15) were measured at the first pool downstream of the main orifice (orifice A, sampling location 1) and a small, stagnant upwelling at the side of the downstream channel (orifice B, sampling location 2).

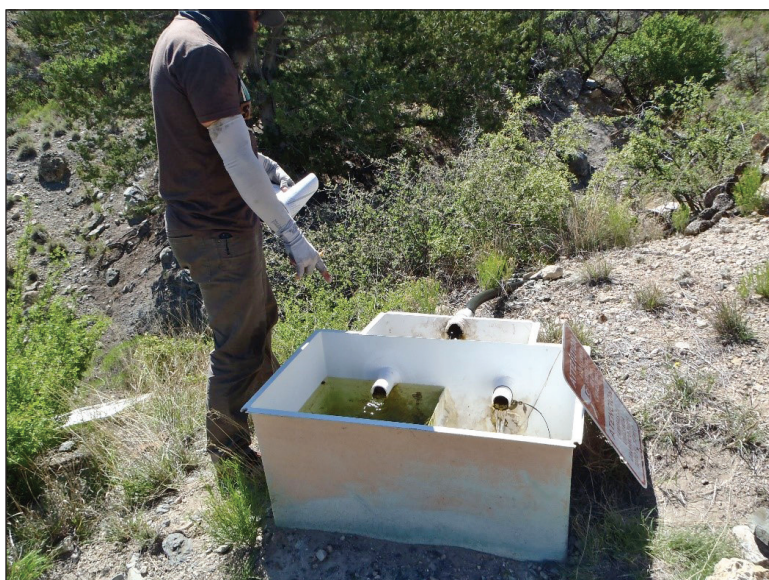
Figure 4-16. Lower Mine Spring, sampling location 1, orifice A springbox, Fort Bowie National Historic Site, April 2019.
