# Coastal Topography Change at Gulf Islands National Seashore, Texas

## *2018–2021 Data Summary*

Natural Resource Data Series NPS/GULN/NRDS—2022/1355

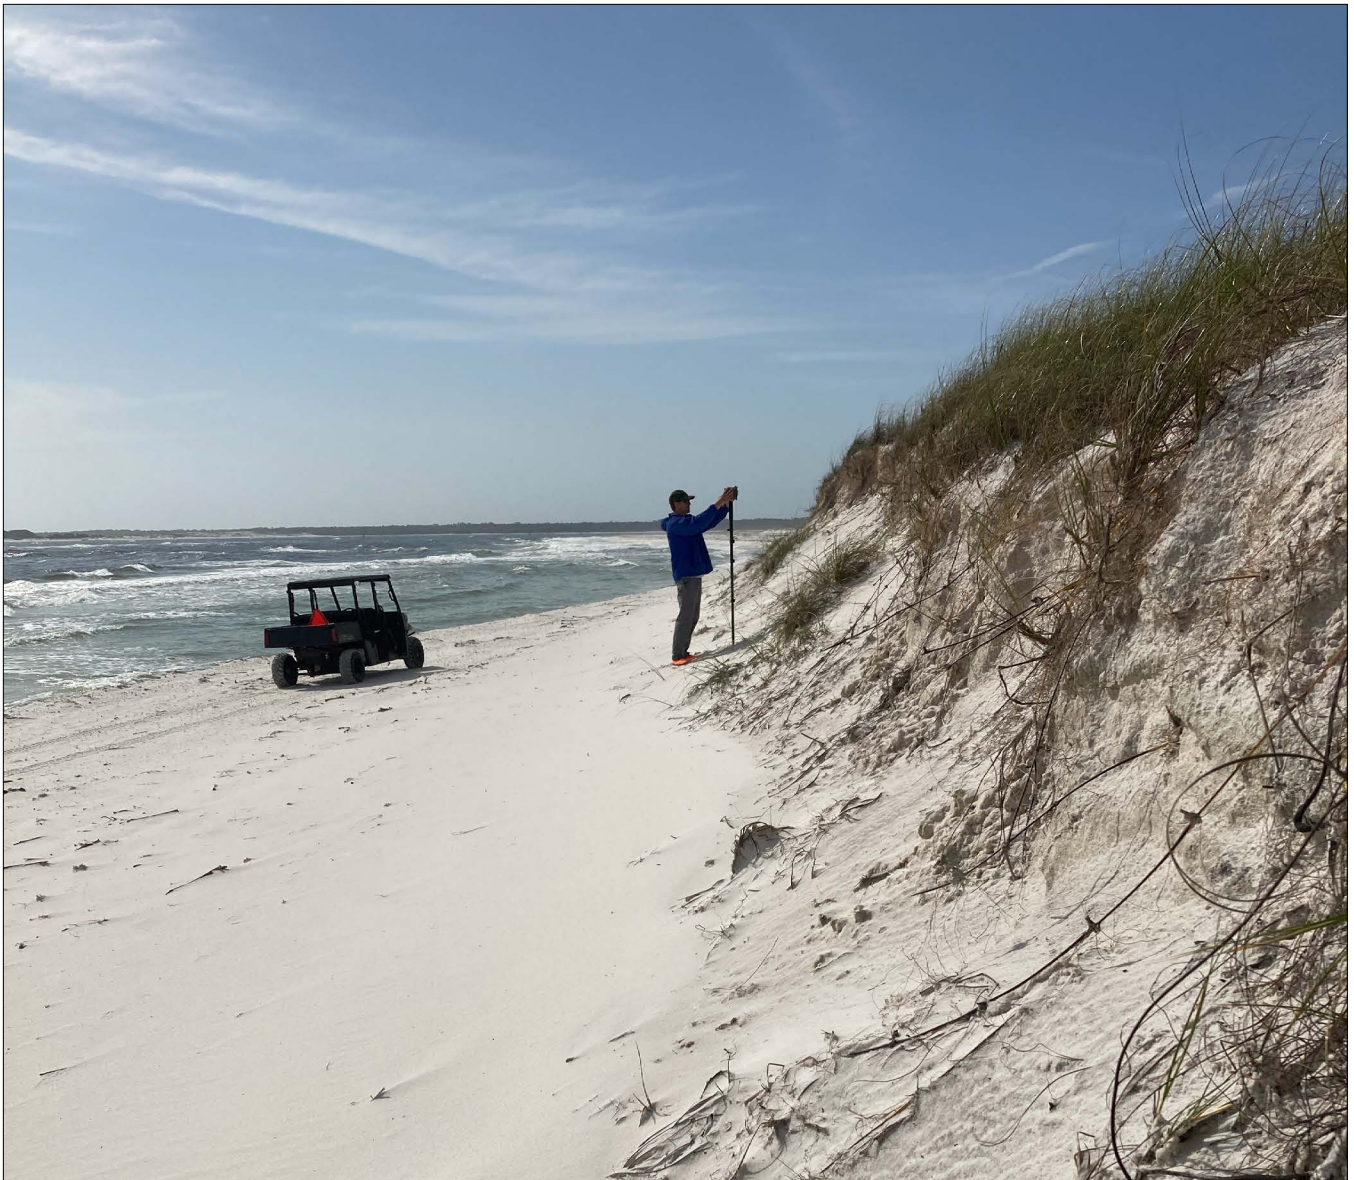
**Figure 2.** Surveyor measuring beach/dune topography taken in April 2021 at Fort Pickens, Gulf Islands National Seashore. NPS photo / GULN staff.

The Gulf Coast Network (GULN) has established a framework of equally spaced cross-shore transects in a Geographic Information System (GIS) along the entire shoreline of Gulf Islands National Seashore. From this framework, a set of monitoring sites was selected to support high-priority park resource management decisions and other GULN vital signs monitoring projects. The Gulf Coast Network monitors topographic change at Fort Pickens, Perdido Key, Petit Bois Island, West Petit Bois Island, and Horn Island (Figure 1). To collect monitoring data, a crew member records elevation using precision GPS equipment at the topographic inflections in the beach and primary dune complex along the transect (Figure 2).

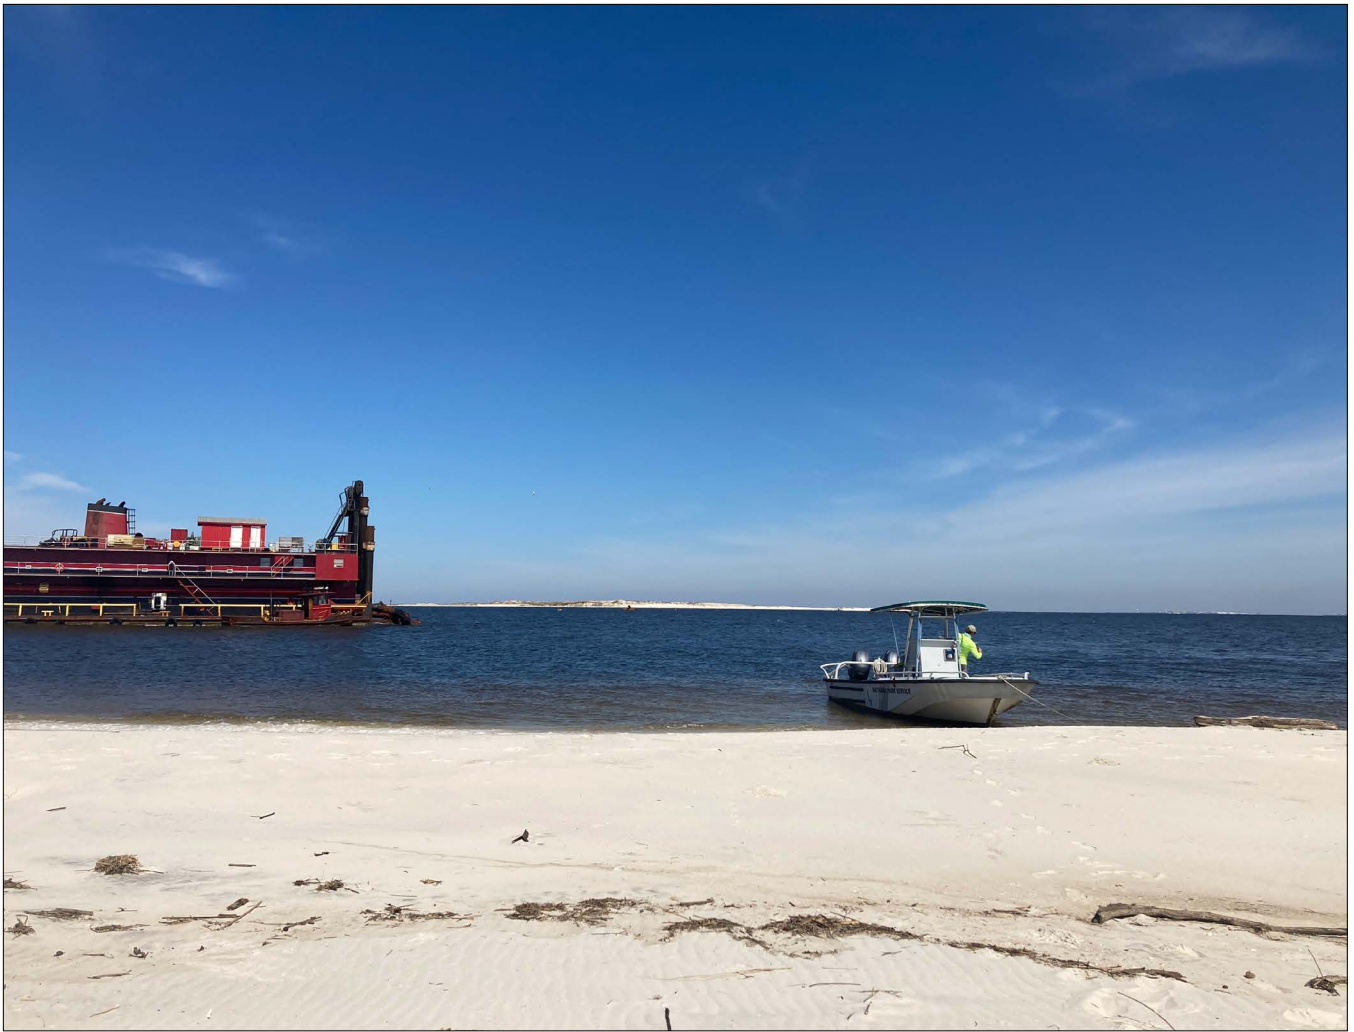
**Figure 4.** NPS boat anchored on Petit Bois Island near a dredging operation at Horn Island Pass, April 2021.

Some of these storms caused island overwash and breaching in parts of the surveyed areas. Table 4 summarizes dredging activities since 2017 at Pensacola Pass, Florida and Horn Island Pass, Mississippi [email correspondence with Bullock, H (Army Corp of Engineers), December 2021]. Figure 4 shows a dredge boat in operation at Horn Island Pass, Mississippi in May 2021.

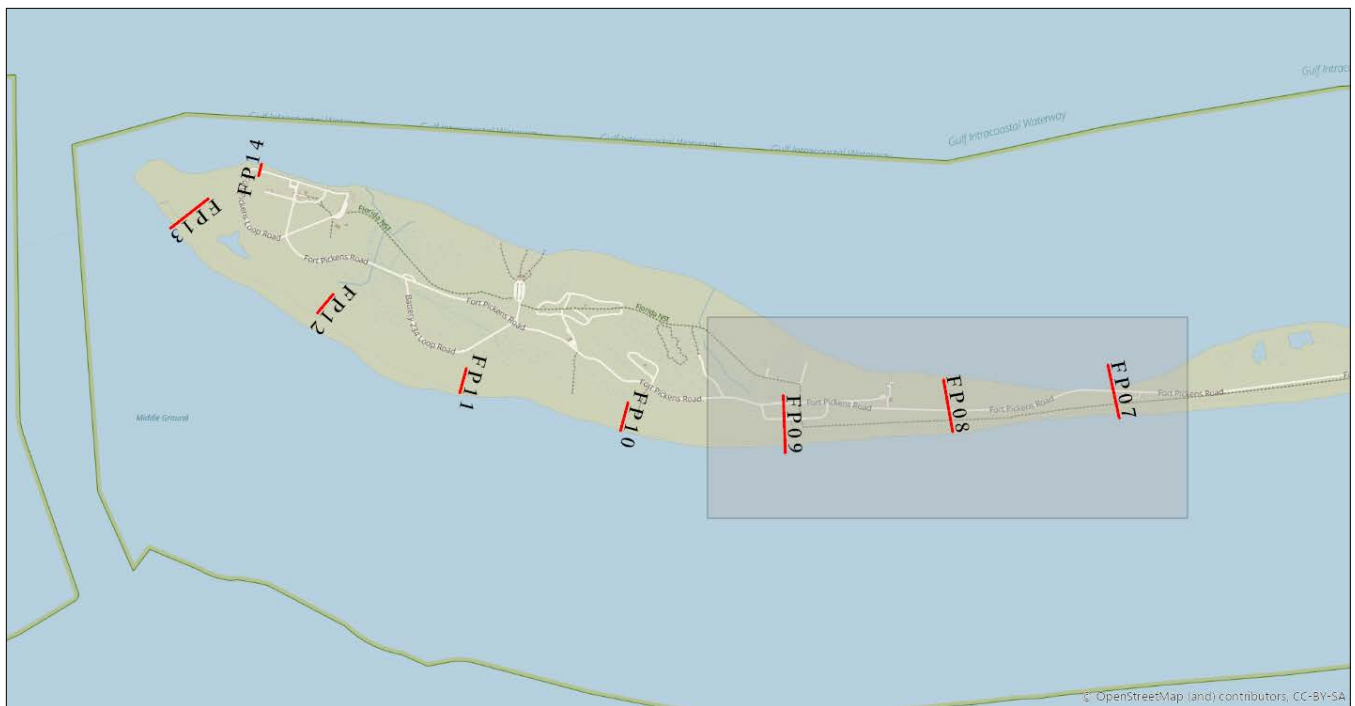
**Figure 6.** Pilot transect added at Fort Pickens includes FP07, FP08 and FP09.

Profile area is the two-dimensional area under the profile measured to 0.0 NAVD 88. Profile area is discussed in the next section. Three pilot monitoring transects were added at the Fort Pickens area, updrift, or east of the GULN’s already established effort. This expands survey coverage about 3km and incorporates a portion of the narrower, washover-prone section of the unit (Figure 6).

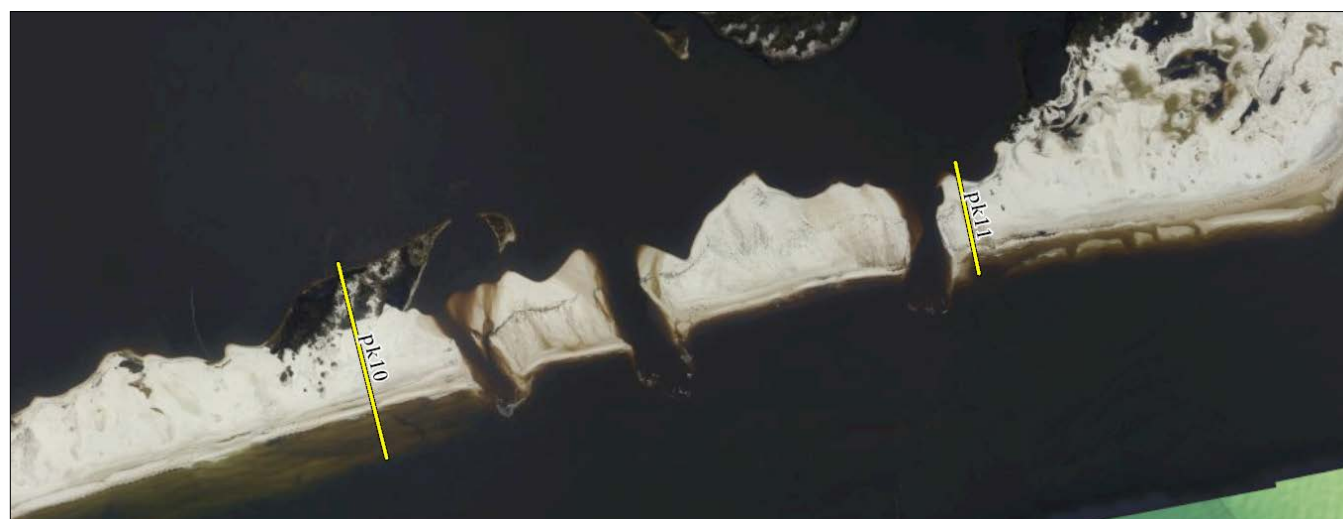
**Figure 7.** Image courtesy of NOAA Remote Sensing Division, taken soon after Hurricane Sally in September 2021, shows breaching in the overwash zones between transects PK 10 and PK 11.
