**Phase 1 Memorandum – Coastal Engineering Review  
ACAD – Evaluate Options And Make Recommendations For Managing  
Vulnerable Infrastructure At Bear Island Light Saving Station Impacted By  
Erosion (Bear Island, Maine)  
TAR 15468**

19 February 2021

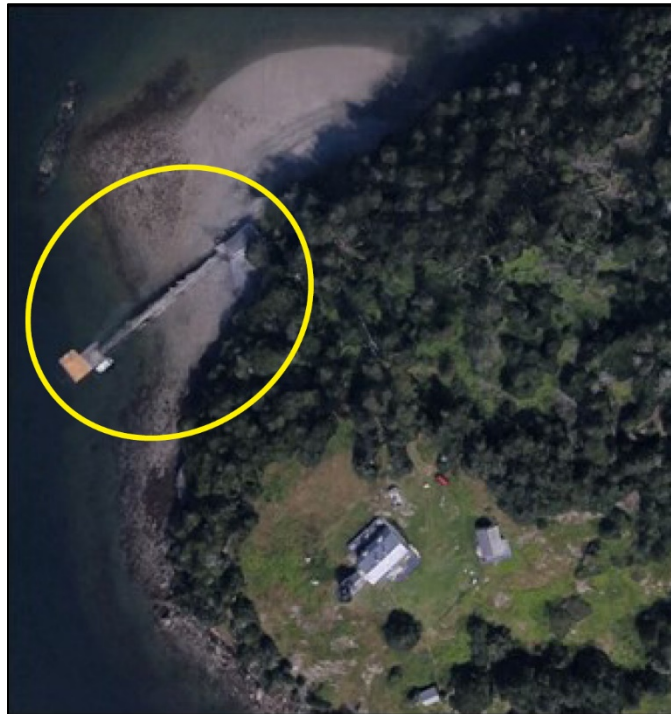
**Figure 1 - Historic Structures at Bear Island with the Boat House Circled**

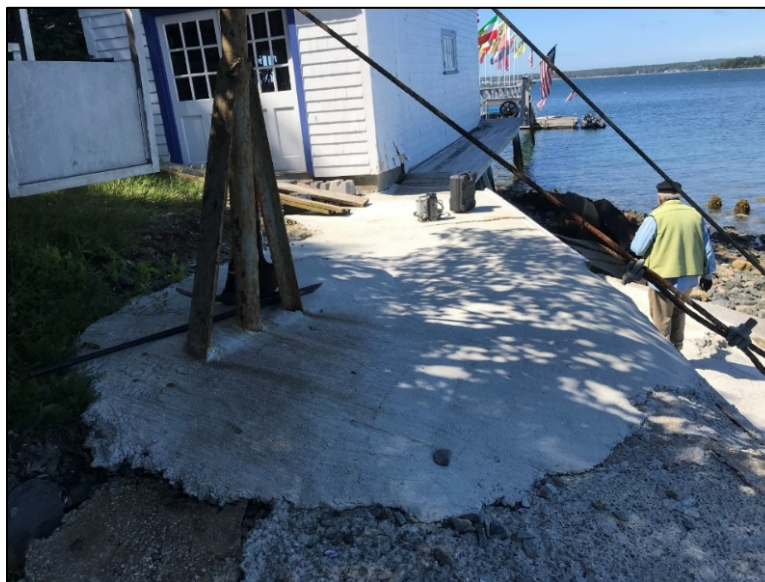
As depicted in the photos provided by NPS, the boathouse is connected to a fixed platform, with a floating dock attached via a gangway (See Figure 2 below as an example). The fixed platform is accessible underneath during normal sea state conditions and was dry during the July 2020 site visit. The old timbers show evidence of repeated wetting/drying, indicating that the water level rises to within a few feet of the top of the fixed platform. NOTE: all elevations in the following discussion are referenced to NAVD88 unless otherwise stated.

**Figure 2 - Bear Island Boat House showing Structure, Fixed Dock, and Floating Dock**
