# Water Quality Monitoring for Devils Tower National Monument

## *2019 Data Report*

Natural Resource Data Series NPS/DETO/NRDS—2022/1363

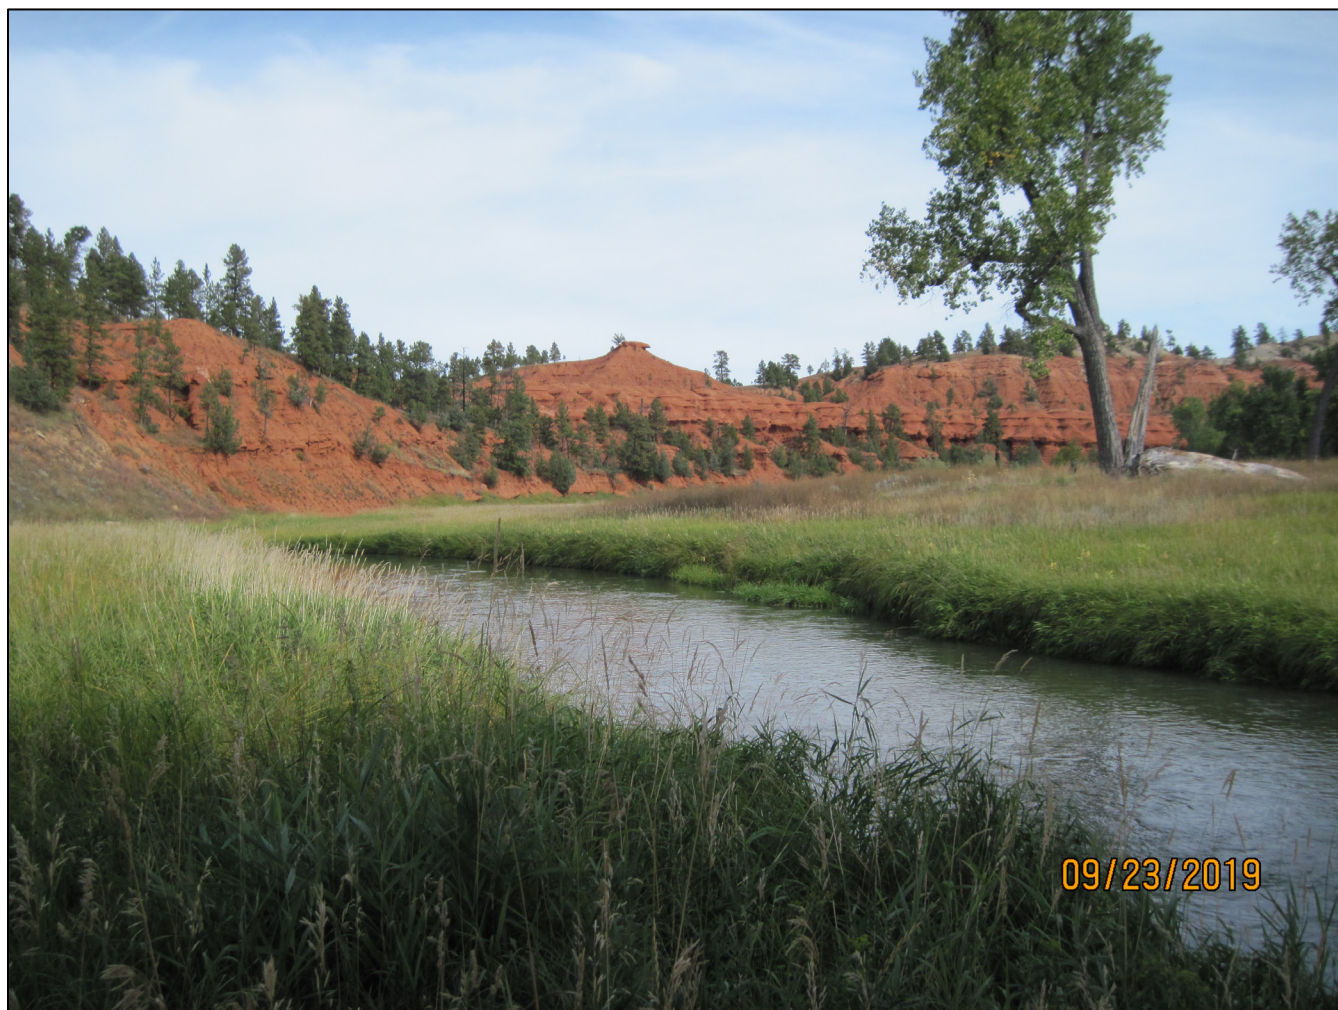
Photograph of Downstream view of gage at Belle Fourche River at Devils Tower National Monument, WY, 2019.  
Photograph courtesy of USGS at Station 06427850.

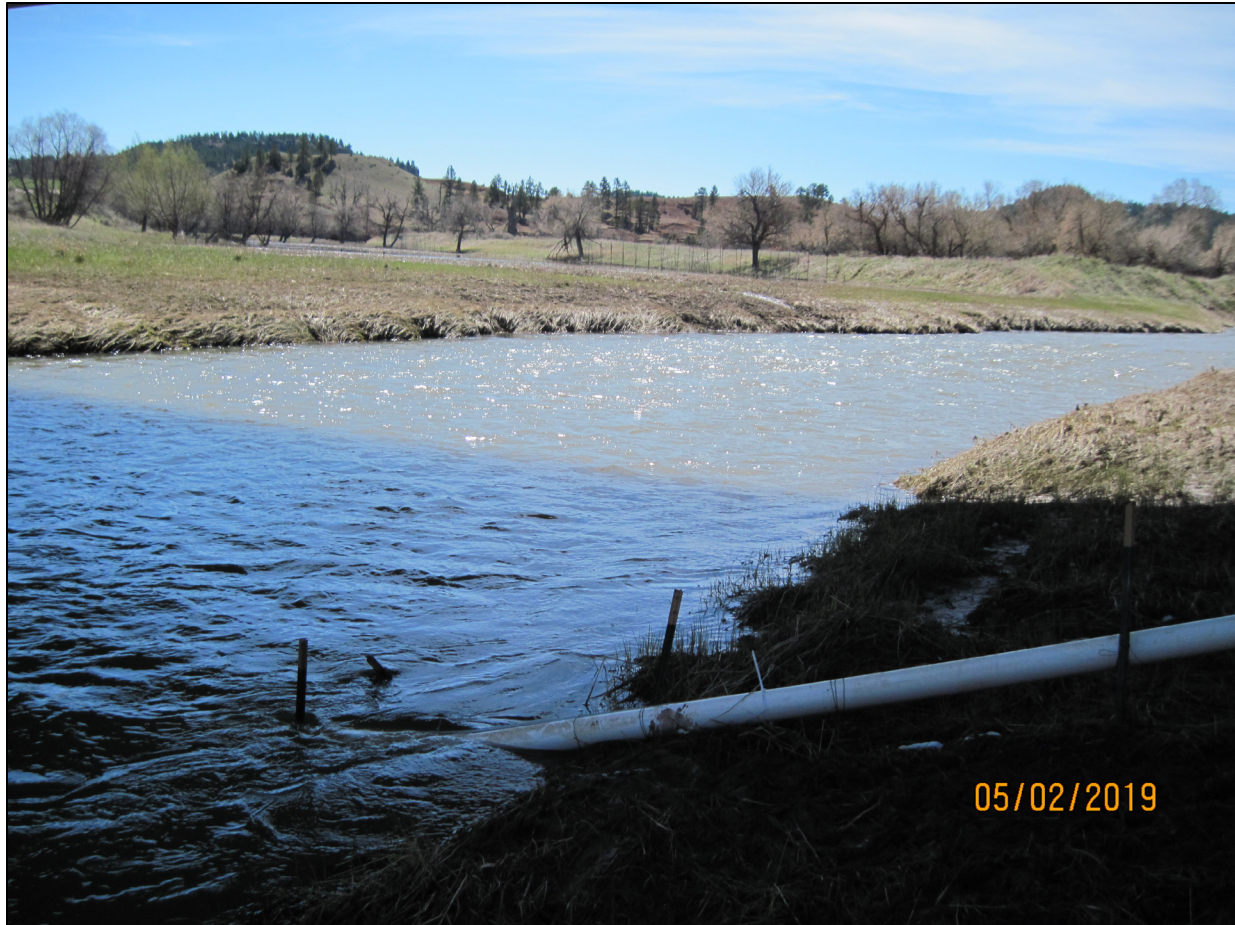
Upstream view of the Belle Fourche River and PVC pipe for sonde from the gage station at Devils Tower National Monument, Wyoming, in 2019.

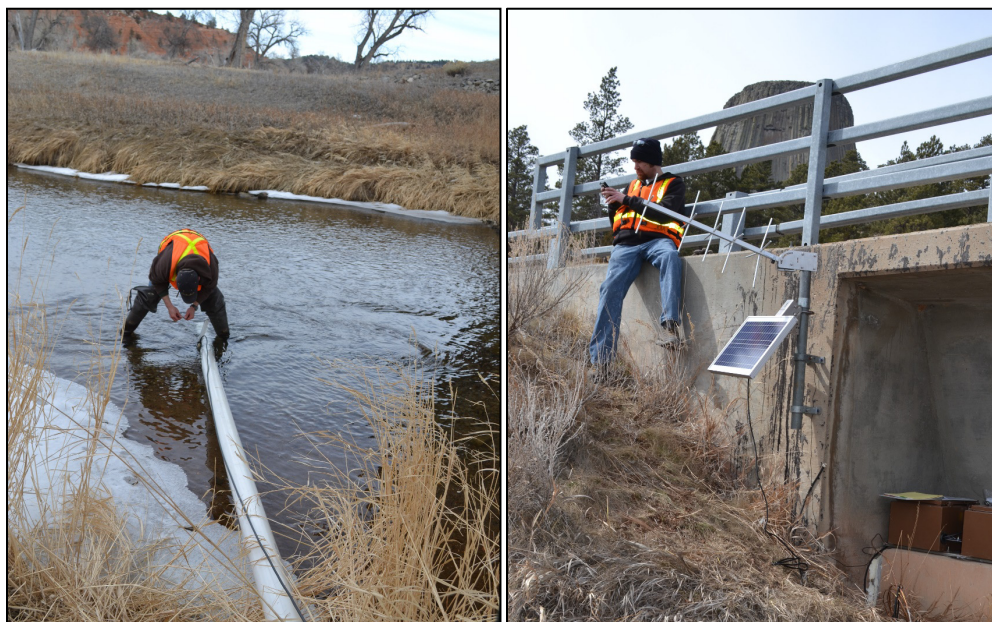
**Figure 3.** A researcher deploys a sonde device to measure water quality on the Belle Fourche River at Devils Tower, WY. The United States Geological Survey Belle Fourche River gaging station (06427850) is set up for real-time data transmission via satellite. Photographs courtesy of NPS.

In 2019, NGPN partnered with the USGS Wyoming-Montana Water Science Center to have USGS staff collect water quality and streamflow data at DETO. The USGS deployed a continuous, multi-parameter sonde at the gage on April 9, 2019 (Figure 3) and visited the gaging station every 3–4 weeks for equipment maintenance (Table 2). This instrument recorded dissolved oxygen, pH, specific conductivity, and water temperature every 15 minutes, while the gage simultaneously measured stream stage (or gage height).
