**National Park Service**

# Climate and Water Monitoring at Chiricahua National Monument, Water Year 2021

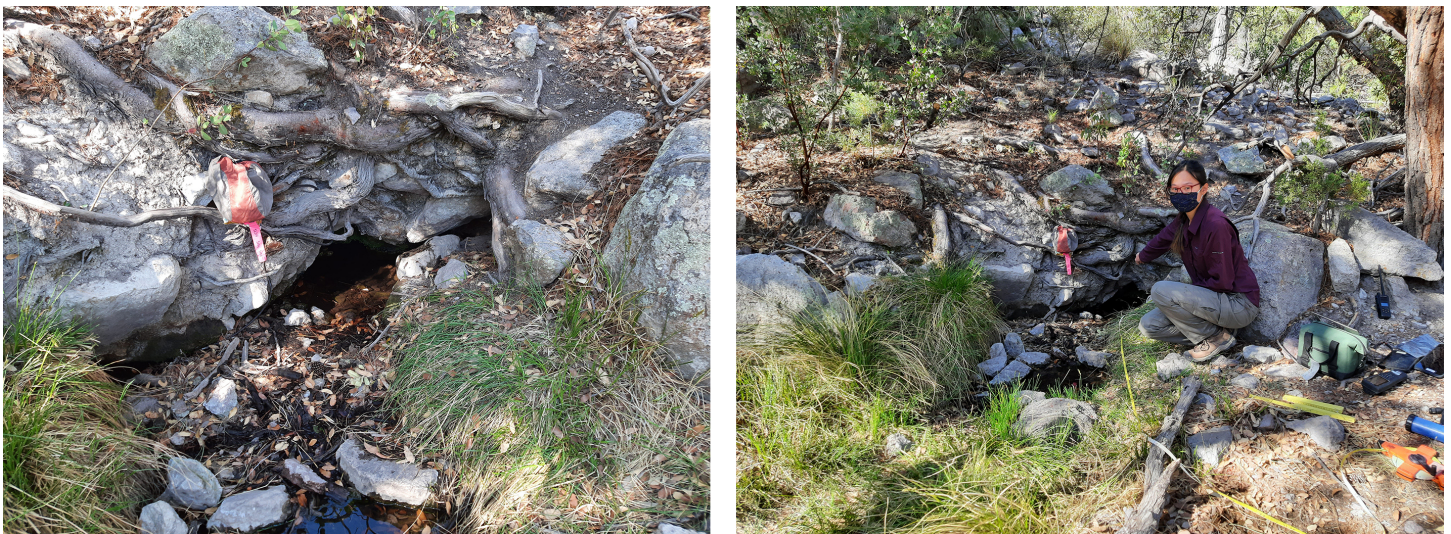
Garfield Spring (Figure 5) is a rheocrene spring (emerges as a flowing stream) on a north-facing slope. When characterized in WY2017, Orifice A emerged as a small pool adjacent to a tree-root overhang. The pool immediately transitioned to a narrow, intermittent springbrook with cool, clear water.

Figure 5. Left: Garfield Spring orifice. Right: Below the orifice, the Garfield Spring springbrook supports sedges and grasses. NPS photos from April 2021.

**Site condition.** As in past years, the crew recorded slight disturbance from the impact of hiking trails in WY2021, due to the well-used path that leads directly to the spring. Also as seen in past years, use by wildlife also was rated as “slightly disturbed” due to digging in the spring orifice and tracks, trampling, and scat found around the site. Impacts from a new (in 2021) wildlife-camera study at the site resulted in “slightly disturbed” ratings for contemporary human use and other human use due to the presence of the cameras, as well as some vegetation clearing and trampling for camera access. All other natural and human-caused disturbance types were rated as “undisturbed.”

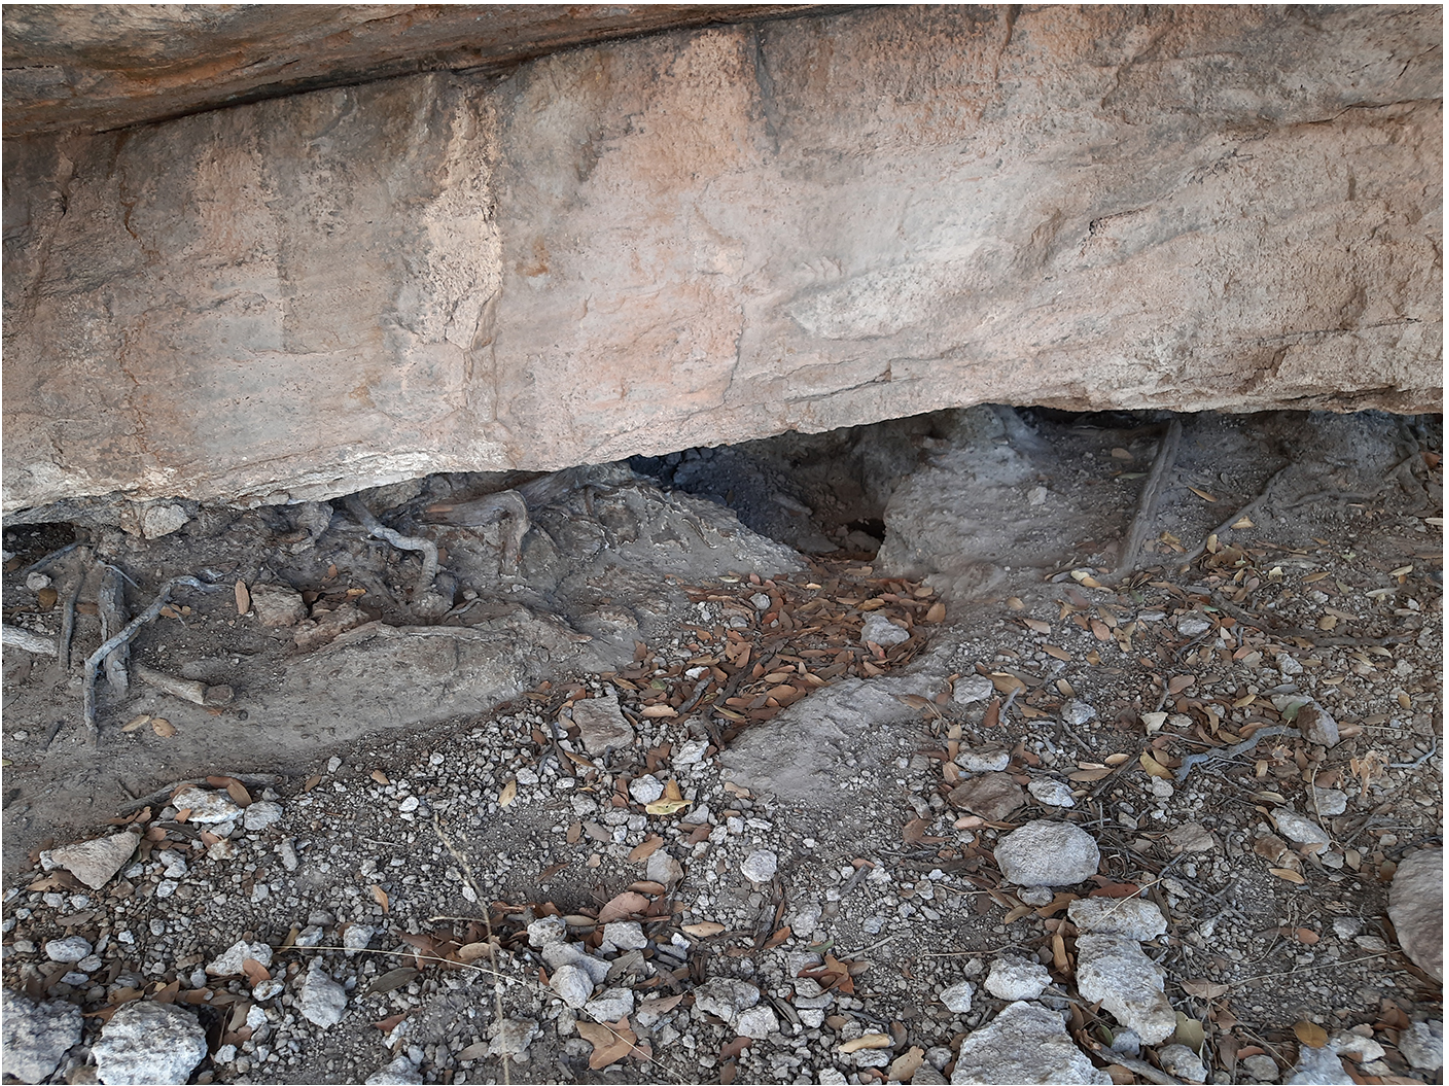
Newton Cave Seep emerges at the base of an east-facing cliff (Figure 7). When characterized in WY2017, its spring type was not certain. There was an approximately 1 × 2 × 5-meter (0.3 × 6.6 × 16.4-foot) overhang above substrate of primarily sand and small gravel. The orifice itself was a small area of moist sand, with moss lining the bedrock wall. Directly out from the orifice, there were a few oak trees that were noticeably greener and denser than the surrounding upland community.

Figure 7. Newton Cave Seep, April 2021. NPS photo.

**Site condition.** When visited in WY2021, Newton Cave Seep was reduced to a five-centimeter patch of saturated soil: a “highly disturbed” condition due to drying that was more extreme than in past years (though this spring has often been rated as “disturbed” due to persistent drying). Oaks and other nearby vegetation are typically greener and more vigorous near the seep, but in WY2021, this vegetation was consistent with the surrounding landscape. Scat and tracks indicated a “slightly disturbed” impact from wildlife use, as in past years. All other natural and human-caused disturbances were rated as “undisturbed” in WY2021.

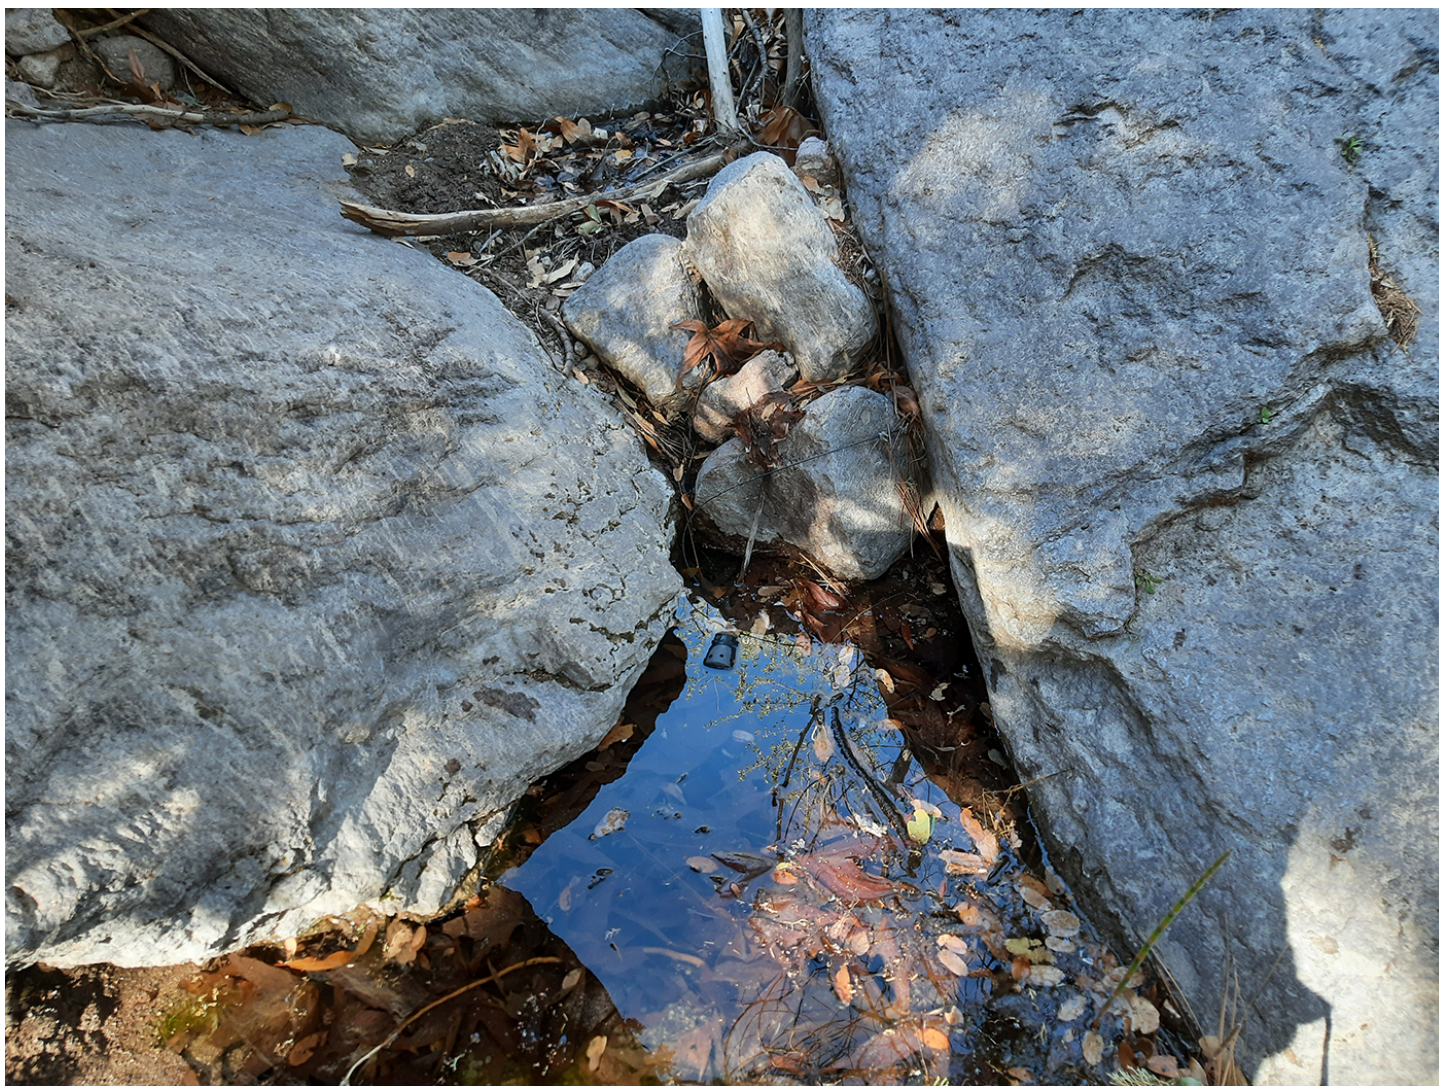
Shake Spring (Figure 9) was characterized in WY2017 as a rheocrene spring (emerges as a flowing stream) situated in a west-facing drainage in Bonita Canyon. Orifice A occurred under underneath a car-sized boulder approximately five meters (16.5 ft) from the spring box. The small springbrook was braided throughout the channel.

Figure 9. Shake Spring, April 2021. NPS photo.

**Site condition.** As in past years, the crew rated anthropogenic disturbance as “moderately disturbed,” due to the impact of the springbox and concrete pad. Wildlife disturbance in the form of vegetation trampling and tracks was rated as “slightly disturbed” for the first time in WY2021. All other disturbance factors were rated as “undisturbed,” as in prior years.

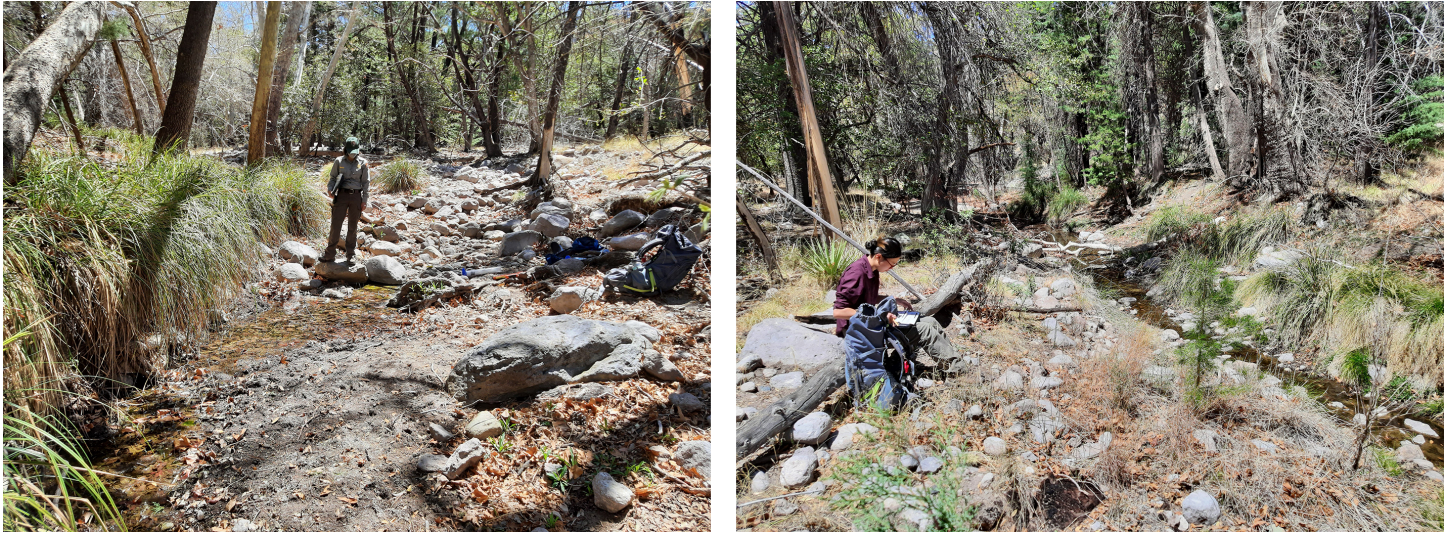
Silver Spur Spring (Figure 11) was characterized in WY2017 as a rheocrene spring (emerges as a flowing stream) in the channel of lower Bonita Canyon. The springbrook was occasionally braided, but largely a single channel. The substrate was dominated by a mix of sand, gravel, cobble, and boulders.

Figure 11. Left: Silver Spur Spring. Right: Silver Spur springbrook. NPS photos from April 2021.

**Site condition.** The crew rated contemporary human use, hiking trails and wildlife as “slightly disturbed,” as there was evidence of human and wildlife tracks and trampling when visited in WY2021. This was consistent with past observations. A well-used hiking trail leads directly to the spring. No other disturbances rated above “undisturbed” in WY2021, as in the past.
