# Miller Field Cultural Resources Investigations

**Investigations on Miller Field – Gateway National Recreation Area, Staten Island, NY – in Connection with the South Shore of Staten Island Coastal Storm Risk Management Project**

August 10, 2022

REPORT ON INVESTIGATIONS AT MILLER FIELD  
GATEWAY NATIONAL RECREATION AREA  
STATEN ISLAND, NY  
IN CONNECTION WITH THE  
SOUTH SHORE OF STATEN ISLAND COASTAL STORM RISK  
MANAGEMENT PROJECT

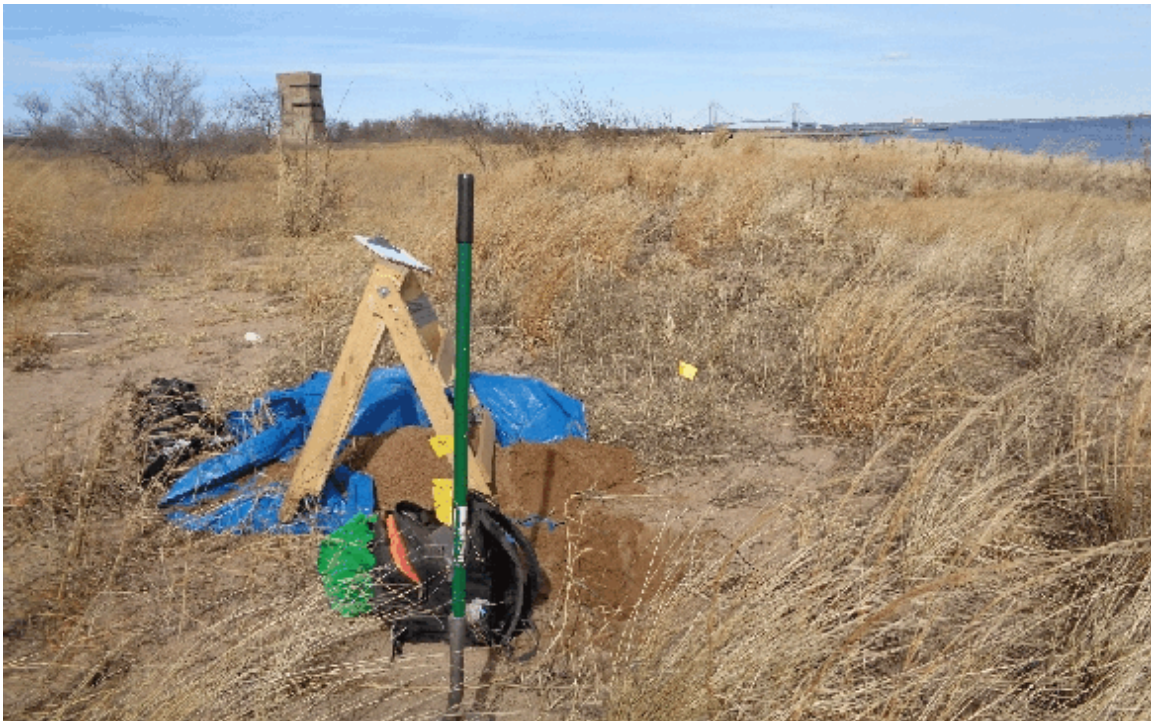
Figure 4 View of the Miller Field shovel test area in the beach grass at STP A10 with the Fire Control Tower in the background, facing northeast (Image 0158: March 8, 2022).

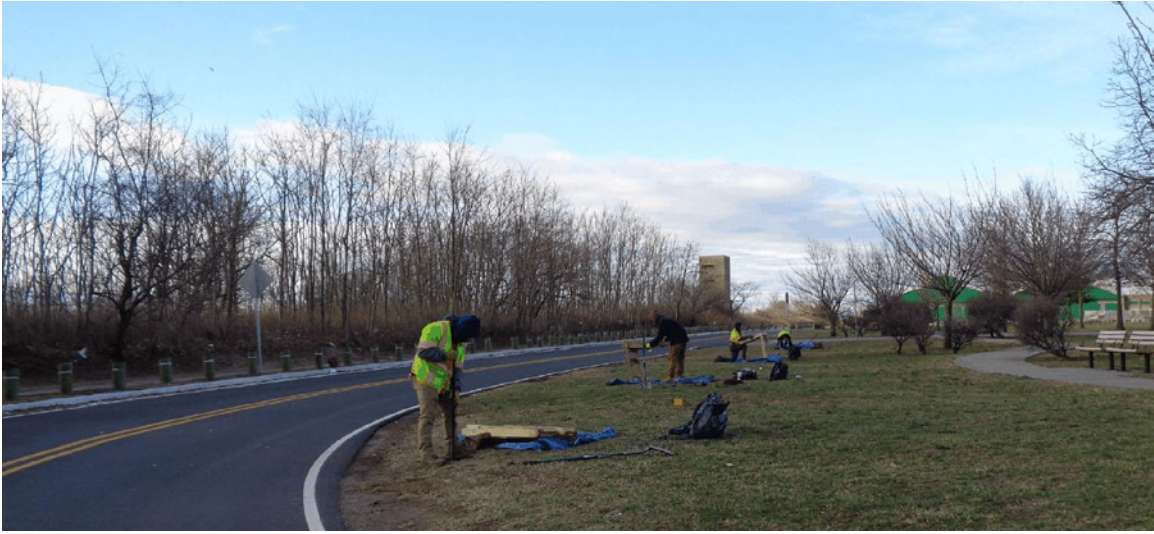
Figure 5 View of the dense varied vegetation on the built-up dunes adjacent to the bollard-demarcated bike path (background) showing shovel testing in progress at STPs D27 - D30 between Cedar Grove Avenue and the bench-lined pedestrian trail (right), with the Fire Control Tower and Hangar 38 in the background, facing southwest (Image 0149: March 8, 2022).

Figure 5 also shows part of the grass covered area that exists adjacent to Cedar Grove Avenue. In addition to the beach and manicured grass, the APE also contained some decaying pavement that was covered with tufts of grass between the cracks (see Figure 6). The area was generally well drained, except for the portions of the APE located on the southwestern and northwestern sides of Hangar 38 where pooling of rain water was present for days after the rain.

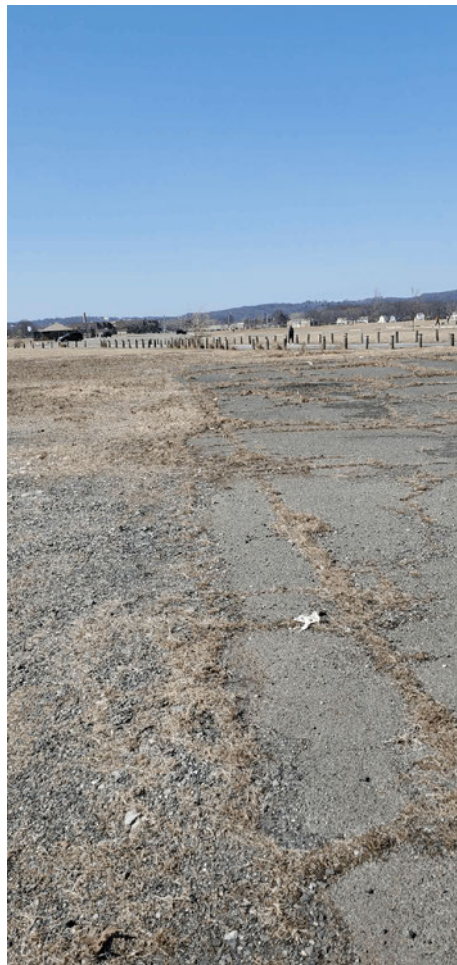
Figure 6 View of the portion of the Miller Field shovel test area between the Concrete Apron and Cedar Grove Avenue showing the decaying paving, facing northwest (Image 130802: March 2, 2022).

STP J11, located just inland of the Concrete Apron, was obstructed by a buried asphalt surface at only 1.5 inches (4 cm). In fact, the entire portion of the shovel test area between the Concrete Apron and Cedar Grove Avenue was ultimately eliminated from shovel testing because of visible paved surfaces. The contract specified avoiding paved areas so these planned tests were eliminated. Some of the planned tests were covered with gravel, like J11, and others had tufts of grass growing out of cracks in the former asphalt surface (see Figure 6). Liebeknecht et al. reproduced an aerial photo from 1970 which shows the extent of paving in that area at that time (see Figure 9) (Liebeknecht, et al. 2005: Plate 4.5). The extent of deteriorating paving today is likely what is depicted on the aerial photo. It shows a similar situation between Hangar 38 and New Dorp Lane, where shovel test excavation encountered compacted deposits with a large amount of crushed asphalt and gravel also seen in the report cover photo.

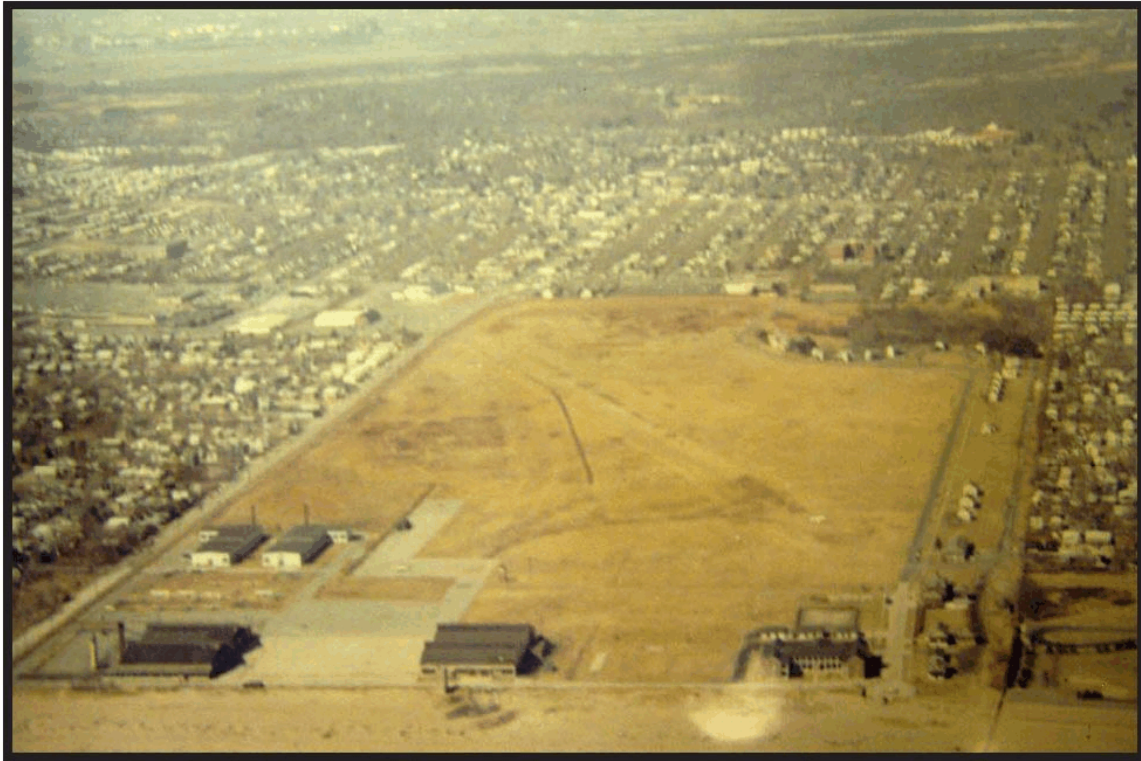
Figure 9 Liebeknecht et al. 2005: Plate 4.5. “Aerial photograph of Miller Field 1970 (source: NPS, Gateway National Recreation Area, Fort Wadsworth)” showing the paved area inland of the Concrete Apron.

The area directly to the northeast of Transect Q was more disturbed. All tests contained gravel or asphalt fragments. These were found through the base of excavation in three of those four tests; O11, P10 and P11. Although not clear in Figure 9, it seems likely this area may have been paved in 1970.

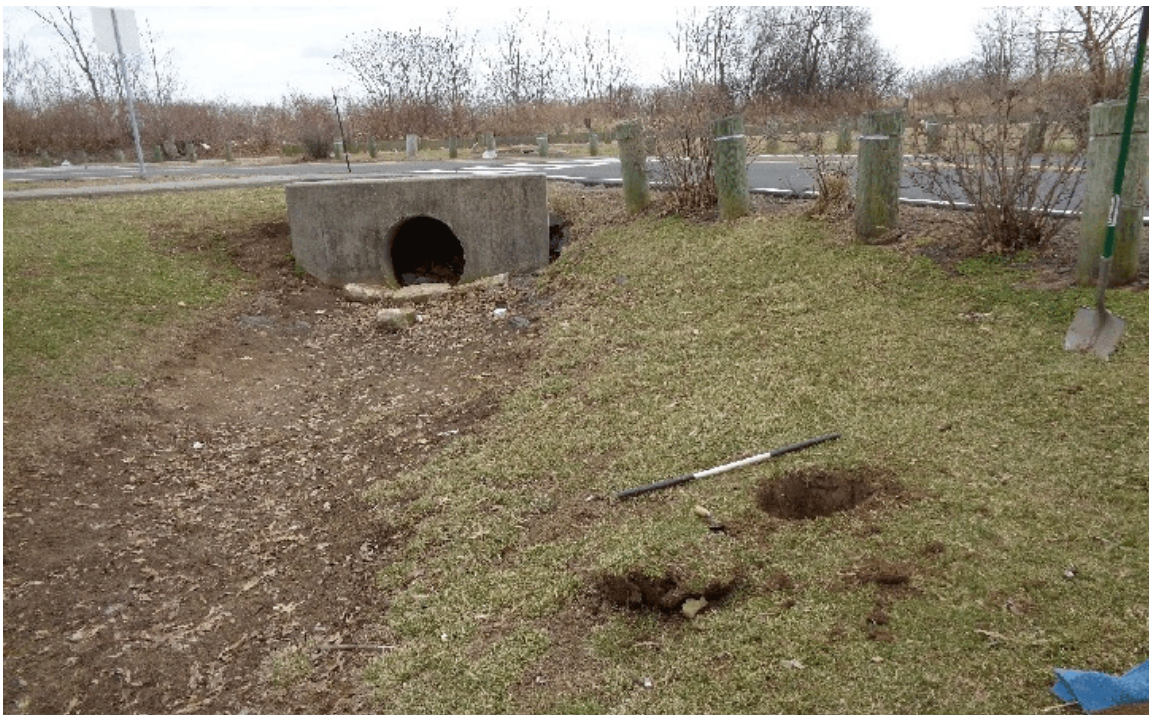
Figure 11 View of the culvert, drainage ditch and STP E20, facing east (Image 0145: March 7, 2022).

Transects 20 and 21 extend eastward along the portion of Cedar Grove Avenue adjacent to the former location of Hangar 33. These transects are located on either side of a drainage ditch. The drainage ditch leads to a culvert between D21 and E21. The ditch extends from Transects E to I where the depression peters out and the topography is relatively level (see Figure 11). Across Cedar Grove Avenue, C21 is at the intersection with the bike path and was shifted to avoid the large manhole associated with the culvert and drainage ditch. Transect 21 was approximately 10 feet (3 m) to the north of the ditch. It was initially thought this transect may exhibit more uniform soil profiles because of its distance from the road and the ditch, in an otherwise open field. Figure 12 is the soil profile of Transect 21 showing that, indeed, once past the manhole and culvert, the deposits were generally uniform from E21 through I21, as were the Transect 20 tests, although there they contained a slightly larger sand component.

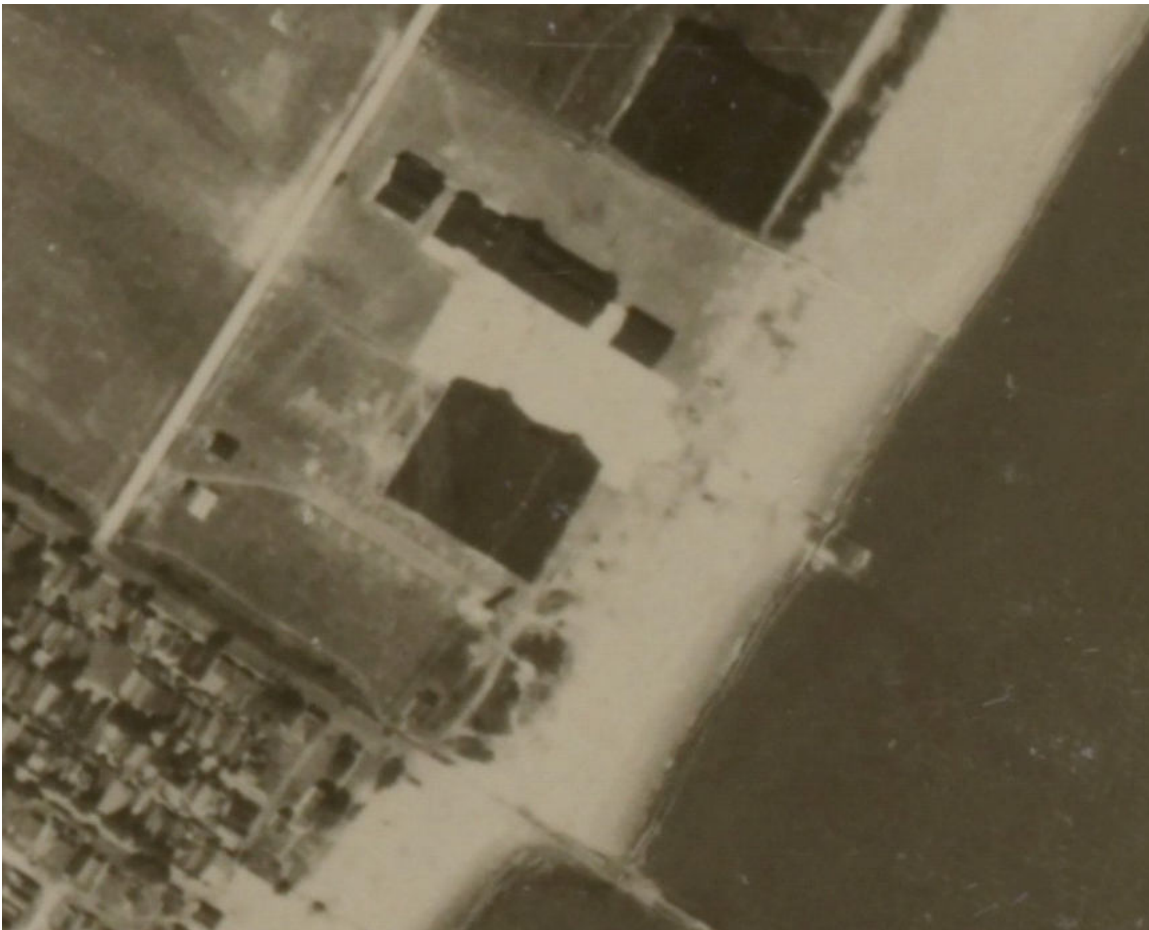
Figure 15 Aerial Photograph from 1924 Showing Hangar 38, Concrete Apron and Seaplane Ramp.  
Source: NYPL Lionel Pincus and Princess Firyal Map Division 1924.

According to the NRHP nomination for the Miller Field Historic District, the Concrete Apron on the northeast side of Hangar 38 connected to a concrete Seaplane Ramp approximately 400 feet long and 40 feet wide extending about 100 feet beyond mean low tide (Greenwood and Torres-Reyes 1976: 7-1). Early aerial photographs clearly show the Concrete Apron with the Seaplane Ramp leading from the east side of the apron to the shore (see Figures 3, 15 and 16).

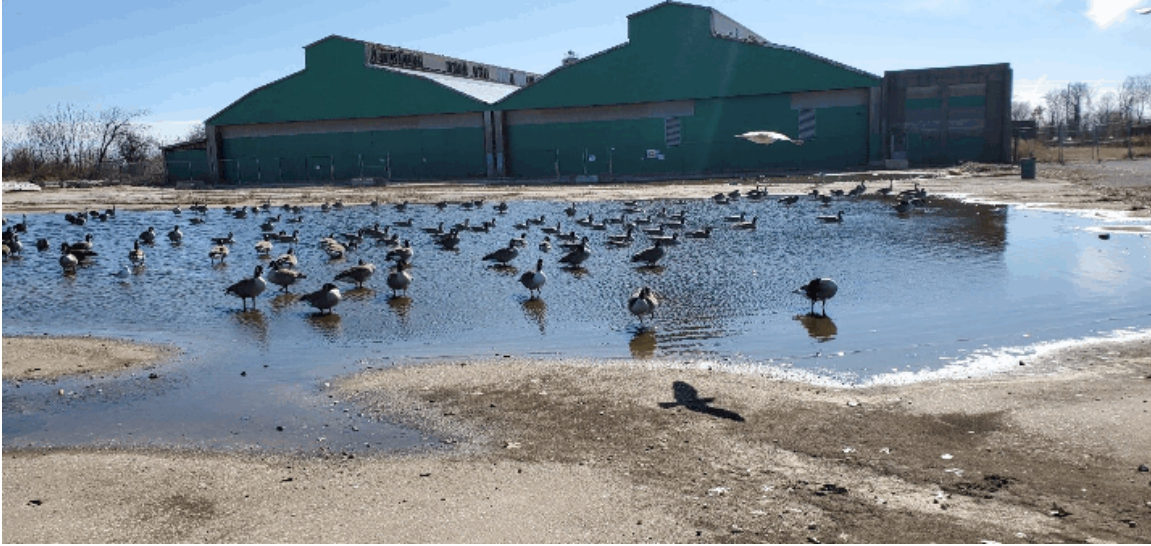
Figure 18 Concrete Apron and Seaplane Hangar 38, Facing Southwest (Stone 2022).

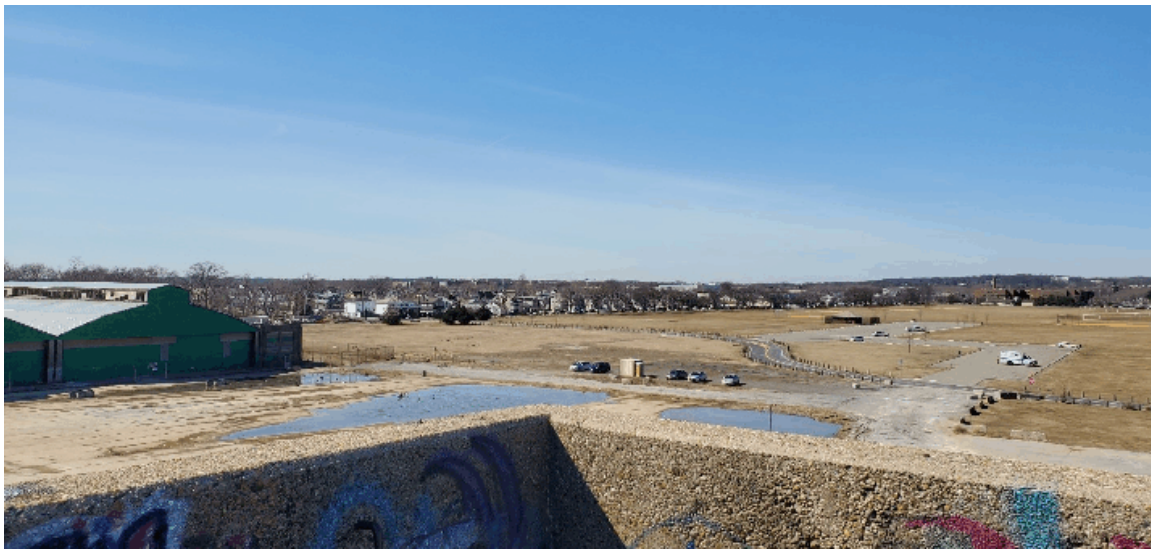
The size and materials of the existing Concrete Apron are consistent with the WPA apron expansion and comparison with historic aerial photographs show deterioration consistent with its age. Comparison of present-day condition with HABS photographs and historic aerials show that as the original joint sealer has deteriorated, there has been significant soil deposited within the joints and cracks causing vegetation to grow, accelerating spalling. The original poor grading of the apron is still very much evident as water continues to collect in the low areas. The Concrete Apron, as a whole is remarkably intact given its age and assuming that the greater Miller Army Air Field Historic District still possesses adequate integrity to be listed on the NRHP, the Concrete Apron still possesses adequate integrity to contribute to the history and interpretation of the air field and should be considered a contributing resource (Figures 18 & 31).

Figure 31 Concrete Apron and Seaplane Hangar 38 From Fire Control Tower, Facing West (Attenborough 2022).

Despite cracking and spalling of the Concrete Apron, preventive maintenance can keep further deterioration to a minimum. Given that the apron is now 100 years old, it has held up remarkably well. The Concrete Apron is significant as a contributing resource to the Miller Field Historic District as it was

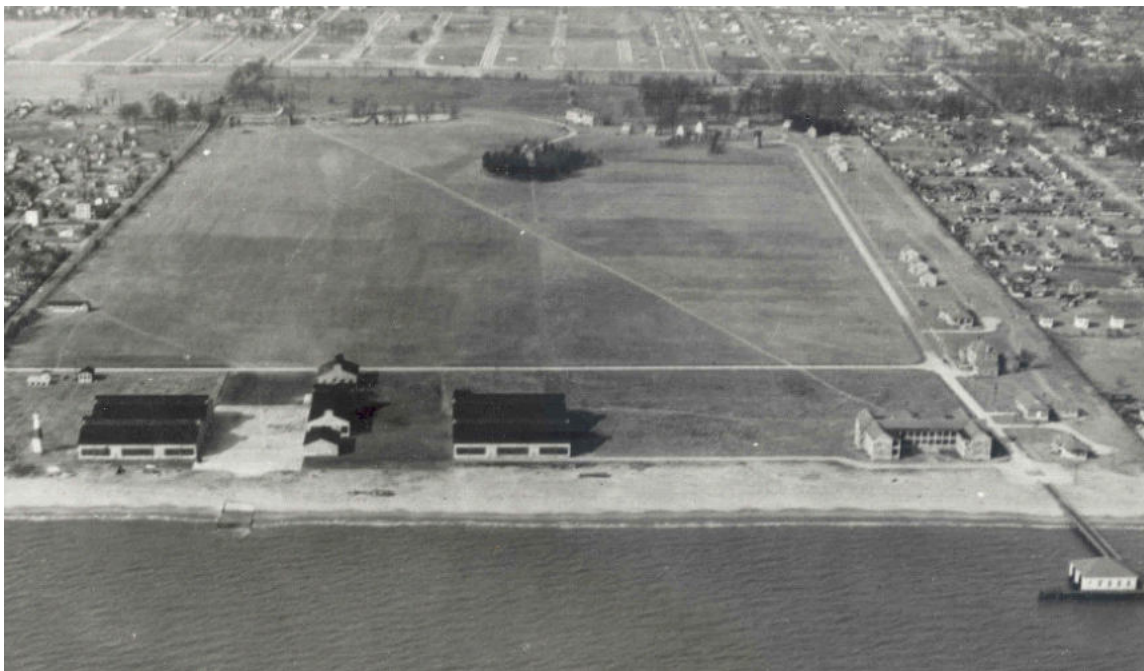
Figure 32 Ca. 1930 Image Showing Miller Field, Original Configuration of Concrete Apron and Seaplane Ramp. Source: NPS, GATE, Fort Wadsworth, No. 19337.

In March of 1924, the Seaplane Ramp sustained heavy damage from a storm as heavy timbers washed ashore and pounded the concrete. By May, completion of a new stone jetty had already added significant

sand to New Dorp Beach, helping to protect the ramp and concrete of the hangars and apron (Unrau and Powell 1981: 40). Despite this jetty, given the ramp's vulnerability, it is possible that the ramp has sustained damage on numerous occasions within the past 100 years.

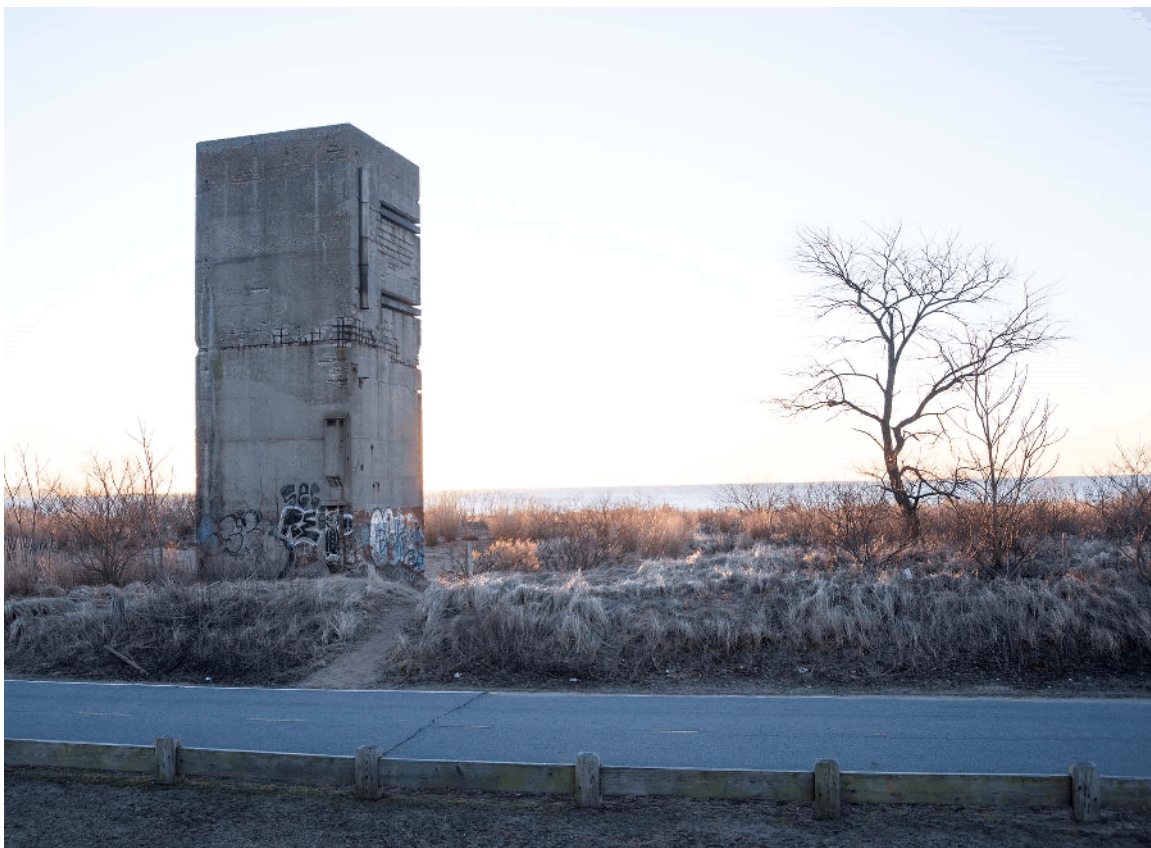
The exterior concrete walls show significant spalling, especially on the fourth and fifth floors of the southwest side. Much less exterior deterioration exists on the southeast and northwest sides, and very little on the northeast side. Although the spalling exposes the reinforcing mesh and reinforcing bars that are very close to the surface of the concrete, none of this damage could be considered structural since it is so close to the surface of walls that are 1' thick. No major stress cracks were noted, but the lower concrete vent structure has been damaged by vandalism and significant graffiti is present on the first level of the exterior and all interior levels (Figures 33 - 44).

Figure 33 Miller Field Fire Control Tower, Northwest and Southwest Façades, Facing East (Attenborough 2022).

The Miller Field Fire Control Tower should be retained, stabilized, included as a contributing element to the existing Miller Field Historic District, eventually restored and interpreted with strict adherence to the Secretary of the Interior's Standards for Historic Preservation. The remaining supporting structure foundations along New Dorp Beach should be cleared of brush and excess sand and stabilized as part of the interpretive framework. If interpretation is not possible, an adaptive use for the structure should be found. Cleaning of the beach of brush and stabilization of the remaining foundations would go a long way towards this goal.

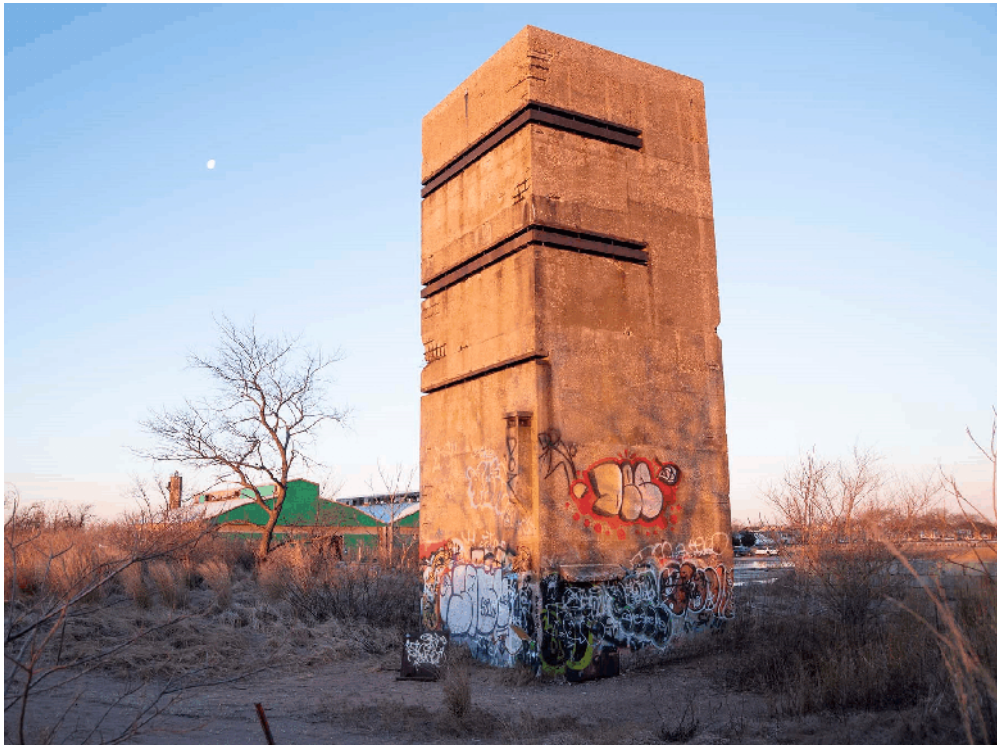
Figure 34 Miller Field Fire Control Tower, Northeast and Southeast Façades, Facing West (Attenborough 2022).

The NRHP assessment of the Fire Control Tower concluded it possesses integrity and should be stabilized and preserved, ultimately recommending its eligibility for listing on the NRHP under criteria A and C. The assessment goes on to suggest the structure be considered a contributing element to the Miller Army Air Field Historic District, and would best be interpreted as part of a potential future “Harbor Defenses of Southern New York Historic District” which would examine the entire regional system of which the Miller Field Fire Control Tower was one part. If implemented, a comprehensive regional survey of the documentation for this proposed district will need to be conducted. The Concrete Apron was evaluated as a contributing resource to the Miller Army Air Field Historic District and this report recommends the NRHP registration form be updated to reflect the addition, and in doing so it should also discuss the implications for future stabilization and treatment.

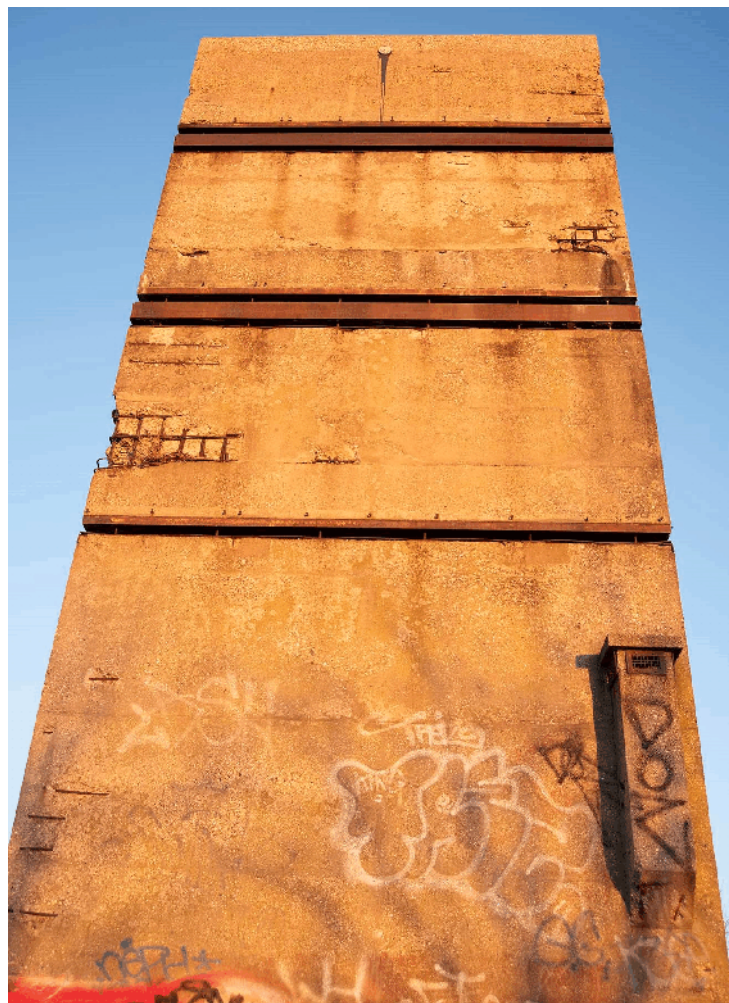
Figure 35 Miller Field Fire Control Tower, Detail of Southeast Façade, Facing Northwest (Attenborough 2022).

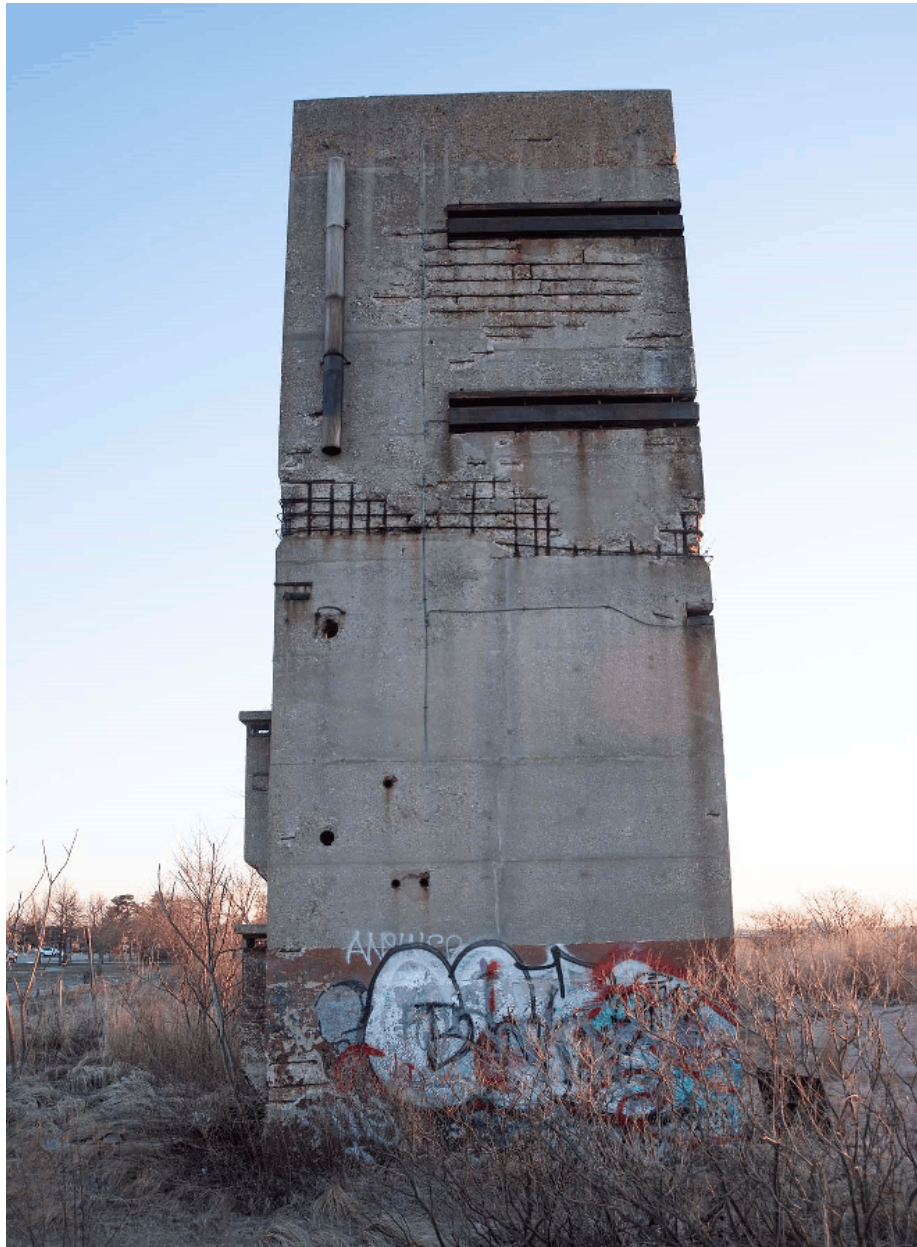
Figure 36 Miller Field Fire Control Tower, Southwest Façade, Facing Northeast (Attenborough 2022).

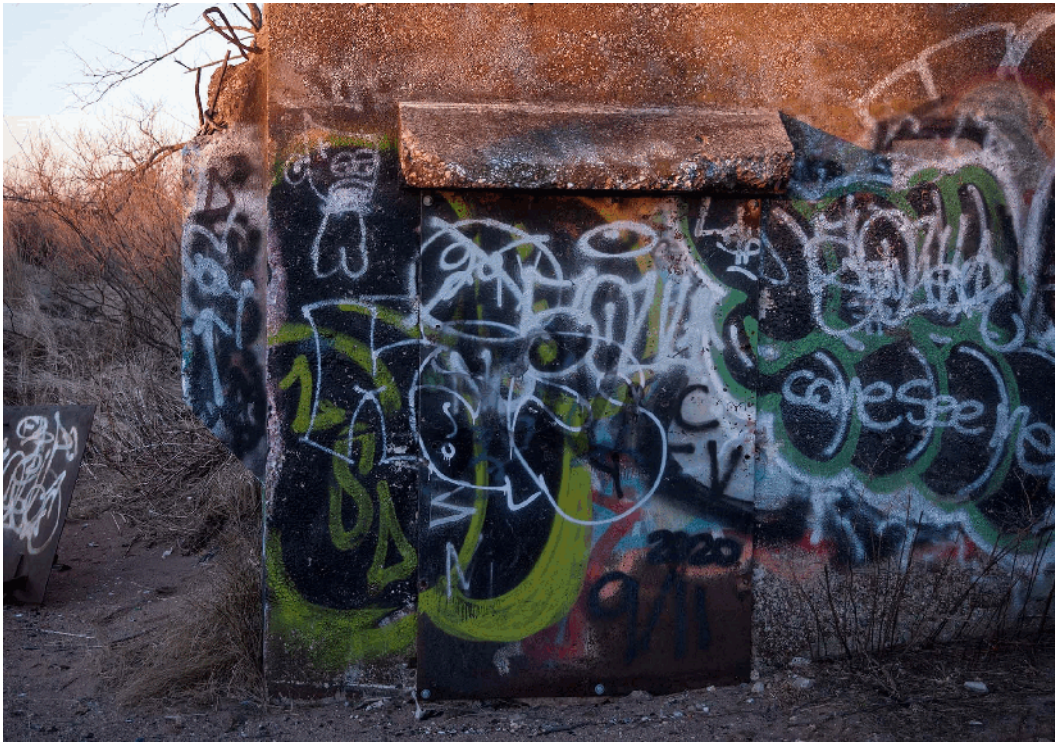
The entrance to the structure is from a 4-foot (1.22 m) wide door opening on the northeast side that has a small cast concrete pent roof above. While this entrance was blocked by a large steel plate during the 2021 field visit, during archaeological investigations in March of 2022, this plate was found to be removed, providing access to the interior. The first two stories have fresh air shafts on the southeast side and chimney shafts on the northwest sides of the structure. Ceiling heights of each floor are approximately 8 feet (2.44 m) high. Various metal electrical equipment boxes and electrical conduits are still present largely on the first level, but also present on other levels. Metal ladder rungs embedded in the concrete on the northwest interior walls lead to upper levels and the ladder openings at each level still possess their steel pipe railings. The third level has a 4-inch (10.16 cm) rectangular slit opening clad with a steel plate on the southeast side facing the ocean. Fourth and fifth levels have double viewing slits for azimuth and DPF instruments facing the shore. The slit surfaces are clad with steel plating. Slits on both floors wrap around slightly more than half the width of the southwest and northeast sides. Steel bars placed vertically within the slits support the concrete walls. Both fourth and fifth floors had two azimuth and two DPF instrument mounts which are still extant on the floor. A steel hinged hatch that covered the opening to the roof level is no longer extant.

Figure 37 Miller Field Fire Control Tower, Detail of Northeast Façade Entrance and Damaged Ventilation Inlet, Facing Southwest (Attenborough 2022).

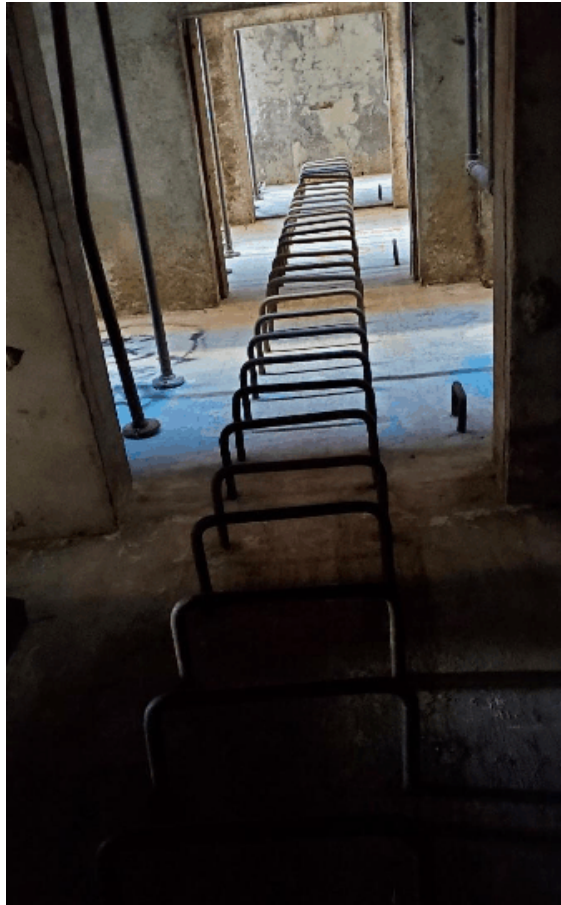
Figure 38 Interior, Miller Field Fire Control Tower, View of Ladder, Facing Northwest (Attenborough 2022).

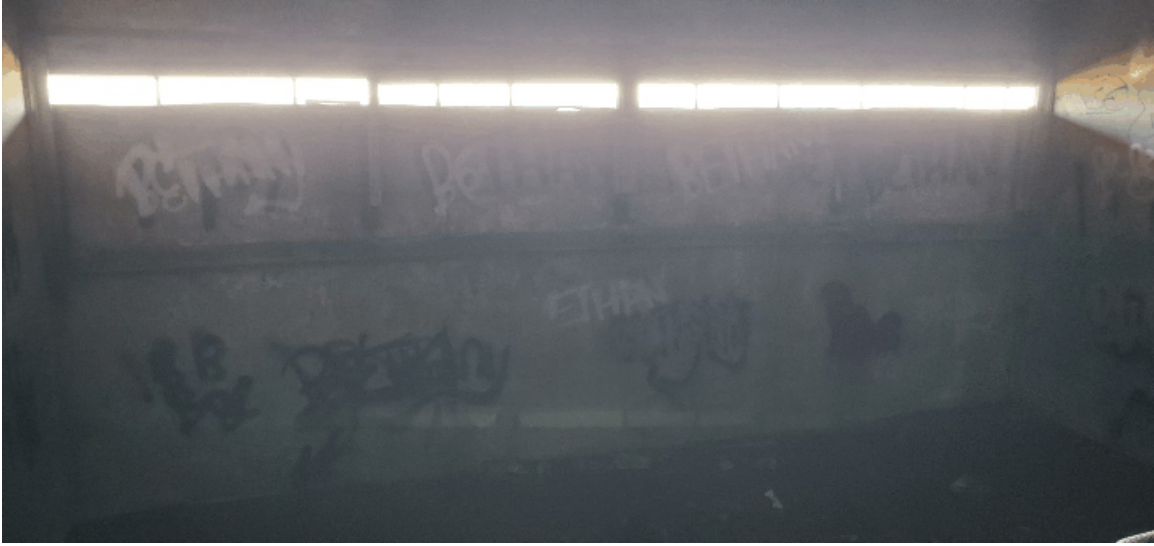
Figure 39 Interior, Miller Field Fire Control Tower, Third Level Showing Single Observation Slit, Facing Southeast (Attenborough 2022).

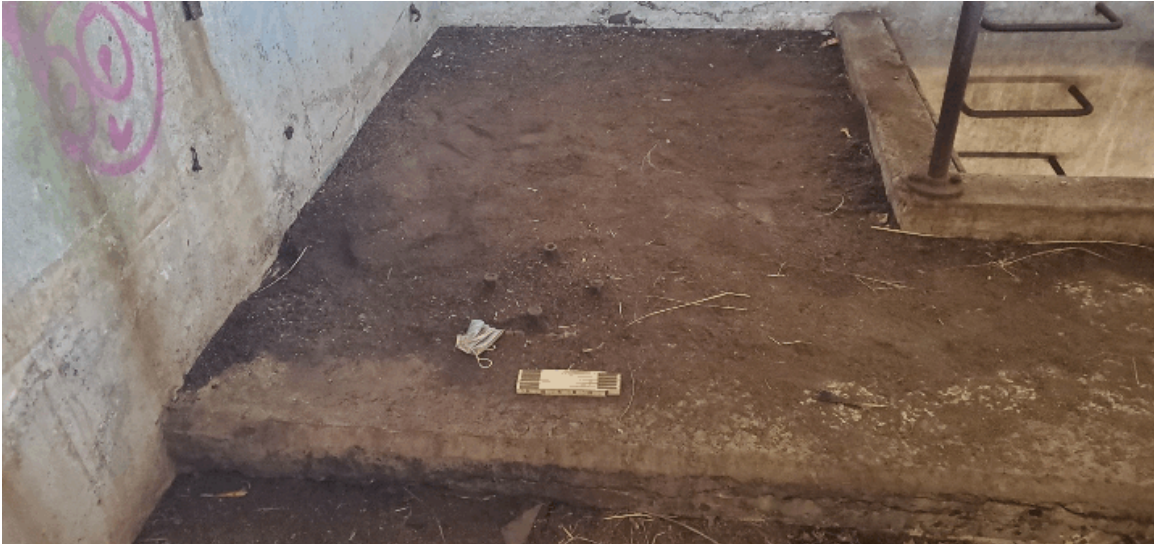
Figure 40 Interior, Miller Field Fire Control Tower, Fourth Level Showing Azimuth Instrument Base Connection (Four Bolts Above Rule), Facing Northwest (Attenborough 2022).

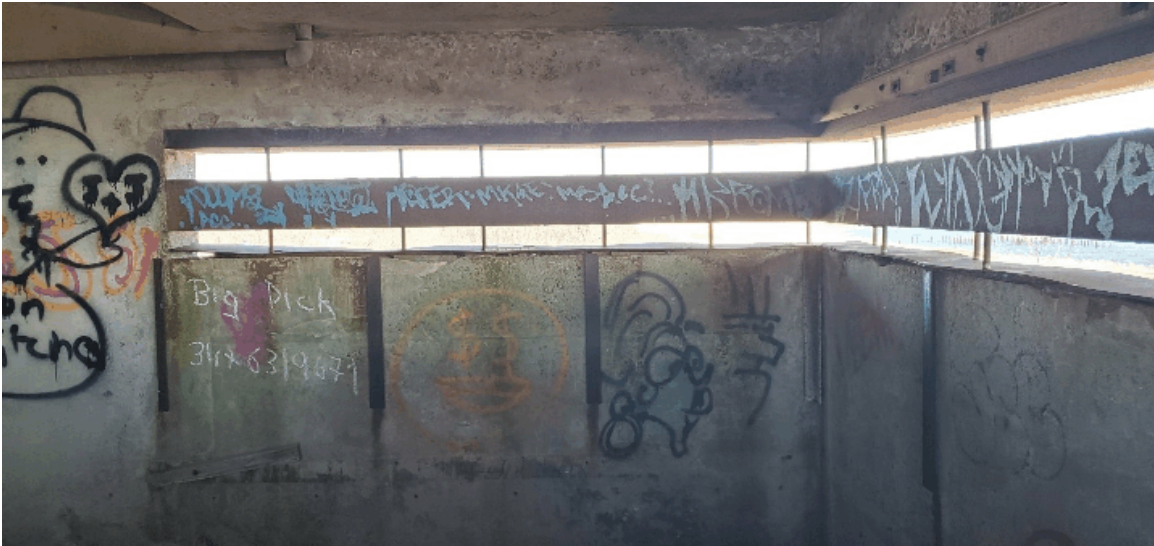
Figure 41 Interior, Miller Field Fire Control Tower, Fifth Level Instrument Observation Slits, Facing Northeast (Attenborough 2022).

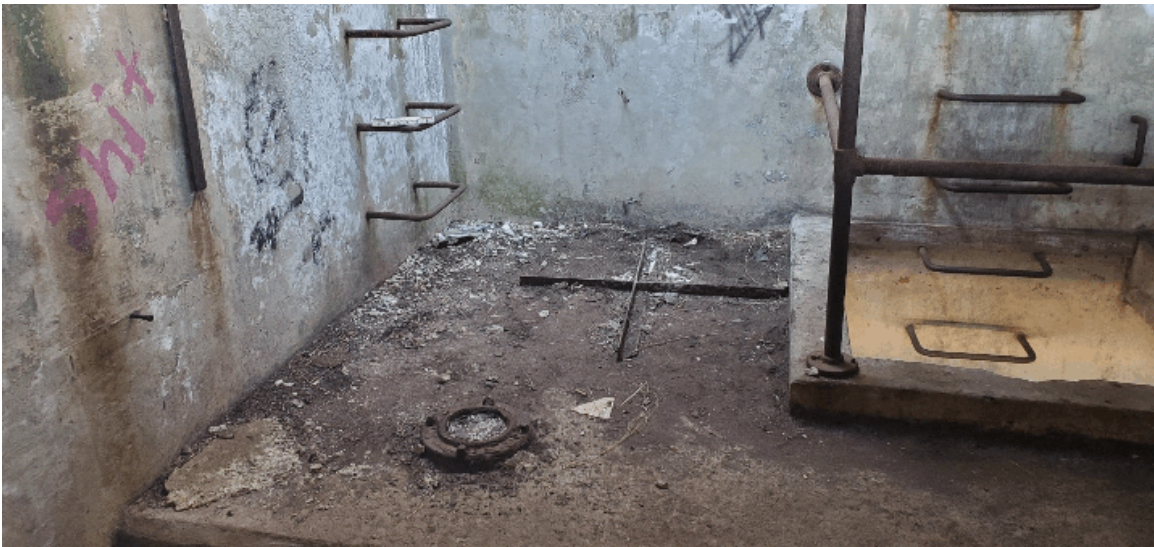
Figure 42 Interior, Miller Field Fire Control Tower, Fifth Level Showing Azimuth Instrument Base Connection (Circular Object, Lower Left), Facing Northwest (Attenborough 2022).

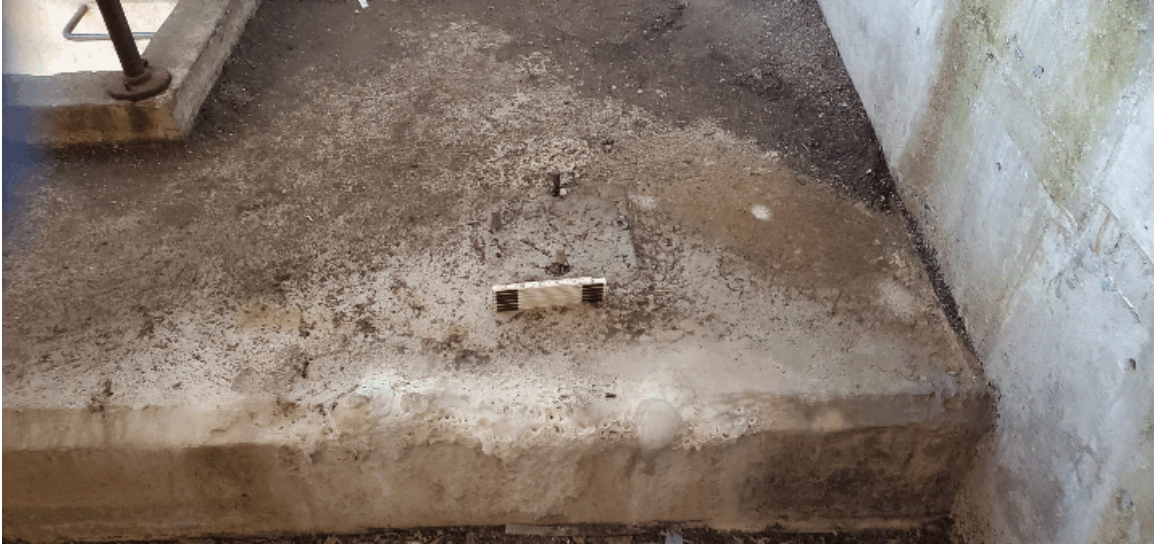
Figure 43 Interior, Miller Field Fire Control Tower, Fifth Level Showing DPF Instrument Base Connection, Facing Northwest (Attenborough 2022).

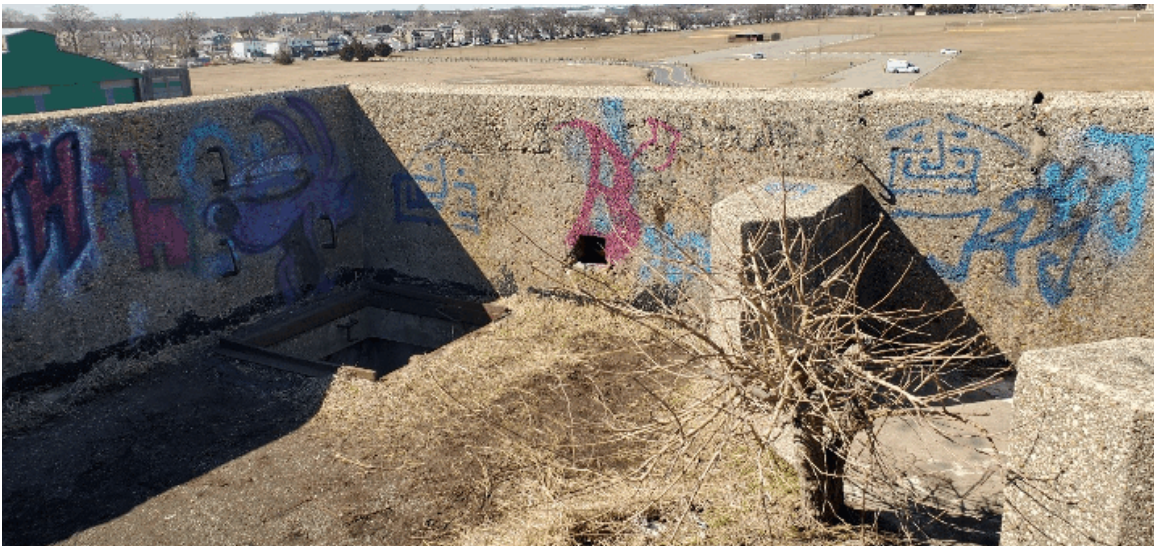
Figure 44 Miller Field Fire Control Tower, Parapet Level, Facing West (Attenborough 2022).

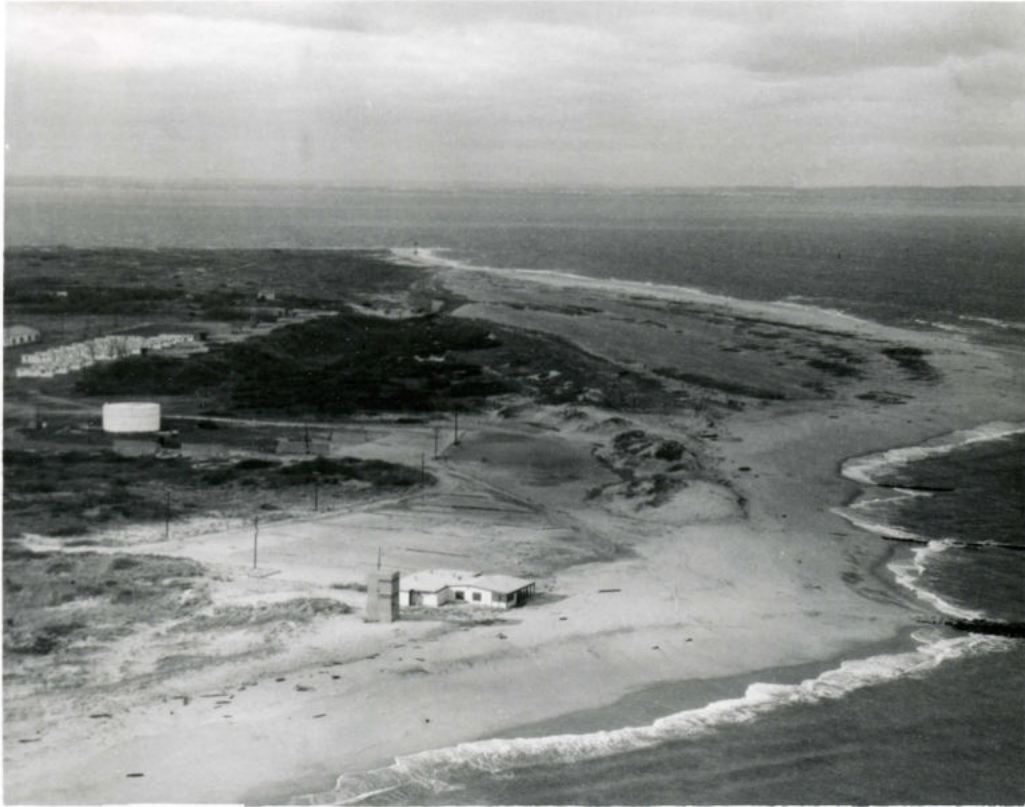
Figure 45 Image Showing Fire Control Tower at North Beach, Sandy Hook, New Jersey in 1960. Source: NPS GATE. Courtesy of Shawn Welch of AGFA.
