**MEMORANDUM – COASTAL ENGINEERING REVIEW  
SOUTHEAST REGION OFFICE – IMPLICATIONS OF REMOVAL OF  
DISPLACED RIPRAP AND JETTY CREATION  
TAR 20171**

4 May 2022

**INTRODUCTION AND TECHNICAL ASSISTANCE REQUEST (TAR)**

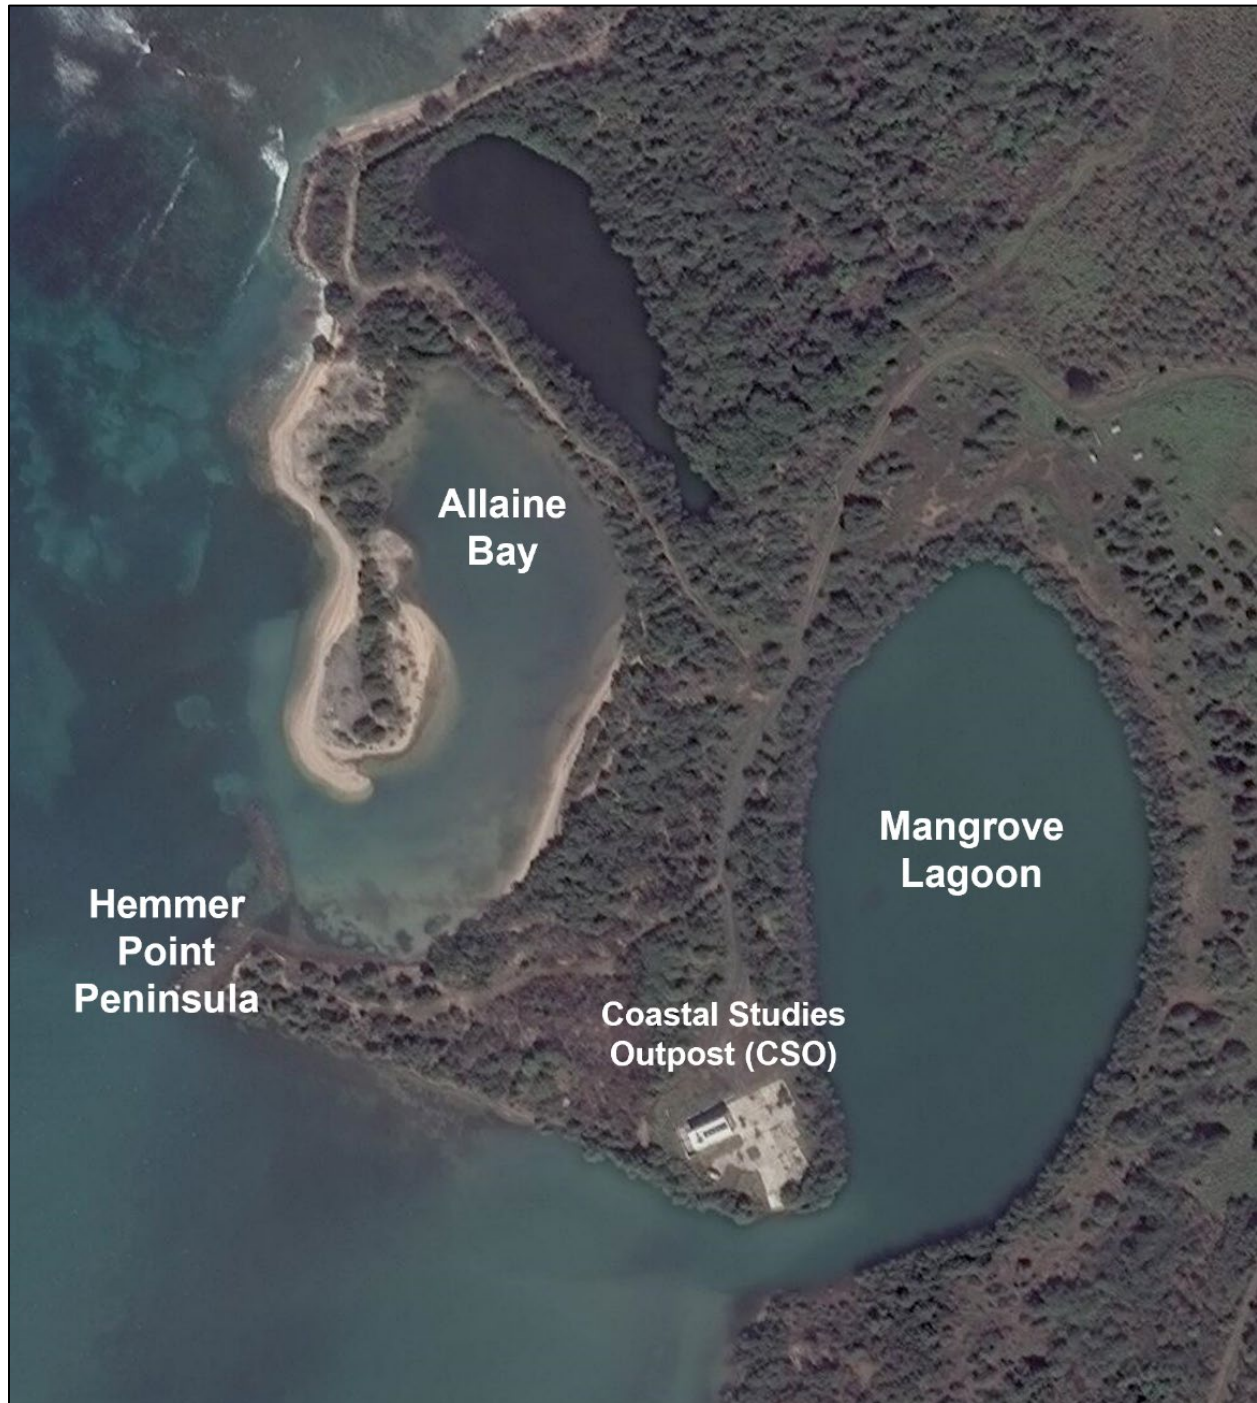
Figure 2. 2019 Aerial Image of the Area of Interest (NPS 2022)

Salt River Bay National Historical Park and Ecological Preserve (SARI) is located along the north/central coast of St. Croix, United States Virgin Island (USVI) (figure 1). SARI was created by Congress in 1992 to preserve, protect, and interpret nationally significant natural and cultural resources. It contains 73 acres of National Park Service (NPS)-owned land, and its full boundaries contain a combination of marine, estuarine, and terrestrial habitats, including coral reefs, seagrass beds, an undersea canyon, and the largest remaining mangrove forest within the USVI (NPS 2008). The area of interest is on the east side of Salt River Bay and includes the Mangrove Lagoon and Hemmer Point (figure 2).

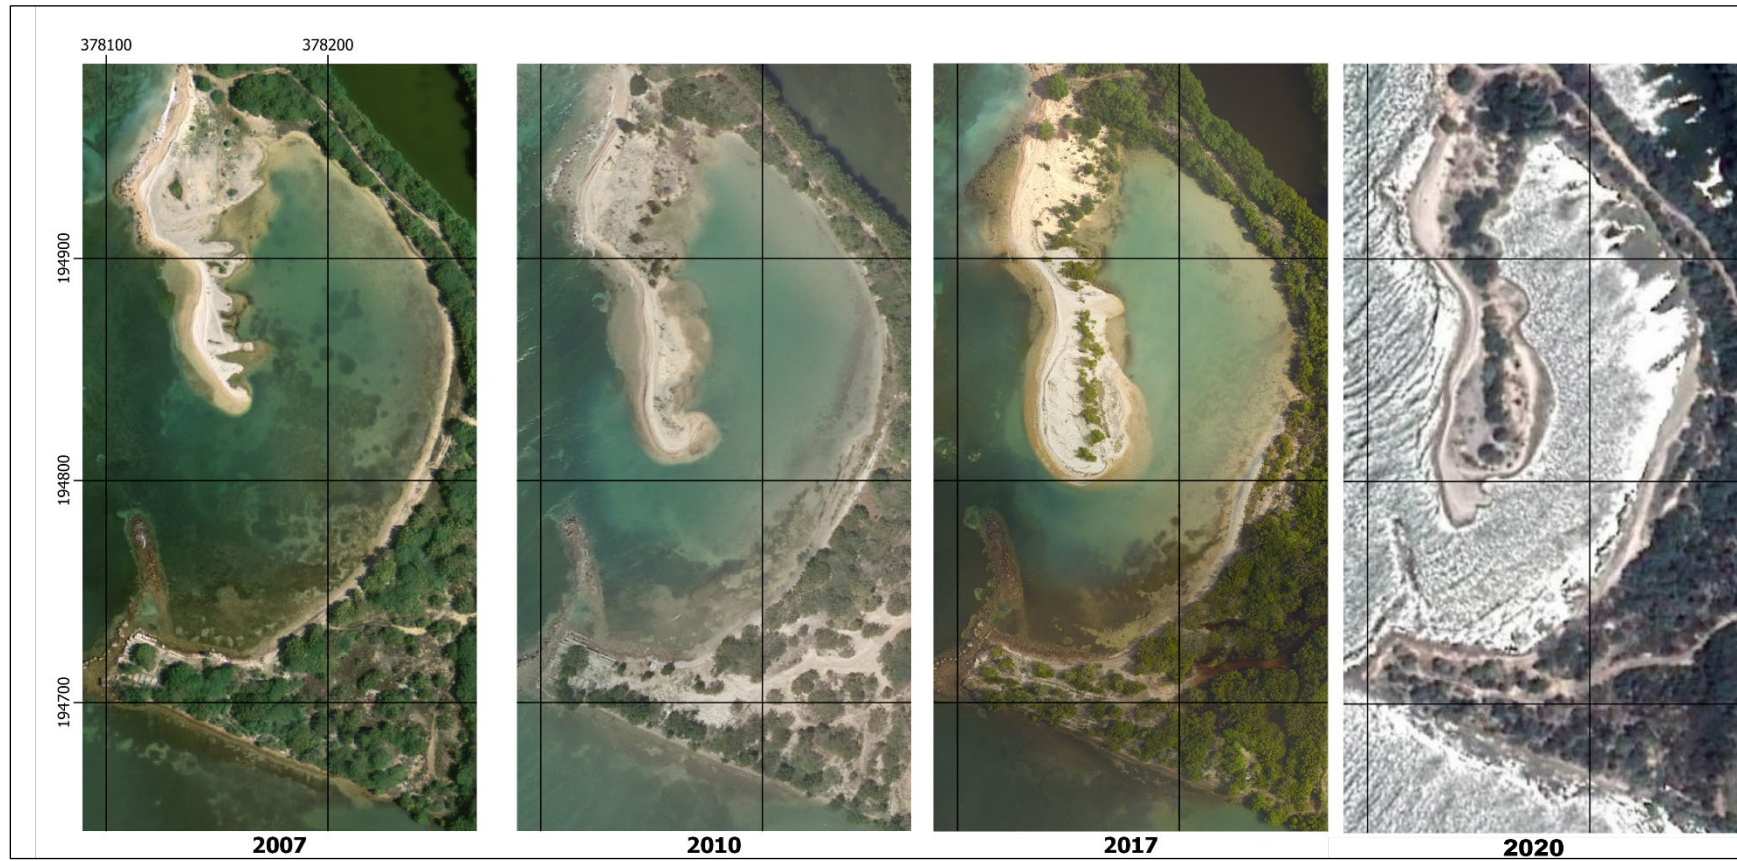
**Figure 6. Accretion in the Area of Interest**

Orthoimagery from 2007 through 2022, available through National Oceanic and Atmospheric Administration's (NOAA's) mapping website, was downloaded and analyzed for the area of interest and is shown in figure 6. This imagery confirms an overall southern/southwestern depositional pattern, showing consistent accretion of the spit that protects Allaine Bay from 2007 to 2020. This imagery also shows that as the spit accretes, it becomes vegetated, increasing the stability of the feature. The southernmost 250 feet of the spit is unvegetated in the 2010 image, and then has well-developed vegetation with approximately 50 additional feet of southern accretion and increased width of approximately 50 feet in the 2017 image. The stability this vegetation provides is also evident because of the minimal erosion that occurred from 2017 to 2020, after the hurricane activity that occurred in 2017 during Hurricanes Maria and Irma.

The series of orthoimages below show how the spit opposite Hemmer Point Peninsula has been accreting since 2007. The southernmost extent of the spit has accreted approximately 100 feet from 2007 to 2017. The grid coordinates are NAD83 meters (NOAA 2022a).

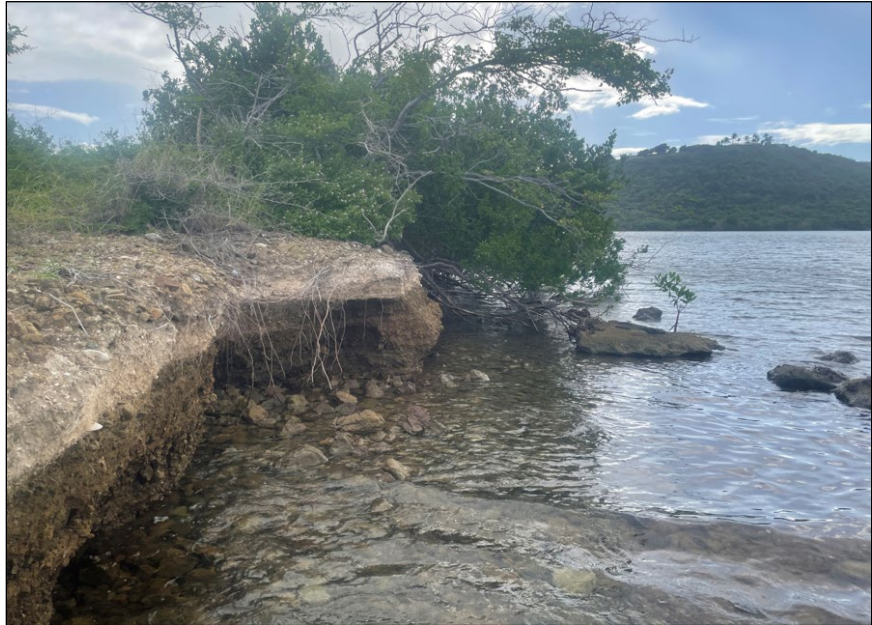
The proposed project is described to consist of “...stabilizing the end of the peninsula using geotextile cloth and quarried stone (available on St. Croix) to be placed on the end of the existing shoreline above the high tide line” (NPS 2021). The photograph to the right shows existing conditions of undercutting and loss of vegetation at Hemmer Point, and figure 11 shows the proposed riprap placement in map and cross-section views.

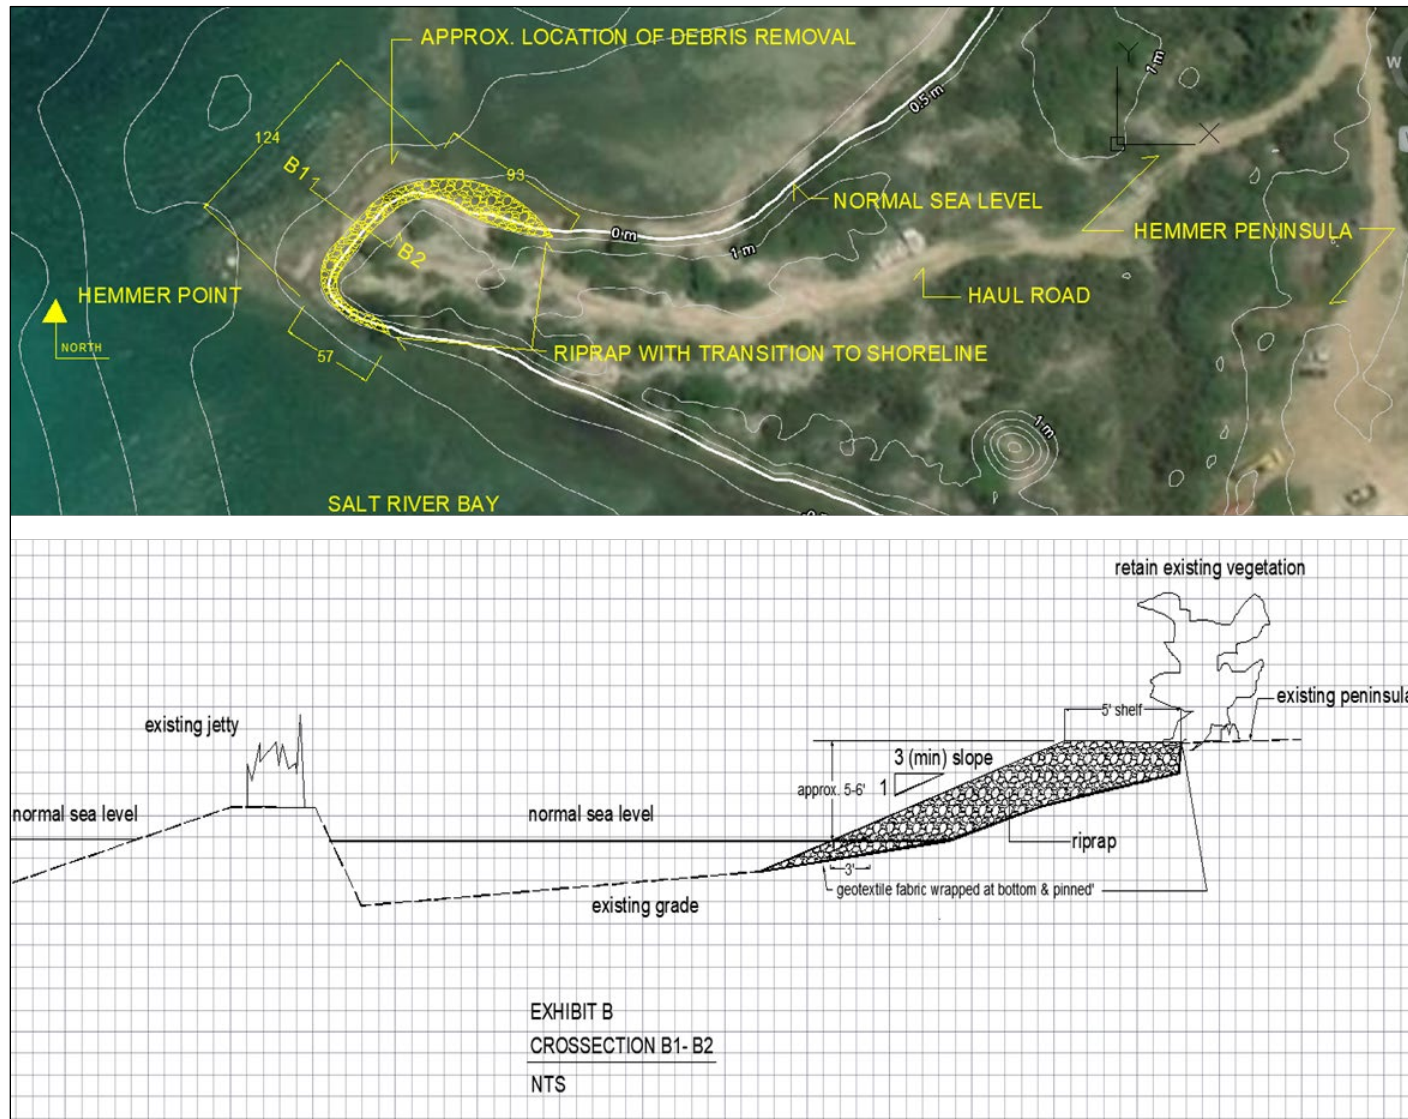
Figure 11. Proposed Shoreline Stabilization at Hemmer Point (NPS 2021)

Although the scope of work provides a suggested size of riprap, it does not provide the calculations or assumed conditions used to determine this design and specification. The plans also do not show an engineer's stamp on them, so comments regarding the technical qualification of the design engineer cannot be made. It is therefore difficult to comment on whether the proposed size will adequately stabilize Hemmer Point Peninsula.

The proposed plans do not include a readable scale; however, the cross section shows the riprap extending below the "normal sea level" line. Although one cannot fully comment without a scale, and the definition of "normal sea level" is not understood, it should be noted that the MHHW elevation is +0.35 feet VIVD09 (NOAA 2022c and figure 10), and it is therefore suggested that the design be further evaluated by the design engineer to clarify whether the design intends for the riprap to be placed below MHW. Placement of riprap to an elevation down to at least the MLLW elevation is recommended to provide the desired shoreline stability, but this results in a situation that would necessitate further regulatory interactions/submittals.

Armoring coastal areas with hard structures often causes erosion down-current of the structure, as well as locally around the structure itself. Hard structures contribute to the transfer of energy, which can lead to the overall removal of sediment from natural transport patterns; therefore, areas down-current do not receive the influx of material they had previously. Locally, additional erosion occurs due to wave reflection off the hard surfaces — waves encounter the structure, and energy is reversed with minimal dissipation, often creating scour at the base. Placing riprap on Hemmer Point may keep the feature at its current location; however, it would likely increase erosion down-current and at the base of the structure.

The SOW to stabilize Hemmer Point Peninsula provided at the time of this TAR was in a draft form, so additional detail may now be available; however, the plans in the version reviewed for this document do not have an engineer stamp, readable scale, or calculations to support the design. Additional review of these plans is suggested to ensure that the design aligns with permits and storm conditions to provide adequate stabilization to Hemmer Point. However, given the recent accretion of material in front of Hemmer Point, the placement of riprap to prevent erosion of the point may no longer be necessary.
